**TRANSCANADA HYDRO NORTHEAST INC.**

**ILP Study 2 and Study 3  
Riverbank Transect and Riverbank Erosion Studies**

***Final Study Report***

Wilder Hydroelectric Project (FERC Project No. 1892-026)  
Bellows Falls Hydroelectric Project (FERC Project No. 1855-045)  
Vernon Hydroelectric Project (FERC Project No. 1904-073)

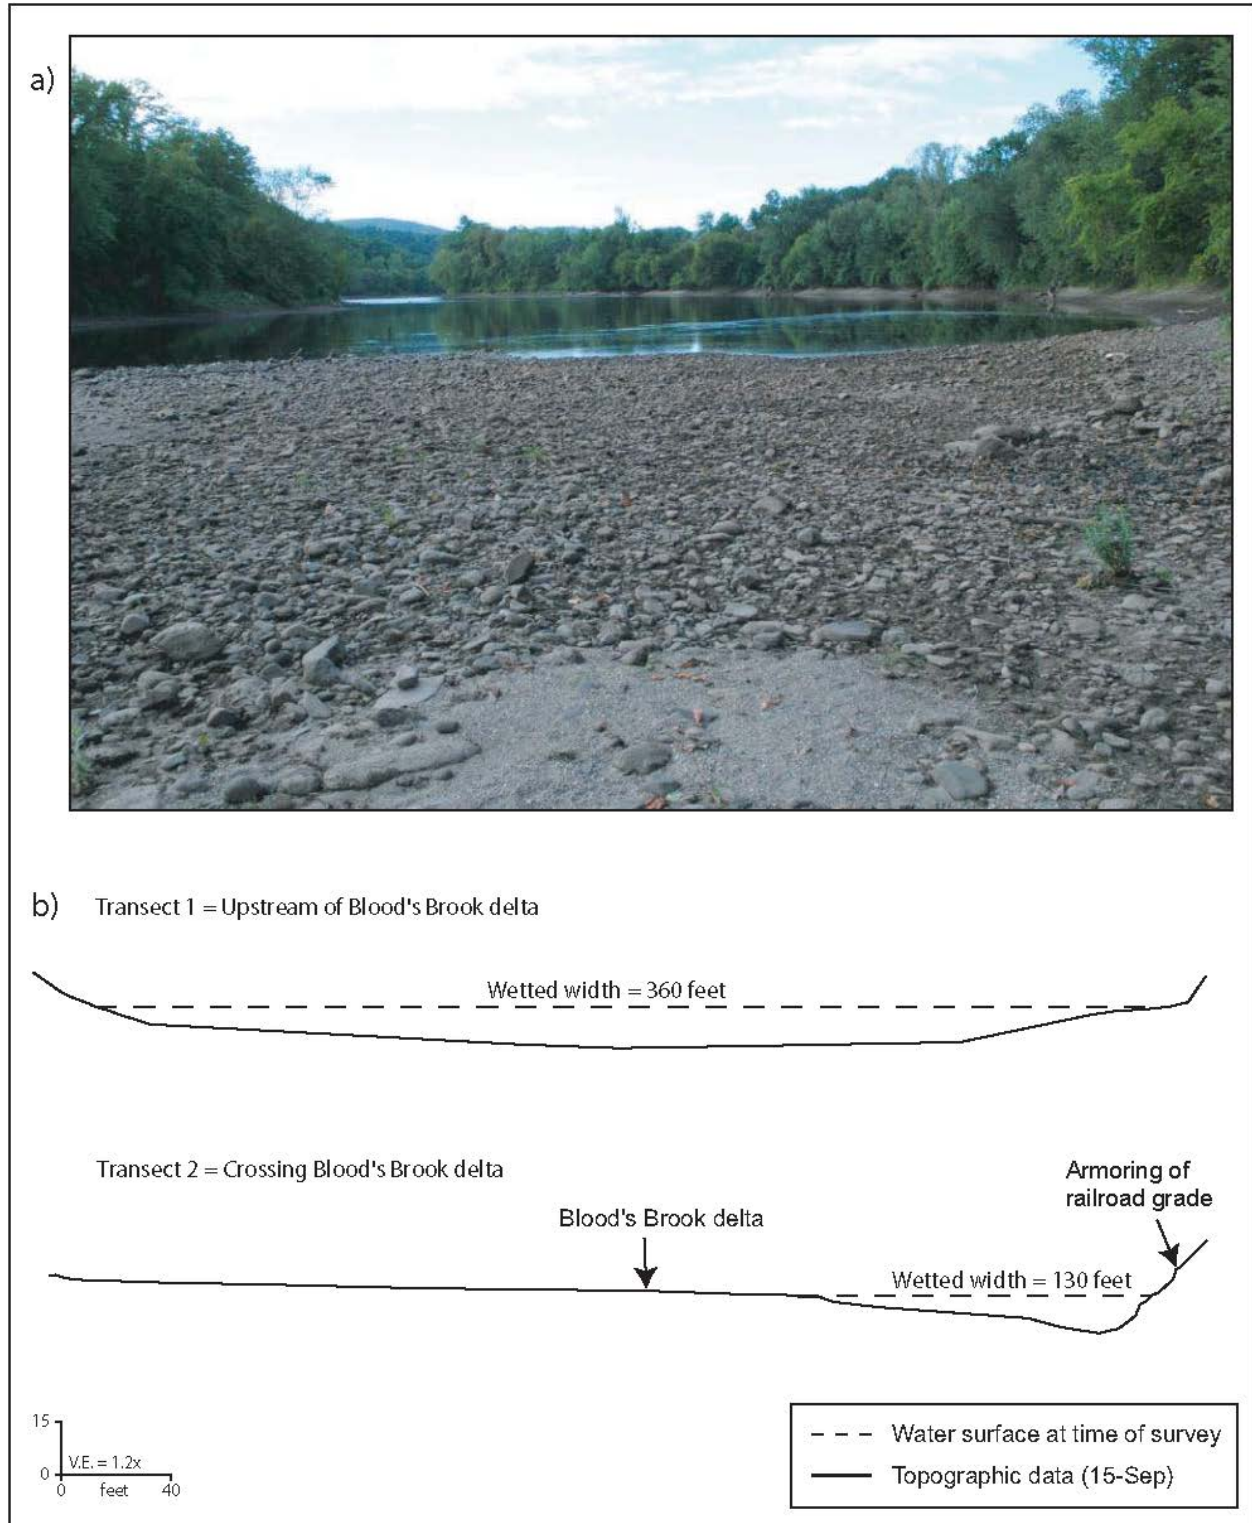
Figure 5.2.1-3. Blood's Brook has a) formed a large boulder delta that has b) narrowed the channel compared to upstream (and downstream, not shown).

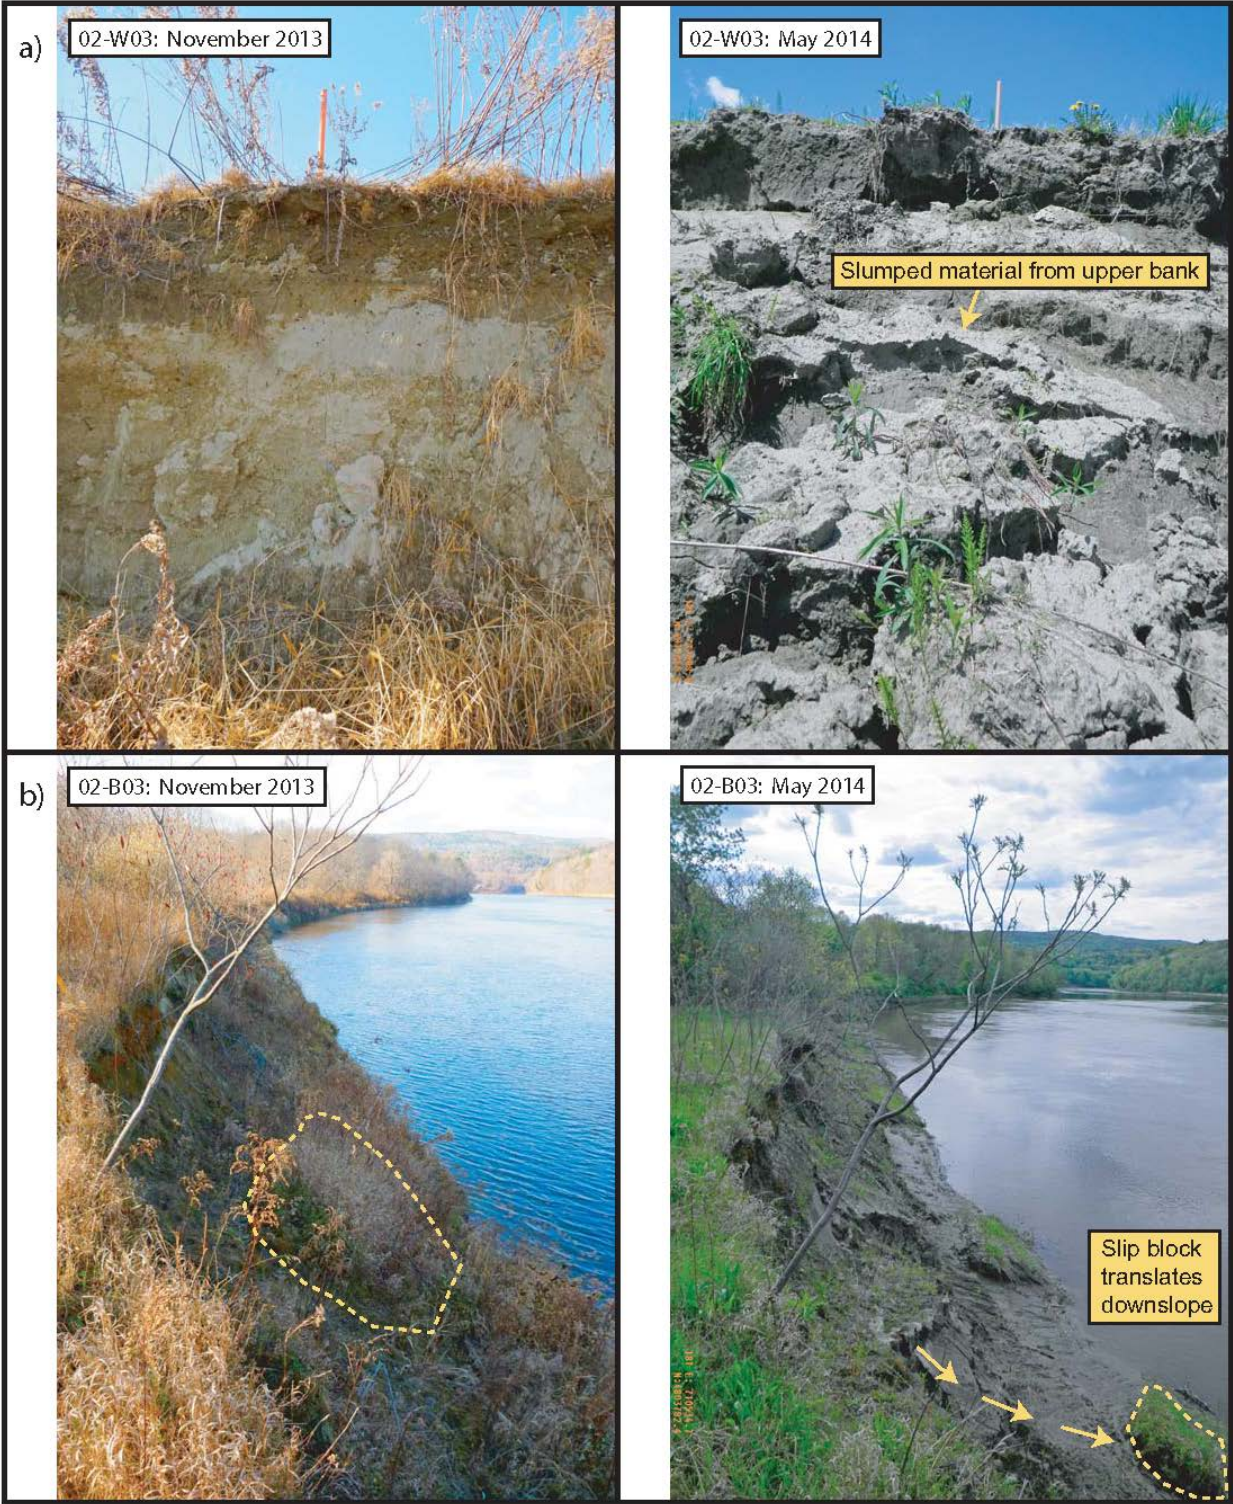
Figure 5.4.2-2a. The types of conditions observed on the repeated ground photographs included a) top of bank recession, and b) bank slope changes.

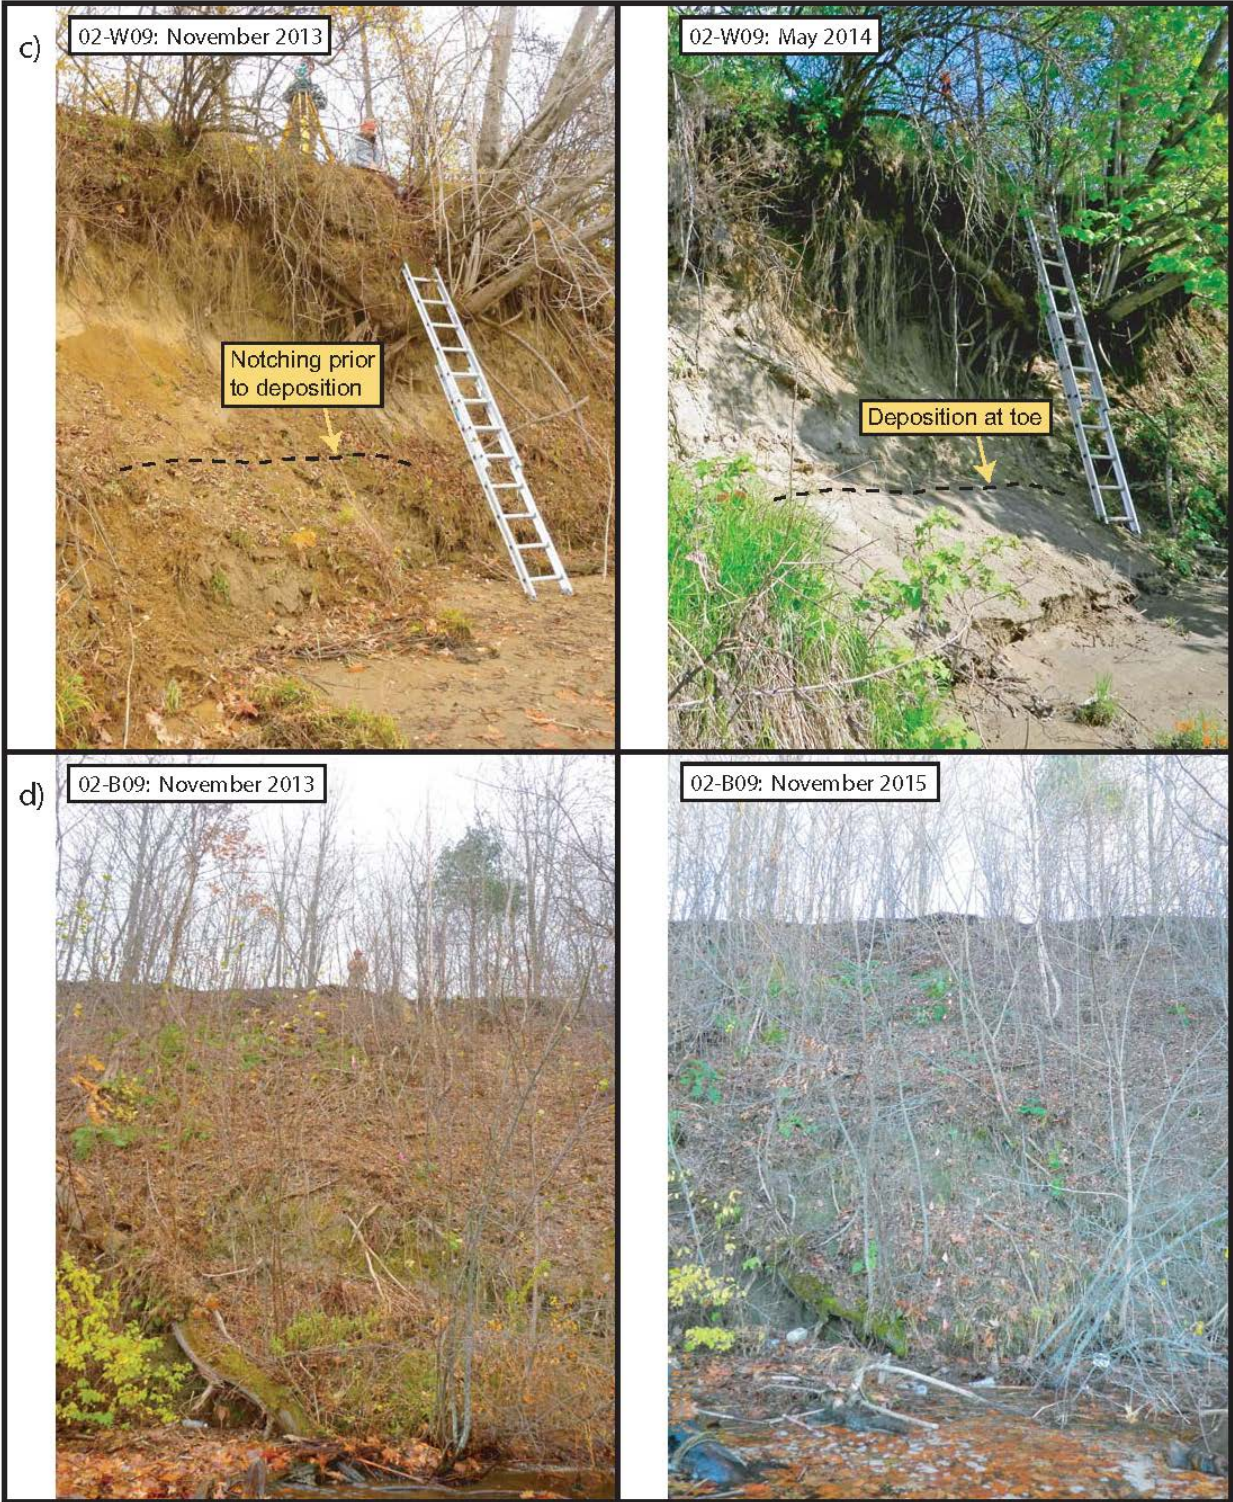
Figure 5.4.2-2b. The types of conditions observed on the repeated ground photographs included a) top of bank recession, and b) bank slope changes.

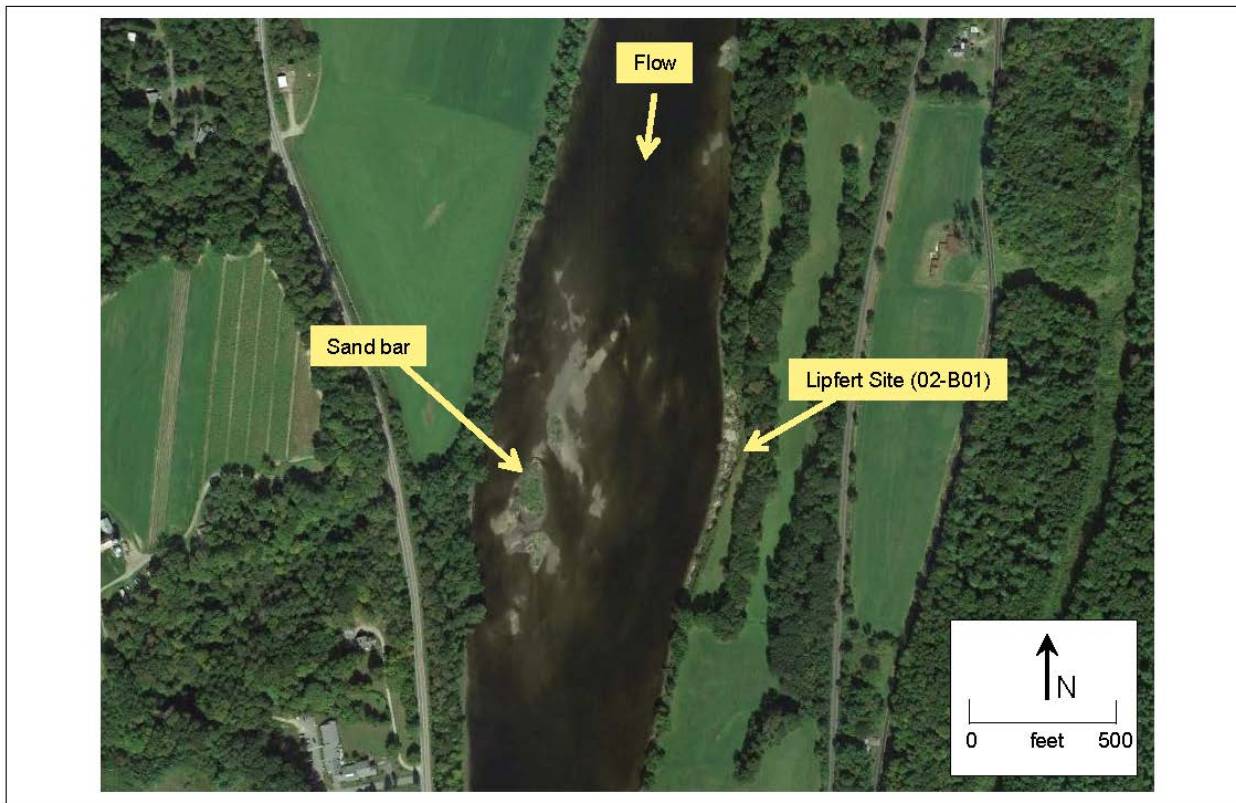
Figure 5.4.2-3. Large sand bar is situated across from 02-B01 (Lipfert site).

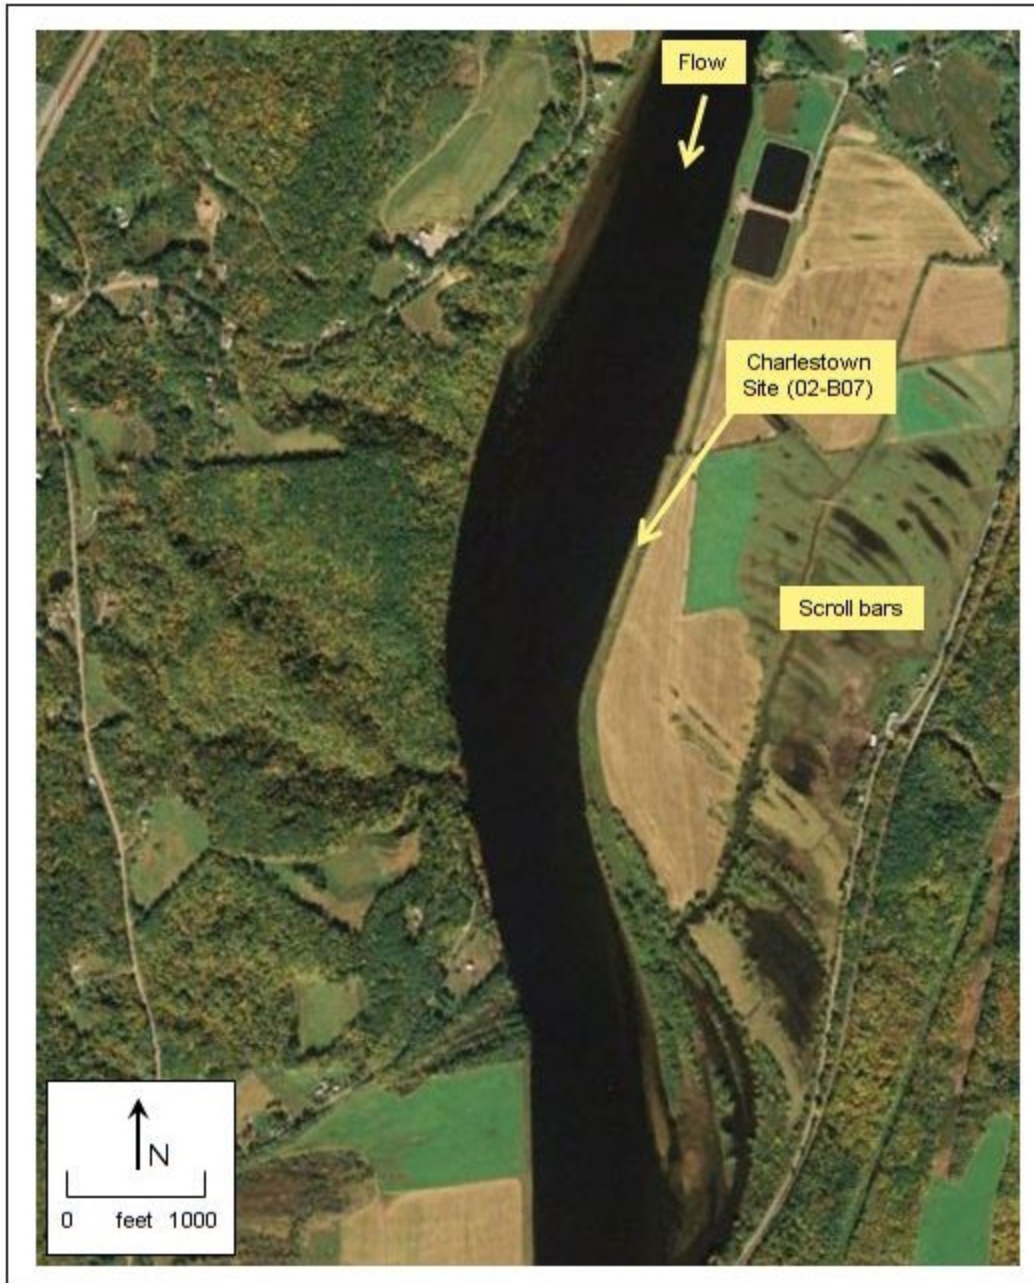
Figure 5.4.2-4. Scroll bars on floodplain at 02-B07 (Charlestown Site) are indicative of decades, if not centuries, of channel migration.

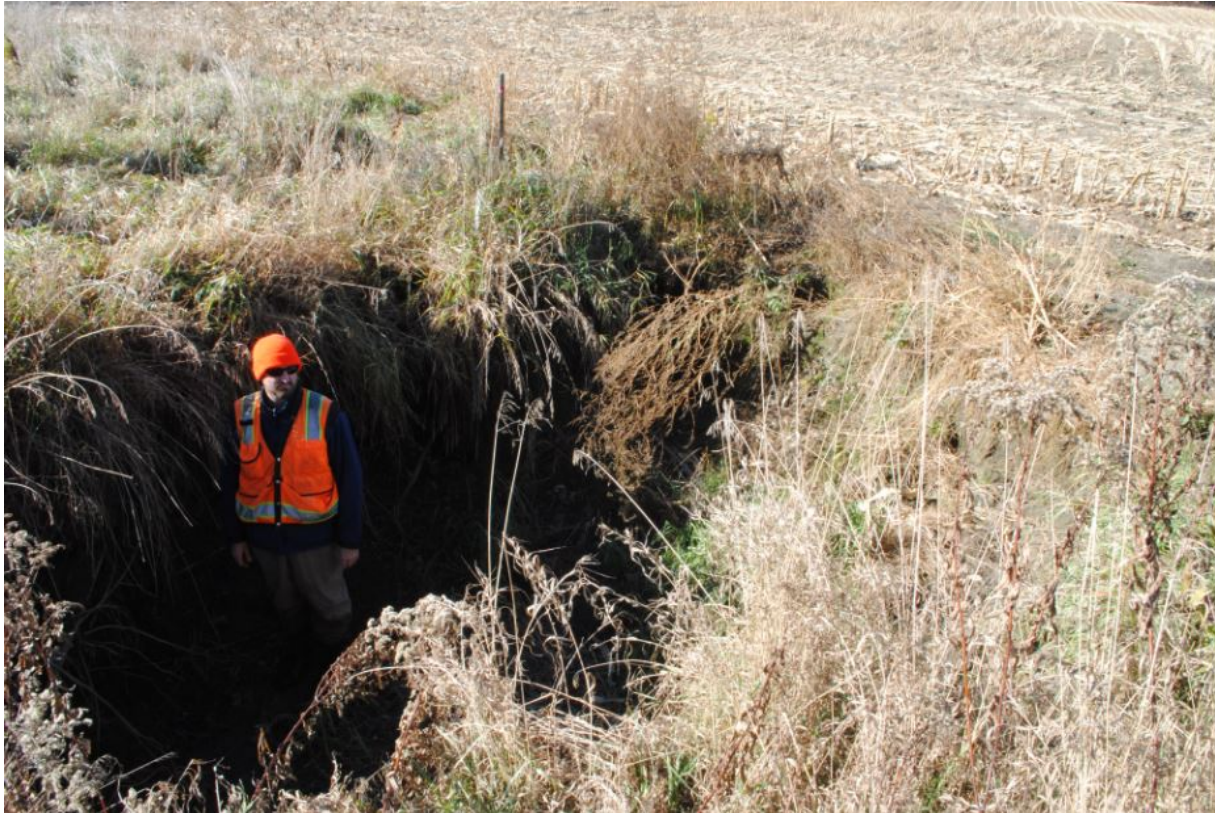
Figure 5.4.2-5. Bank collapse and recession in 2015 occurred near 02-W09 (Mudge Site) despite no recession at the transect itself.

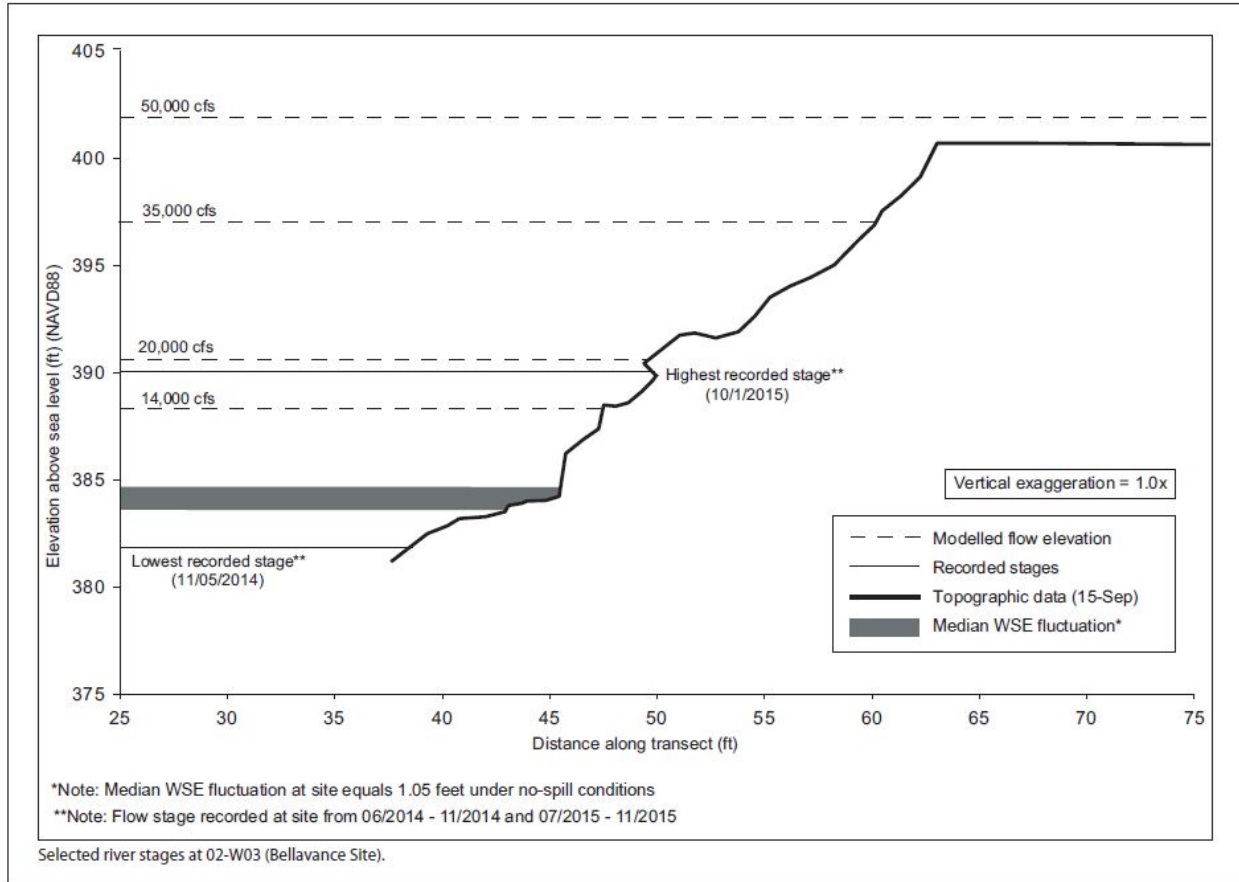
Figure 5.4.2-6. Position on bank of normal operating range aligns with location of notching at 02-W03 (Bellavance Site).

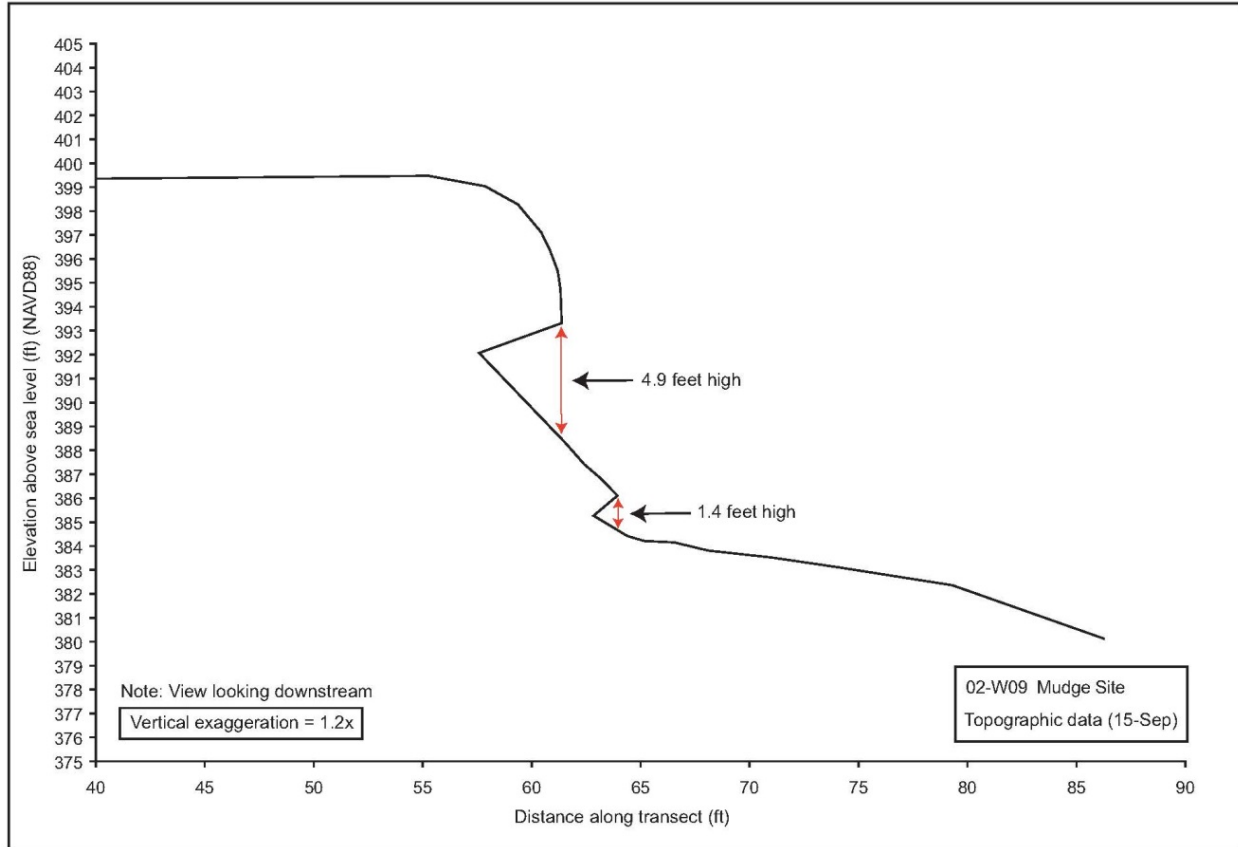
Figure 5.6.1-1. The height of overhangs is generally less than 1.5 ft but can reach nearly 5 ft (or more).

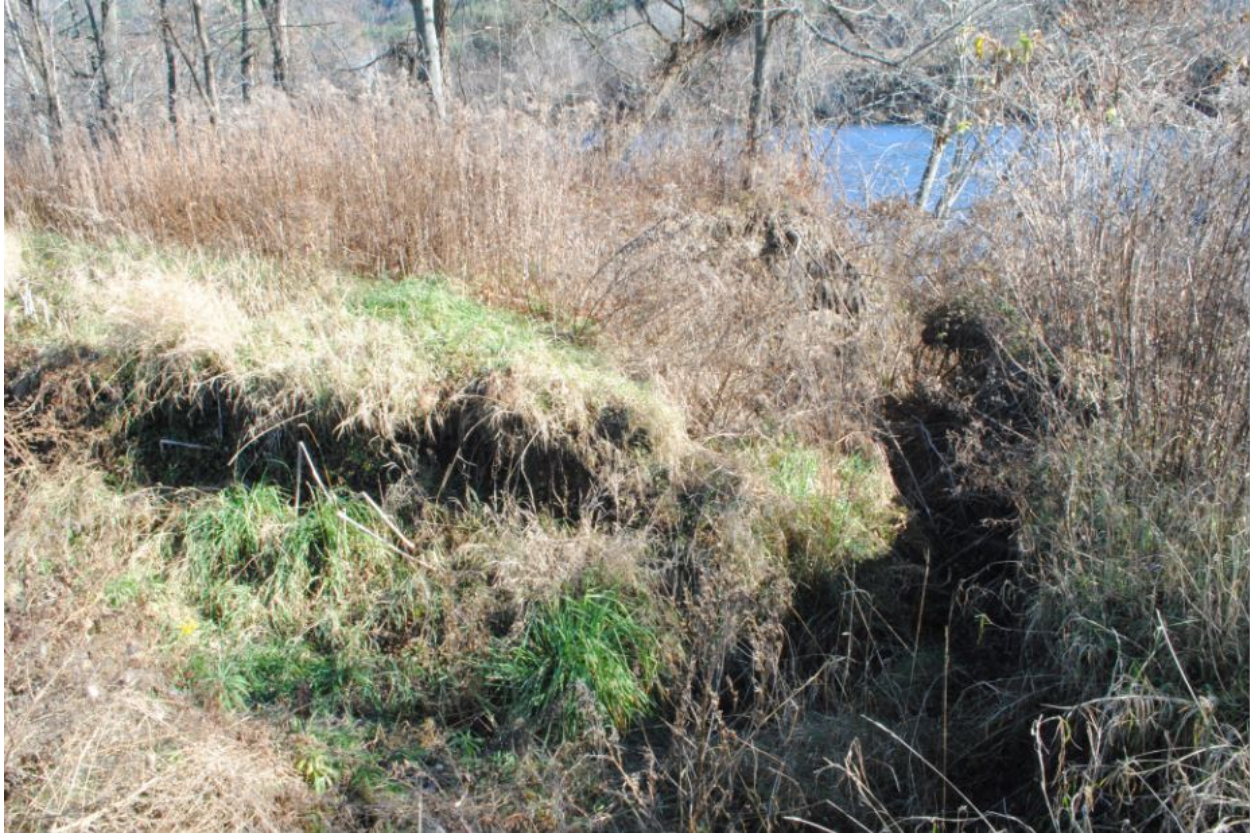
Figure 5.6.1-2. Tunnel scour can form circular depressions that transform over time into gullies as the material between the river and depression collapse. Photo from Fairlee, VT – in left foreground is portion of circular depression initially formed in 2014.

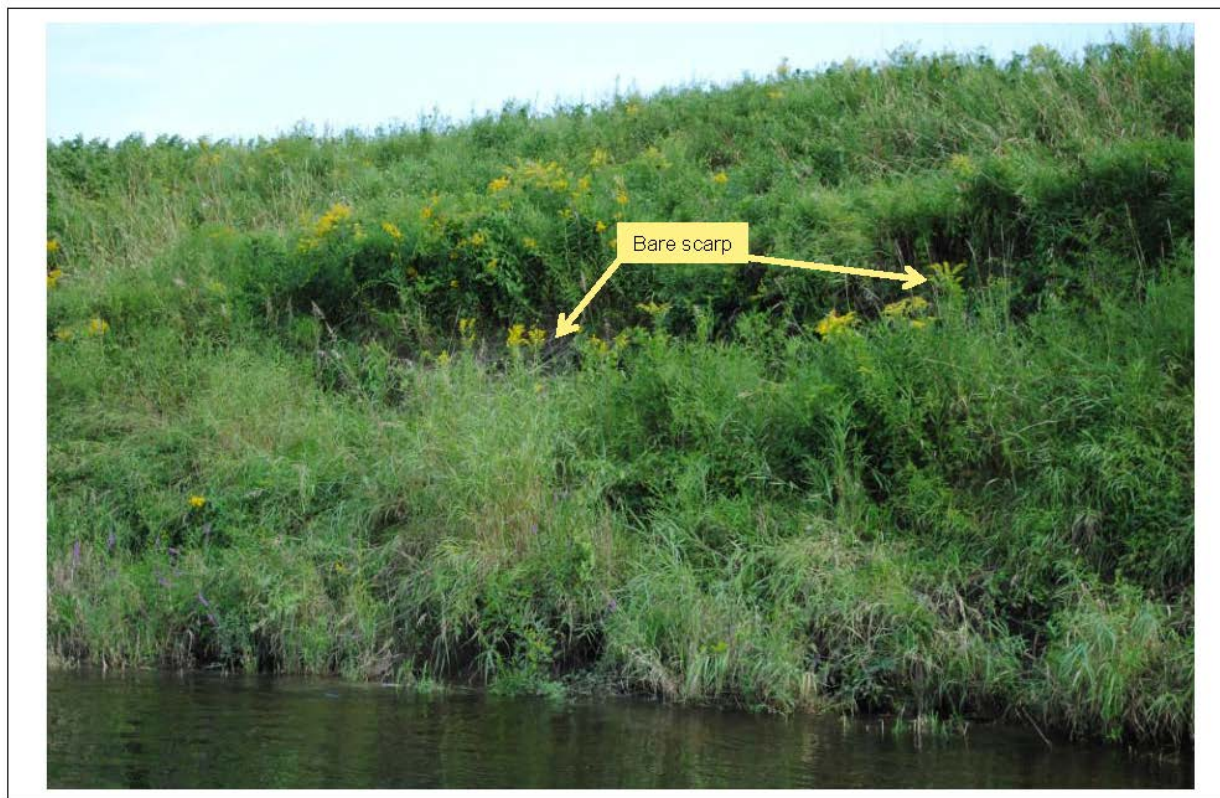
Figure 5.6.1-3. Sometimes barely visible scarps are the only evidence of active erosion on well vegetated banks.

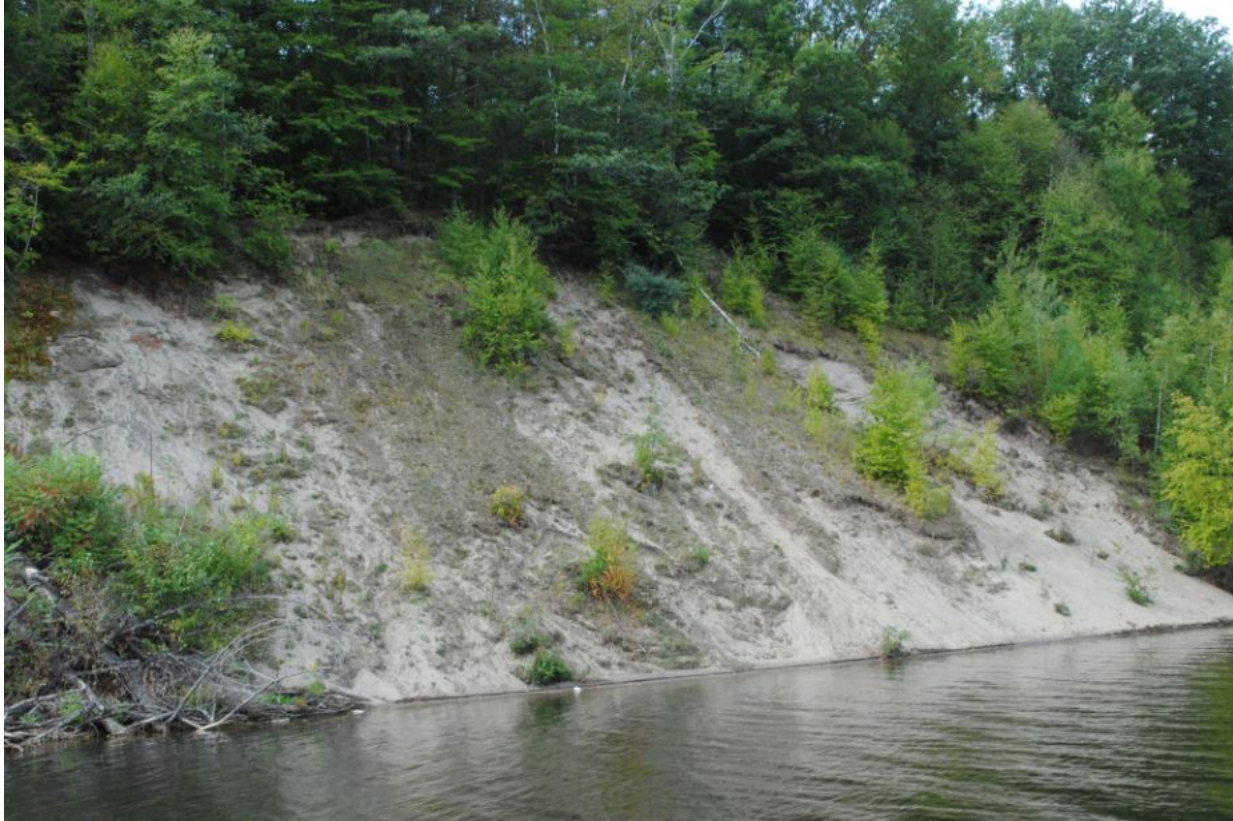
Figure 5.6.1-4. Wide colluvial apron at base of bank formed by series of adjacent sediment flows.

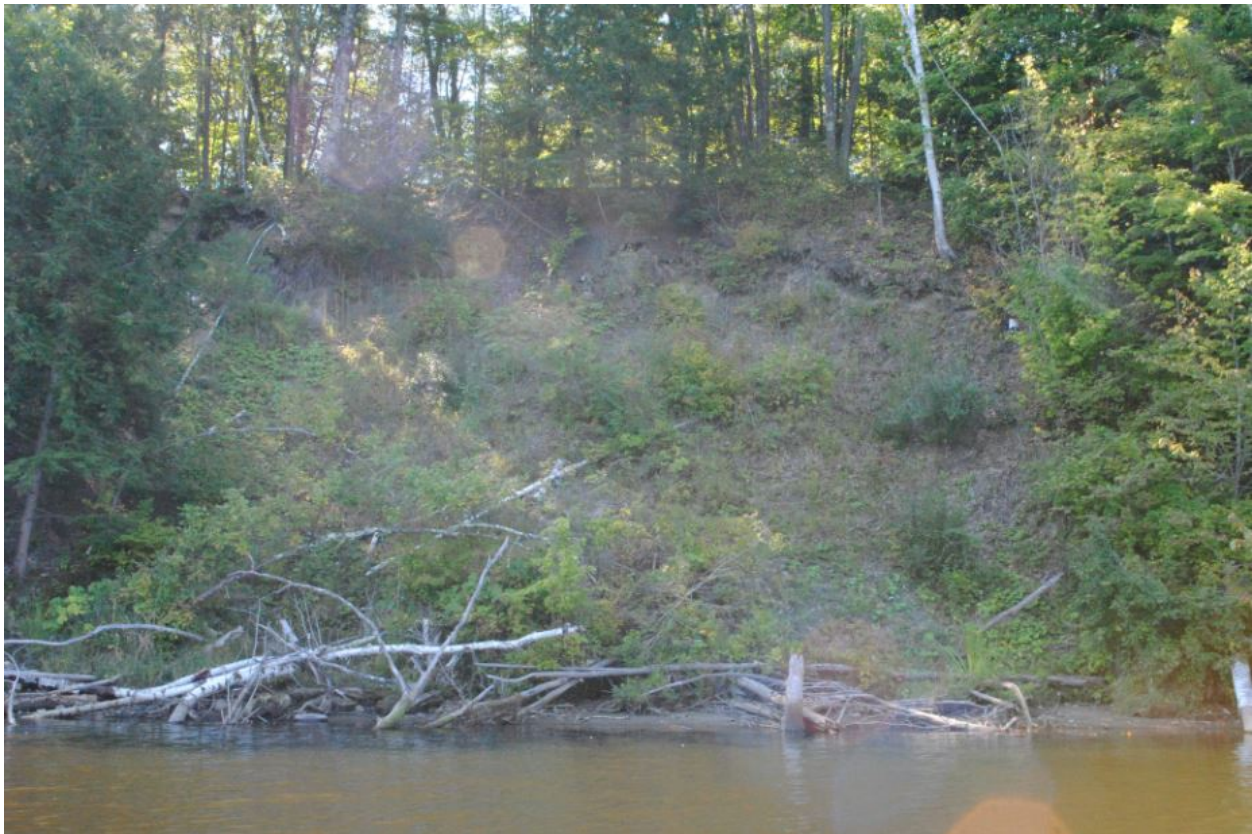
Figure 5.6.2-2. Trees that have fallen to the base of the bank may remain for several years and buttress the bank from further erosion.

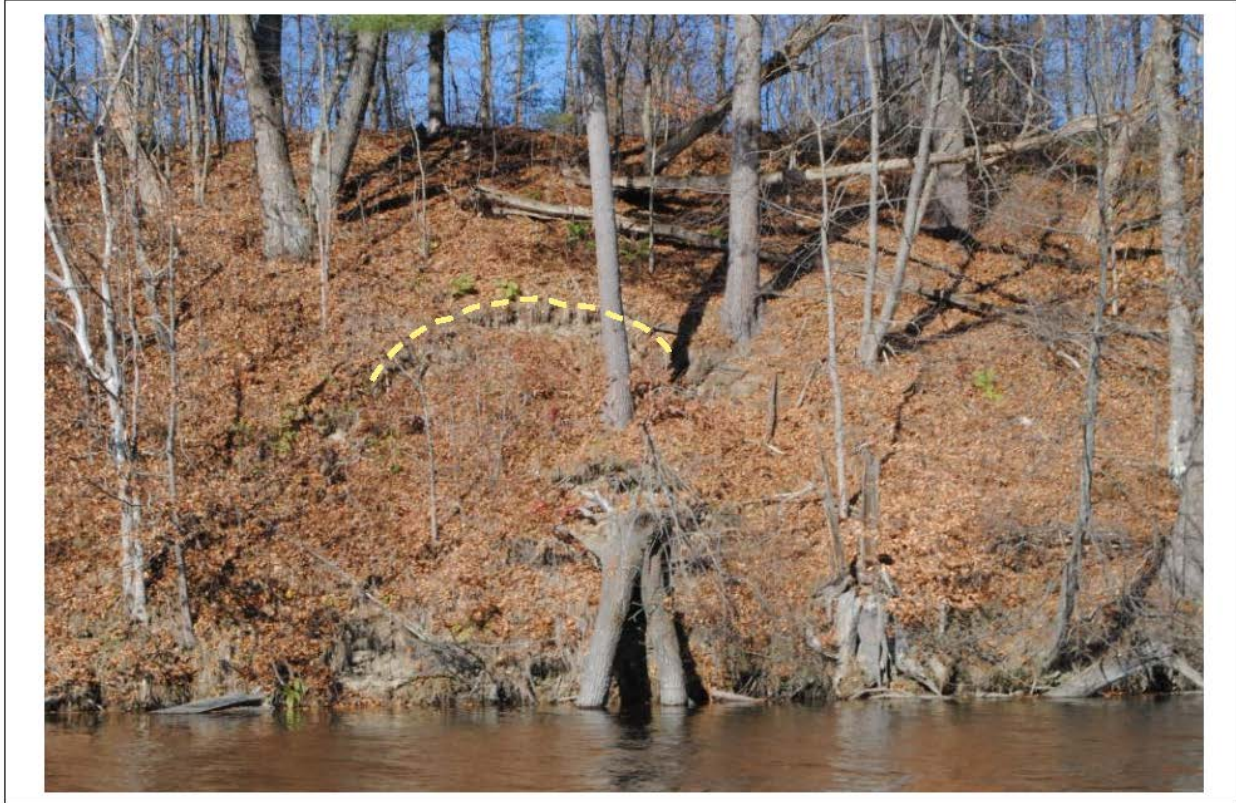
Figure 5.6.2-3. Active erosion can occur despite the presence of bank vegetation. Dashed yellow line outlines top of planar slip scarp.

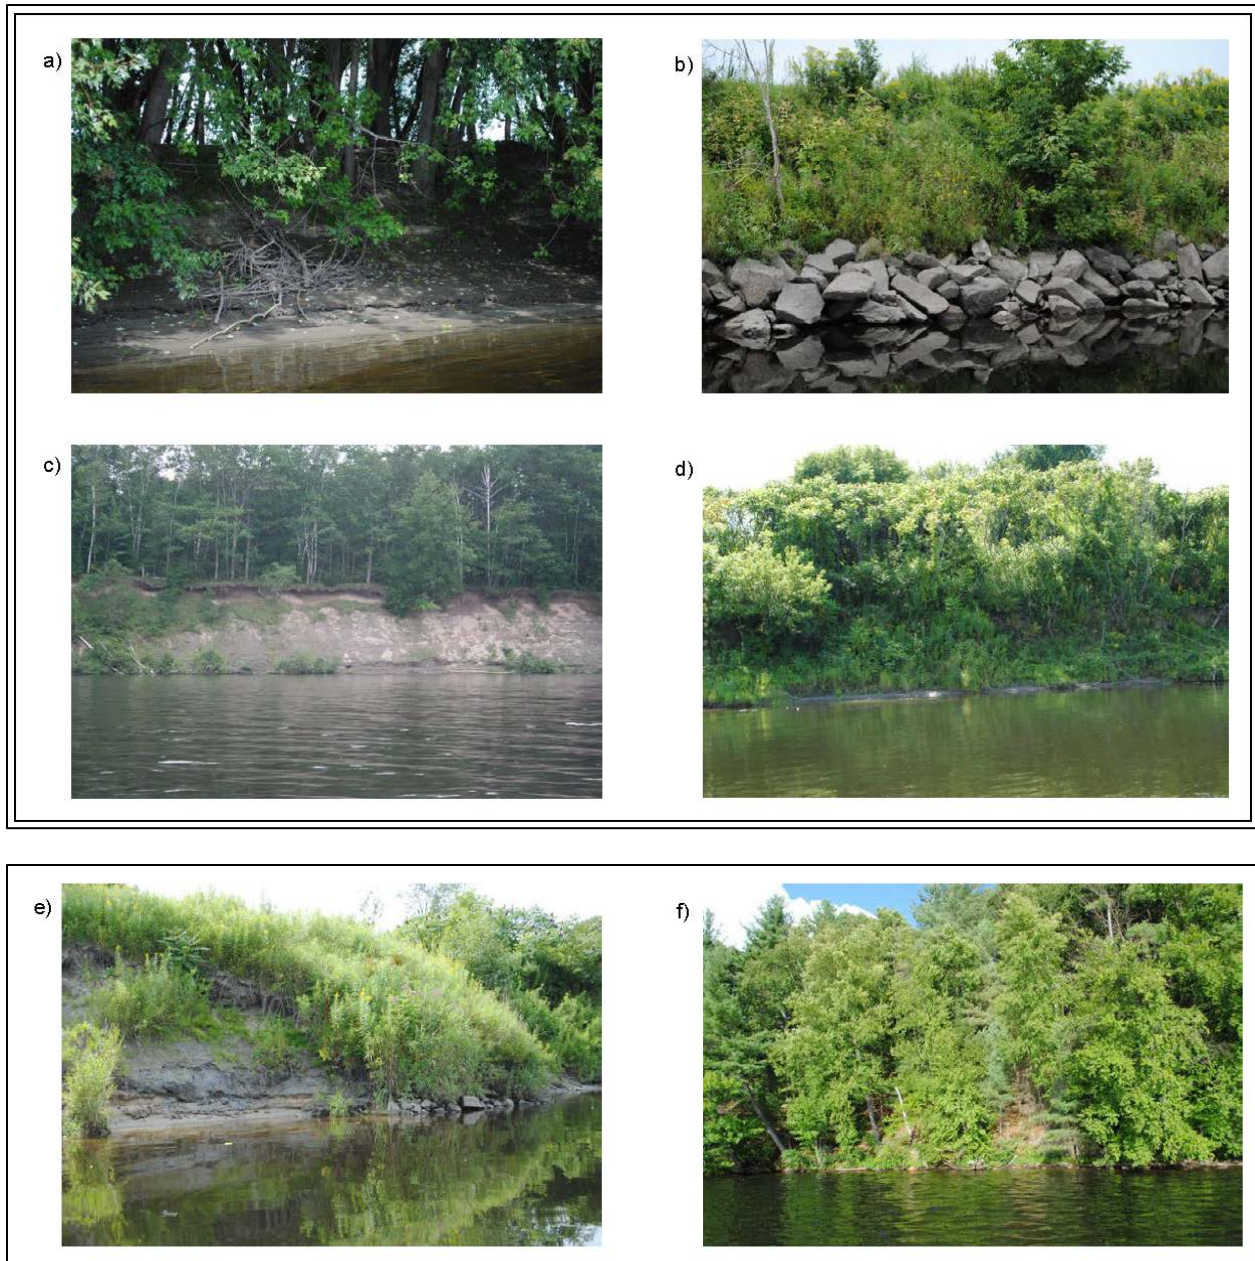
Figure 5.6.3-1. Photos of the six erosion categories: a) stable, b) armored, c) eroding, d) vegetated eroding, e) failing armor, and f) healed erosion.

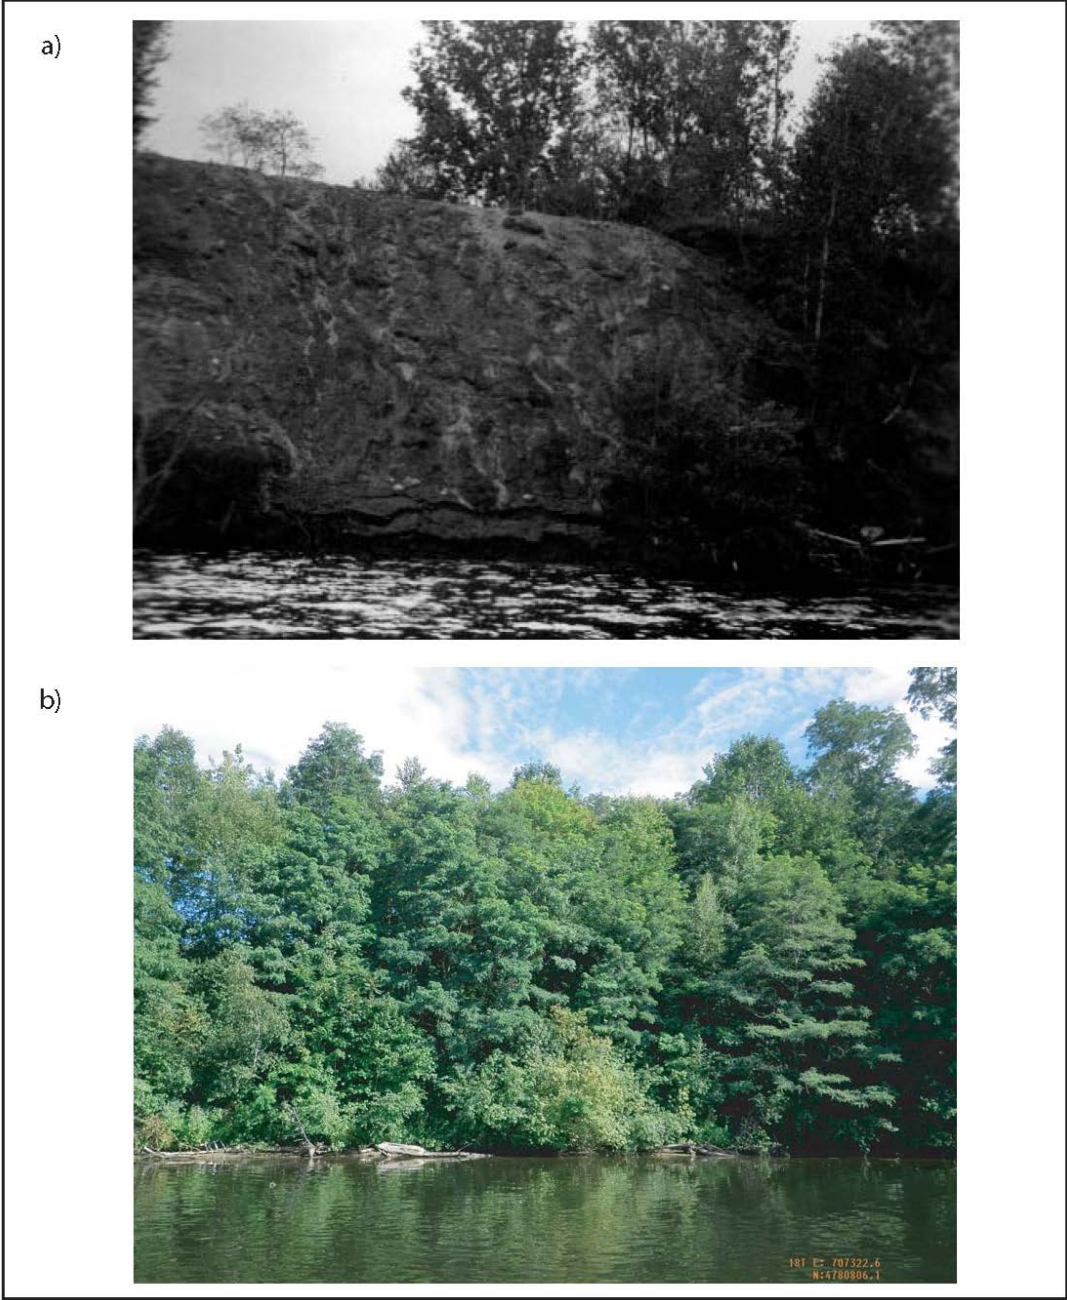
Figure 5.6.3-2. Bank near 02-B09 shown in a) historic photo from 1964, and b) modern photo from 2015. Previously eroding bank dominated by sediment flows is now stable.

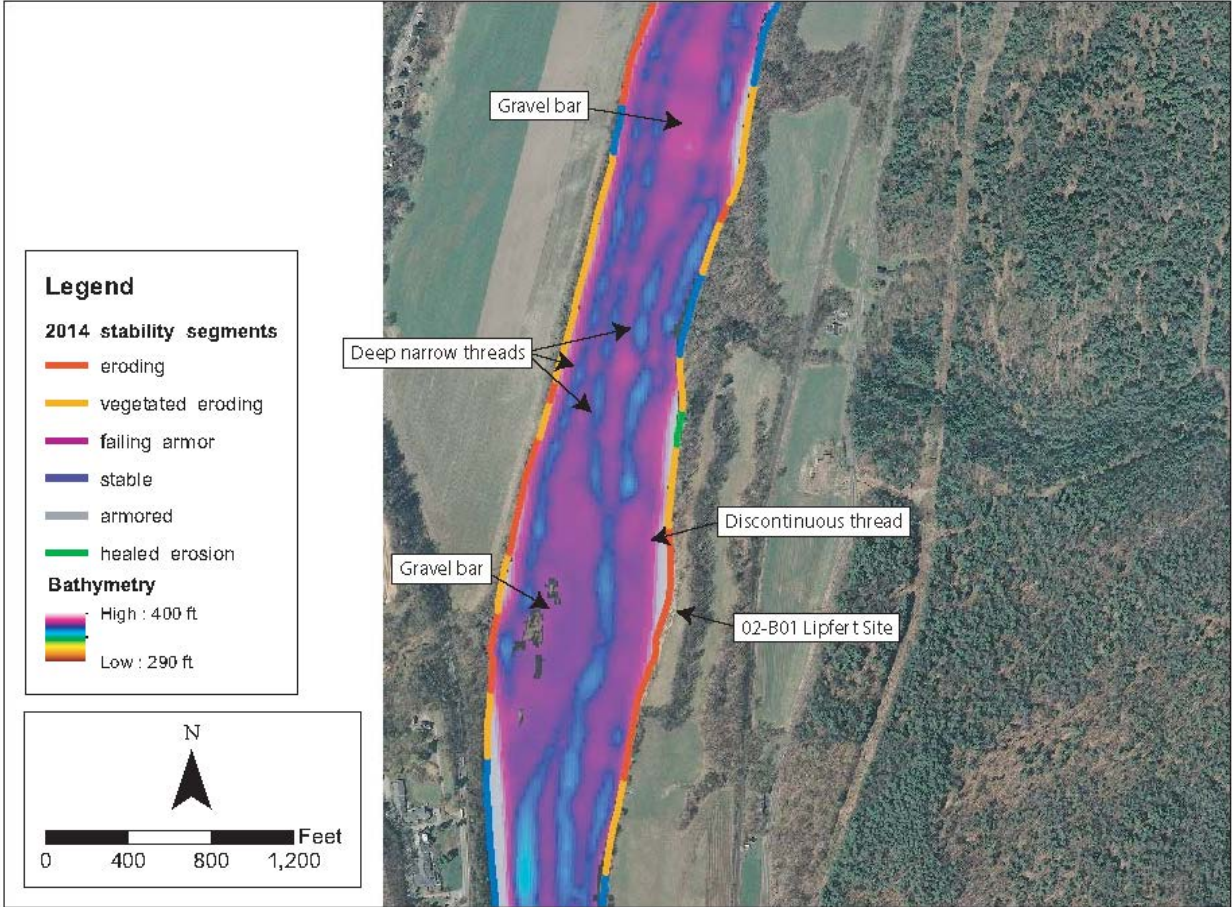
Figure 5.8-1. Bathymetric data showing deeper channels within the river diverted around gravel bars and toward unstable banks, Lipfert Site, upper Bellows Falls impoundment.

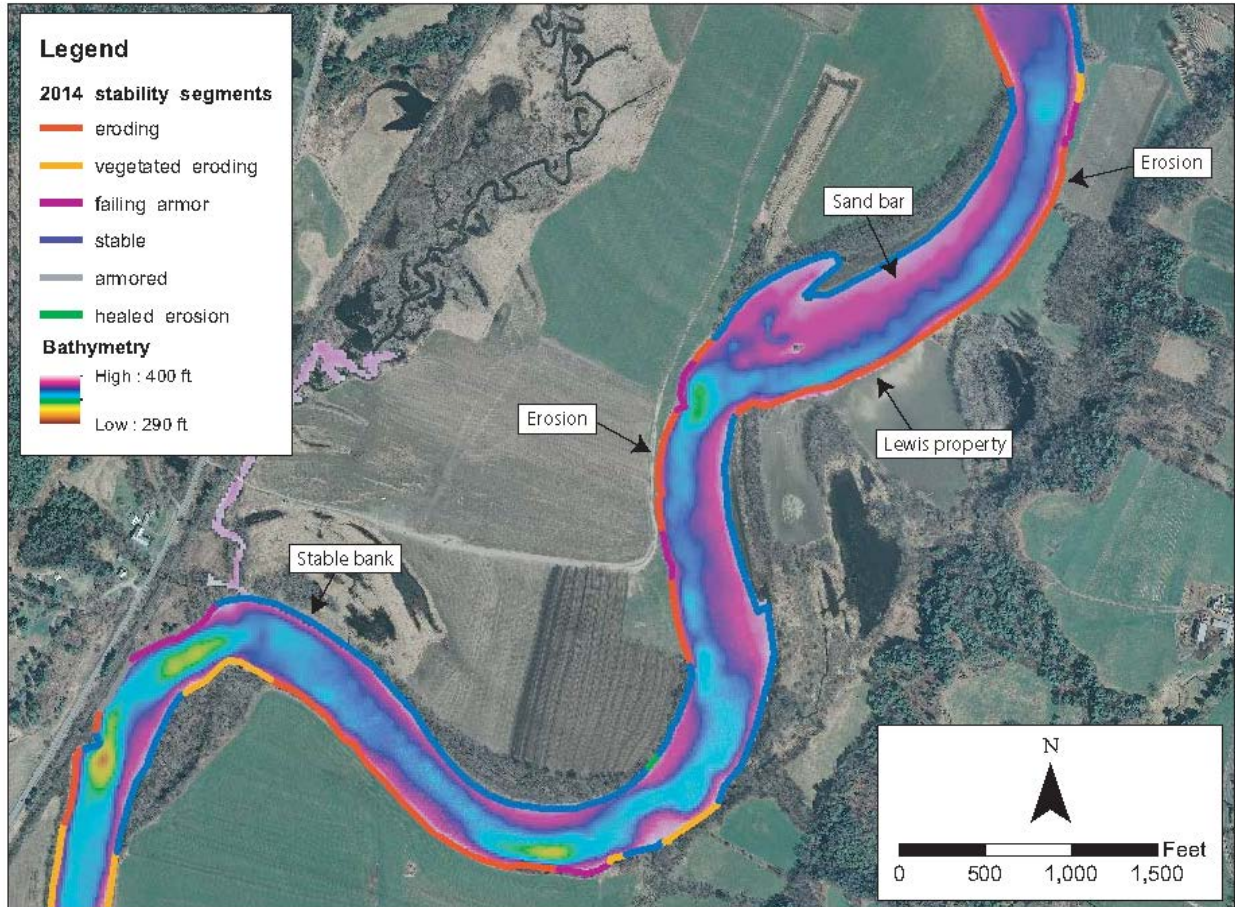
Figure 5.8-2. Bathymetric data showing channel thalweg along outside of meander bends and adjacent to unstable banks, Lewis Property, upper Wilder impoundment.
