Wilder Project, (FERC No. 1892-026)

TransCanada Hydro Northeast Inc.'s ILP Study 1 — Historical Riverbank

Position and Erosion Study released March 1, 2016

CONTENTS: Landowner's comments, Study #1, (Comment period ends May 2, 2016).

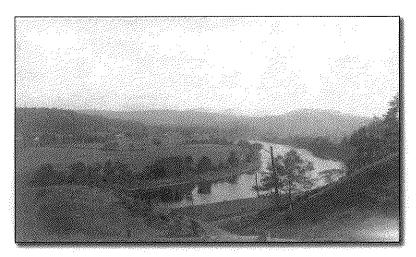
Pre 1896 photograph:

Looking south, and taken from north of East Thetford, Vermont, the riparian buffer by the fields is very obvious. There is a stable, gently sloping bank, vegetation, and then trees on top of the slope at the edge of the field. The riverbank survived for many years, even thousands of years, with spring melts and major storms.

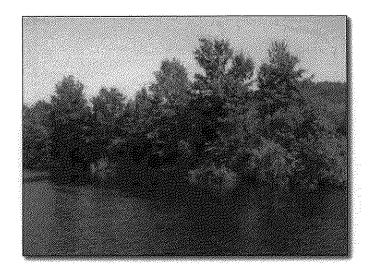
One problem anyone encounters when trying to assemble photographs of the riverbank is the summer foliage that can hide the erosion. In Study #1, Appendix B, Photo Match 59 appears to be of the Mudge land in Lyme. Photo 2015-88 (Match 59), below, was obviously taken in the summer and shows the thick summer foliage.

I know this land, and I am certain that I know exactly where this picture was taken. I can see in Photo 2015-88 collapsed material near the river, and behind that collapsed material is a large tree. Another view of this area, taken in the fall, is below.

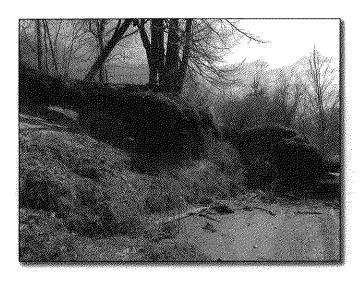
Again, the riparian buffer destroyed, the bank slumping and eroding, a tree about to fall into the river and valuable topsoil to be forever lost. This is a very different picture of the same section of riverbank than is shown in Study 1, Appendix B, Match 59, 2015-88. This is the same section of the riverbank, with a strong riparian buffer, as shown in the photographs on pages six and seven.

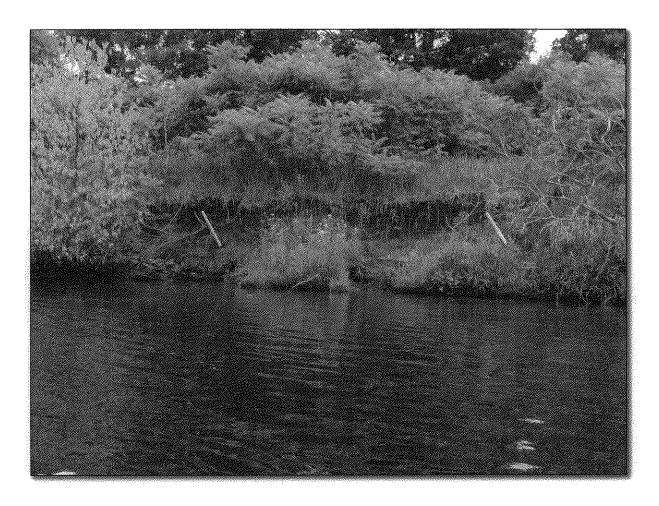
The fence that I wonder about:

What is the history of that fence?

Did a farmer really build it with two posts just hanging in the air?

How much land was between the fence and the river when the fence was built?

How many acres of farmland has the farmer lost?

When will the top of the riverbank fall in?

How much more land will the farmer lose?

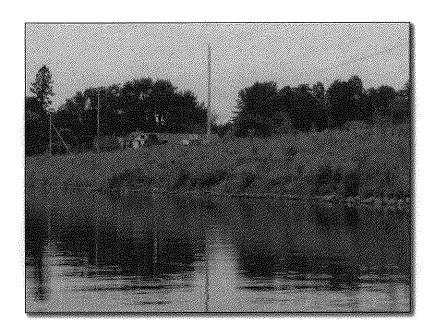
The green section of the River Road in Lyme is identified in this exhibit as "Still Stable." There may be no clear records of how that classification was determined in 1978. However, we do know that in 2010-2012 that section of road was closed because engineers determined it to be <u>very unstable</u>. The town spent \$685,000 repairing this 1,200± feet of road of which \$287,247 was a grant from NRCS (U. S. Department of Agriculture.) The below photograph shows this section of riverbank, repaired, in 2014.

The River Road in Lyme, a historic road, perhaps 250 years old, that has withstood spring melts and large storms, nearly collapsed because of the operations of a dam.

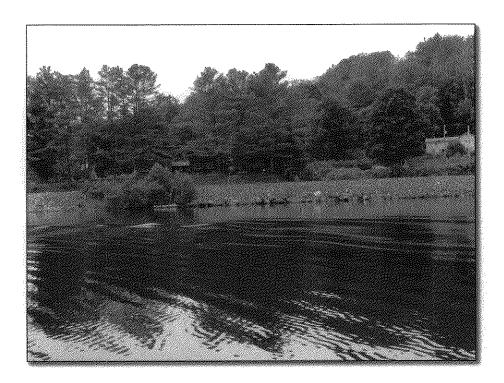
A more recent stabilization project undertaken by the railroad near North Thetford, Vermont, is shown below.
