Comments and Recommendations TransCanada Studies 2/3
O.Ross McIntyre
9/14/16

Re: Wilder Project (FERC No. 1892-026)
Bellows Falls Project (FERC No. 1855-045)
Vernon Hydroelectric (FERC No. 1904-073)

TransCanada Hydro Northeast Inc. Consolidated Report
Study 2/3 Riverbank Transect and Riverbank Erosion Study

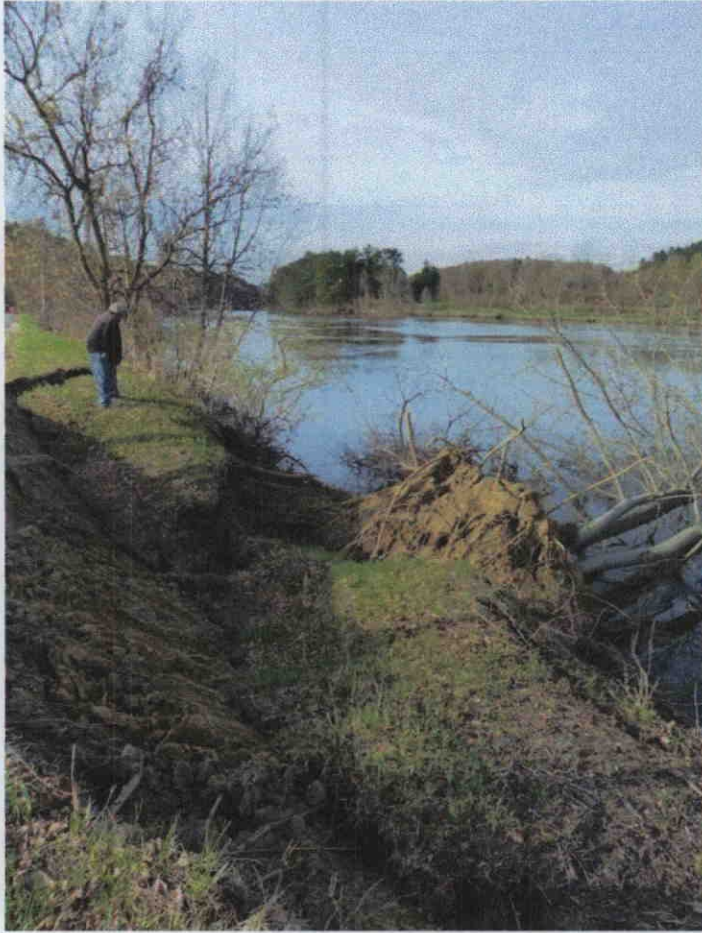
Figure 1. Collapse of a portion of Wilder impoundment bank in spring of 2011 necessitating reconstruction of 1200 feet of River Road near its intersection with the North Thetford Road in Lyme , New Hampshire.

Lyme's consulting engineer on the repair of this damage, HTE Northeast, Inc. stated that the cause of the bank collapse was long-term erosion and undermining due to flow action, and existence of water in the riverbank soils. **"The frequent raising and lowering of the water level by downstream dam management (Wilder Dam), over time, is a contributing factor."**

In order to repair the road, it was moved east because of the excessive cost of reconstructing it *in situ*. The farmland to the east of the road was the subject of a conservation easement. Because of the protection of farmland conferred by the easement, it was necessary to take the land by eminent domain. The total cost of the project was about \$850,000.

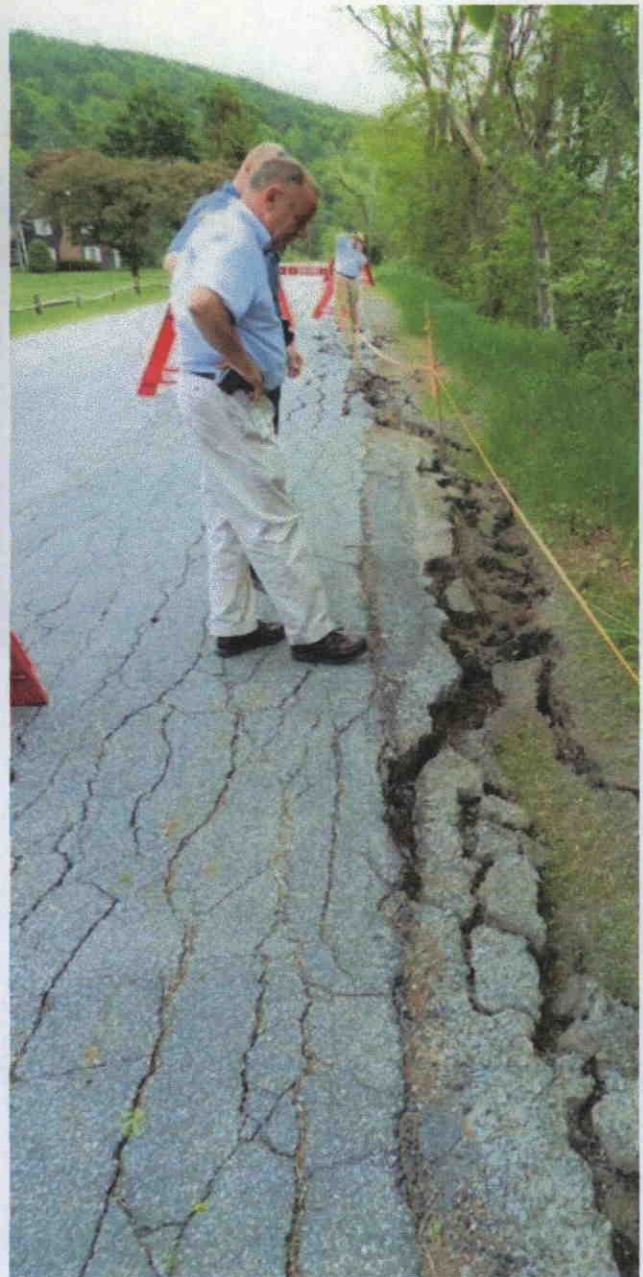
Figure 2 River Road north adjacent to bank collapse. Note pattern of cracks in blacktop and compare with those in photo X, below, in area of slumping River Road South.

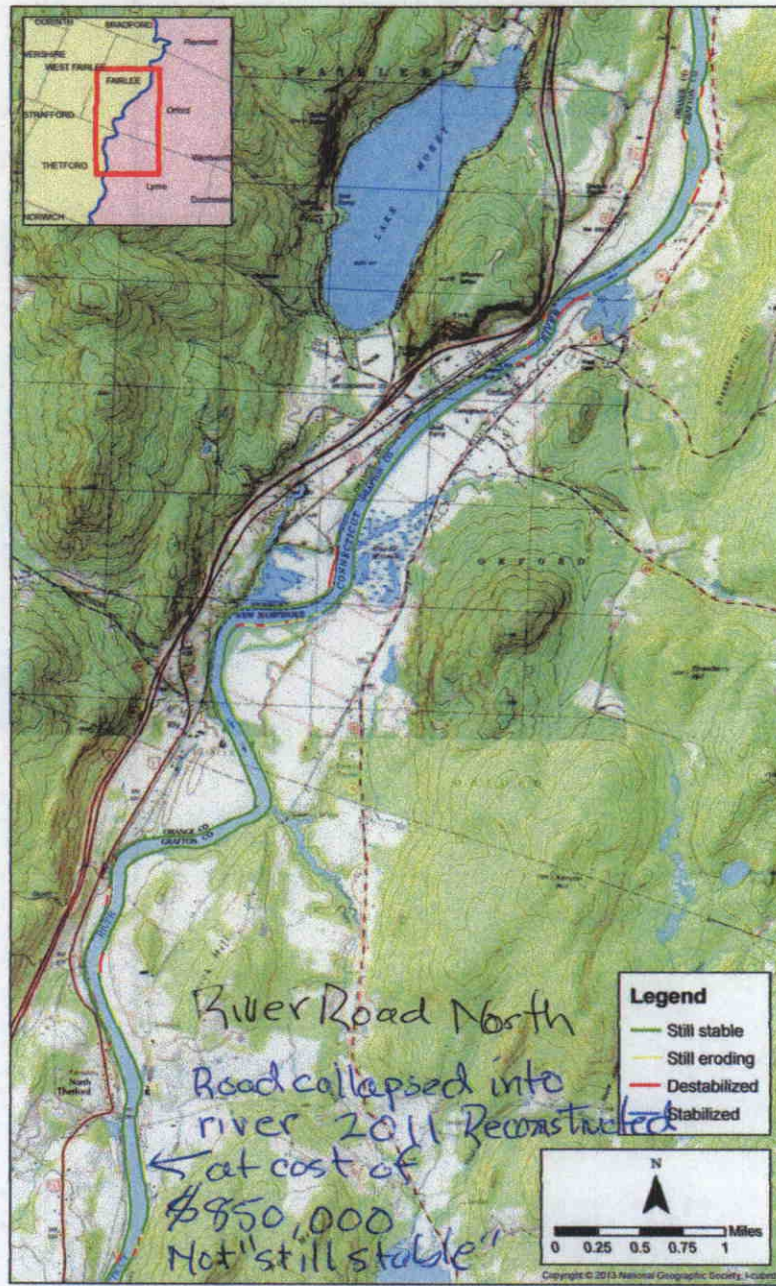
Appendix D. Comparison of 1958 and 2014 erosion. Plate 3 of 14.

Fig. 3 I have annotated figure 20 in Appendix A of study 2 and 3 (Also described as Appendix D, Plate 3 of 14) to show this section of River Road. It is classified for erosion

as “still stable” in 2014. There is no mention that this section of road and the river bank has been completely reconstructed.

Note: At the August 25 meeting at which the results of the combined Study 2 and 3 were presented by TransCanada and at which I objected to the results presented in the two figures cited above, John Ragonese of TransCanada stated that he would have a look at the figures I described in the report Appendix and that they "would be changed." FERC should make certain that they are changed.

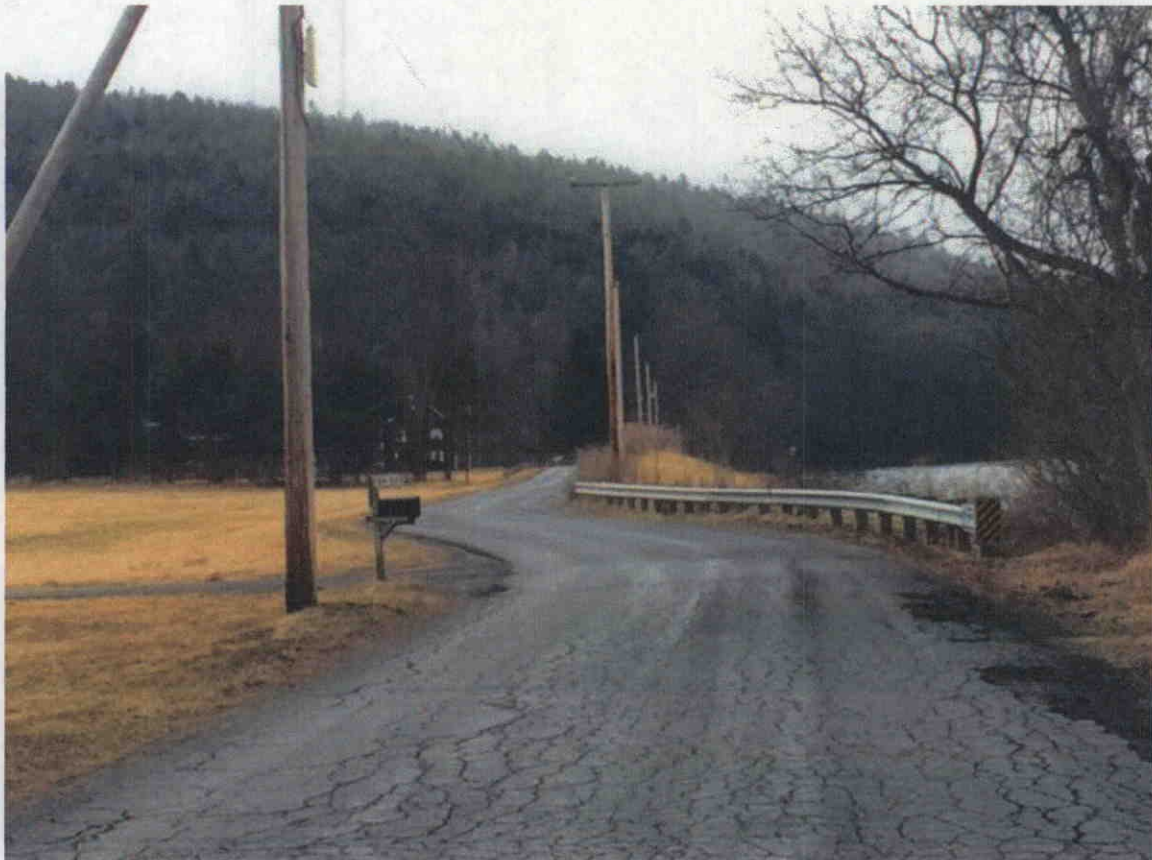
Fig4. This is the “dog leg” of the reconstructed road. It can be viewed from the river as well. Why was this change not noted on 2014 map of survey of erosion?

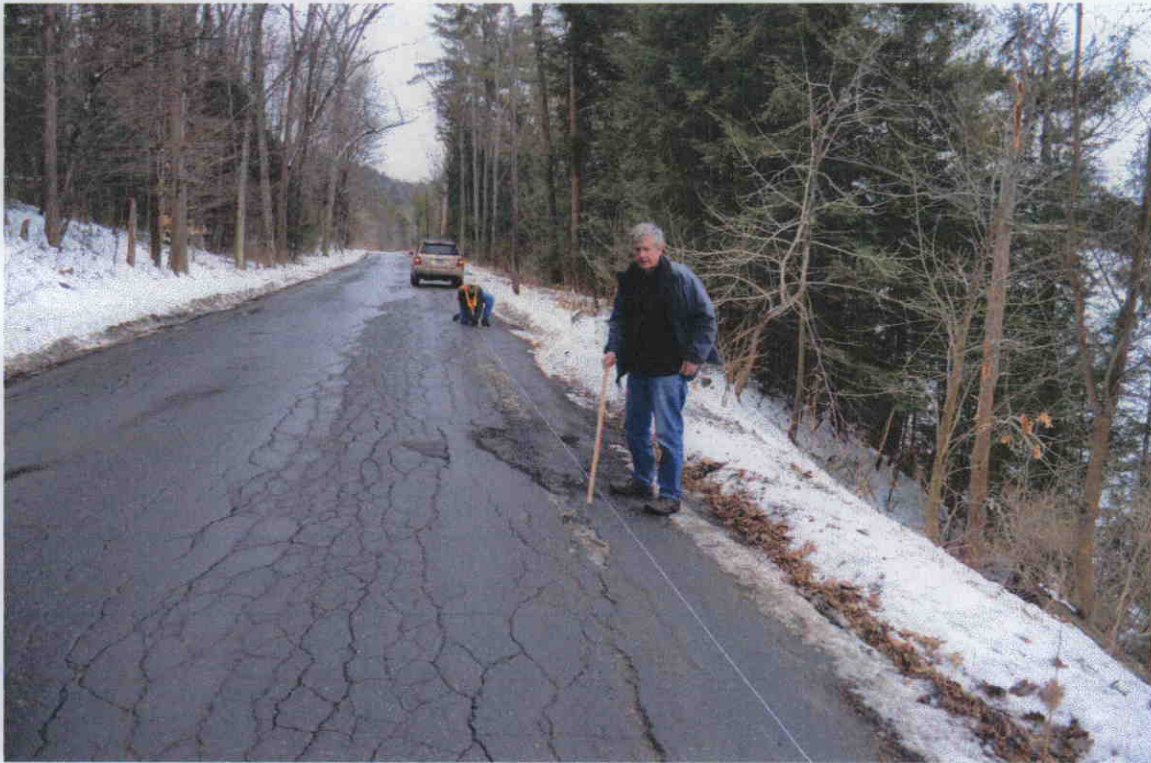
River Road a quarter mile south of the East Thetford Bridge ascends to a bench that runs along farm and woodland to the east. On the west a steep bank descends to the river below. In 2013 this section 120 feet of the western half of this road had settled, with a more pronounced dip along 30 feet the road as shown in Figure 5 below.

Figure 5. A photo taken in 2013 of River Road, Lyme, looking south about a quarter of a mile south of the East Thetford bridge. The string is on the road at each end of the slump which is 7 inches below the string in the center. Note the cracking of the blacktop on the west side of the road due to the slump and compare it with the linear cracking seen in the photo taken at the site of the collapse near the North Thetford road in Figure 2

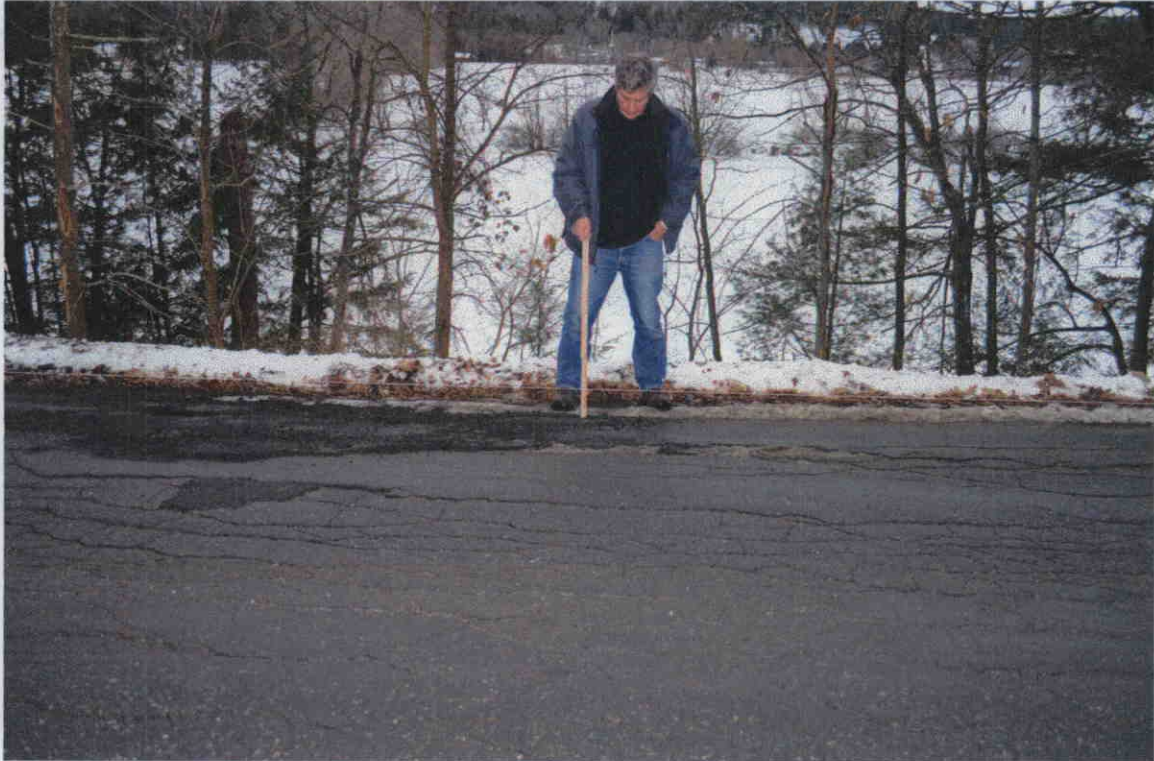
Figure 6. 2013 photo of River road south looking west. Wilder impoundment in background. Slump in road is 7 inches. In 2014 this slump had progressed alarmingly and catastrophic failure was felt likely by consulting engineers. The road has been closed for two years while plans for constructing a bypass are developed and financed. Cost estimates are in the \$2 million range.

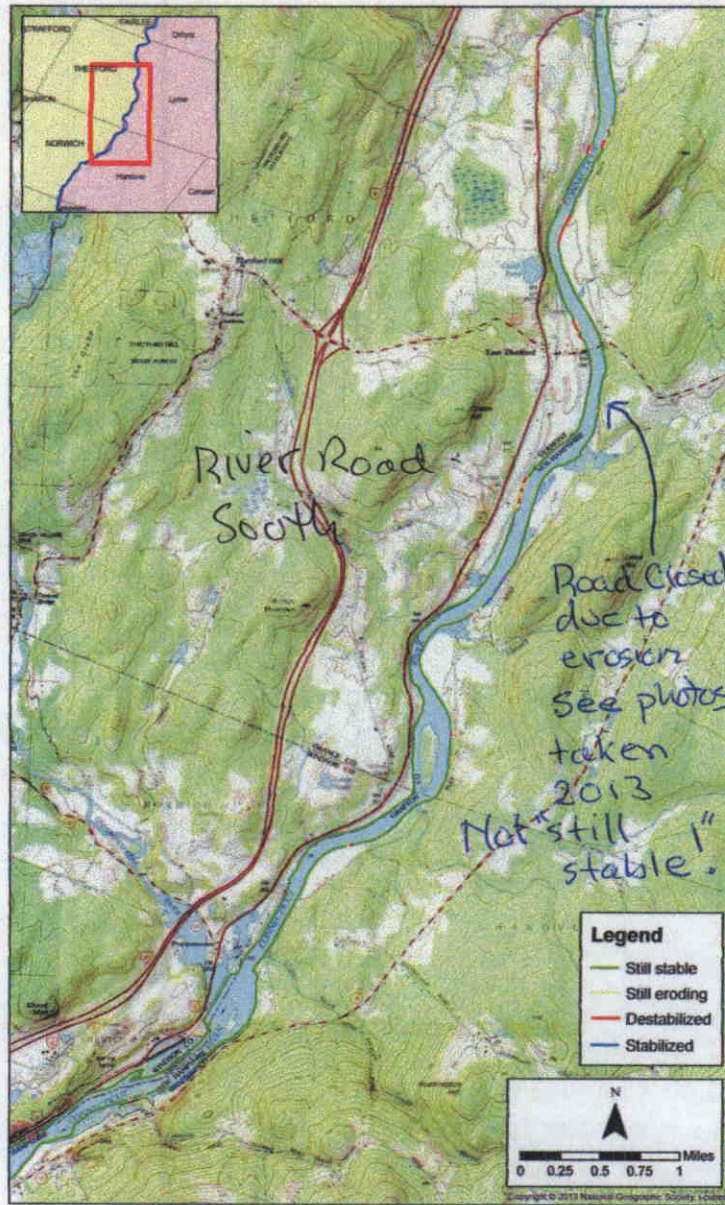
Appendix D. Comparison of 1958 and 2014 erosion. Plate 4 of 14.

Fig. 7 Annotated Figure 21 from Appendix A (Also described as Appendix D plate 4 of 14) showing River Road south of the bridge to East Thetford, VT. Note that this section is classified as “still stable” despite a large hole in the bank adjacent to road and subsiding pavement road pavement above. The hole is easily visible from river, but the sagging road surface is not easily seen from river.

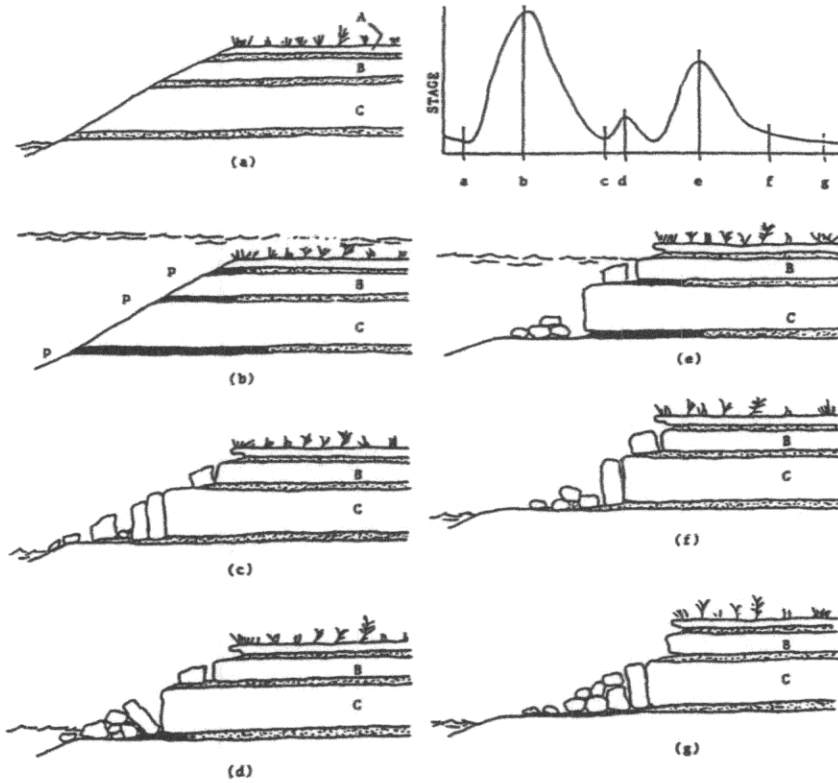
Figure 2. Sequence of stage fluctuation with attendant recharge into pervious zones (sections b, d, and e) and subsequent piping/sapping and failure (sections c, f, and g)

Fig 9 of my comments is taken from Identification of Piping and Sapping Erosion of Streambanks, by D.J. Hagerty, Prepared for the Department of the Army, U.S. Army Corps of Engineers. Contract Report HL-92-1 Water infiltration into susceptible soils when they are exposed to elevated water levels results in loss of material when water

levels recede. Repeated high water levels shown in the graph in the upper right hand corner, lead to progressive bank collapse.
