**ILP Study 2 and Study 3
Riverbank Transect and Riverbank Erosion Studies**

Study Report

Wilder Hydroelectric Project (FERC Project No. 1892-026)
Bellows Falls Hydroelectric Project (FERC Project No. 1855-045)
Vernon Hydroelectric Project (FERC Project No. 1904-073)

August 1, 2016

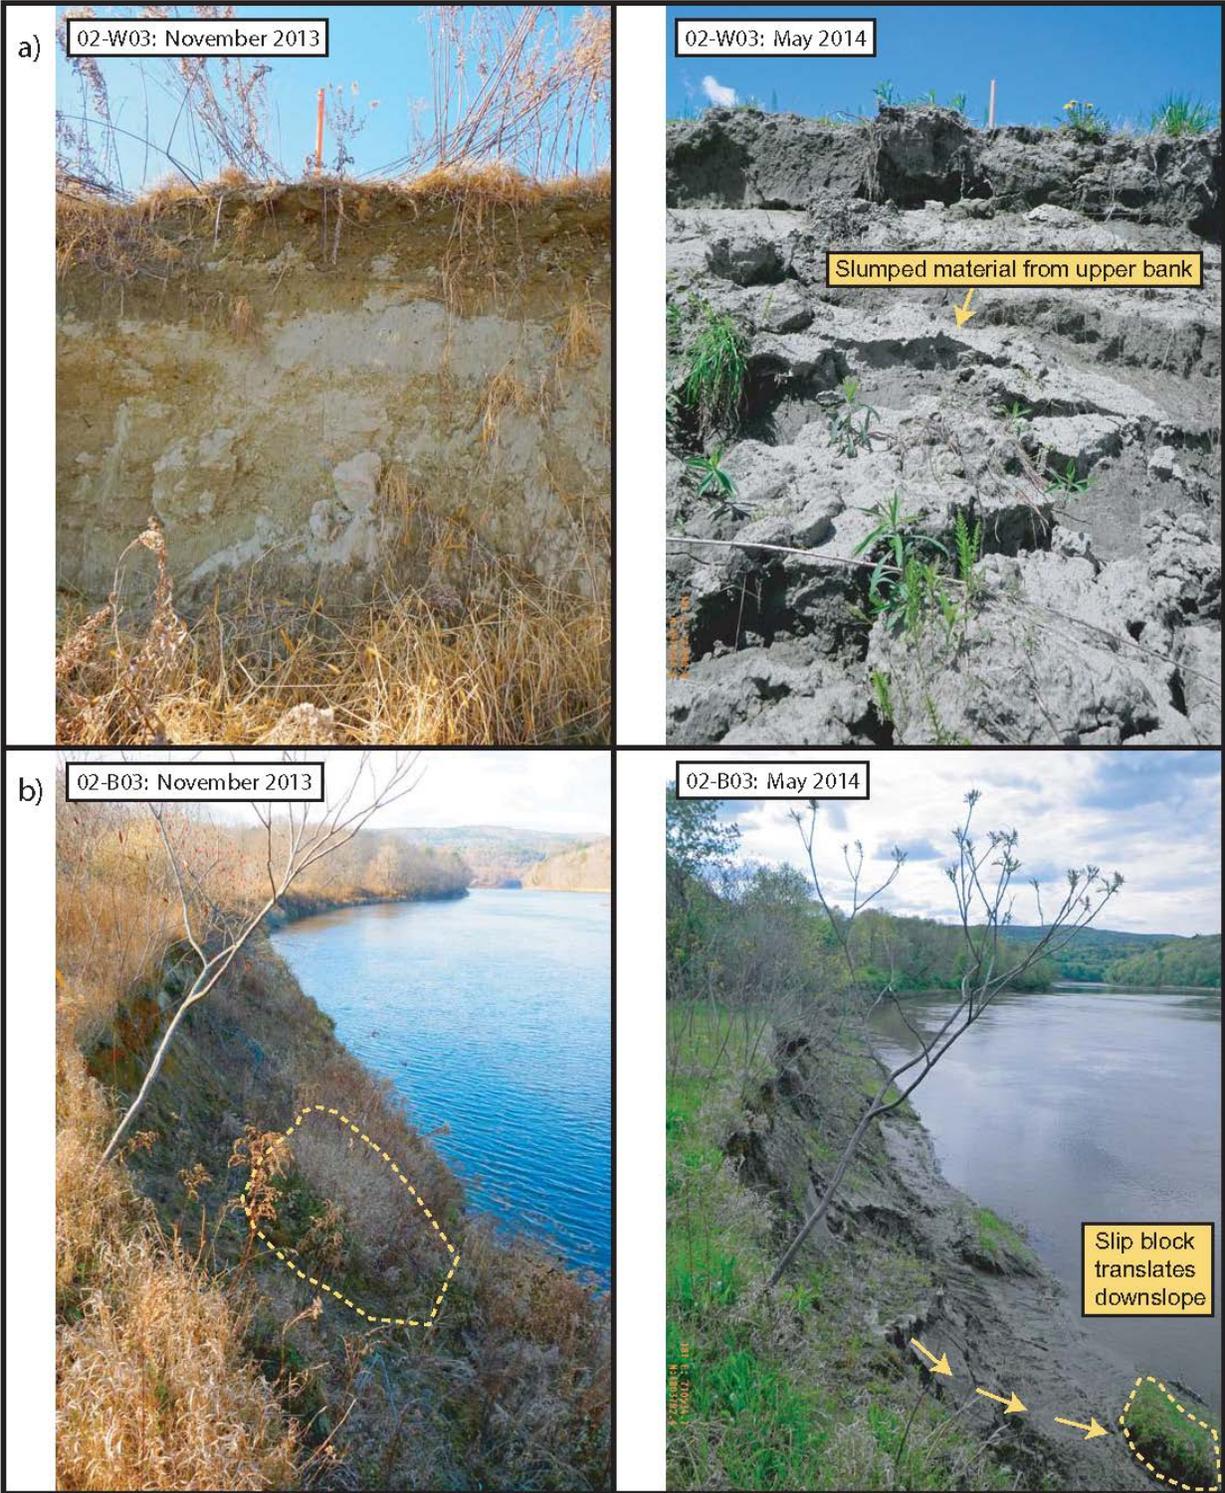
Figure 5.4.2-2a. The types of conditions observed on the repeated ground photographs included a) top of bank recession, and b) bank slope changes.

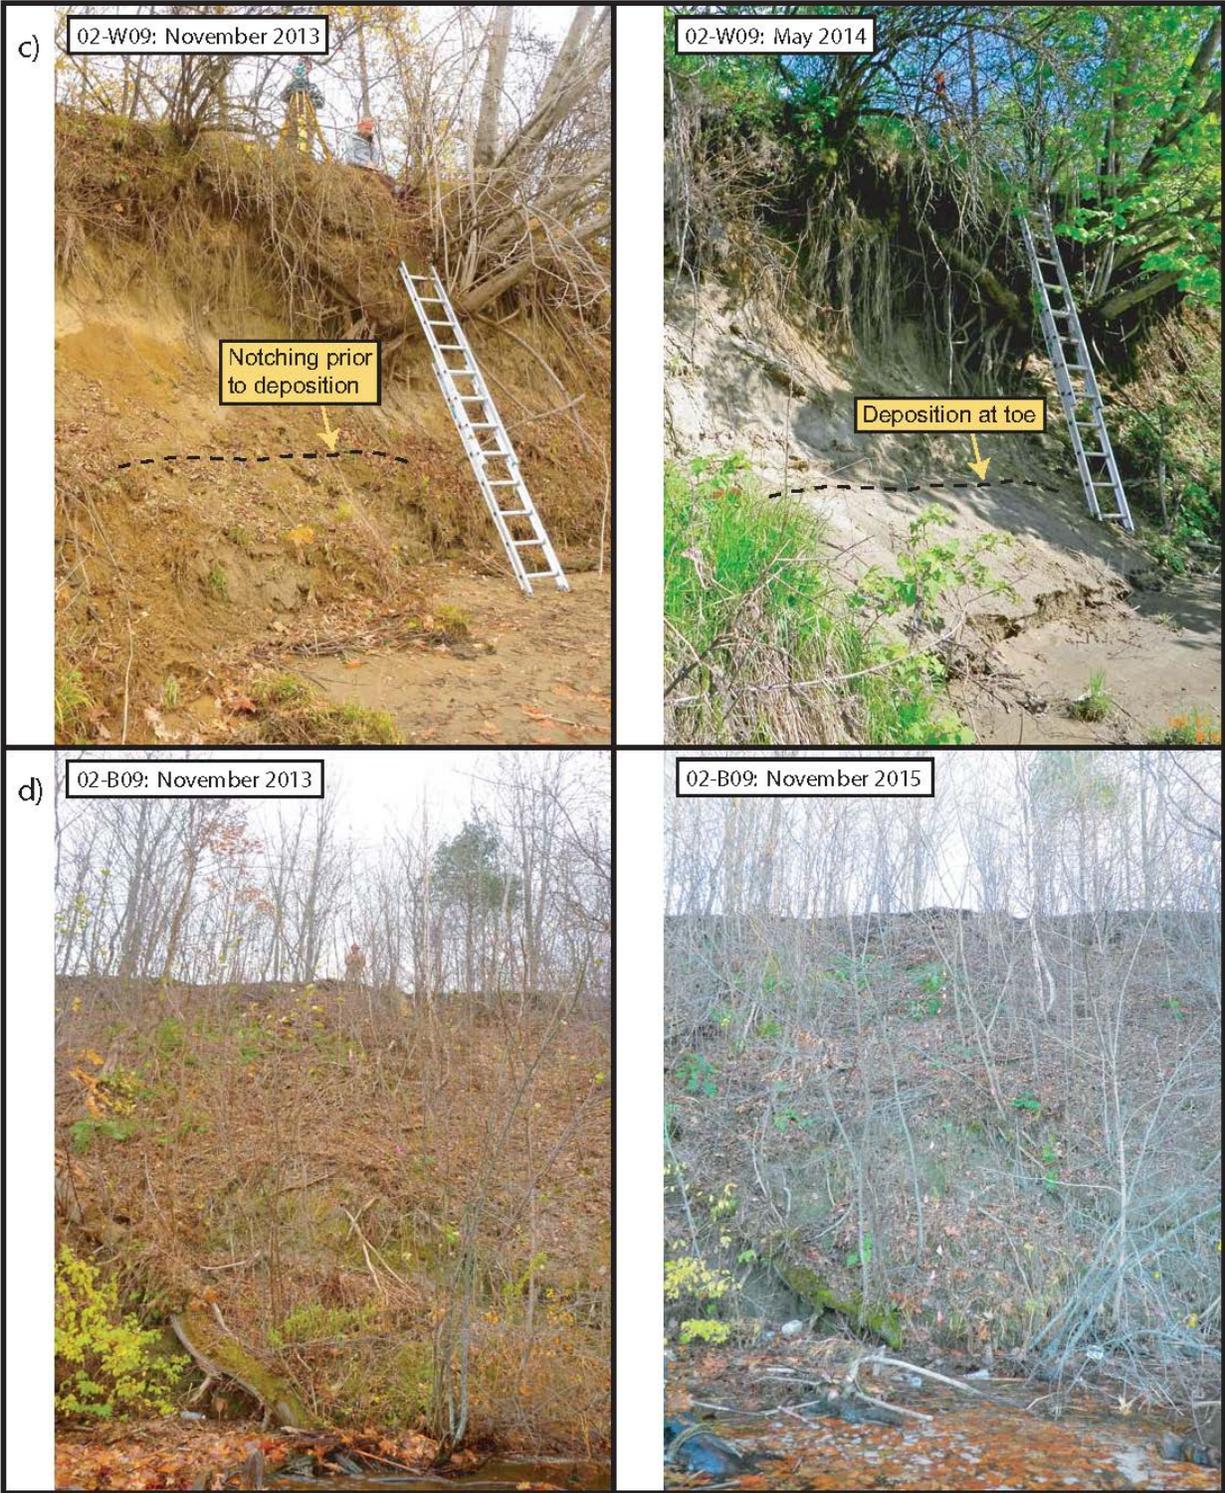
Figure 5.4.2-2b. The types of conditions observed on the repeated ground photographs included a) top of bank recession, and b) bank slope changes.

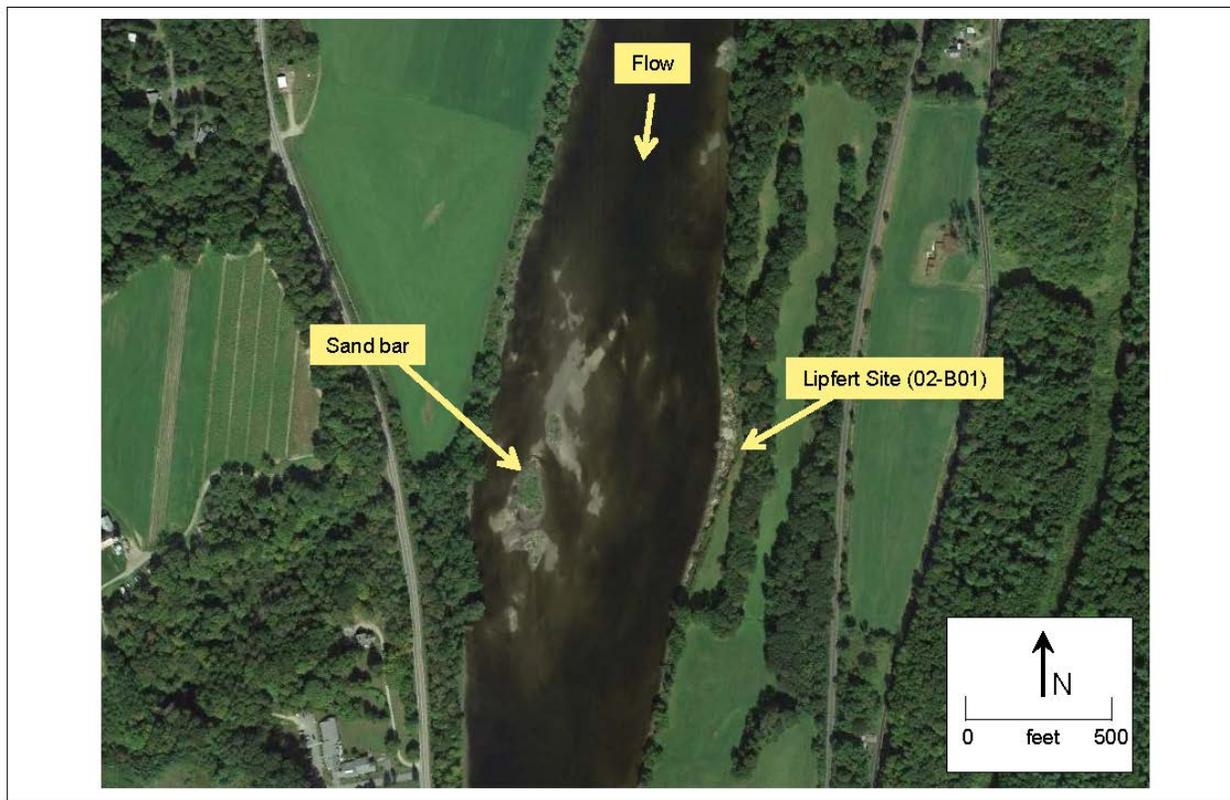
Figure 5.4.2-3. Large sand bar is situated across from 02-B01 (Lipfert site).

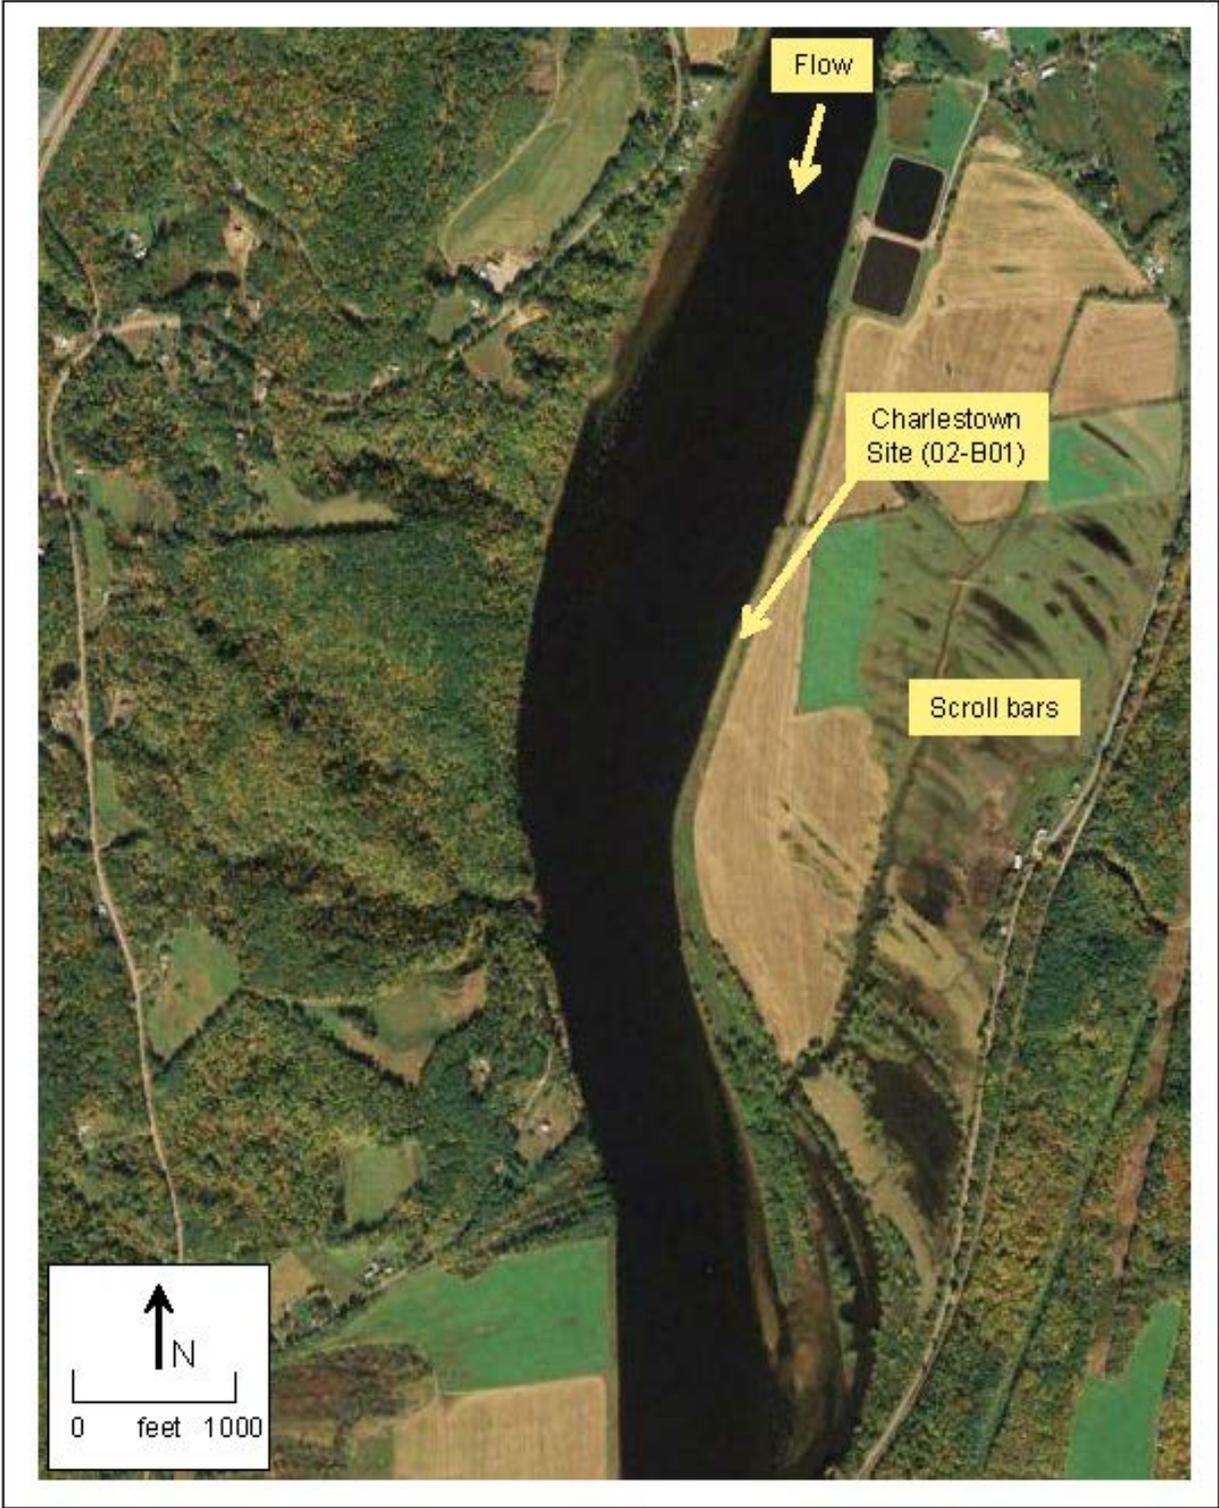
Figure 5.4.2-4. Scroll bars on floodplain at 02-B07 (Charlestown Site) are indicative of decades, if not centuries, of channel migration.

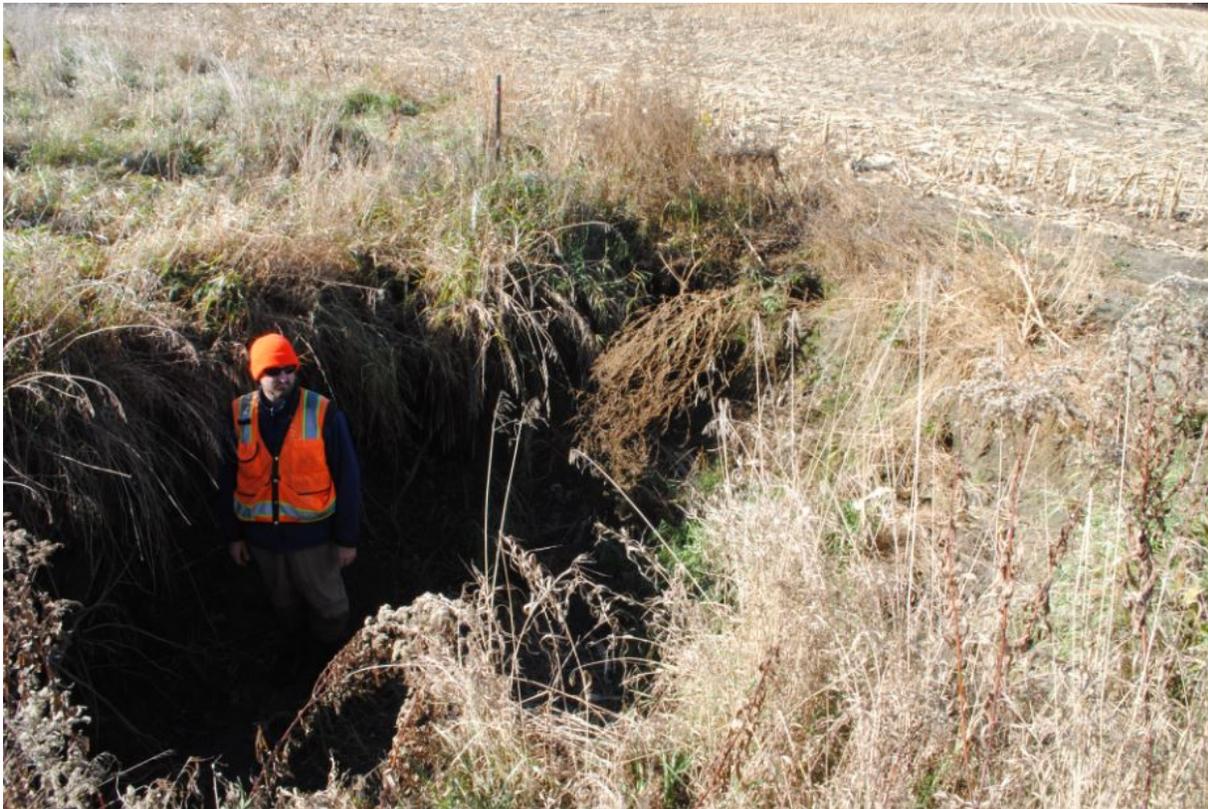
Figure 5.4.2-5. Bank collapse and recession in 2015 occurred near 02-W09 (Mudge Site) despite no recession at the transect itself.

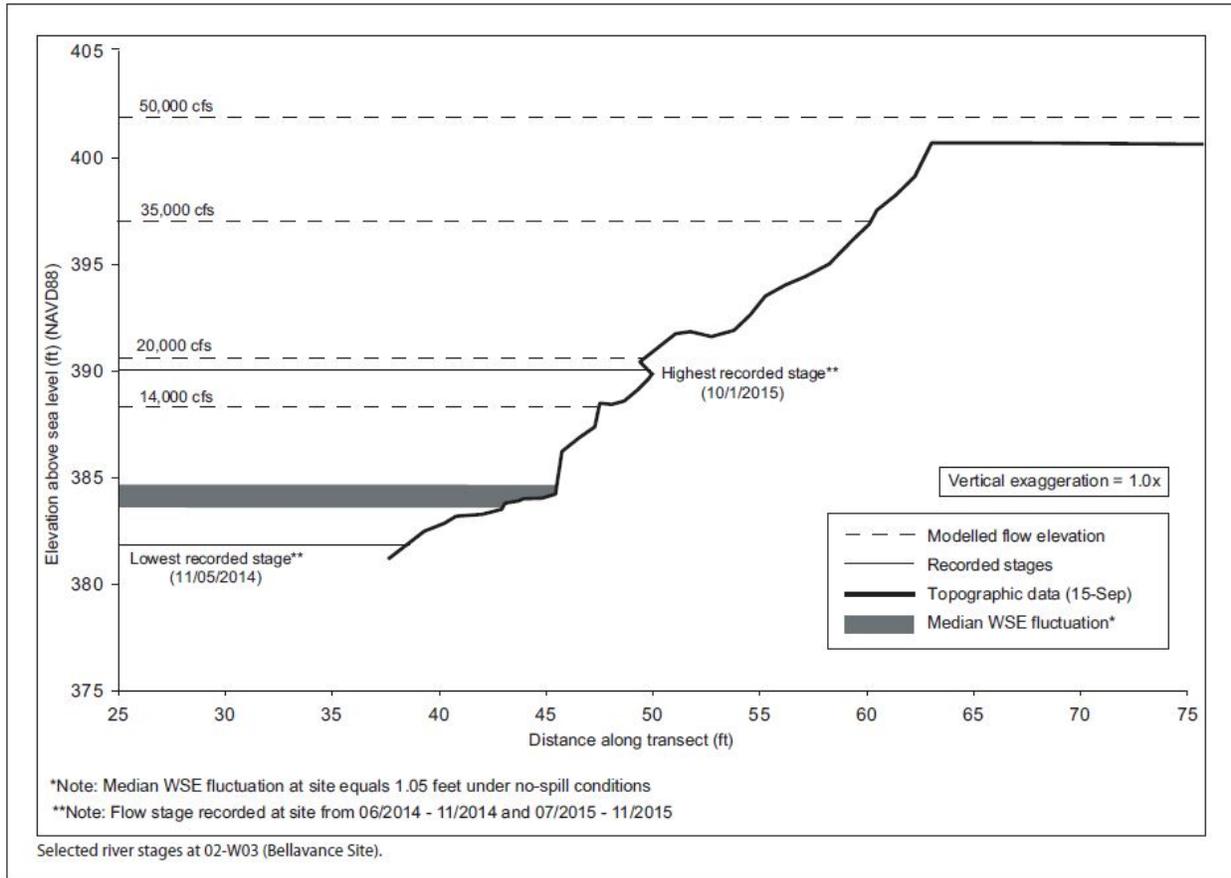
Figure 5.4.2-6. Position on bank of normal operating range aligns with location of notching at 02-W03 (Bellevance Site).

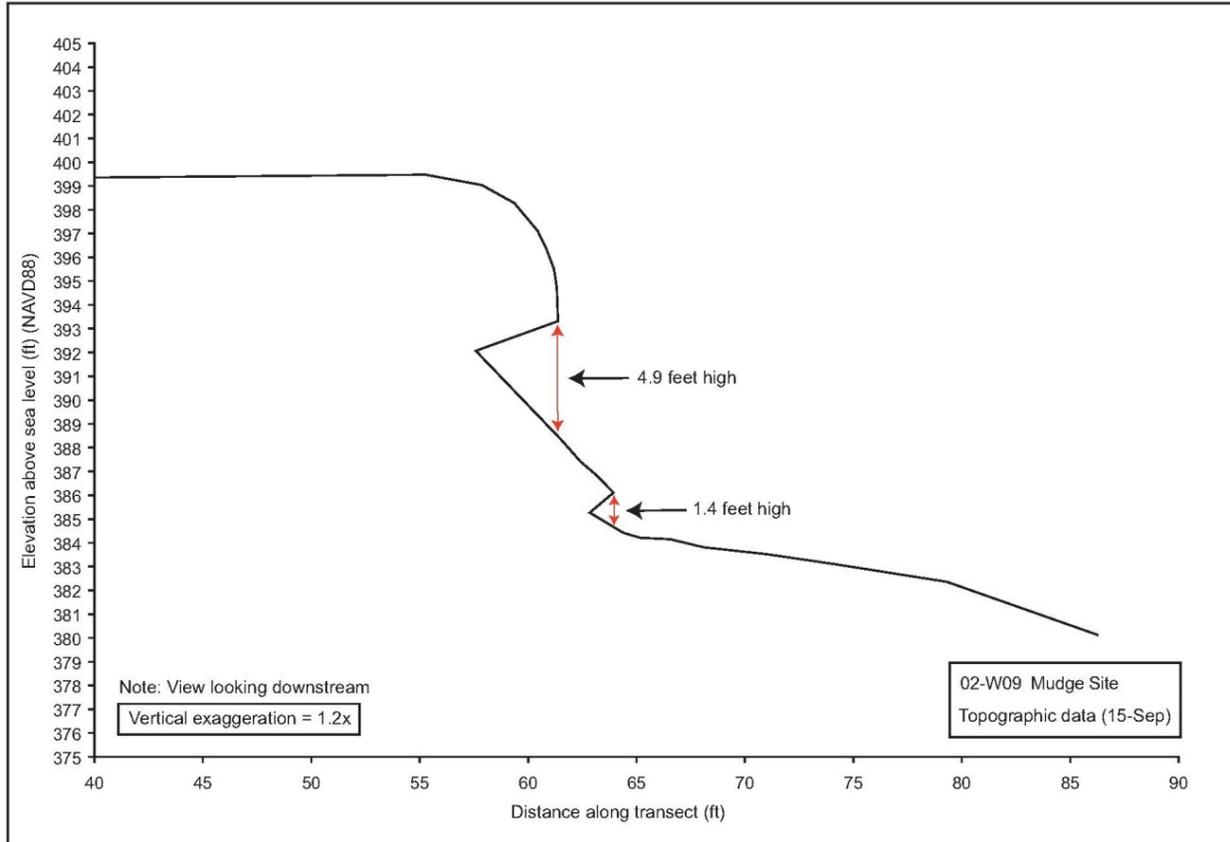
Figure 5.6.1-1. The height of overhangs are generally less than 1.5 ft but can reach nearly 5 ft (or more).

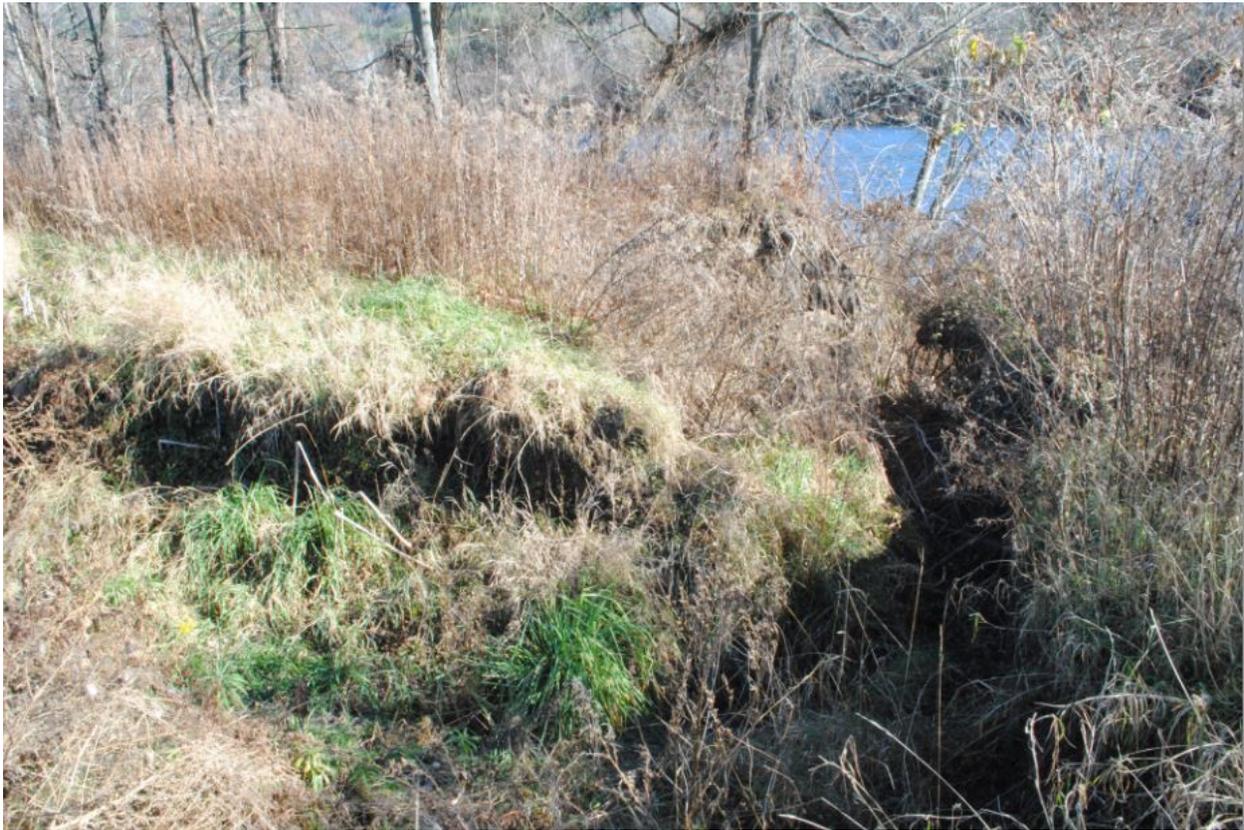
Figure 5.6.1-2. Tunnel scour can form circular depressions that transform over time into gullies as the material between the river and depression collapse. Photo from Fairlee, VT – in left foreground is portion of circular depression initially formed in 2014.

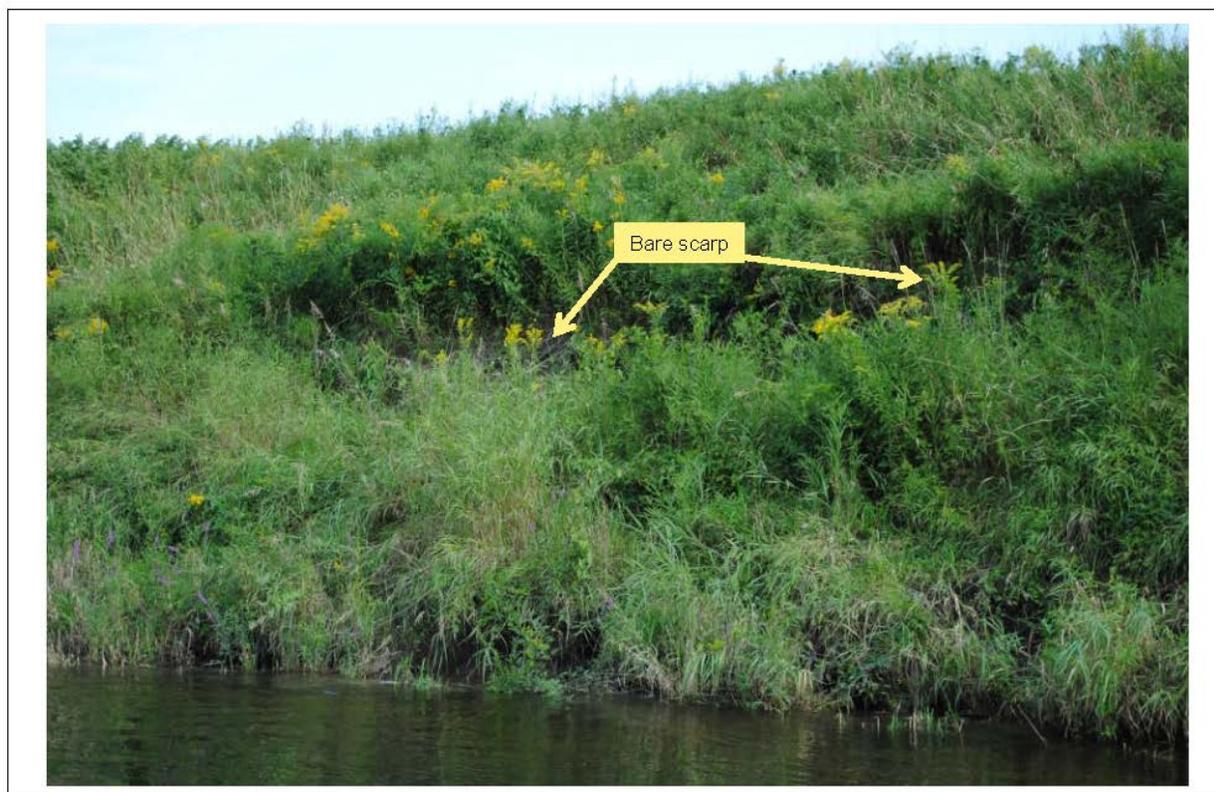
Figure 5.6.1-3. Sometimes barely visible scarps are the only evidence of active erosion on well vegetated banks.

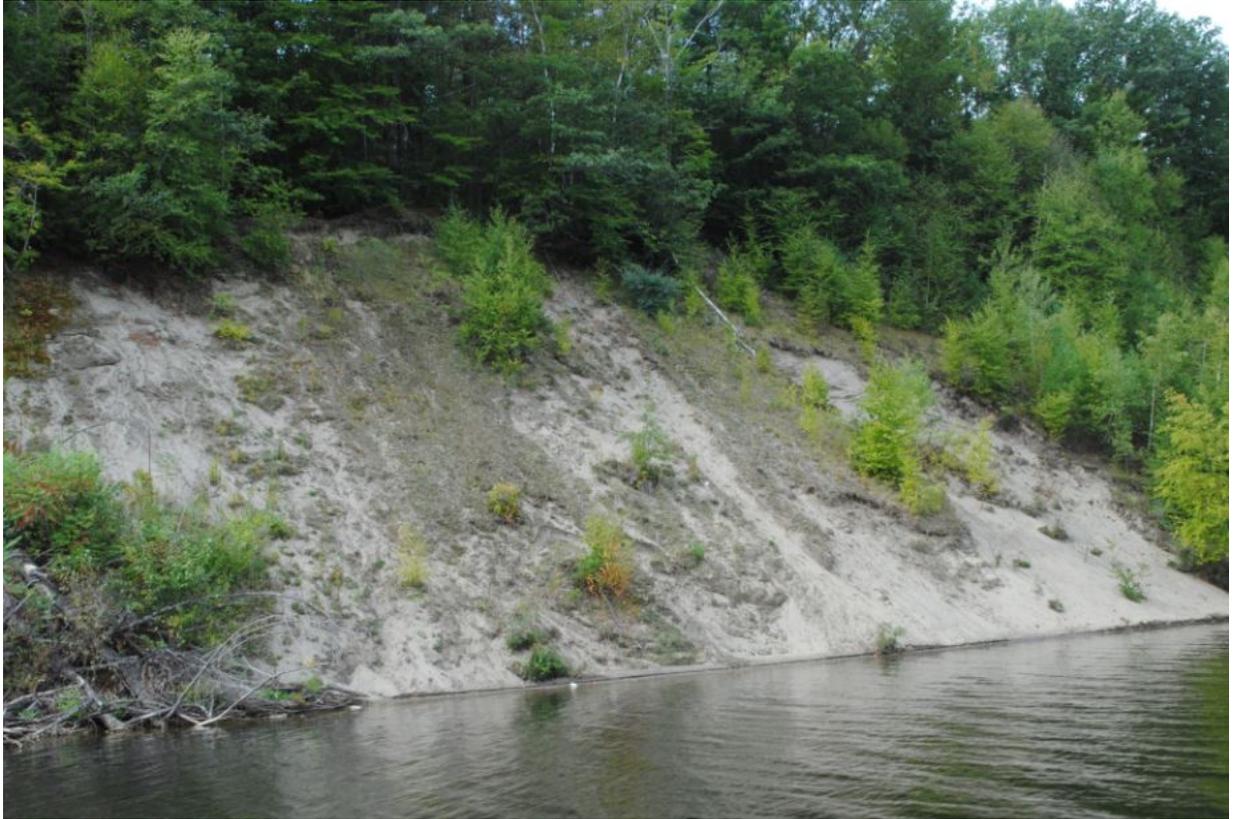
Figure 5.6.1-4. Wide colluvial apron at base of bank formed by series of adjacent flows.

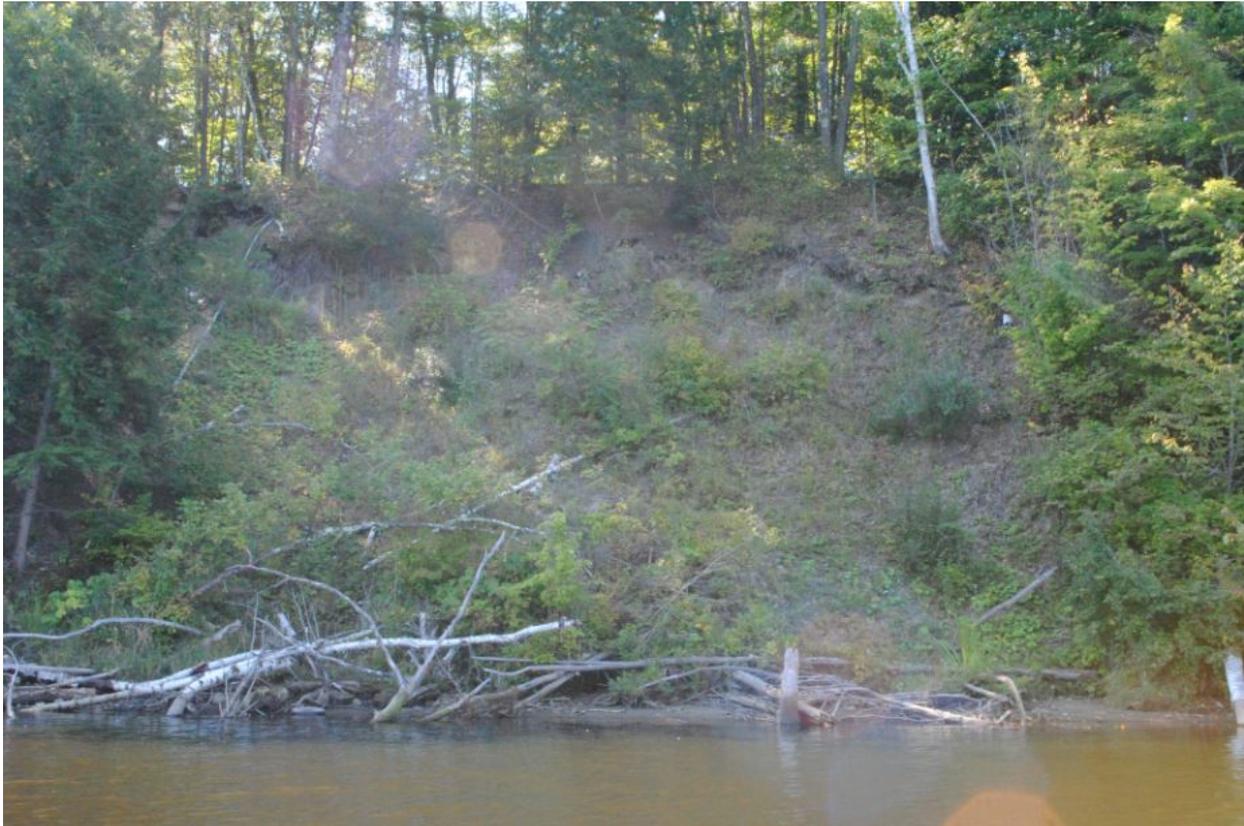
Figure 5.6.2-2. Trees that have fallen to the base of the bank may remain for several years and buttress the bank from further erosion.

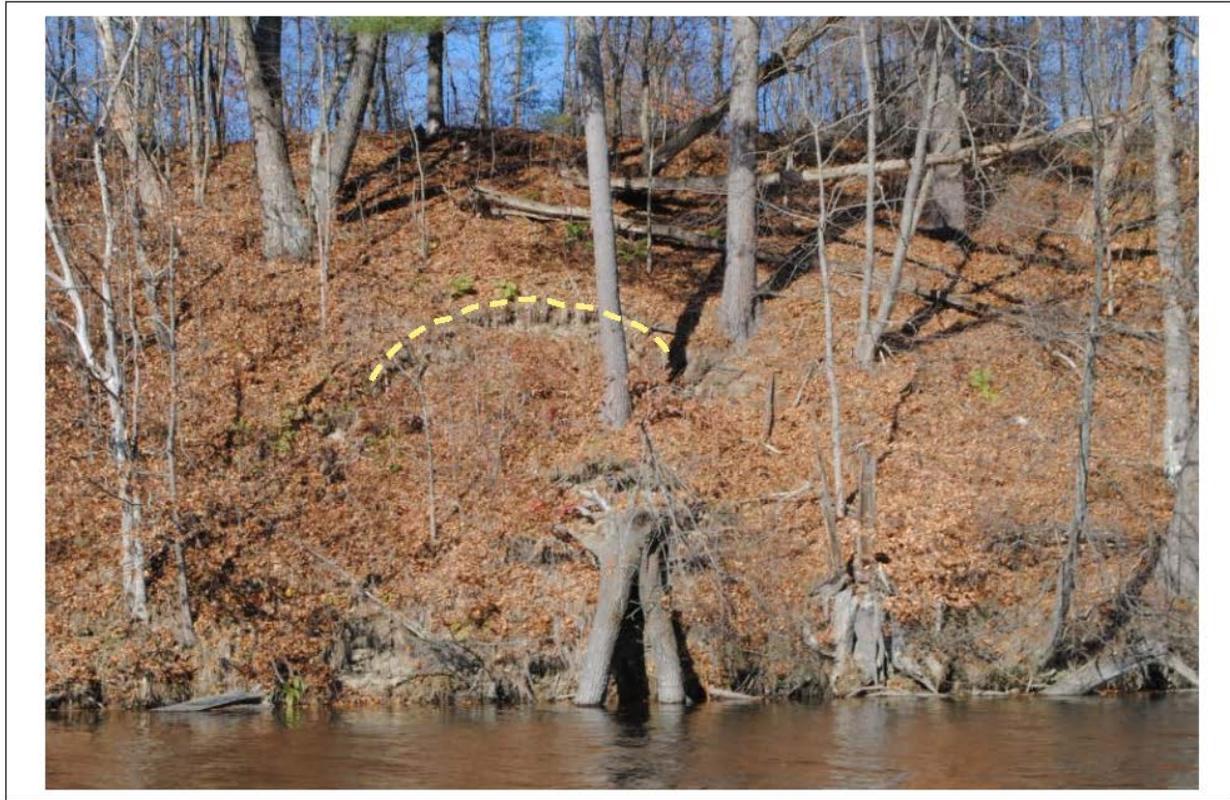
Figure 5.6.2-3. Active erosion can occur despite the presence of bank vegetation. Dashed yellow line outlines top of planar slip scarp.

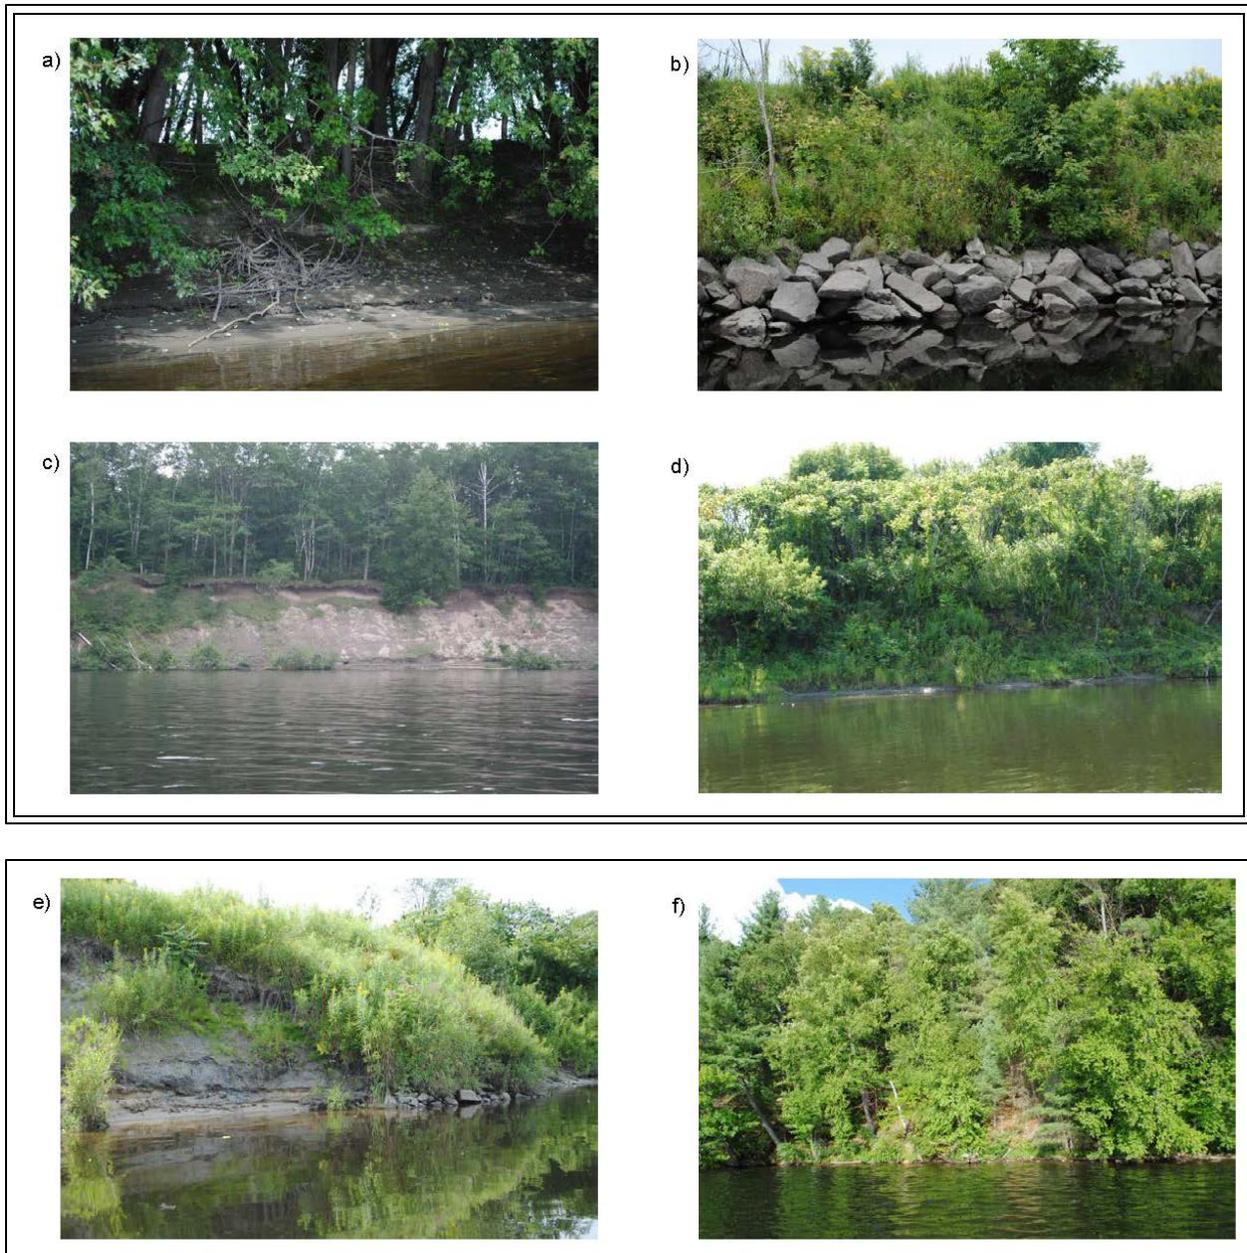
Figure 5.6.3-1. Photos of the six erosion categories: a) stable, b) armored, c) eroding, d) vegetated eroding, e) failing armor, and f) healed erosion.

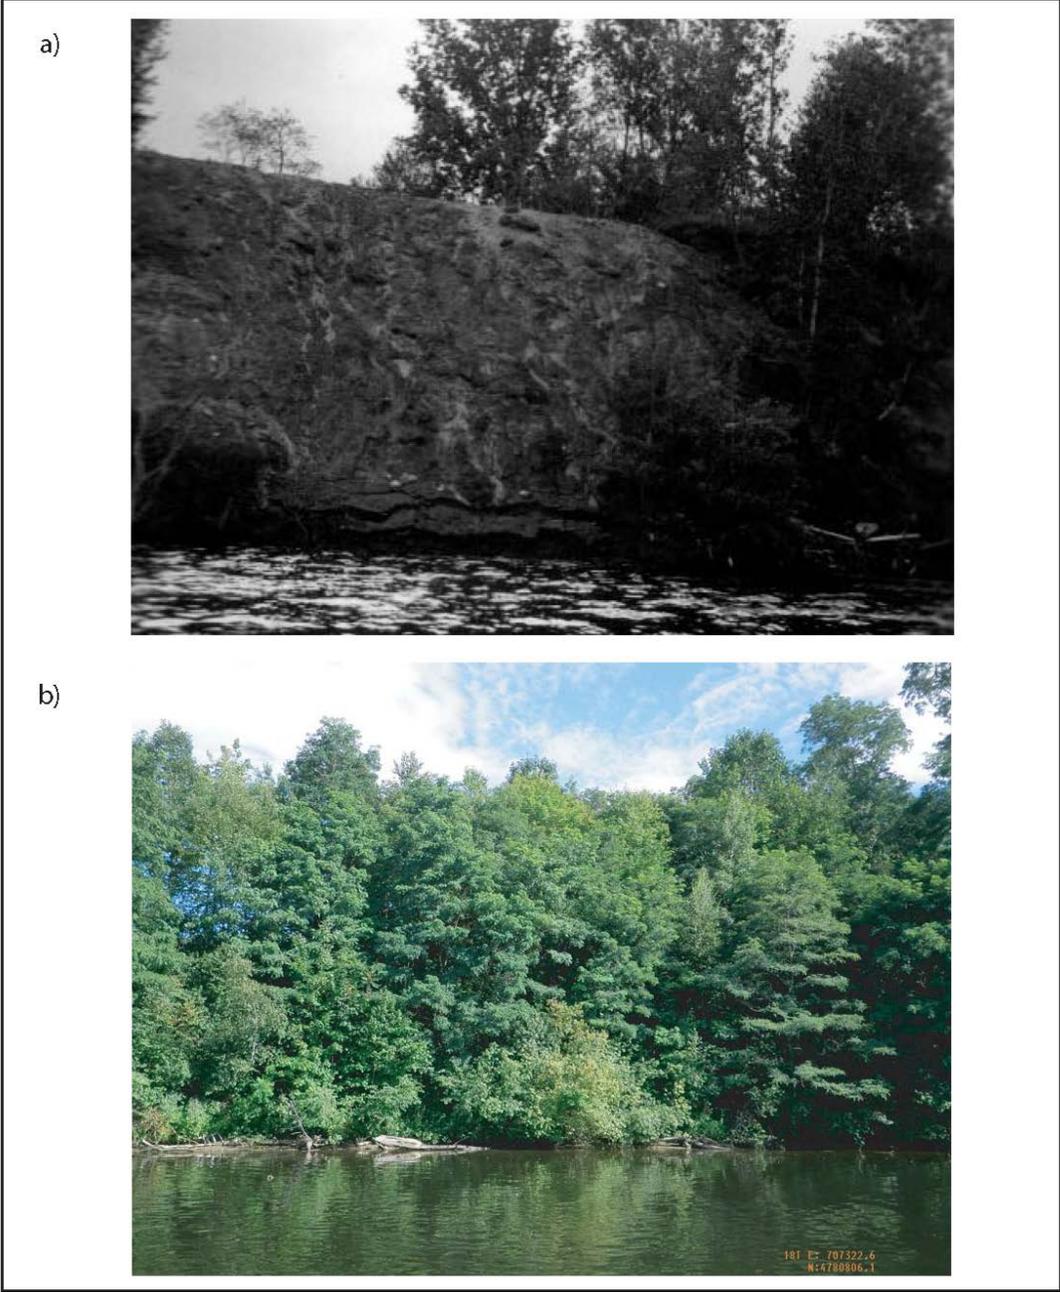
Figure 5.6.3-2. Bank near 02-B09 shown in a) historic photo from 1964, and b) modern photo from 2015. Previously eroding bank dominated by flows is now stable.
