O. Ross McIntyre, M.D.  
Comments on Report of Study No. 1  
Wilder Hydroelectric Project (FERC Project No. 1892-026) 3/28/16

**Comments by O. Ross McIntyre M.D.**  
**Wilder Hydroelectric Project (FERC Project No 1892-026) Study Number 1**  
**Historical Riverbank Position and Erosion** – Study Report TransCanada Hydro  
Northeast Inc. in connection with Federal Energy Regulatory Commission Relicensing of  
the Wilder Project.

**Comments on Study Number 1 by O. Ross McIntyre, M.D.** the owner of land abutting the project in Lyme, NH.

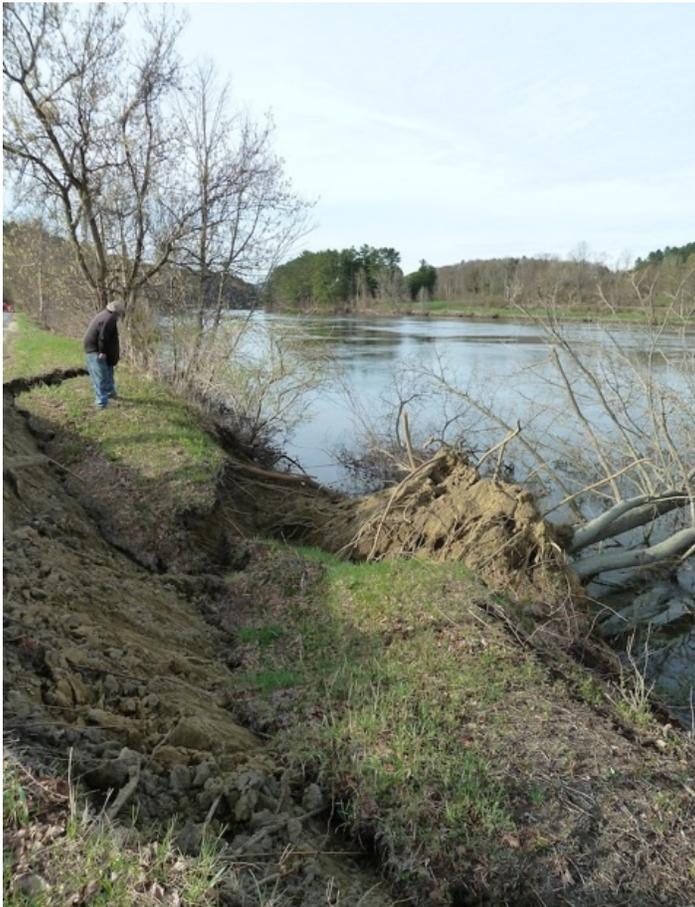
Figure 1. Collapse of a portion of Wilder impoundment bank in spring of 2011 necessitating reconstruction of 1200 feet of River Road south of its intersection with the North Thetford Road in Lyme , New Hampshire.

The engineering report prepared by HTE Northeast, Inc. states that the cause of the bank collapse was long-term erosion and undermining due to flow action, and existence of water in the riverbank soils. Piping was not a named cause although the statements concerning water in the riverbank soils is consistent with that mechanism. The report also states, **“The frequent raising and lowering of the water level by downstream dam management (Wilder Dam), over time, is a contributing factor.”**

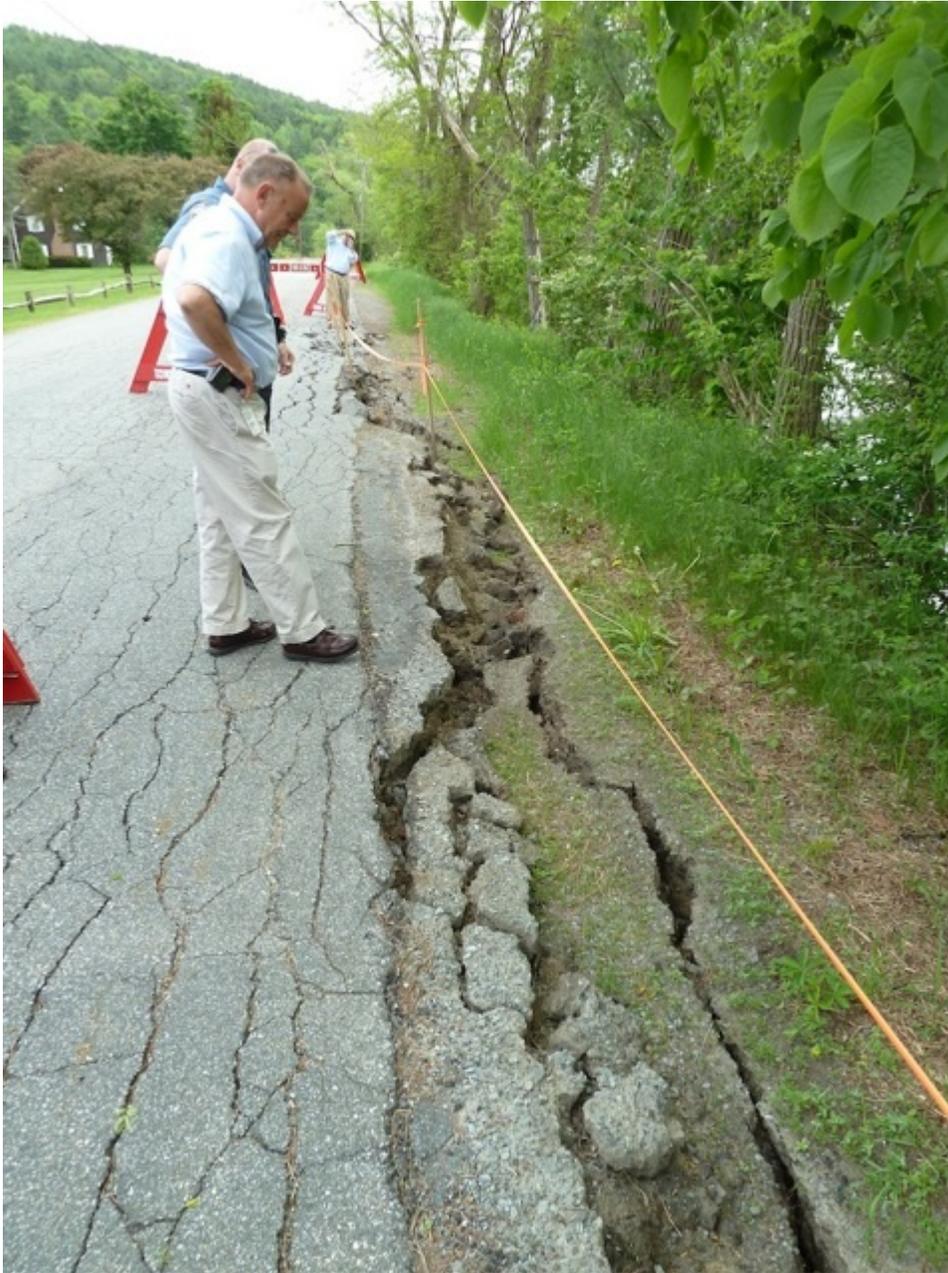
Figure 2 River Road north adjacent to bank collapse. Note pattern of cracks in blacktop and compare with those in photo 3, below, in area of slumping River Road South.

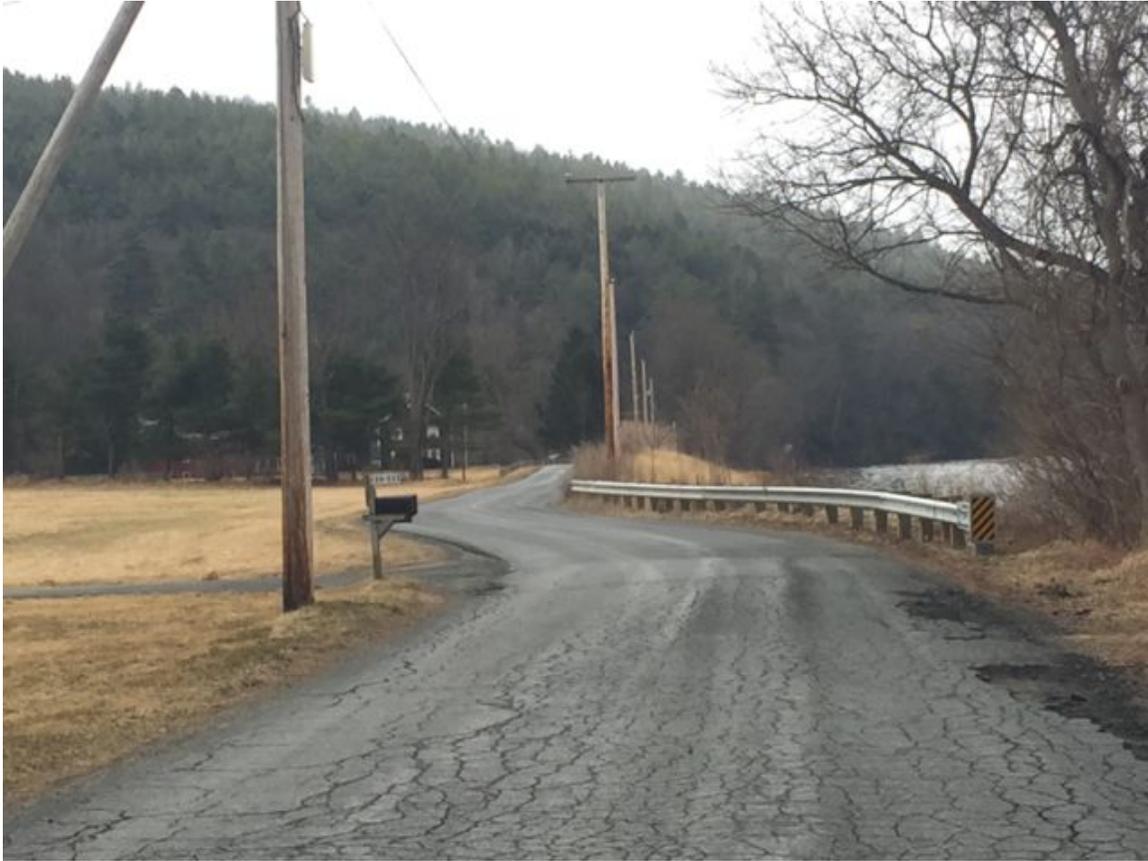
Figure 3. Dog-leg on River Road, Lyme, NH. by-passes land lost to erosion.

In order to repair the road, it was moved east with a resulting “dog-leg” because of the excessive cost of reconstructing it in situ. The farmland to the east of the road was the subject of a conservation easement. Because of the protection of farmland conferred by the easement, it was necessary to take the land by eminent domain. Following this, the road was rebuilt according to an engineering plan that fails to mention piping and may not have used impervious material to mitigate erosive piping in the future. The total cost of the project was \$685,308 of which the Town paid \$398,061. The remaining \$287,247 was paid by a grant from the U.S. Department of Agriculture (NRCS). Because of regulatory and financing requirements related to the repair, the road was closed to travel for nearly 2 years.

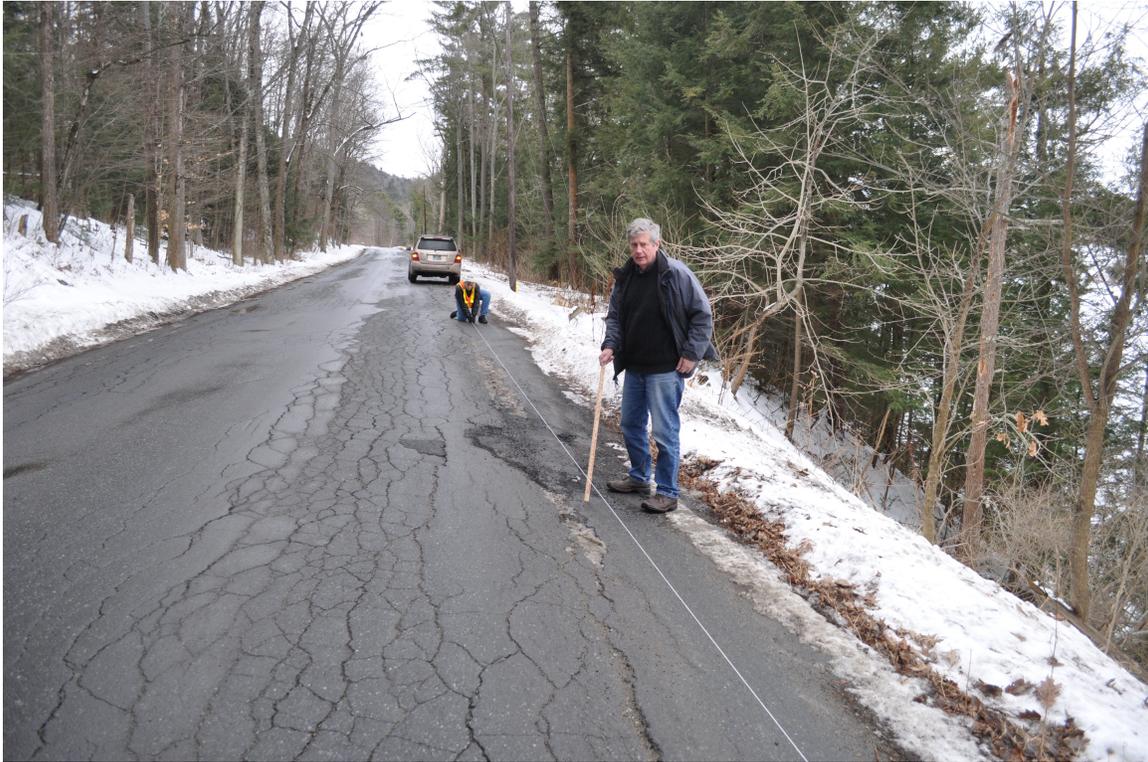
River Road a quarter mile south of the East Thetford Bridge ascends to a bench that runs along farm and woodland to the east. On the west a steep bank descends to the river below. In this section 120 feet of the western half of this road has settled, with a more pronounced dip of 30 feet as shown in figure 3 below.

Figure 4. River Road, Lyme, looking south about a quarter mile south of the East Thetford bridge. The string is on the road at each end of the slump which is 7 inches below the string in the center. Note the cracking of the blacktop on the west side of the road due to the slump and compare it with the cracking seen in the photo taken at the site of the collapse near the North Thetford road in figure 2

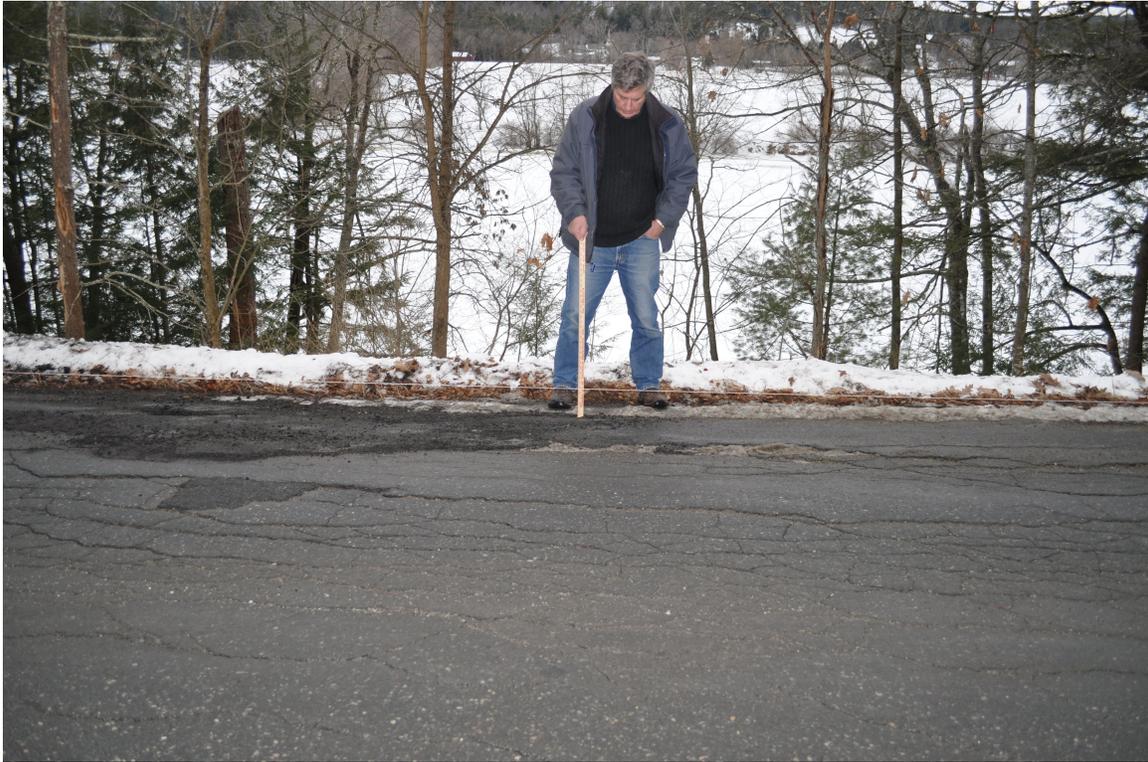
Figure 5. River road south looking west. Wilder impoundment in background. Slump in road is 7 inches.

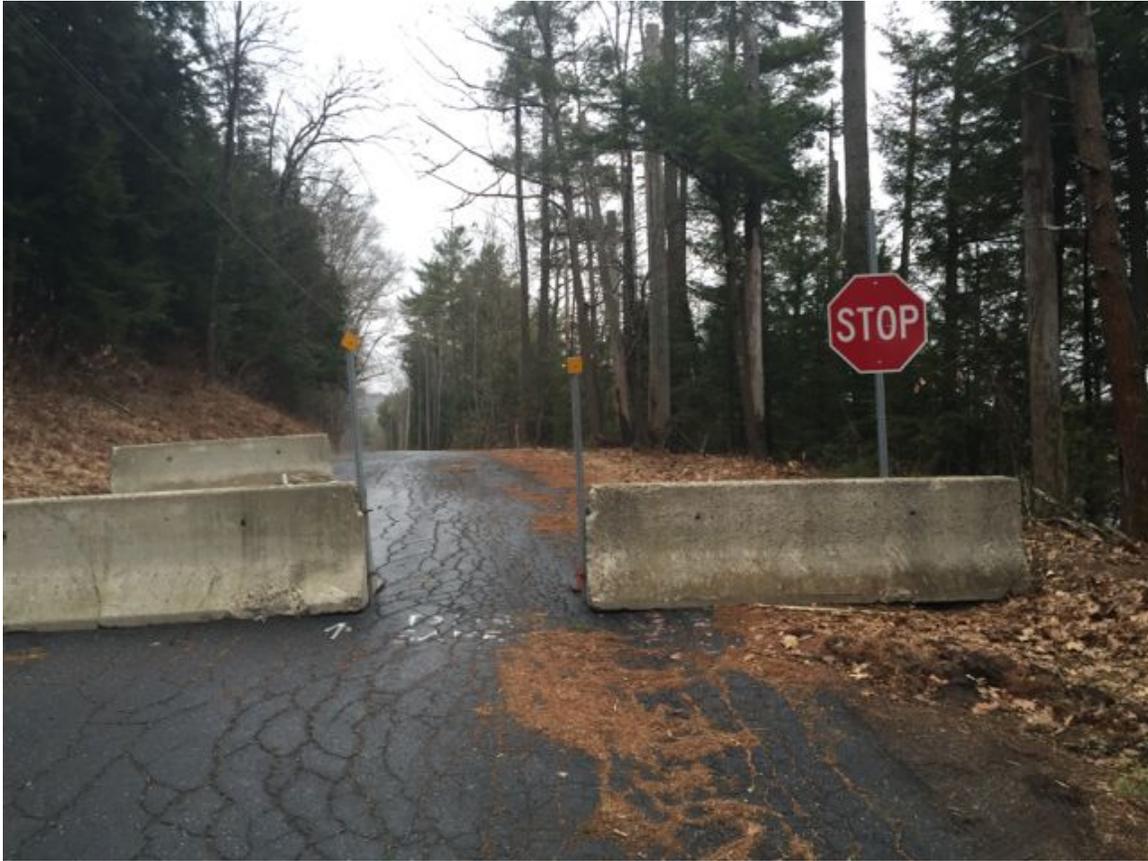
Two years later the road was closed because of further subsidence and the risk of sudden catastrophic slippage that could result in a plunge into 40 feet of water. The resulting closure with estimated costs to a town of less than 2000 persons of more than a \$1 million. It has also created a continuing financial hardship to residents, farmers, and others, including emergency services, who must use long detours around the blocked road segment

Fig. 6. Barrier closes River Road segment with threat of catastrophic slippage.
