<u>Fluvial Geomorphology Assessment of the</u> <u>Northern Connecticut River, Vermont</u> <u>and New Hampshire</u>

Connecticut River Joint Commissions Charlestown, New Hampshire

Field Geology Services Farmington, ME

October 2004

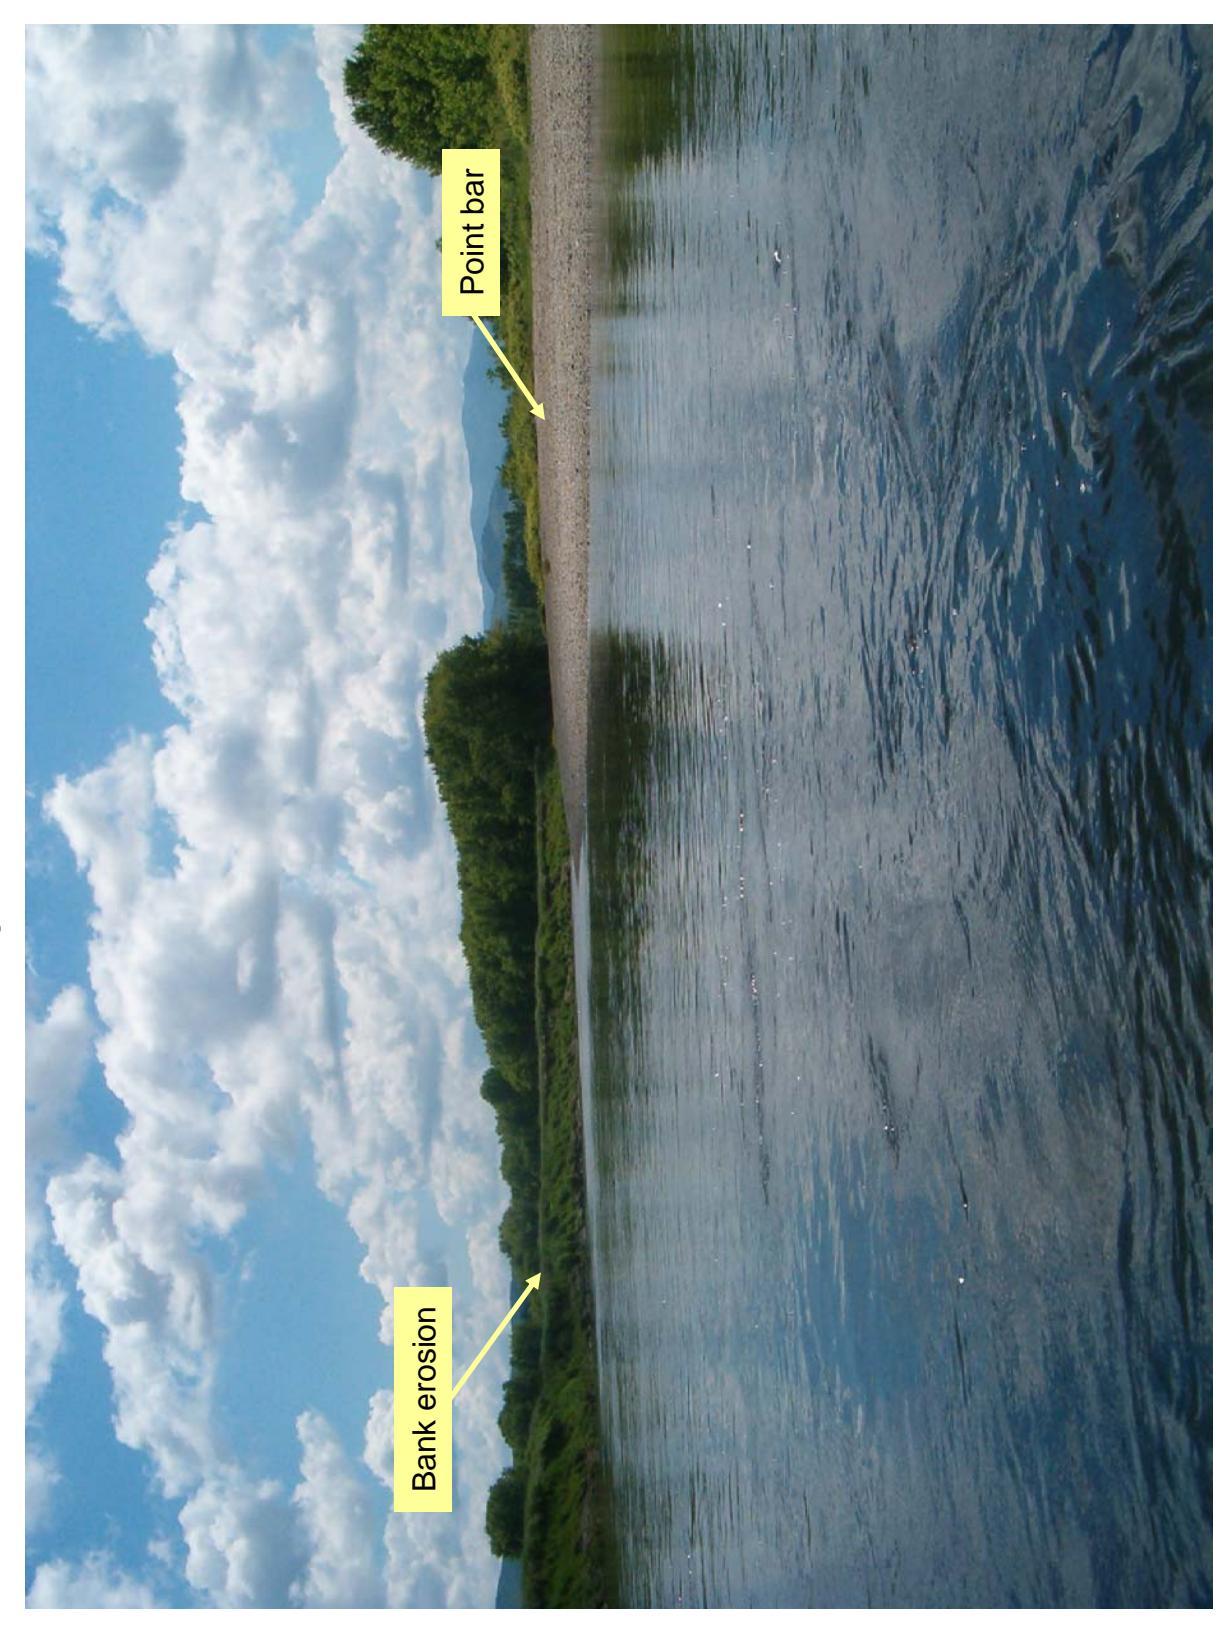
Northern Connecticut River Fluvial Geomorphology Assessment – Figure 9

Point Bar Formation Causing Erosion of Opposite Bank – Reach 7
