TRANSCANADA HYDRO NORTHEAST INC.

ILP Study 8
Channel Morphology and Benthic Habitat Study
Study Report

Wilder Hydroelectric Project (FERC Project No. 1892-026)
Bellows Falls Hydroelectric Project (FERC Project No. 1855-045)
Vernon Hydroelectric Project (FERC Project No. 1904-073)

March 2, 2015

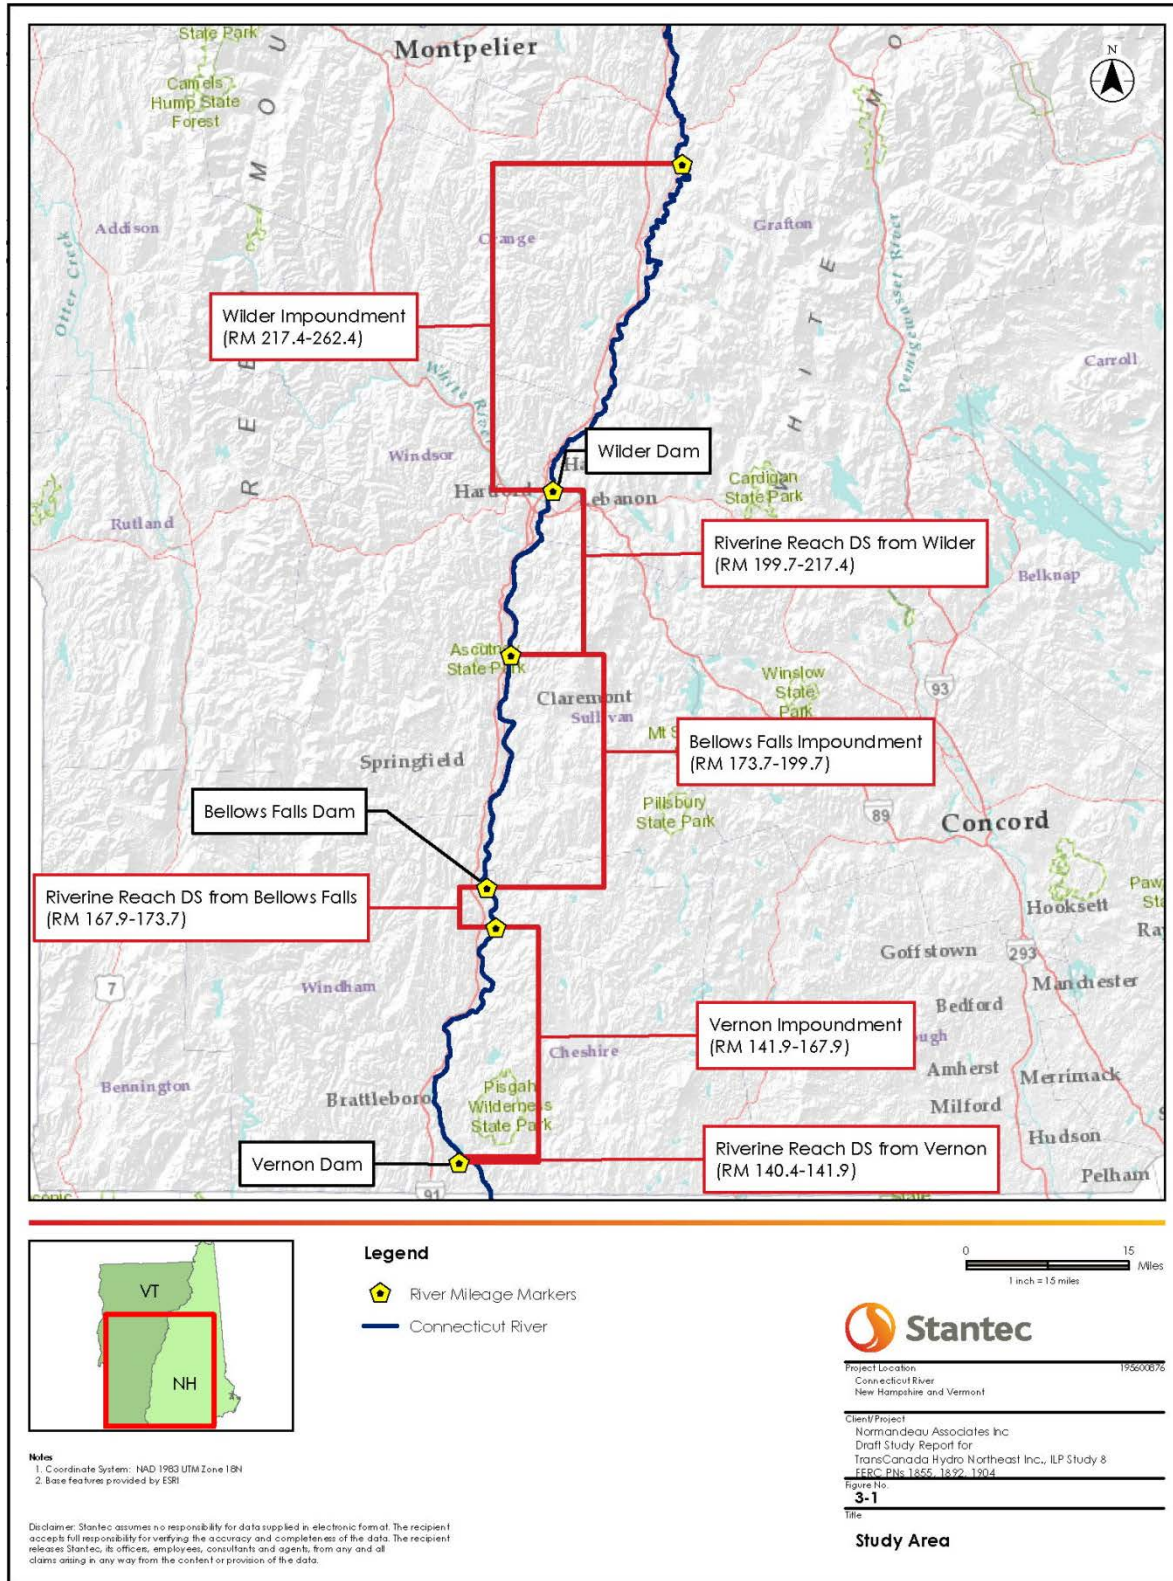
Figure 3-1. Study area.

The study area excludes the portions of tributaries outside of project influence as these are influenced by non-project related inflow. The approximate 1.5-mile reach downstream from Vernon Dam is included in the study area, consistent with the geographic scope of other ILP studies (Figure 3-1).

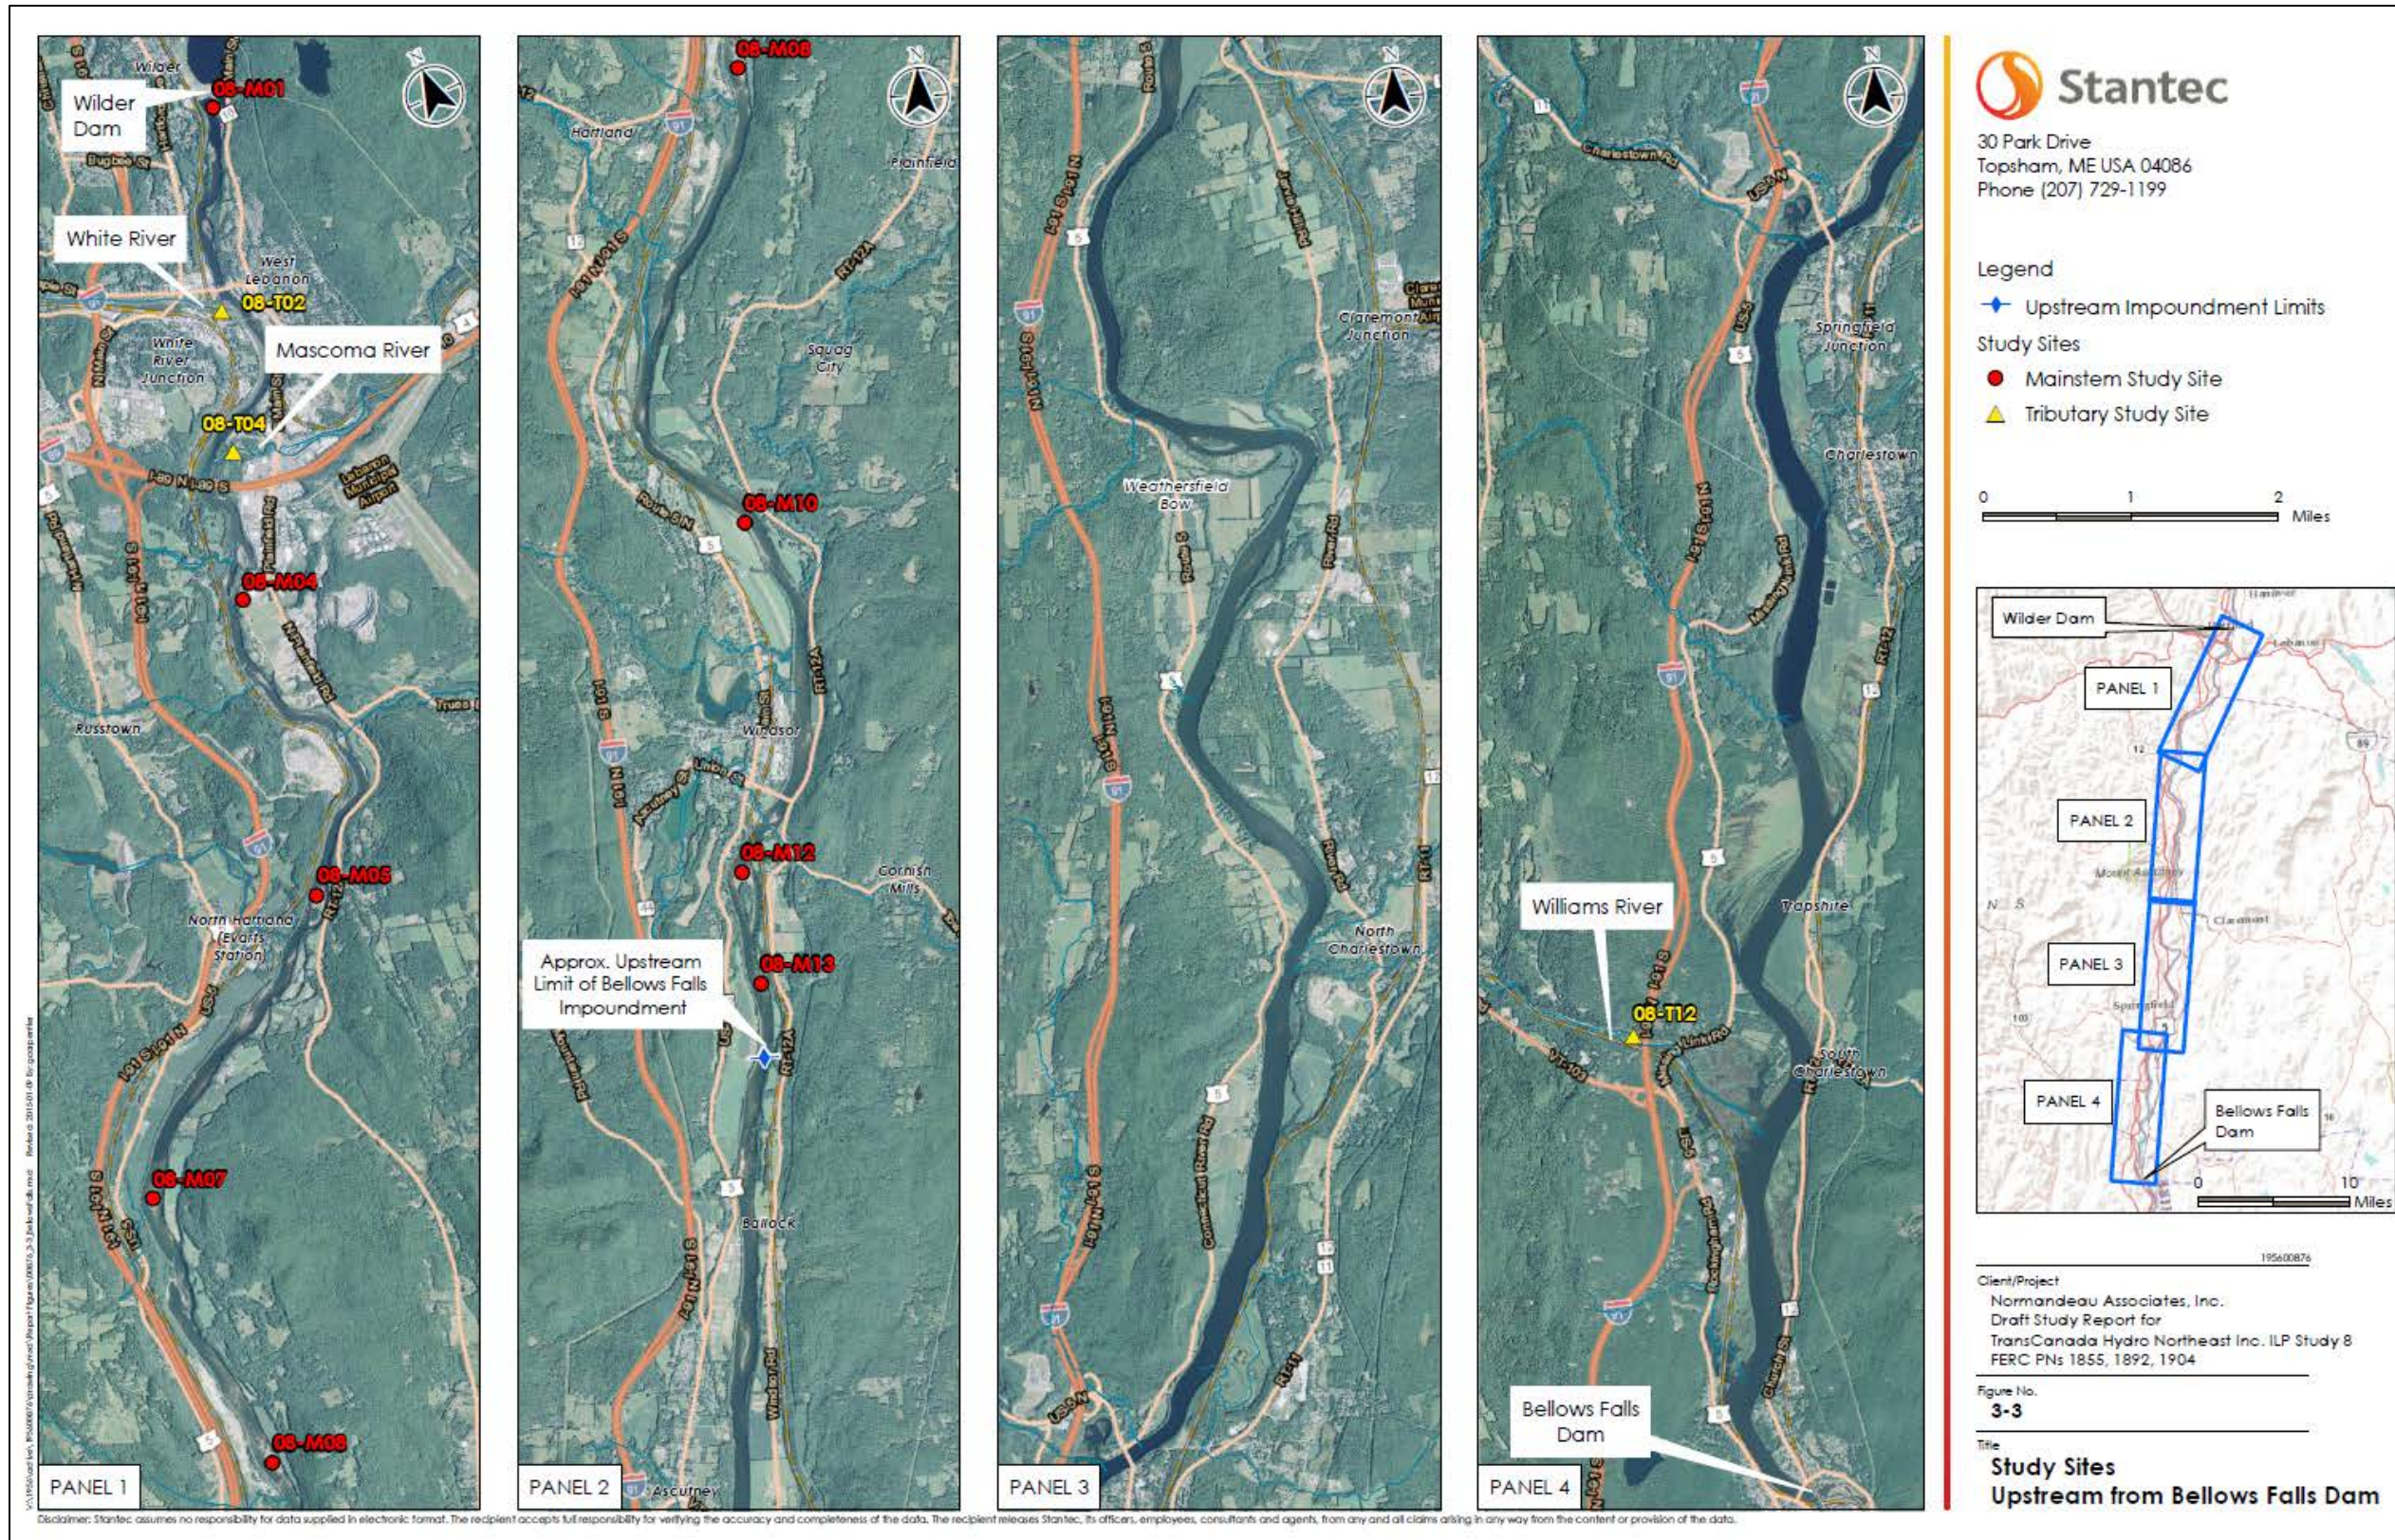
Figure 3-3. Study sites upstream of Bellows Falls Dam.

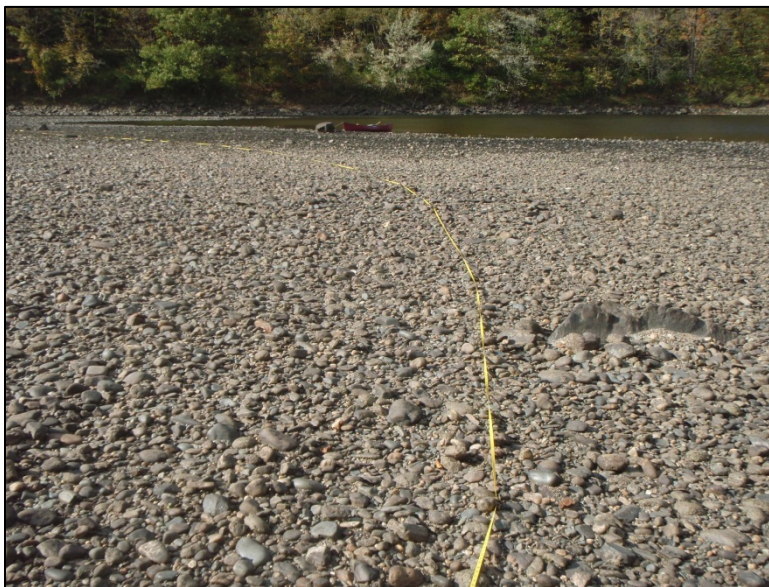
Photo 3-2. Mainstem study site 08-M05, facing across the upstream end of Burnaps Island, towards the right bank of the Connecticut River. (Stantec 10/8/2014)

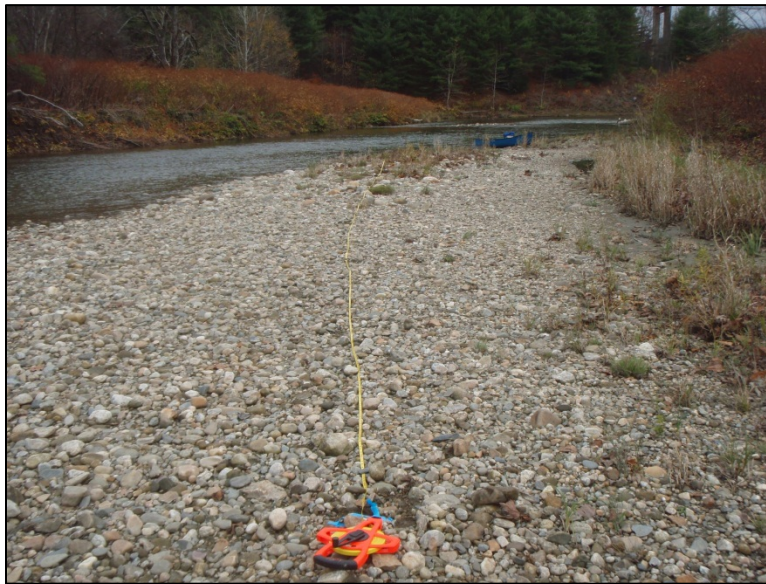
Photo 3-3. Tributary study site 08-T12 facing downstream along the Williams River. (Stantec 10/31/2014)

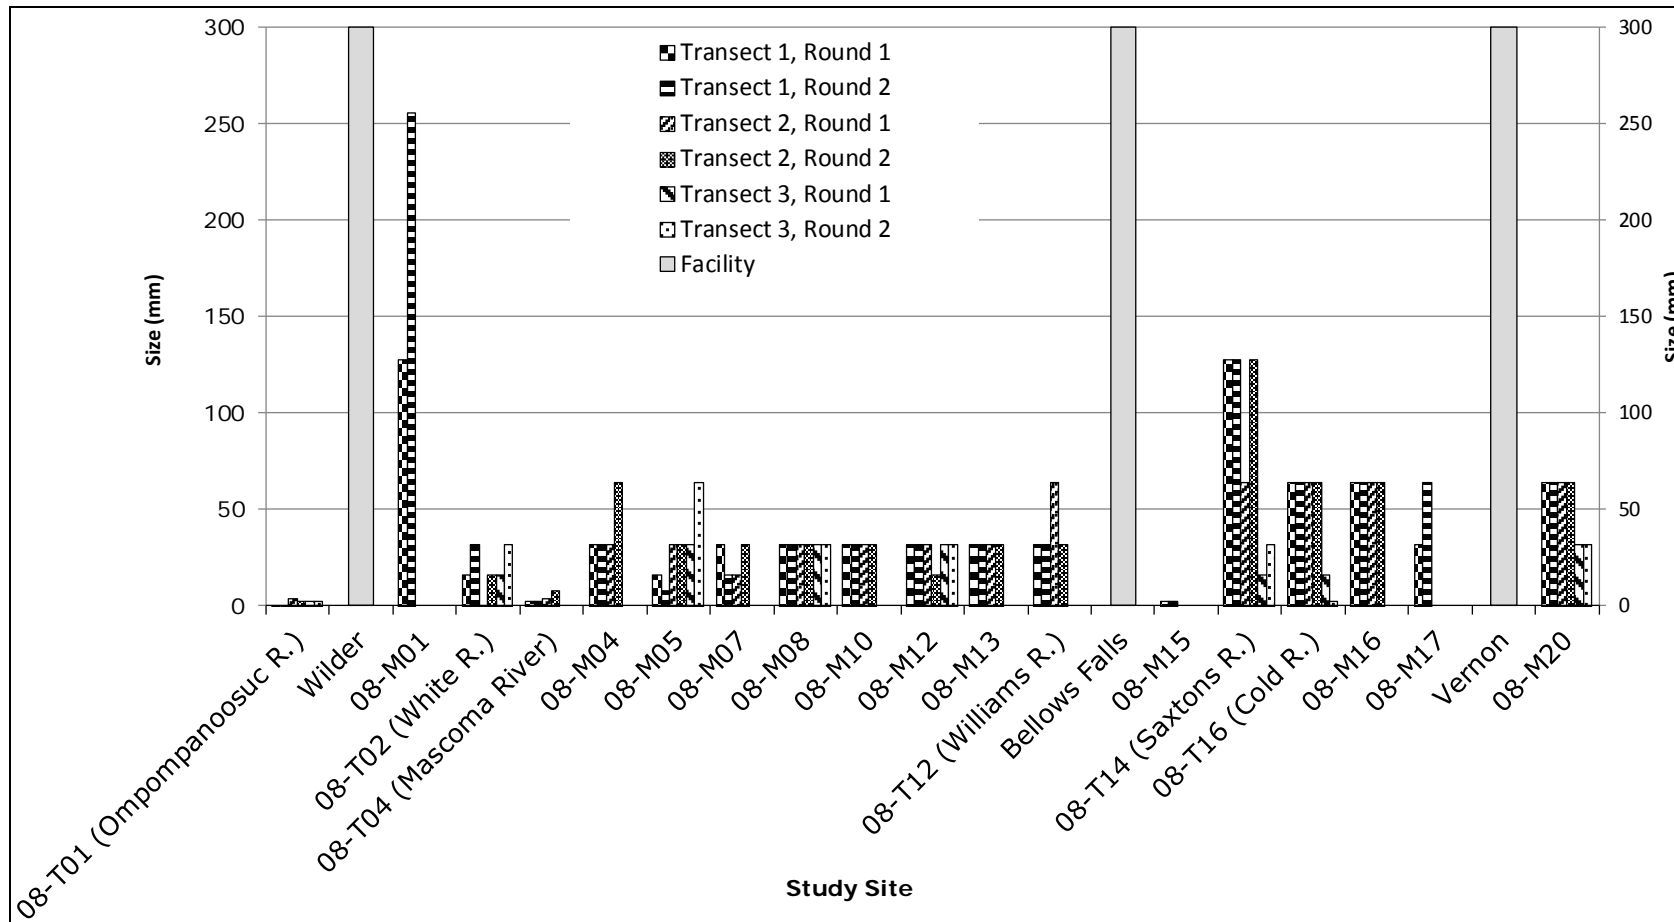
Figure 5-1 below presents histograms of the median particle size that is presented in Table 5-1 (mainstem study sites) and Table 5-2 (tributary study sites).

Note: The study sites and locations of the three project dams are presented from upstream to downstream.

The median-diameter particle sizes in Figure 5-1 indicate similarity of particle sizes at sites between the Wilder and Bellows Falls dams, and between the Bellows Falls and Vernon dams. It is apparent from the figure that the median particle size is larger at sites downstream of Bellows Falls dam relative to the sites upstream of the dam. Apparent causes of the larger size material downstream of Bellows Falls are the input of sediment from the Saxtons and Cold rivers. The median particle size downstream of Vernon dam is similar to the median particle size at sites downstream of Bellows Falls.

Observed conditions and information obtained at the study sites suggest that sediment delivery from tributary streams affects the distribution of coarse-grained substrates in the adjacent downstream reach of the Connecticut River at some locations. For example, information obtained at tributary study sites 08-T14 (Saxtons River) and 08-T16 (Cold River) indicates that the median particle size class is similar to the downstream mainstem study sites (08-M16, 08-M17). However, sampling at tributary study sites 08-T02 (White River) and 08-T04 (Mascoma River) indicates that the median particle size class is smaller than the downstream mainstem study sites (08-M04, 08-M05, 08-M07, 08-M08, 08-M10, 08-M12, and 08-M13) that are upstream of Bellows Falls.

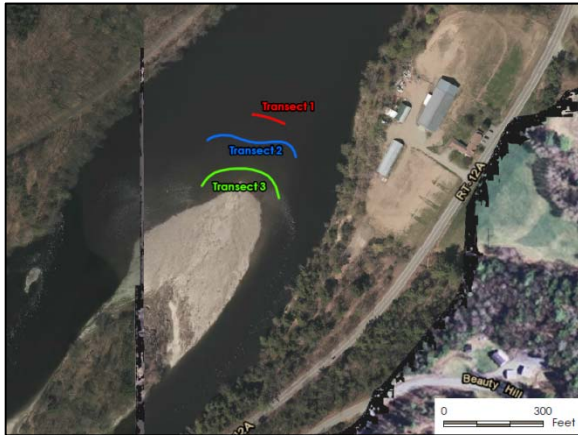
Figure B-3. Location of Study Site **08-M05** transects at upstream end of Burns Island.

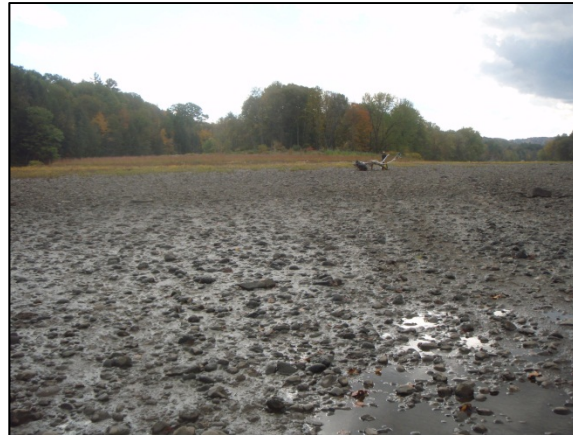
Photo B-9. View across Study Site 08-M05, facing downstream towards Burns Island. Photograph is taken from approximate location of Transect 1. (Stantec 10/08/14)

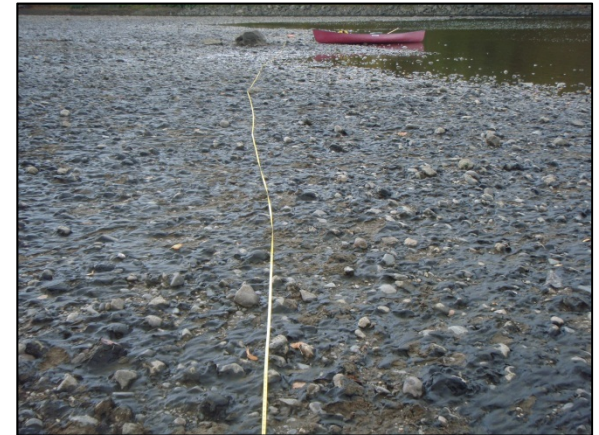
Photo B-10. View across Study Site 08-M05, facing west. Photograph is taken from the start (east limit) of Transect 1. The location of Transect 1 is indicated by the tape measure in the center of the photograph. (Stantec 10/08/14)

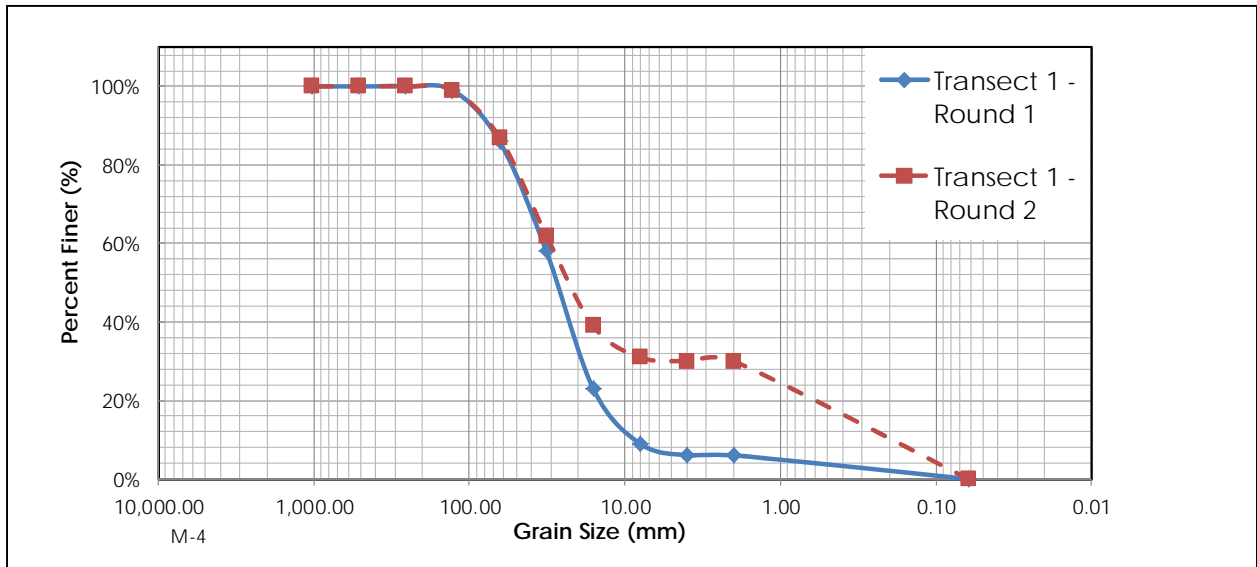
Figure C.2-1. Study site 08-M04 Transect 1 gradation curves.

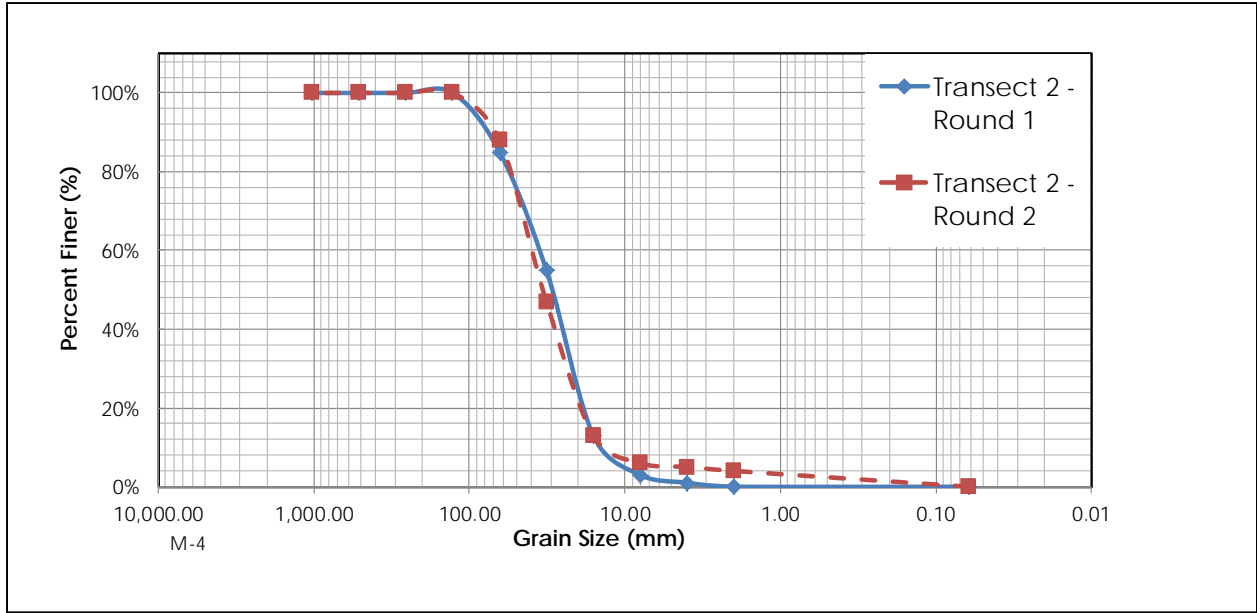
Figure C.2-2. Study site 08-M04 Transect 2 gradation curves.

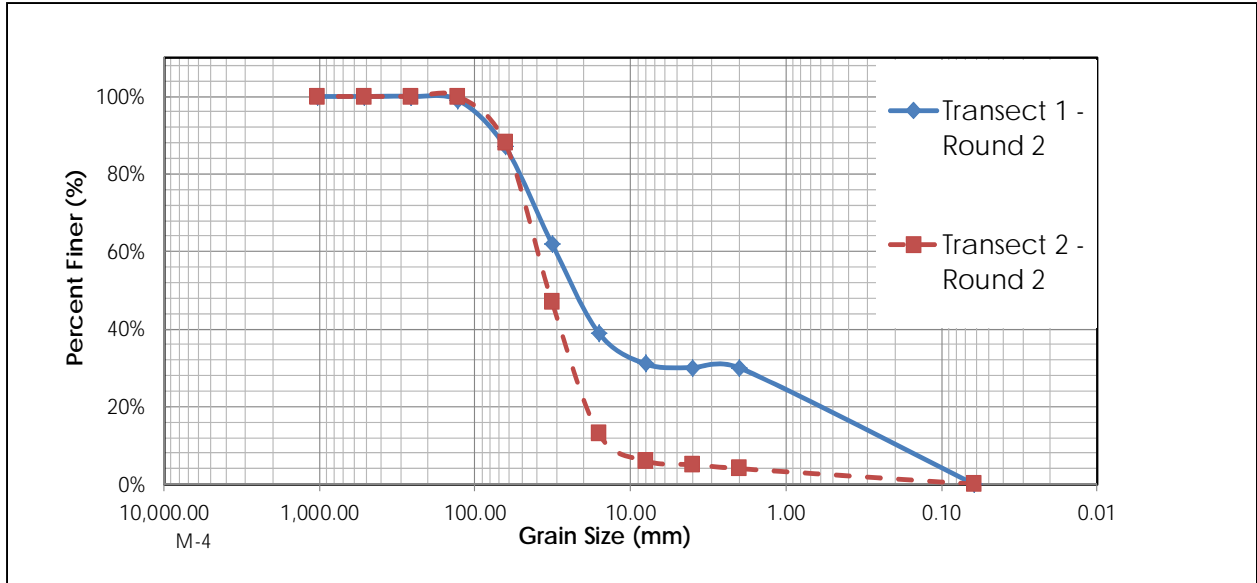
Figure C.2-4. Study site 08-M04 Transects 1 and 2, Round 2 gradation curves.

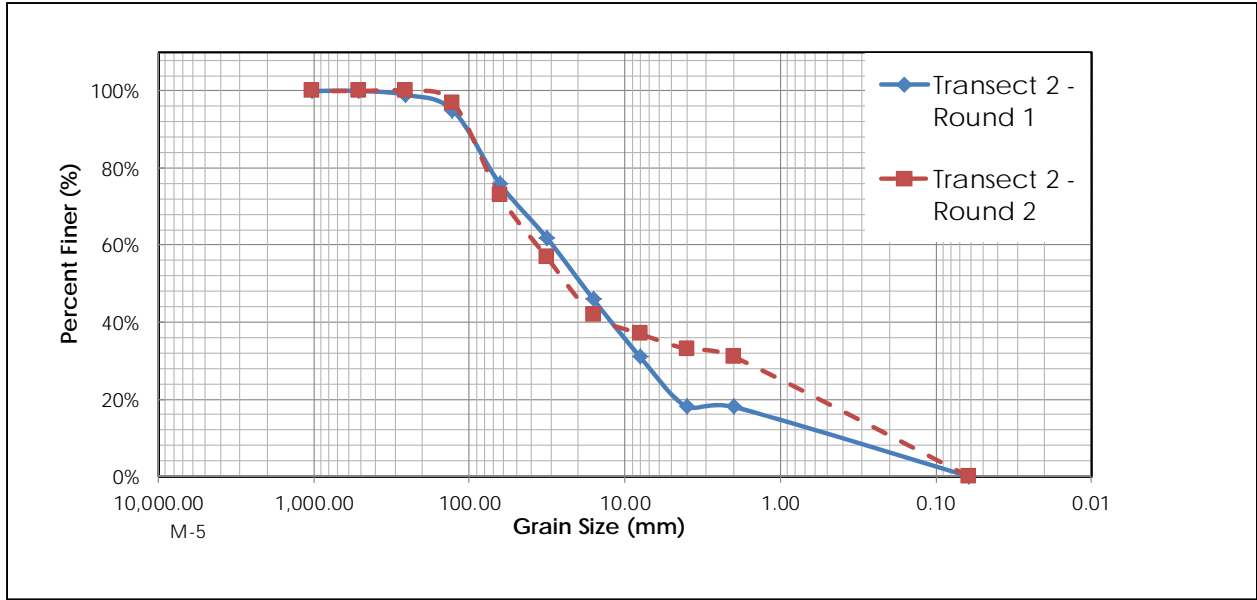
Figure C.3-2. Study site 08-M05 Transect 2 gradation curves.

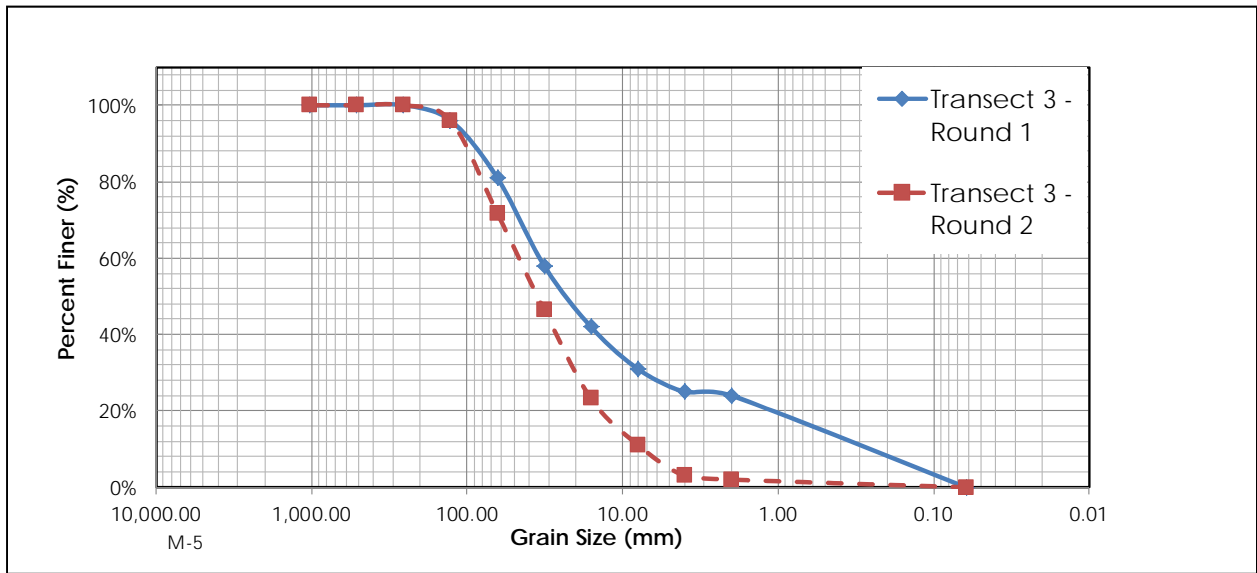
Figure C.3-3. Study site 08-M05 Transect 3 gradation curves.

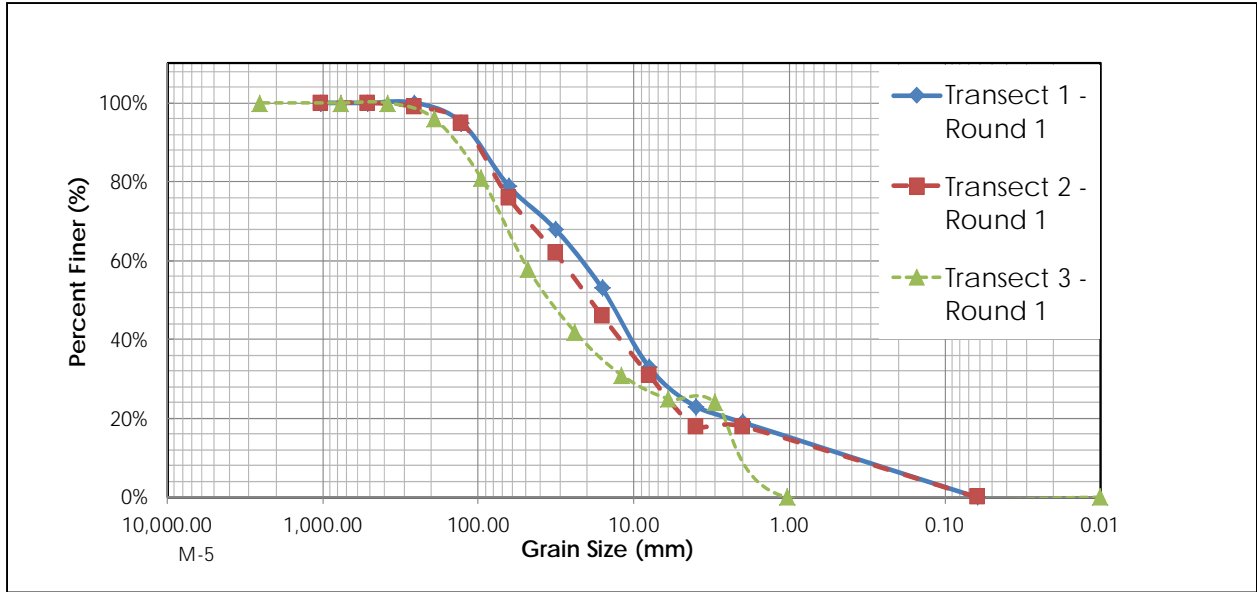
Figure C.3-4. Study site 08-M05 Transects 1, 2, and 3, Round 1 gradation curves.

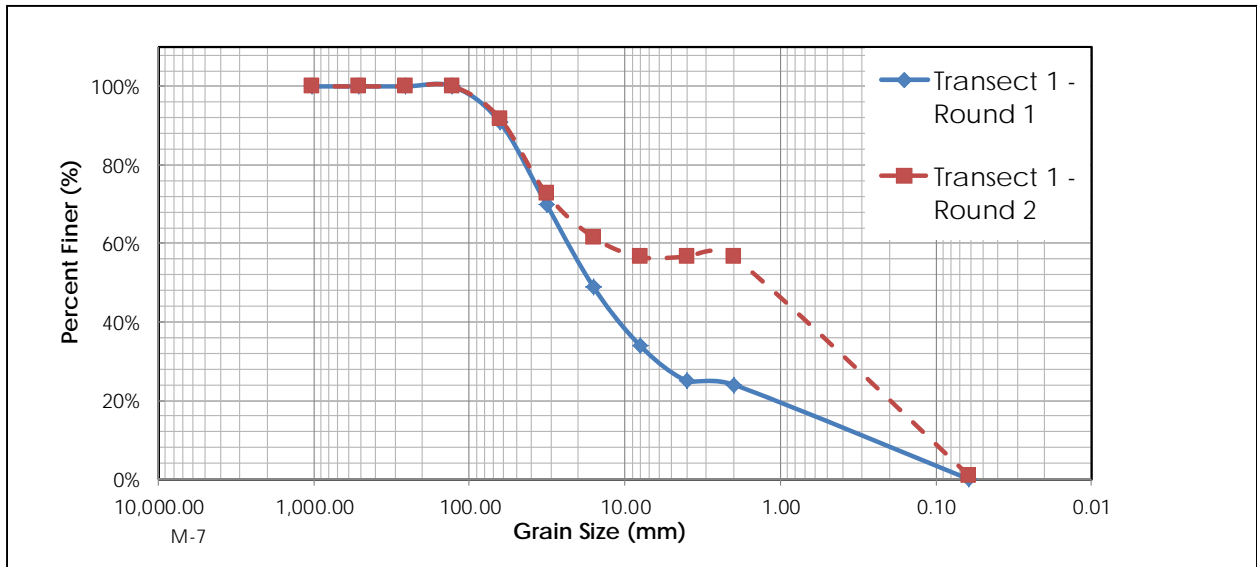
Figure C.4-1. Study site 08-M07 Transect 1 gradation curves.

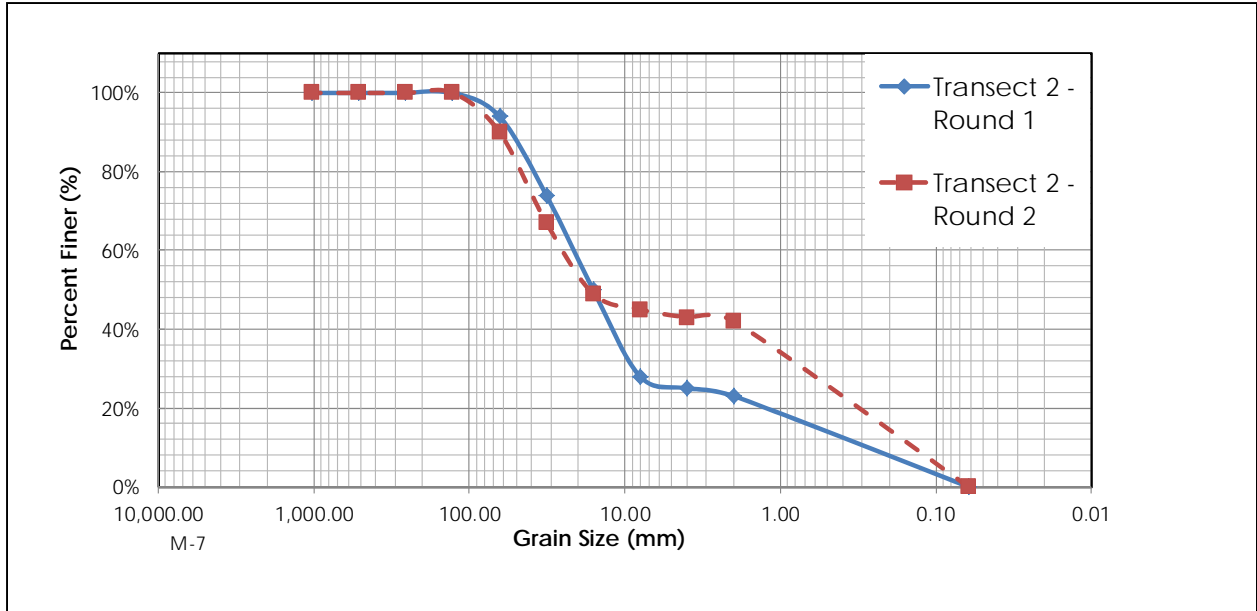
Figure C.4-2. Study site 08-M07 Transect 2 gradation curves.

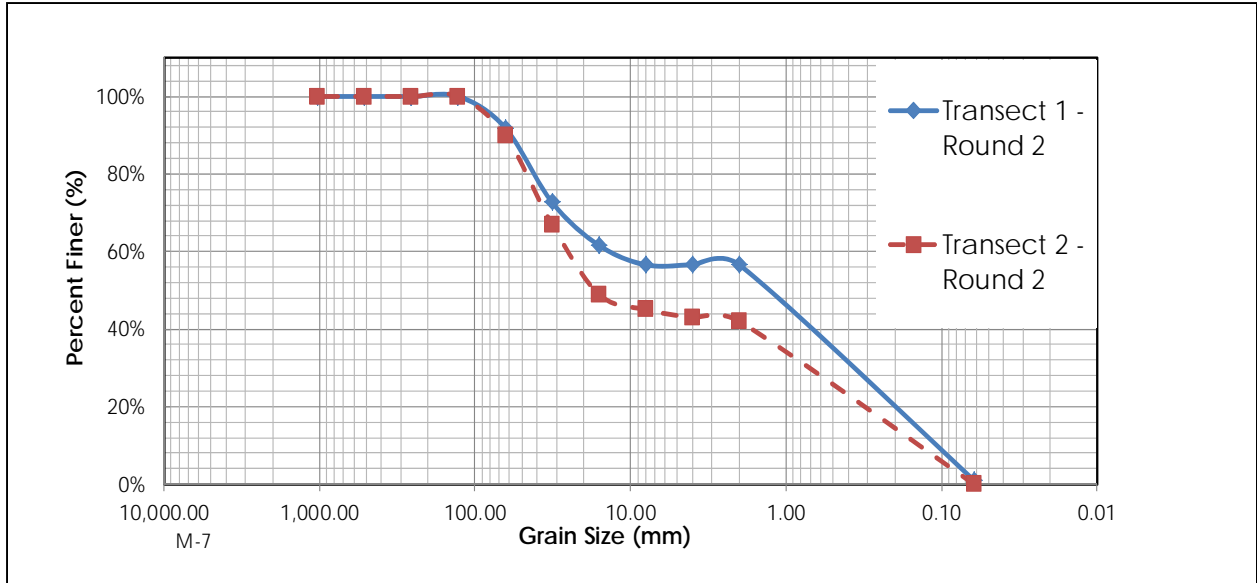
Figure C.4-4. Study site 08-M07 Transects 1 and 2, Round 2 gradation curves.

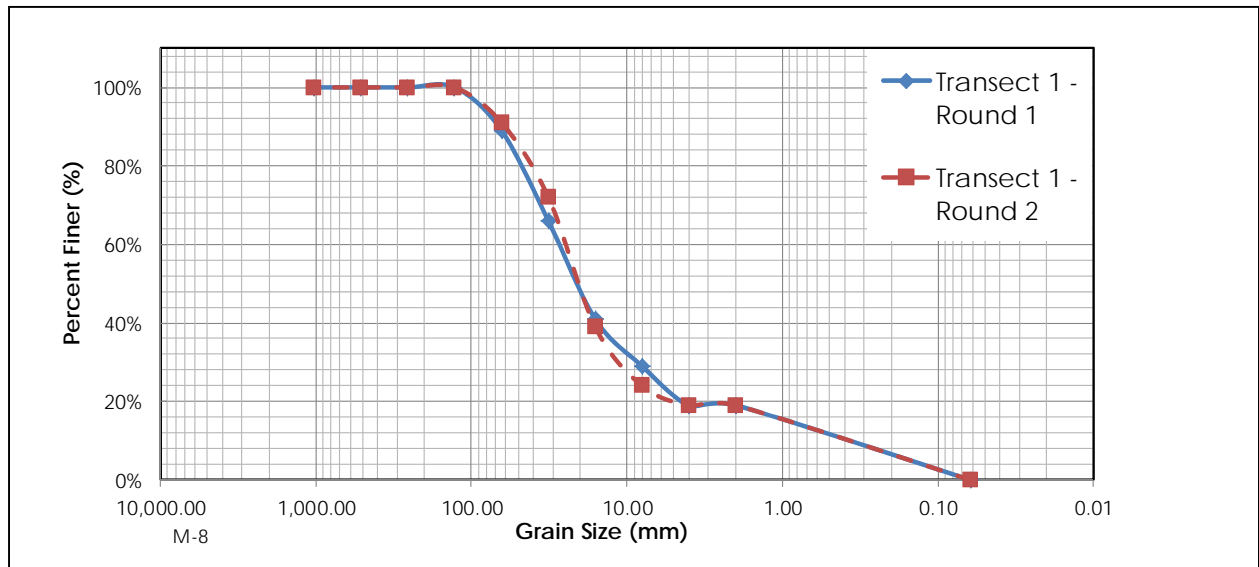
Figure C.5-1. Study site 08-M08 Transect 1 gradation curves.

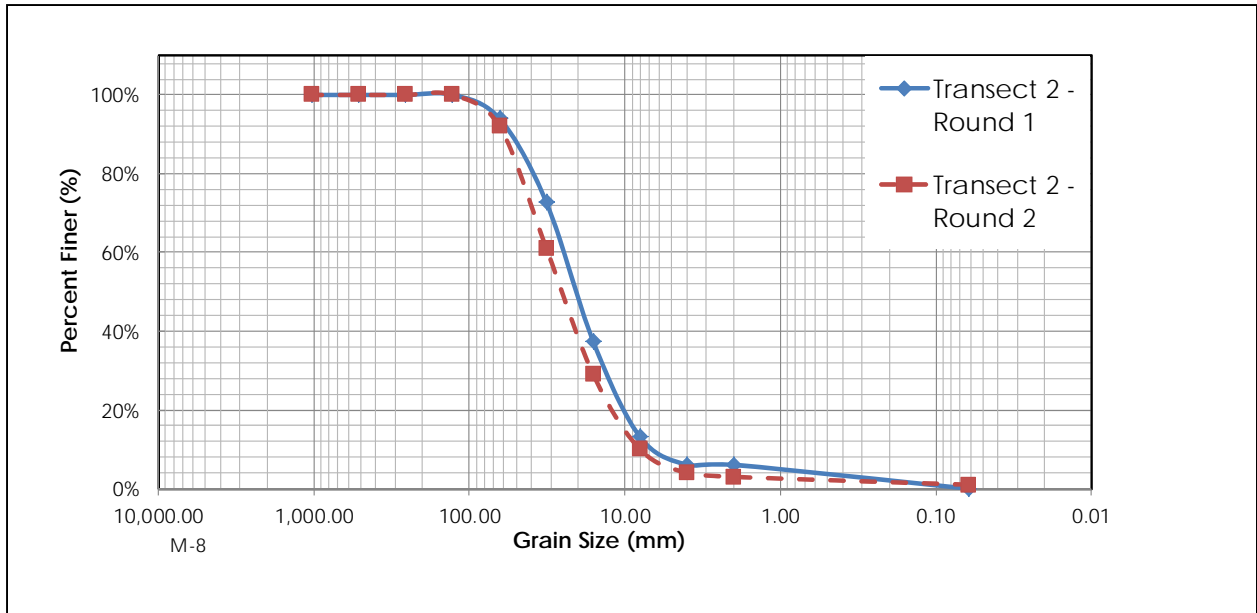
Figure C.5-2. Study site 08-M08 Transect 2 gradation curves.

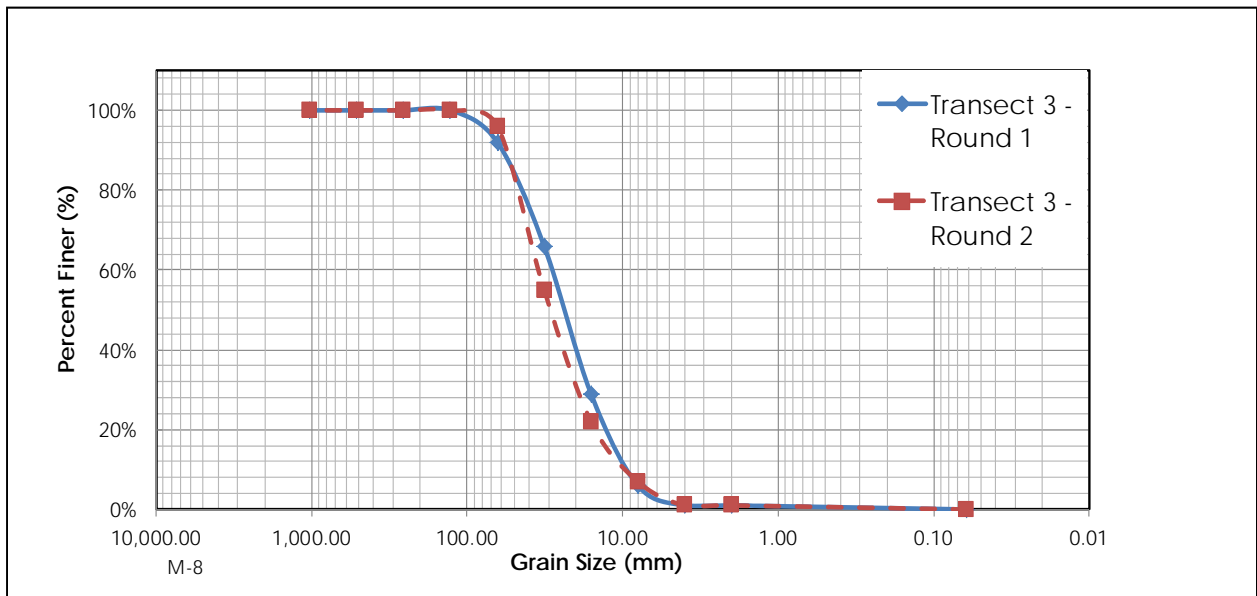
Figure C.5-3. Study site 08-M08 Transect 3 gradation curves.

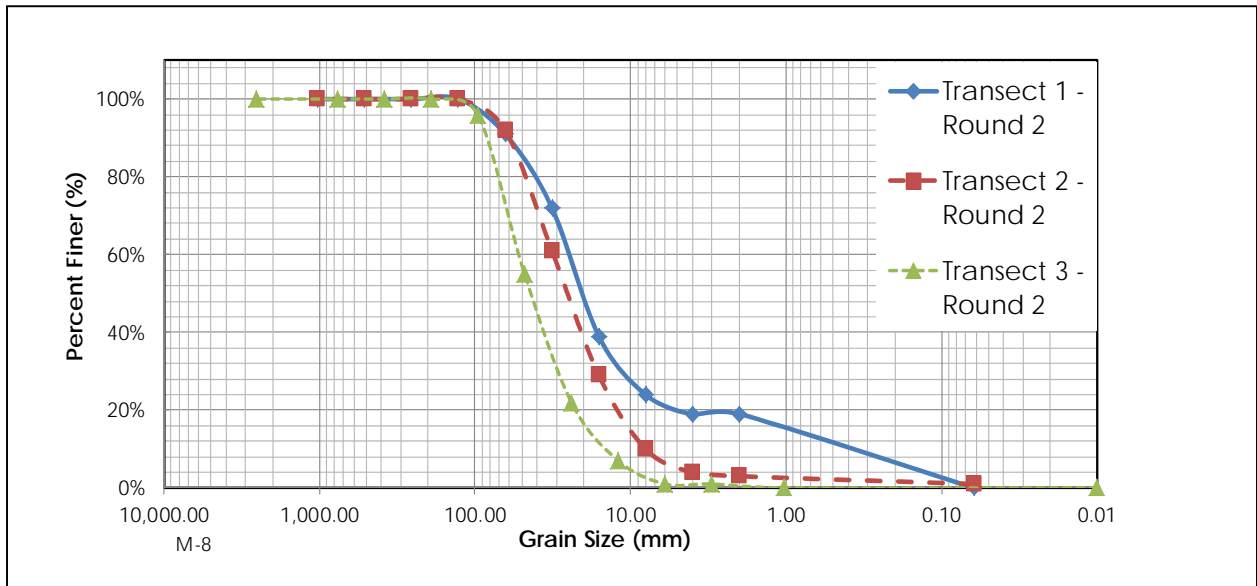
Figure C.5-5. Study site 08-M08 Transects 1, 2, and 3, Round 2 gradation curves.

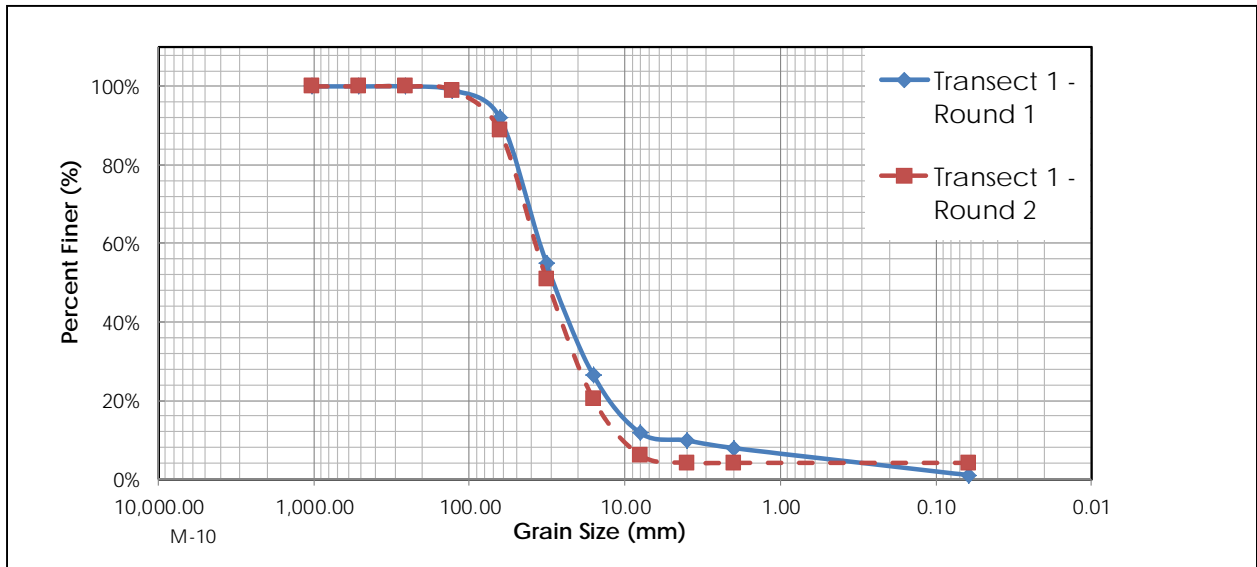
Figure C.6-1. Study site 08-M10 Transect 1 gradation curves.

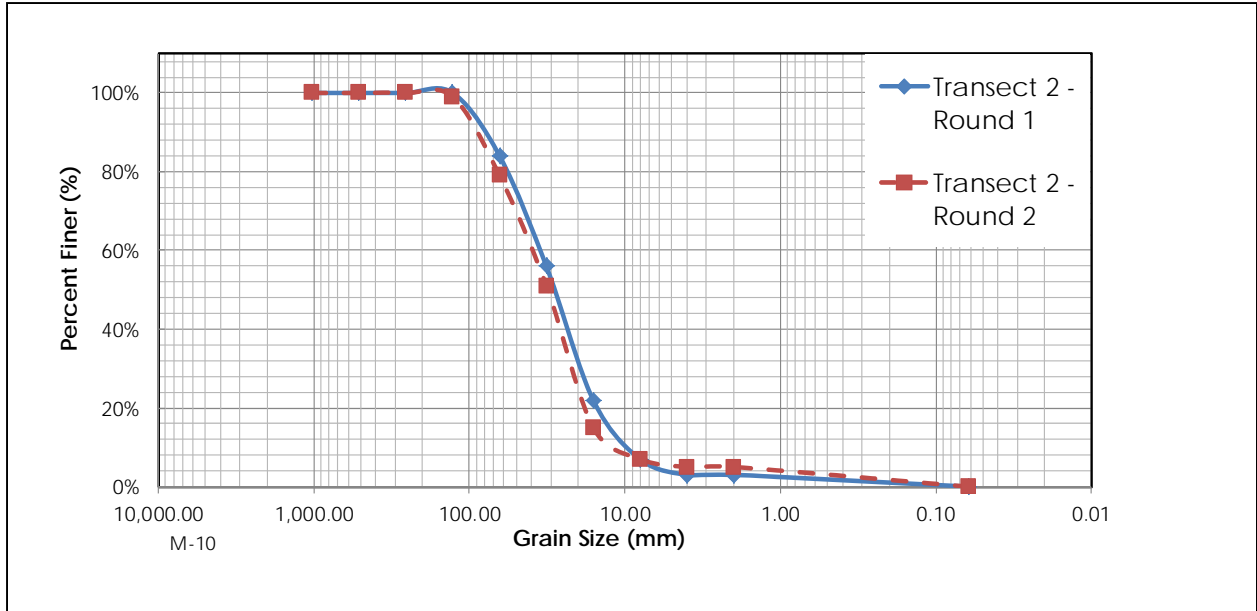
Figure C.6-2. Study site 08-M10 Transect 2 gradation curves.

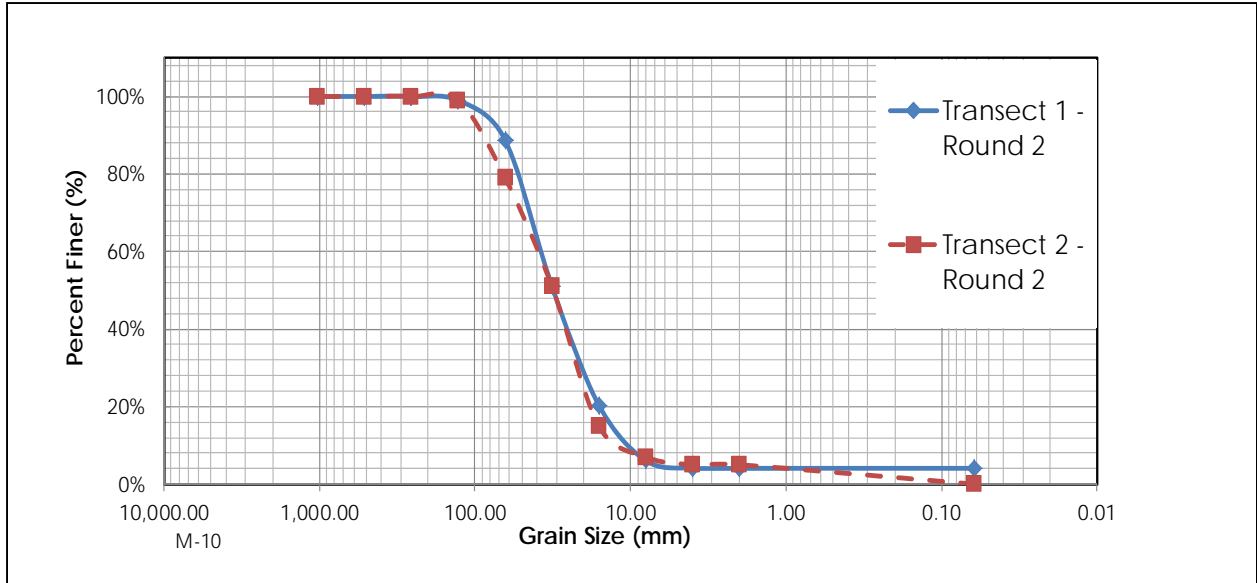
Figure C.6-4. Study site 08-M10 Transects 1 and 2, Round 2 gradation curves.

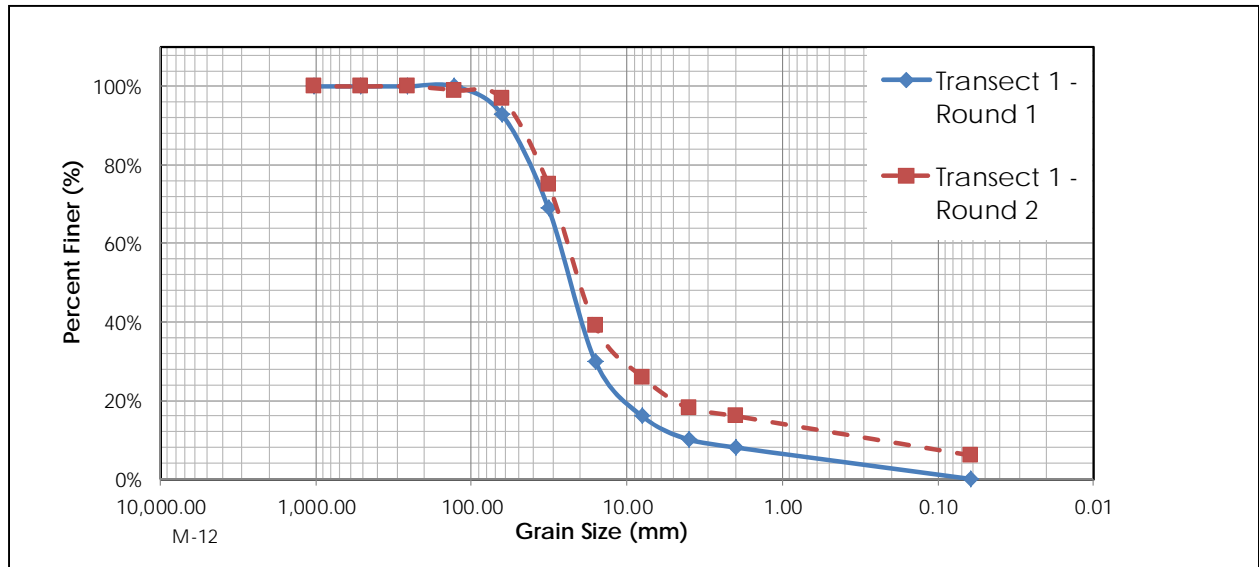
Figure C.7-1. Study site 08-M12 Transect 1 gradation curves.

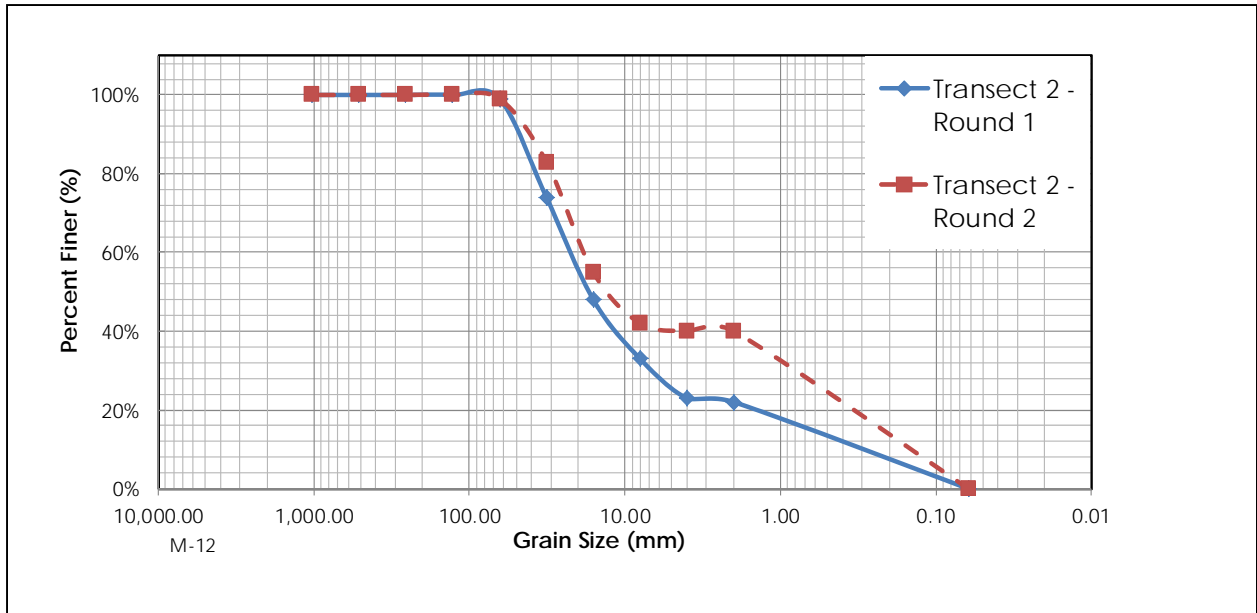
Figure C.7-2. Study site 08-M12 Transect 2 gradation curves.
