TRANSCANADA HYDRO NORTHEAST INC.

ILP Study 8
Channel Morphology and Benthic Habitat Study
Study Report

Wilder Hydroelectric Project (FERC Project No. 1892-026)
Bellows Falls Hydroelectric Project (FERC Project No. 1855-045)
Vernon Hydroelectric Project (FERC Project No. 1904-073)

March 2, 2015

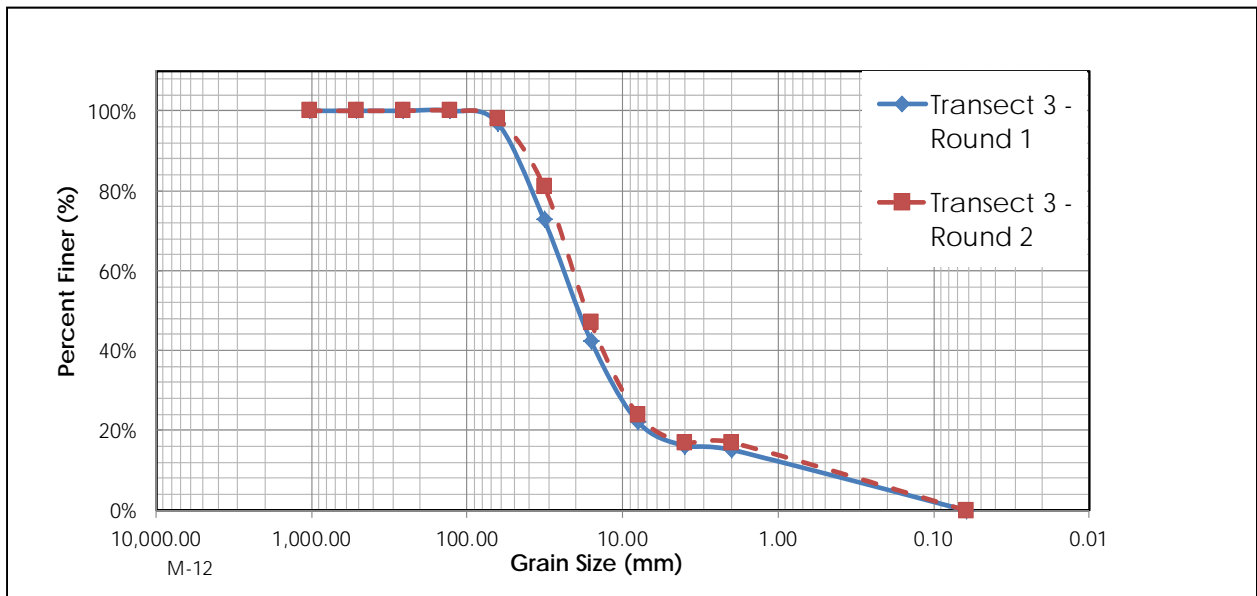
Figure C.7-3. Study site 08-M12 Transect 3 gradation curves.

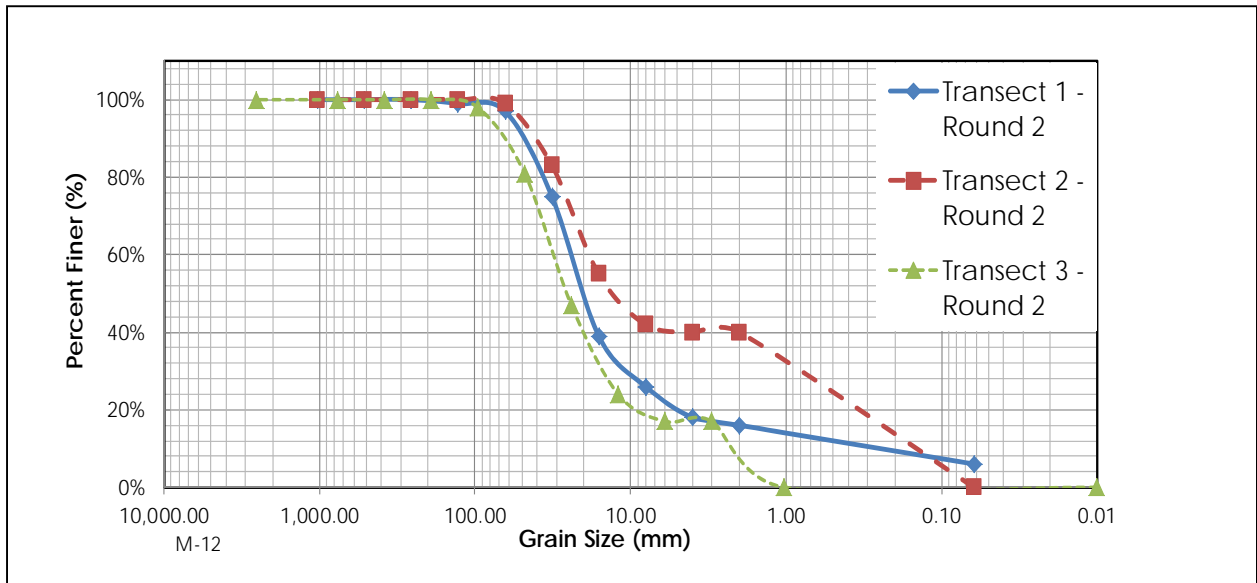
Figure C.7-5. Study site 08-M12 Transects 1, 2, and 3, Round 2 gradation curves.

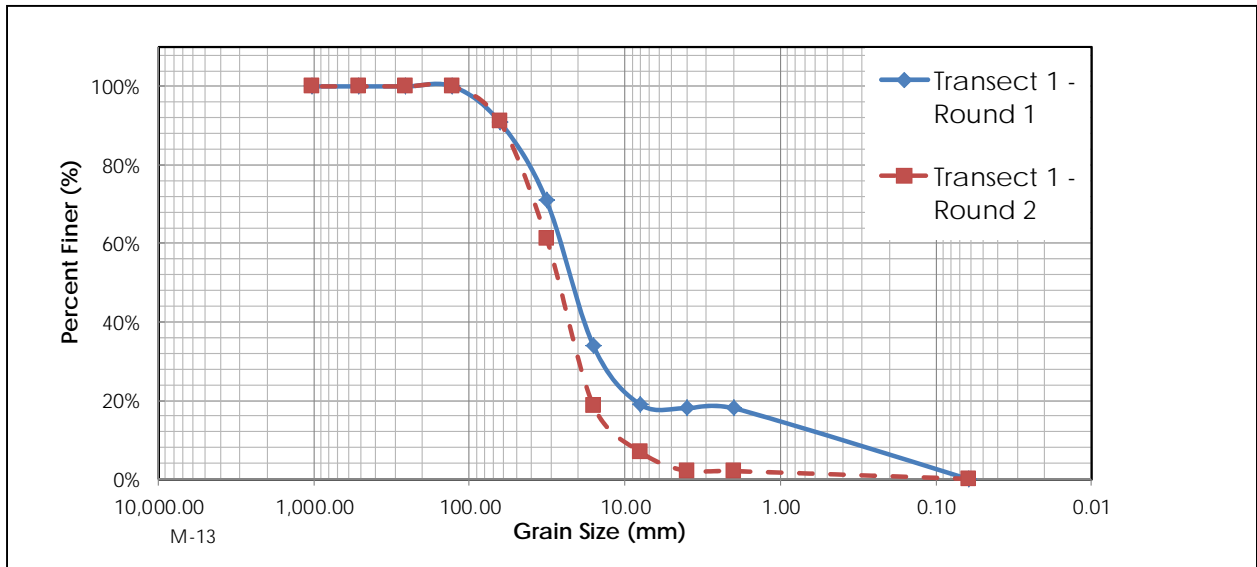
Figure C.8-1. Study site 08-M13 Transect 1 gradation curves.

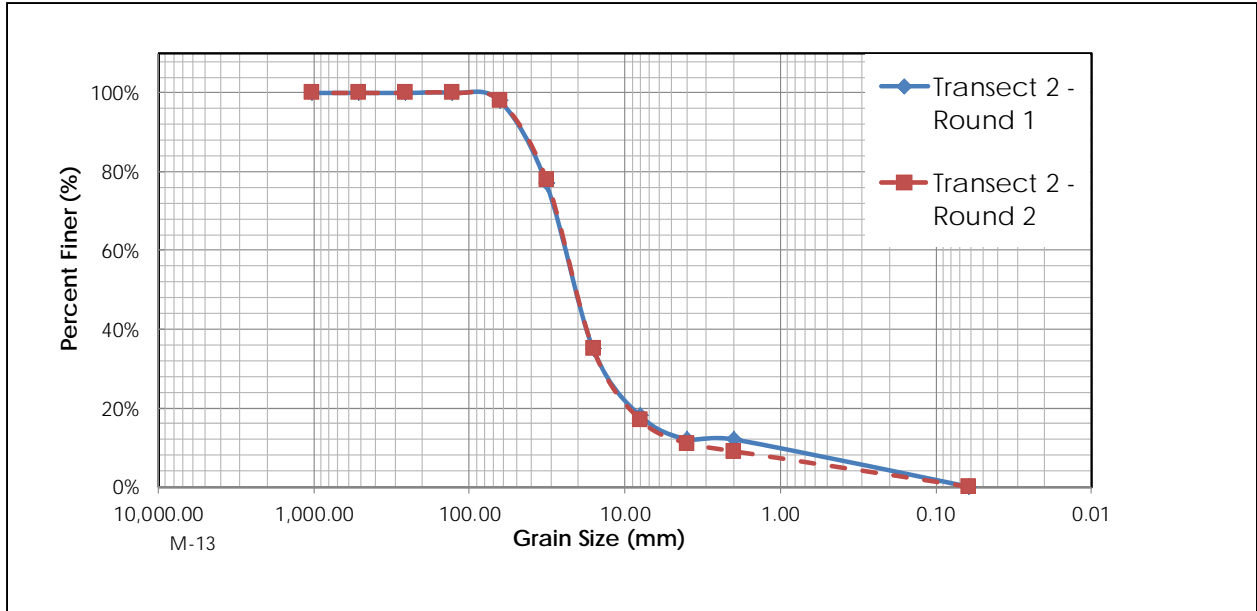
Figure C.8-2. Study site 08-M13 Transect 2 gradation curves.

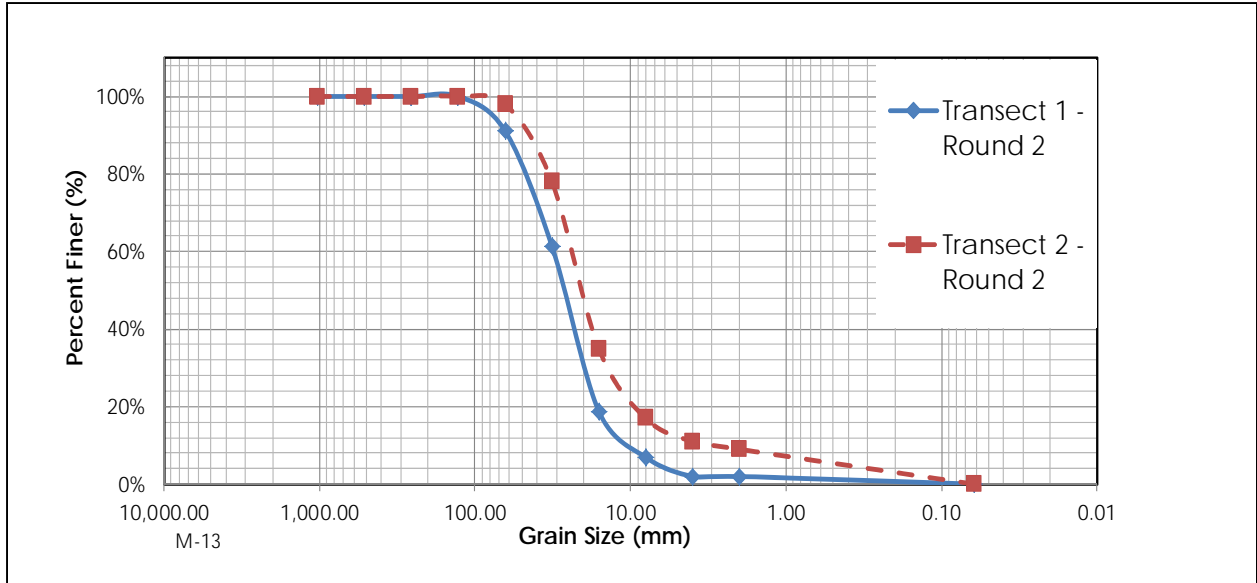
Figure C.8-4. Study site 08-M13 Transects 1 and 2, Round 2 gradation curves.

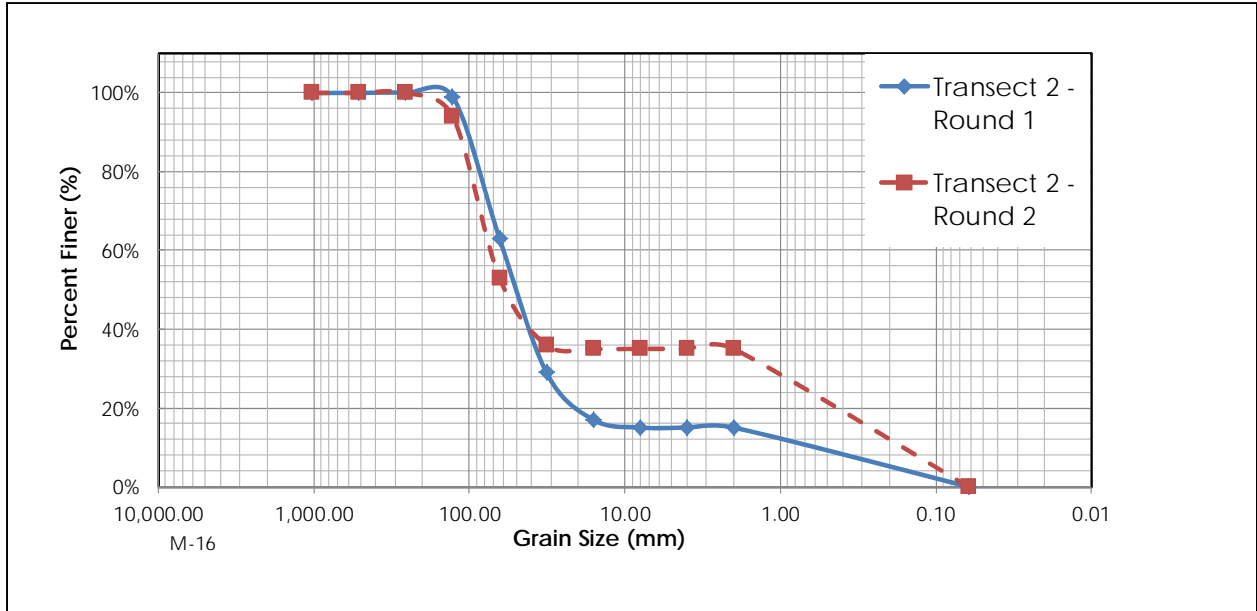
Figure C.10-2. Study site 08-M16 Transect 2 gradation curves.

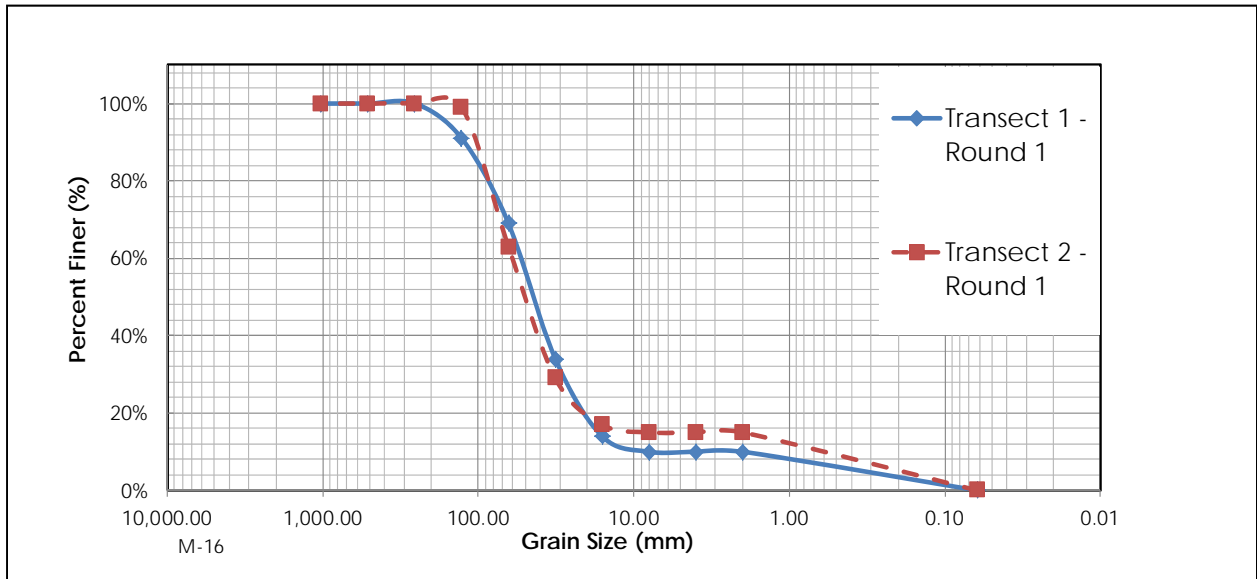
Figure C.10-3. Study site 08-M16 Transects 1 and 2, Round 1 gradation curves.

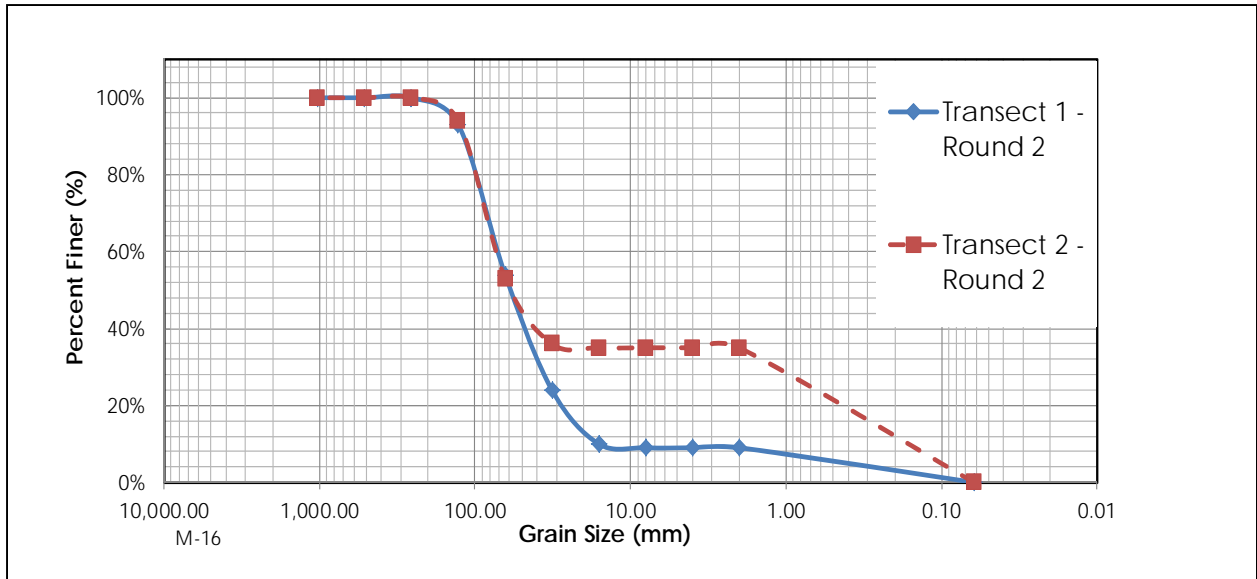
Figure C.10-4. Study site 08-M16 Transects 1 and 2, Round 2 gradation curves.

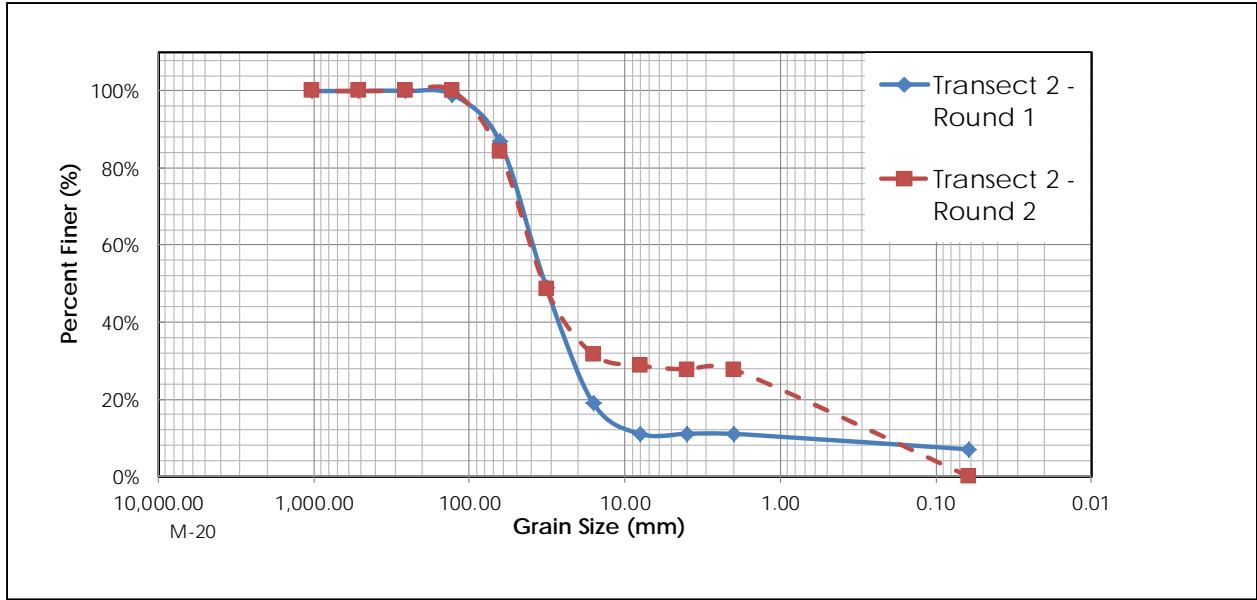
Figure C. 12-2. Study site 08-M20 Transect 2 gradation curves.

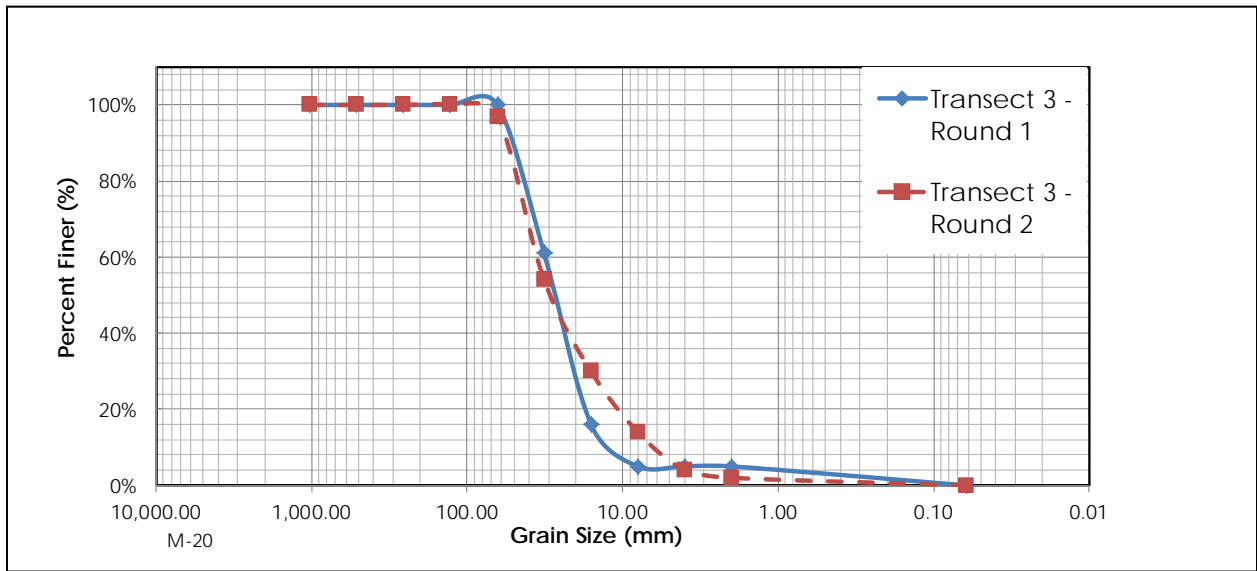
Figure C. 12-3. Study site 08-M20 Transect 3 gradation curves.

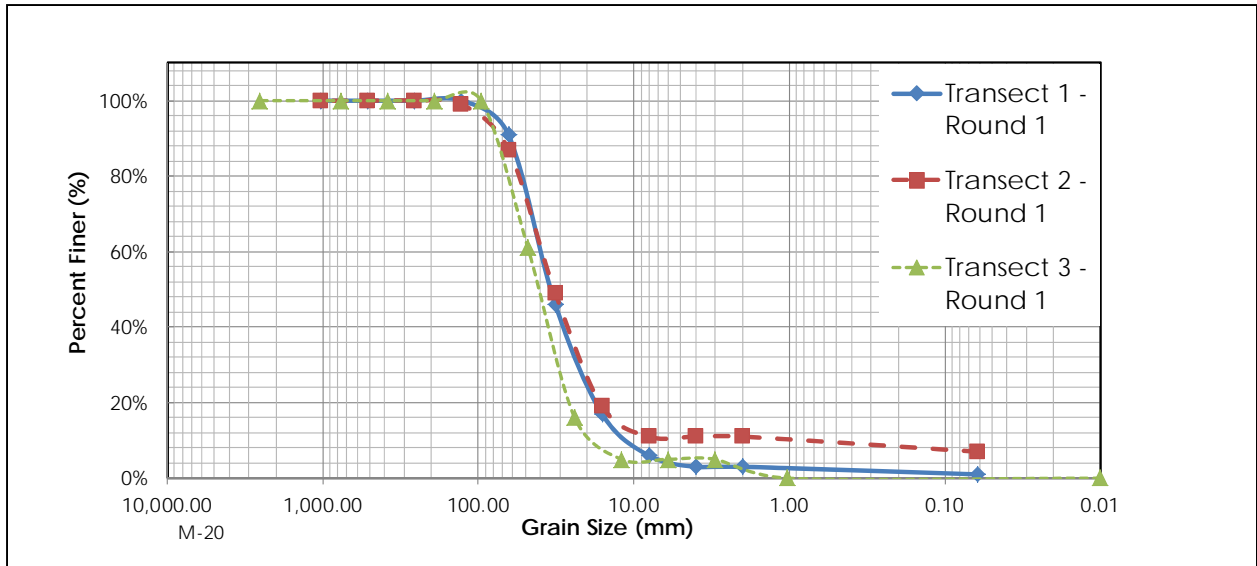
Figure C. 12-4. Study site 08-M20 Transects 1, 2, and 3, Round 1 gradation curves.

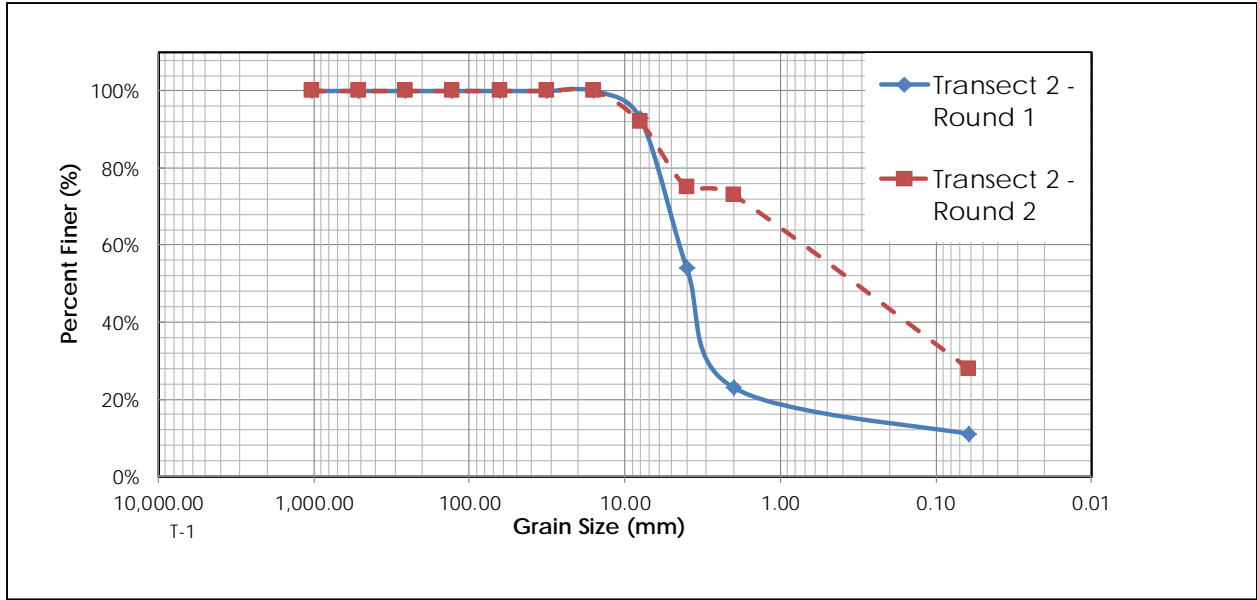
Figure C.13-2. Study site 08-T01 Transect 2 gradation curves.

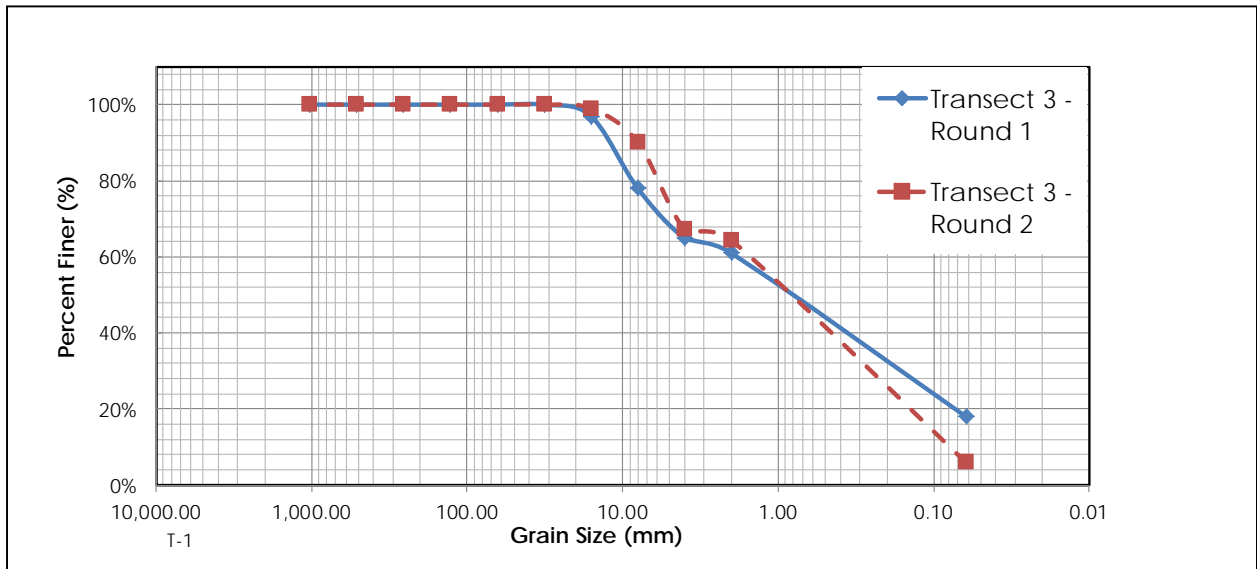
Figure C.13-3. Study site 08-T01 Transect 3 gradation curves.

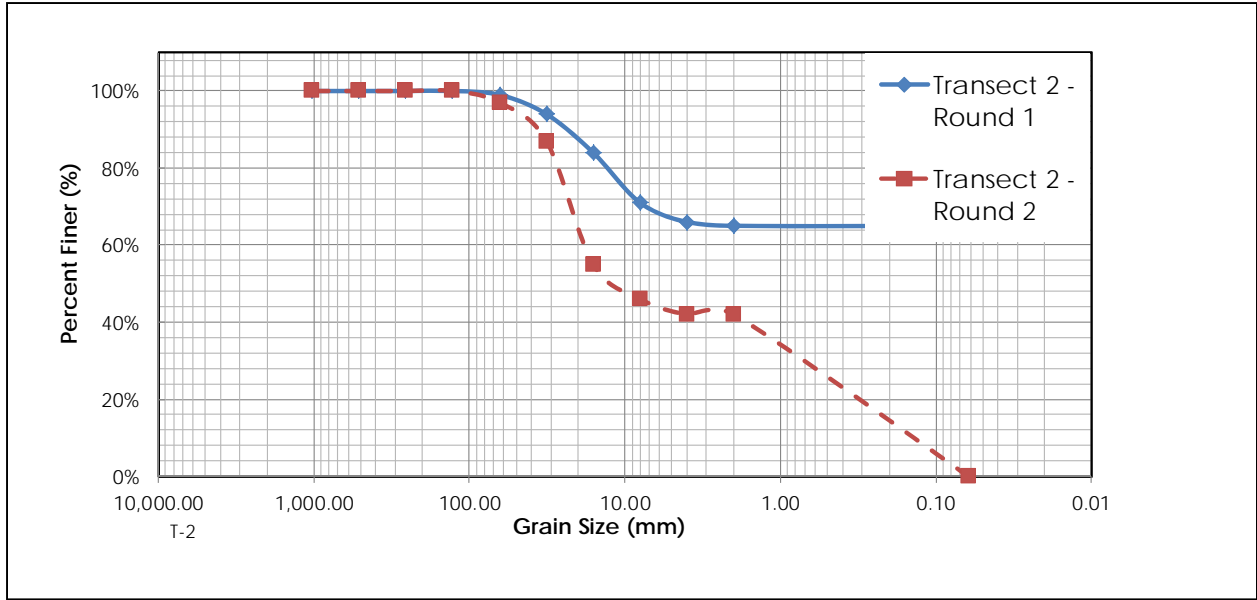
Figure C.14-2. Study site 08-T02 Transect 2 gradation curves.

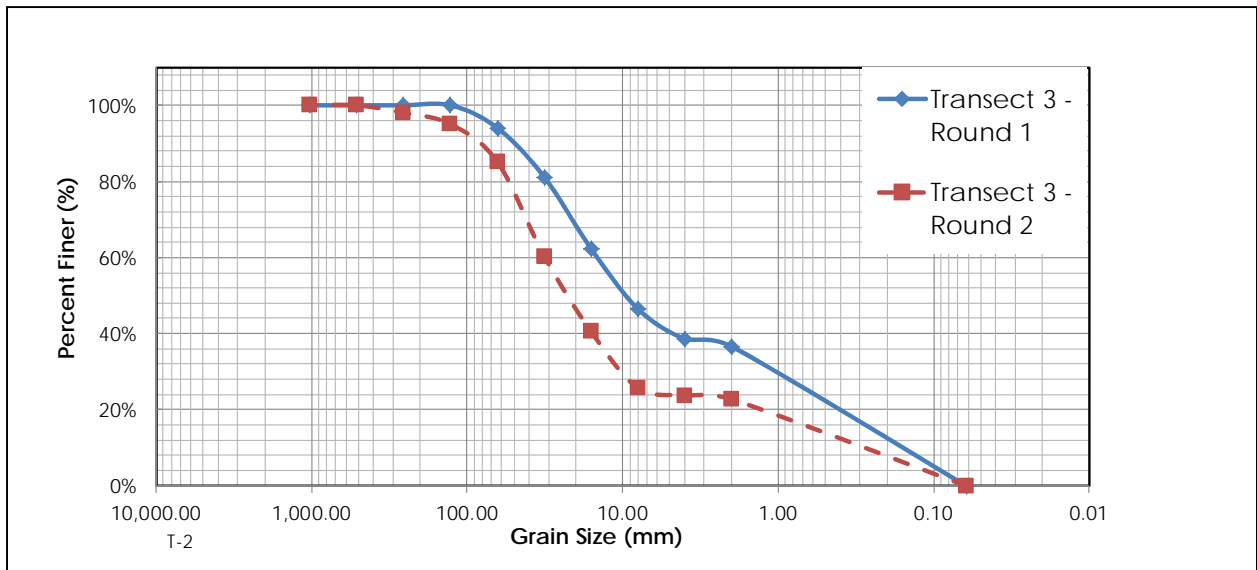
Figure C.14-3. Study site 08-T02 Transect 3 gradation curves.

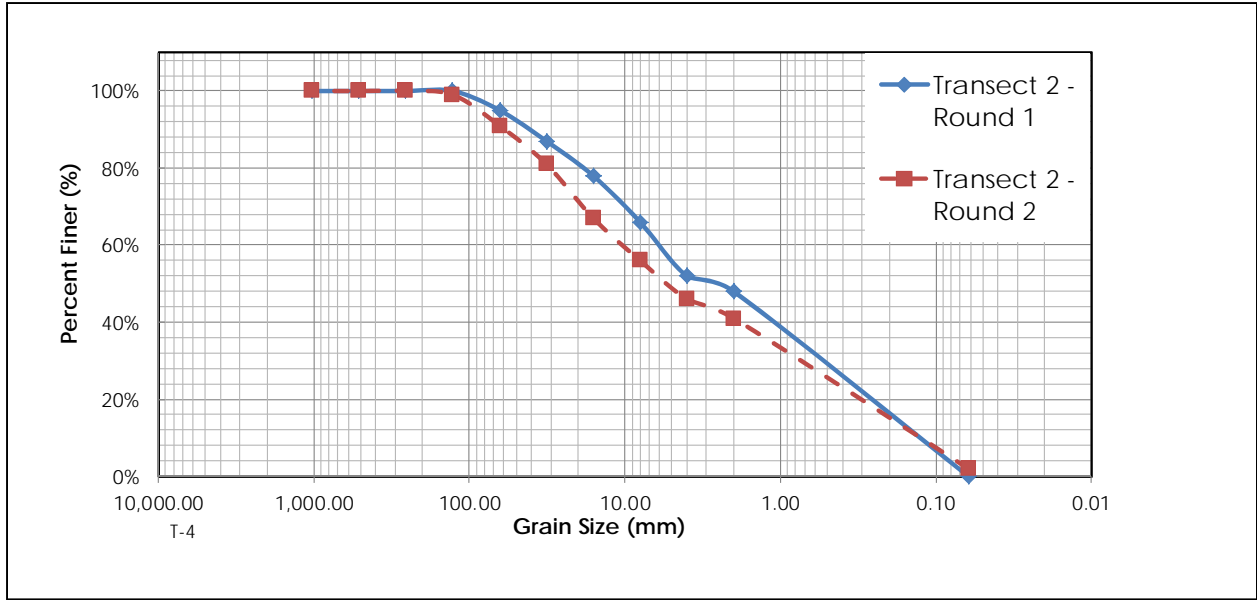
Figure C.15-2. Study site 08-T04 Transect 2 gradation curves.

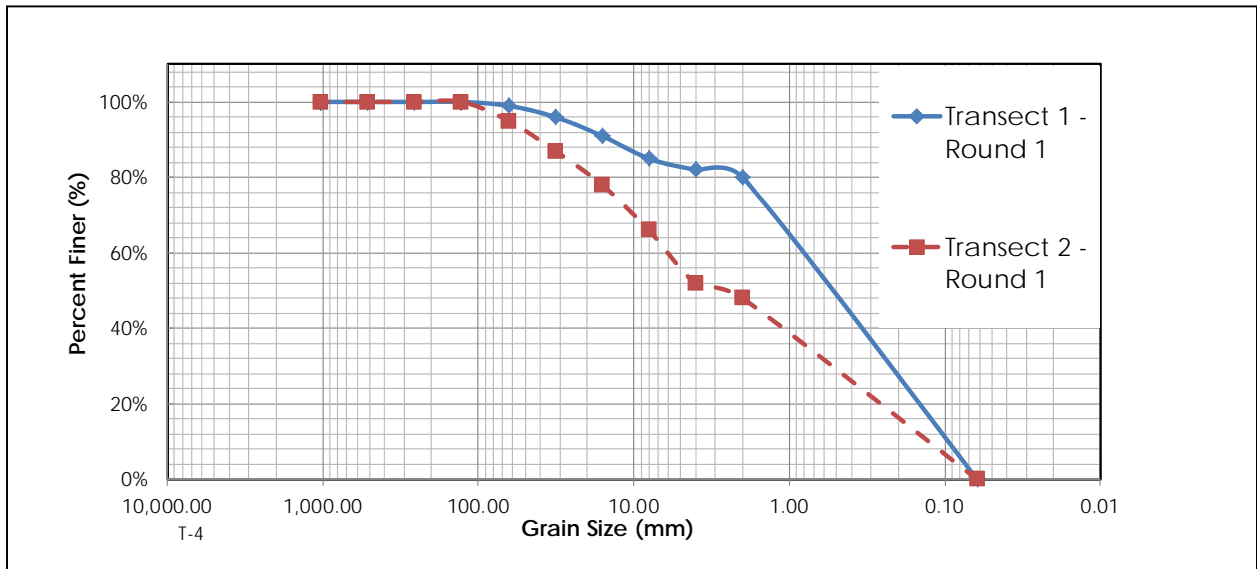
Figure C.15-3. Study site 08-T04 Transects 1 and 2, Round 1 gradation curves.

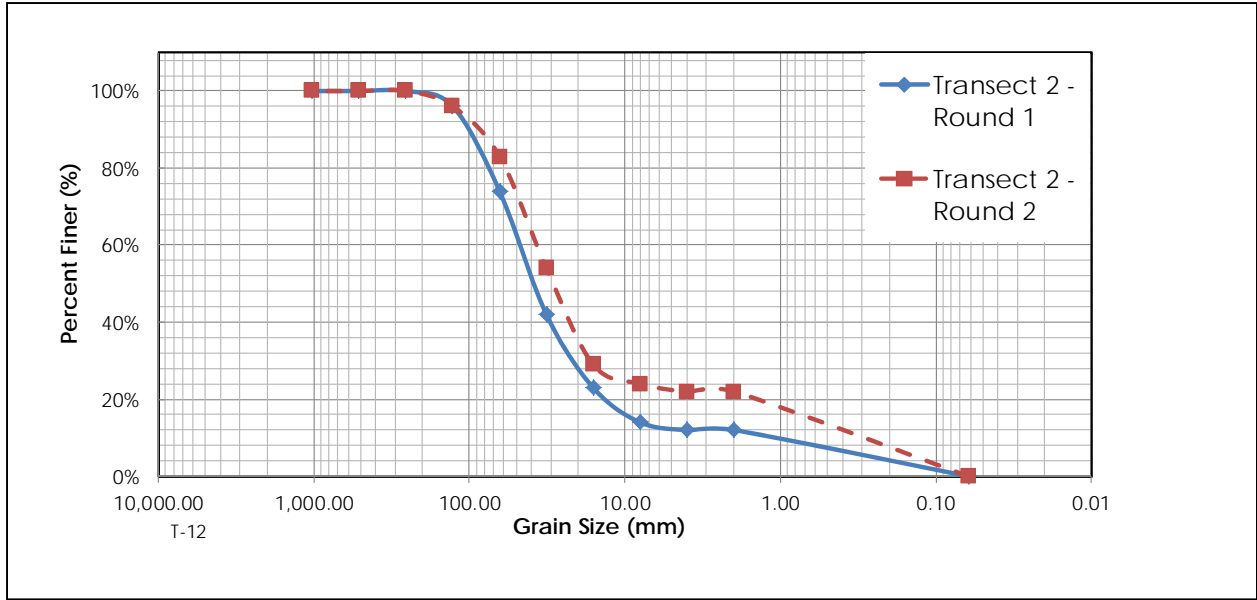
Figure C.16-2. Study site 08- T12 Transect 2 gradation curves.

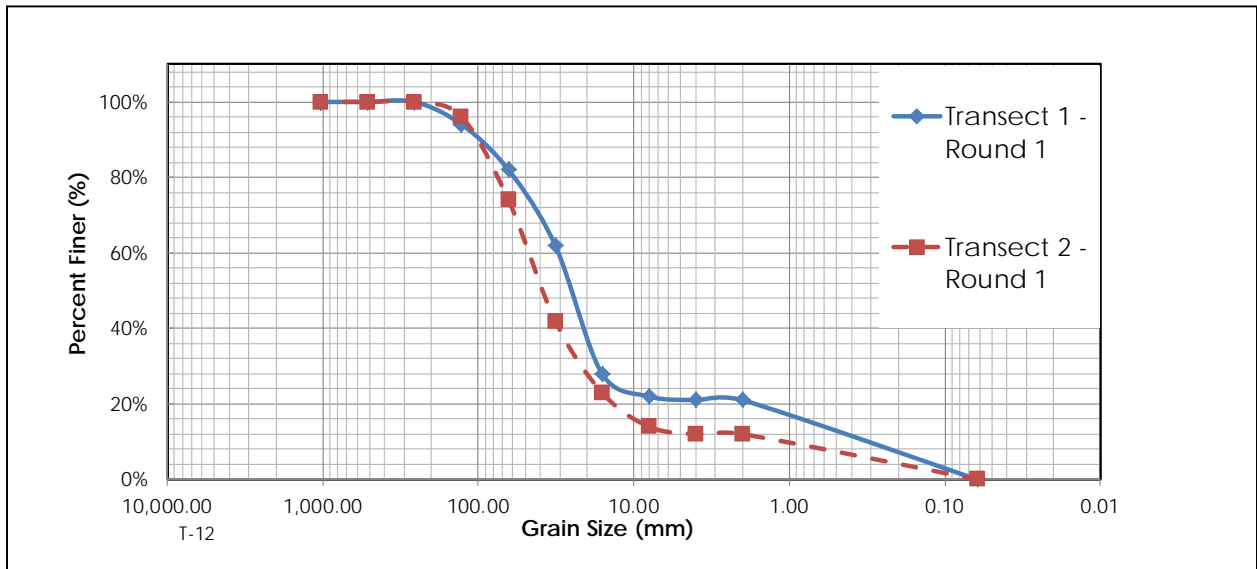
Figure C.16-3. Study site 08- T12 Transects 1 and 2, Round 1 gradation curves.

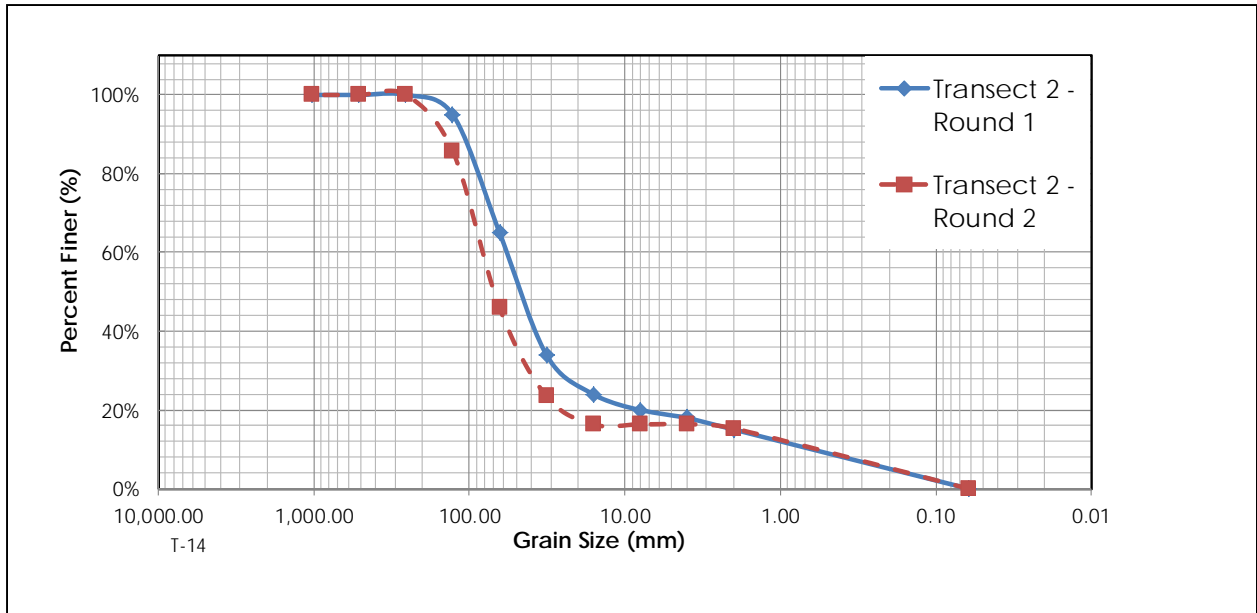
Figure C.17-2. Study site 08-T14 Transect 2 gradation curves.

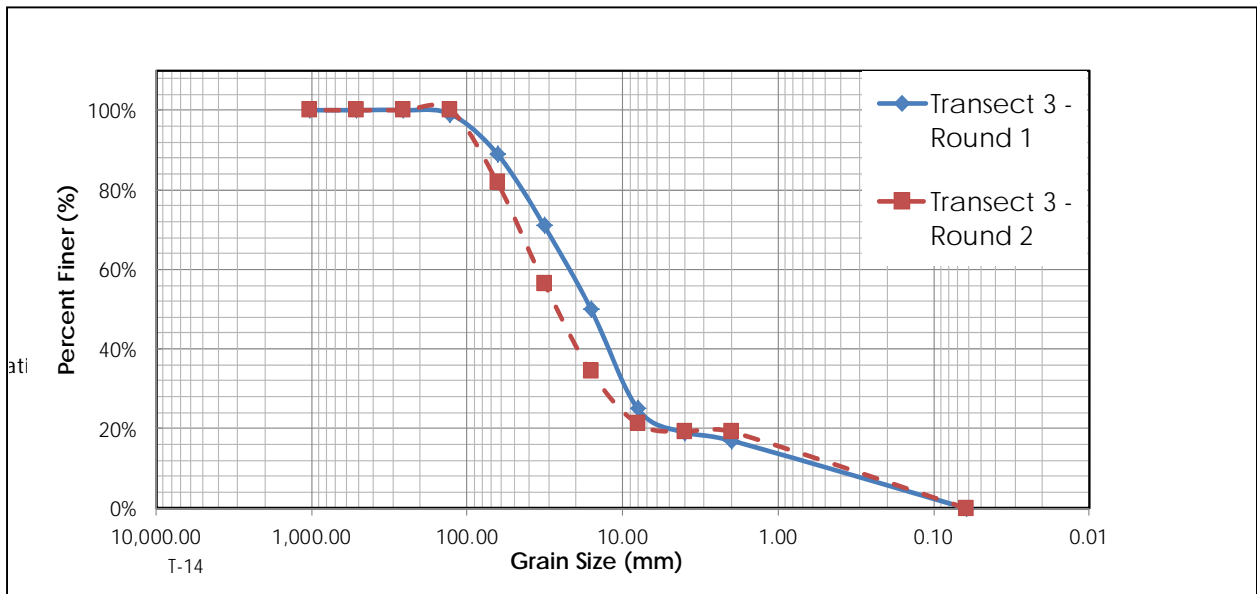
Figure C.17-3. Study site 08-T14 Transect 3 gradation curves.

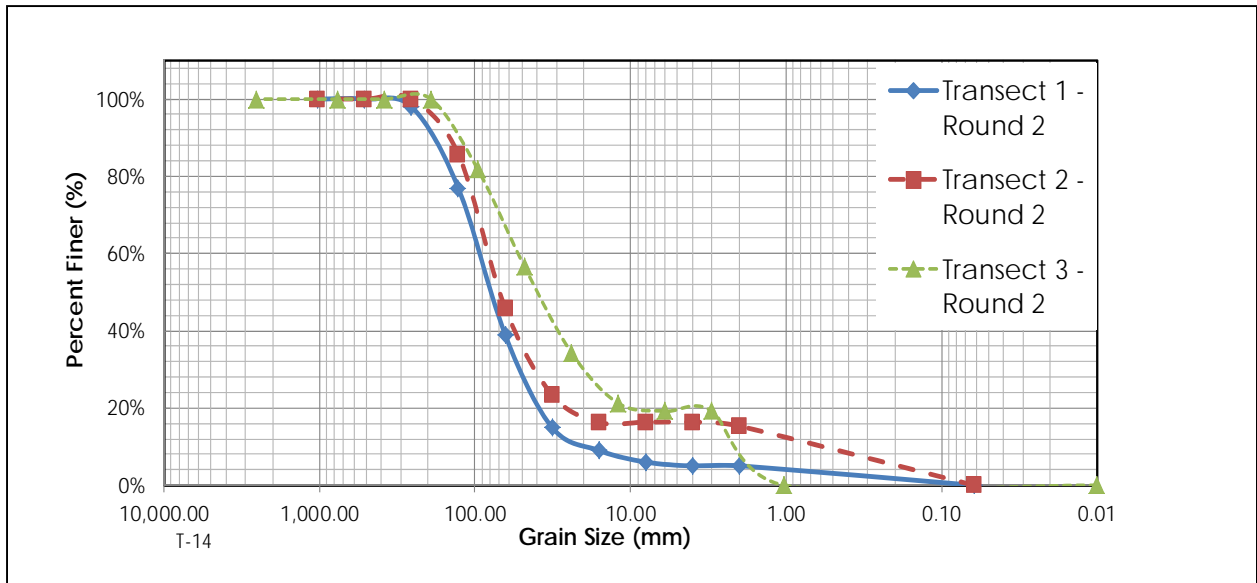
Figure C.17-5. Study site 08-T14 Transects 1, 2, and 3, Round 2 gradation curves.

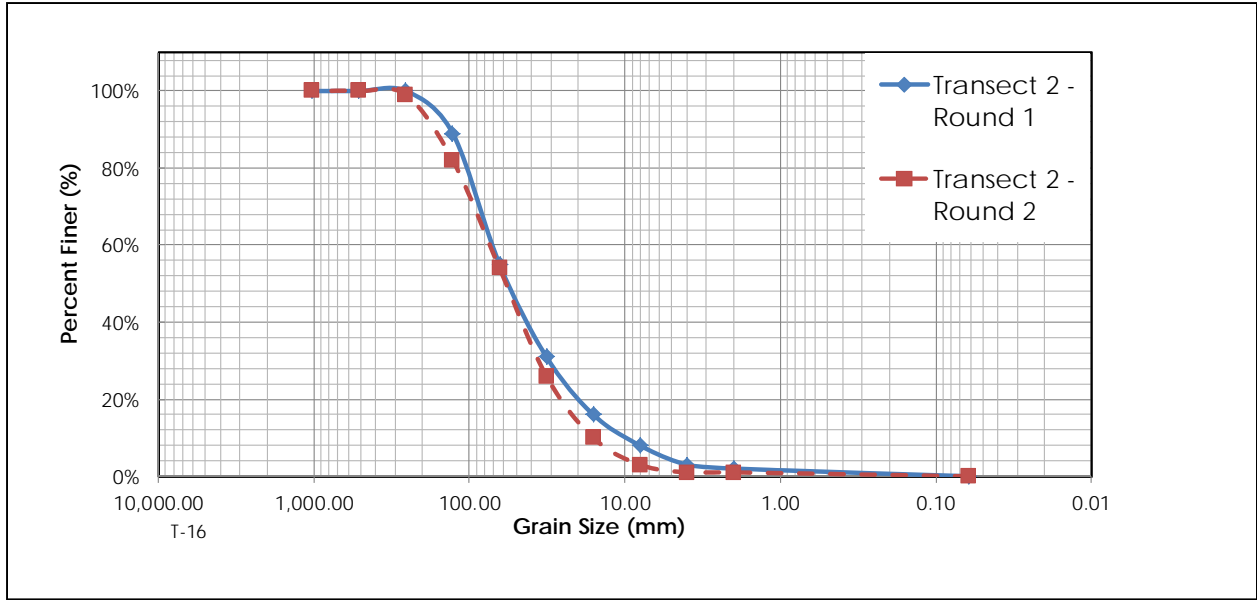
Figure C.18-2. Study site 08-T16 Transect 2 gradation curves.

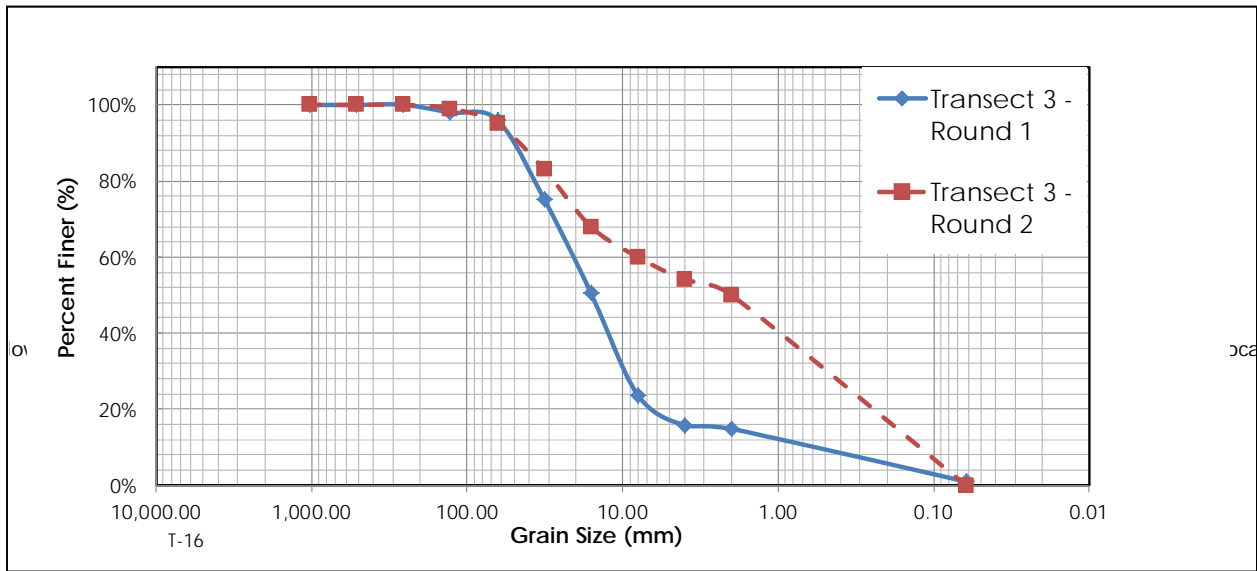
Figure C.18-3. Study site 08-T16 Transect 3 gradation curves.
