TRANSCANADA HYDRO NORTHEAST INC.

ILP Study 8
Channel Morphology and Benthic Habitat Study
Revised Study Report

Wilder Hydroelectric Project (FERC Project No. 1892-026)
Bellows Falls Hydroelectric Project (FERC Project No. 1855-045)
Vernon Hydroelectric Project (FERC Project No. 1904-073)

May 16, 2016

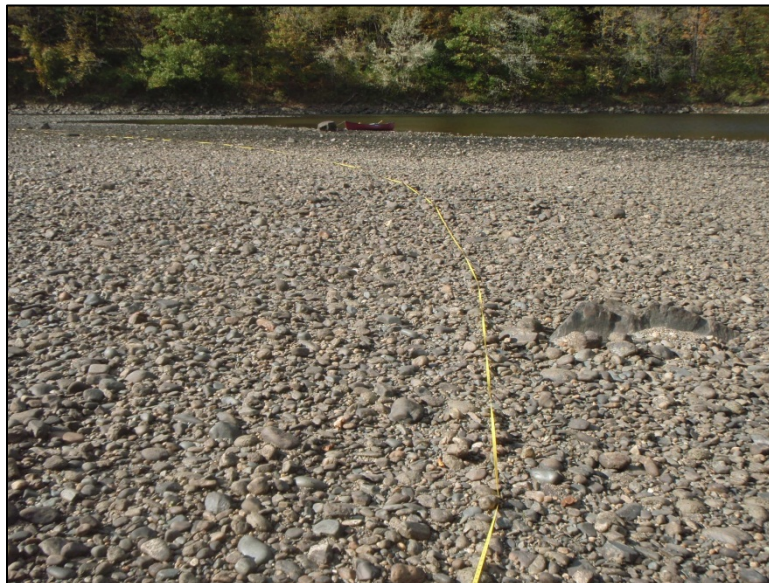
Photo 3.2. Mainstem Site 08-M05, facing across the upstream end of Burnaps Island, towards the right bank of the Connecticut River. (Stantec 10/8/2014)

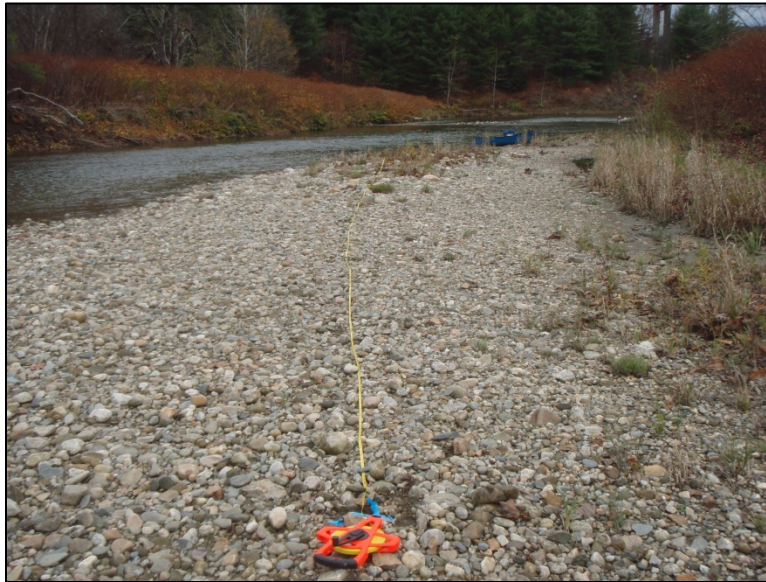
Photo 3.3. Tributary Site 08-T12 facing downstream along the Williams River. (Stantec 10/31/2014)

The six tributary sites included one tributary that discharges to the Wilder impoundment, one tributary that discharges to the Bellows Falls impoundment, and four tributaries that discharge to riverine reaches of the Connecticut River downstream of the project dams. The sites on impoundment tributaries (08-T01 and 08-T12) were located near the upstream limit of the project influence on each tributary. These sites were selected to obtain information on coarse-grained sediments expected to accrete in the vicinity of the confluence of the tributary with the impoundment (Photo 3.3). The four sites at tributaries that discharge to riverine reaches of the Connecticut River (08-T02, 08-T04, 08-T14, and 08-T16) are located at or immediately adjacent to the Connecticut River (Photo 3.4).

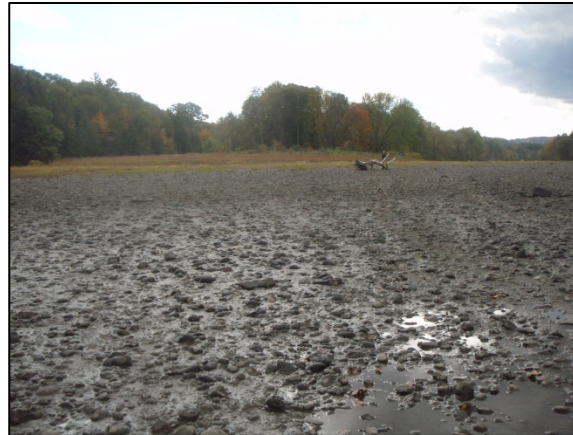
Photo C.9. View across Study Site 08-M05, facing downstream towards Burnaps Island. Photograph is taken from approximate location of Transect 1. (Stantec 10/08/14)

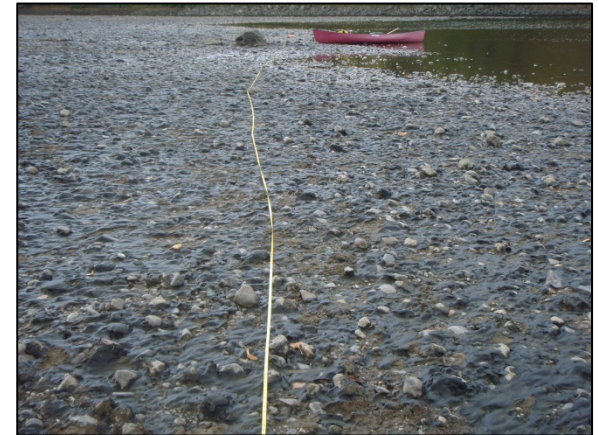
Photo C.10. View across Study Site 08-M05, facing west. Photograph is taken from the start (east limit) of Transect 1. The location of Transect 1 is indicated by the tape measure in the center of the photograph. (Stantec 10/08/14)
