**GREAT RIVER HYDRO, LLC**

**ILP Study 18  
American Eel Upstream Passage Assessment**

***Supplement #2 to Study Report***

Wilder Hydroelectric Project (FERC Project No. 1892-026)  
Bellows Falls Hydroelectric Project (FERC Project No. 1855-045)  
Vernon Hydroelectric Project (FERC Project No. 1904-073)

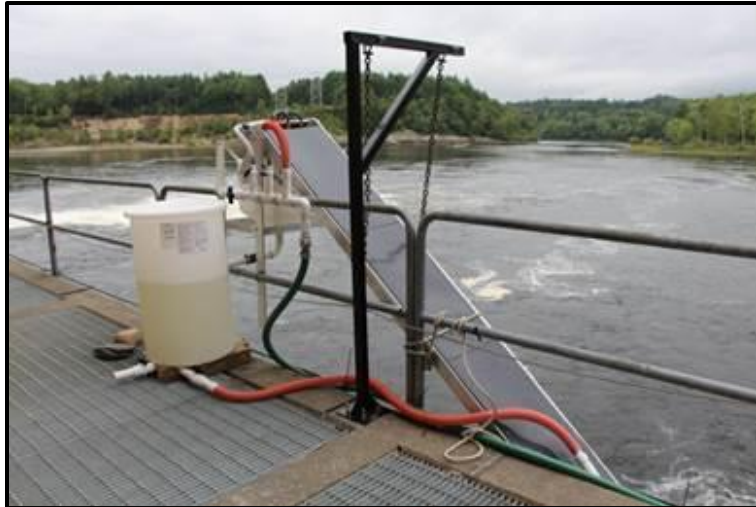
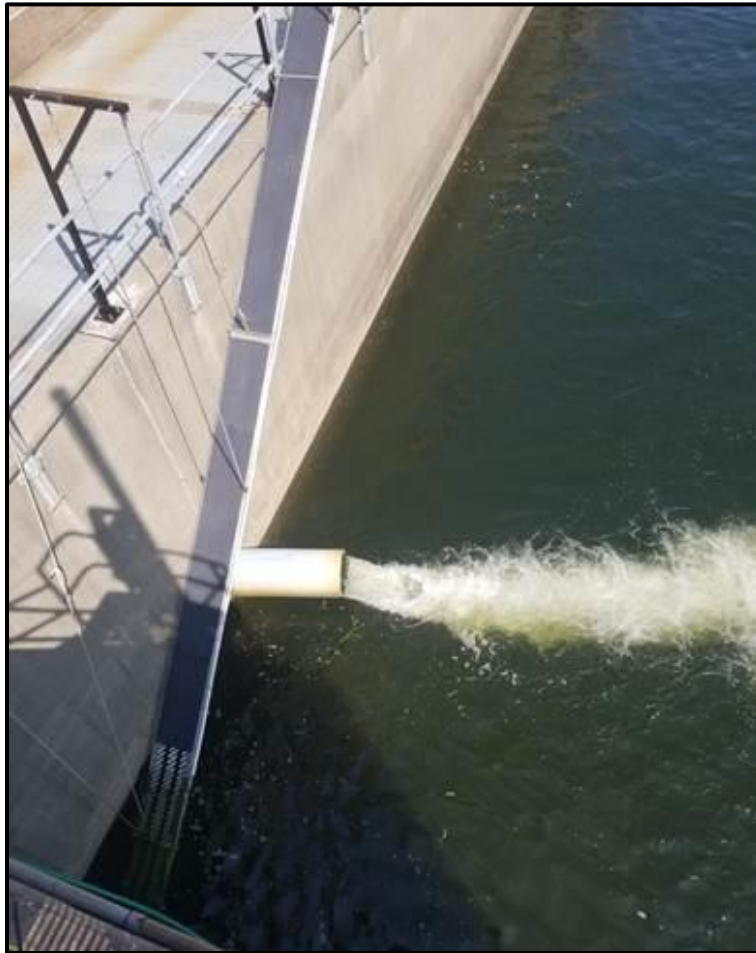
Figure 3.2-1. Vernon temporary eel ramp trap.

Normandeau with staff from FWS, VFWD, and USGS on July 20, 2016. The eel ramp design was based on the Haro (2013) generic temporary eel ramp trap design modified for the site (Figure 3.2-1).

The ramp framework was constructed from 6063 aluminum channel, 37 feet long, 18.5 inches wide, and 3.5 inches high. The framework supported Milieu elver ramp climbing substrate (<http://www.milieuinc.com/products>) and was covered, except for the bottom 8 feet, with 0.25-inch thick PVC sheet. The substrate was composed of a molded ABS plastic tray with three sections (overall width of 18 inches) with staggered 1-inch diameter PVC vertical studs. The ramp was installed at an angle of approximately 36 degrees parallel to the downstream face of the dam with its base adjacent to the corner formed by the fish ladder entrance. At minimum tailwater elevation the point where the ramp met the water surface was less than one foot from the wall, and at a tailwater elevation five feet higher than minimum, it terminated approximately seven feet from the wall. The ramp was supported by two davits mounted on the dam deck, and secured to the wall near its base with an angle bracket. The overshoot at the top of the ramp fell to a drop-off hopper designed to funnel eels to a 32-gallon collection tank with standpipe. The collection tank was designed to reintroduce water drained through the standpipe to the ramp. The climbing substrate was wetted by three 0.5-inch diameter flexible hoses, and a fourth hose provided additional water to the drop-off and collection hopper. Attraction water was introduced near the base of the ramp via a 1-inch diameter pipe that was perforated along the lower 6 feet. The overall expected flow rate was 0.08-0.1 cfs (35-50 gpm) supplied by a continuous duty submersible pump. An additional attraction flow of approximately 60 gpm, supplied by a second submersible pump, was introduced by splashing down the wall adjacent to the ramp base.

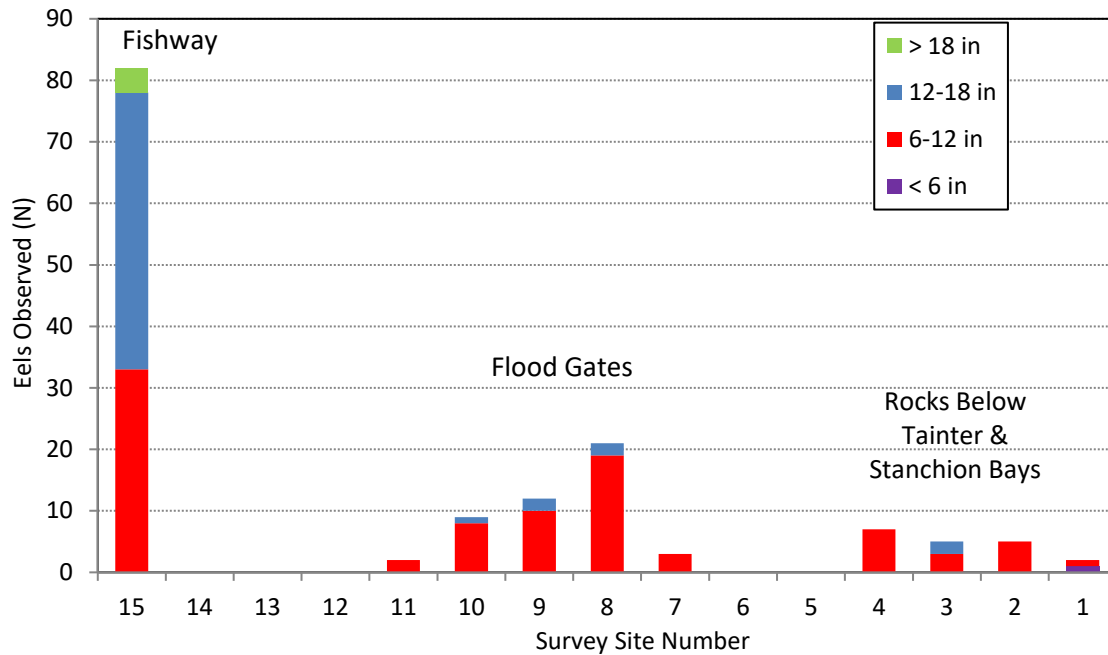
Figure 4.3-1. Length classified counts of eels observed by survey site in nighttime visual surveys, June 1 – November 8, 2017.

Eels classified in the 6-12 inch size group dominated the visual observations, contributing 61% of all eels observed (Table 4.3-1, Figure 4.3-1). Eels classified in the 12-18 inch group accounted for 35% of the total. One eel was classified in the smallest group, <6 inches, and four eels (3%) were classified in the largest group, >18 inches. The length classification of the eel <6 inches was verified by both biologists conducting the survey. At the fishway survey site (15), the majority of eels observed fell within the 12-18 inch size class. At all remaining sites where observations were made, the majority of eels were within the 6-12 inch size class. All four of the eels greater than 18 inches were observed in the fishway. The one eel

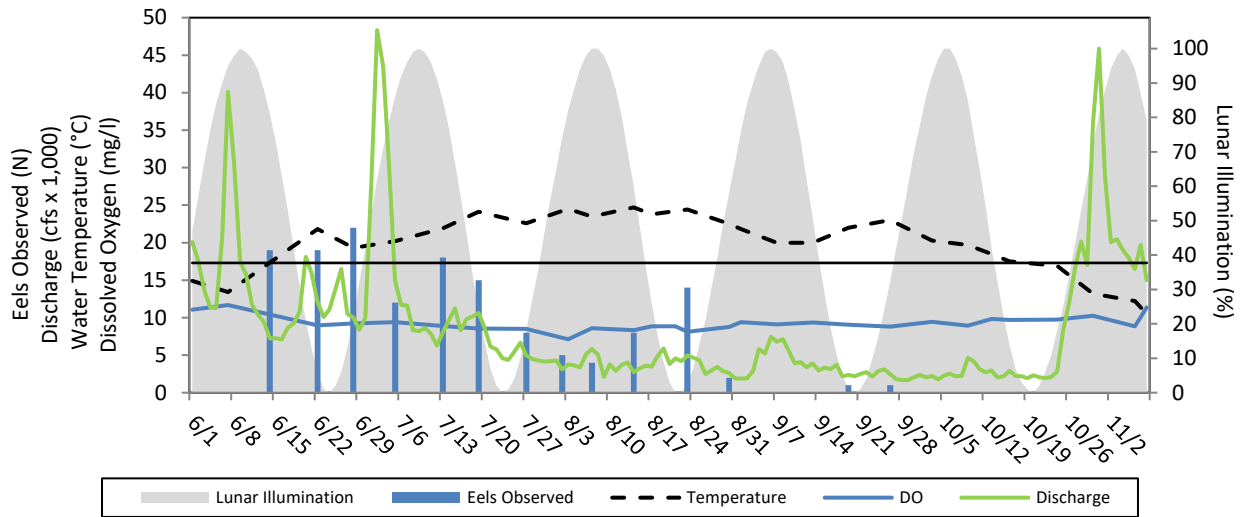
Figure 4.4-1. Number of eels observed in visual surveys by date, with water temperature, dissolved oxygen, lunar illumination, and total discharge. Horizontal line indicates maximum project controlled (non-spill) discharge.

The majority of eels observed in visual surveys occurred from mid-June to late August, coincident with the highest observed water temperatures (Figure 4.4-1). The majority of eels collected in the ramp trap occurred during the month of August, later than most observed in visual surveys, and after the fishway was dewatered. All eel collections occurred when water temperatures were relatively high, and 92% (113 of 123) were collected when temperatures exceeded 23°C. Dissolved oxygen quality remained good throughout the study (Figure 4.4-2).
