**TRANSCANADA HYDRO NORTHEAST INC.**

**ILP Study 18**  
**American Eel Upstream Passage Assessment**  
***Study Report***

Wilder Hydroelectric Project (FERC Project No. 1892-026)  
Bellows Falls Hydroelectric Project (FERC Project No. 1855-045)  
Vernon Hydroelectric Project (FERC Project No. 1904-073)

**March 1, 2016**

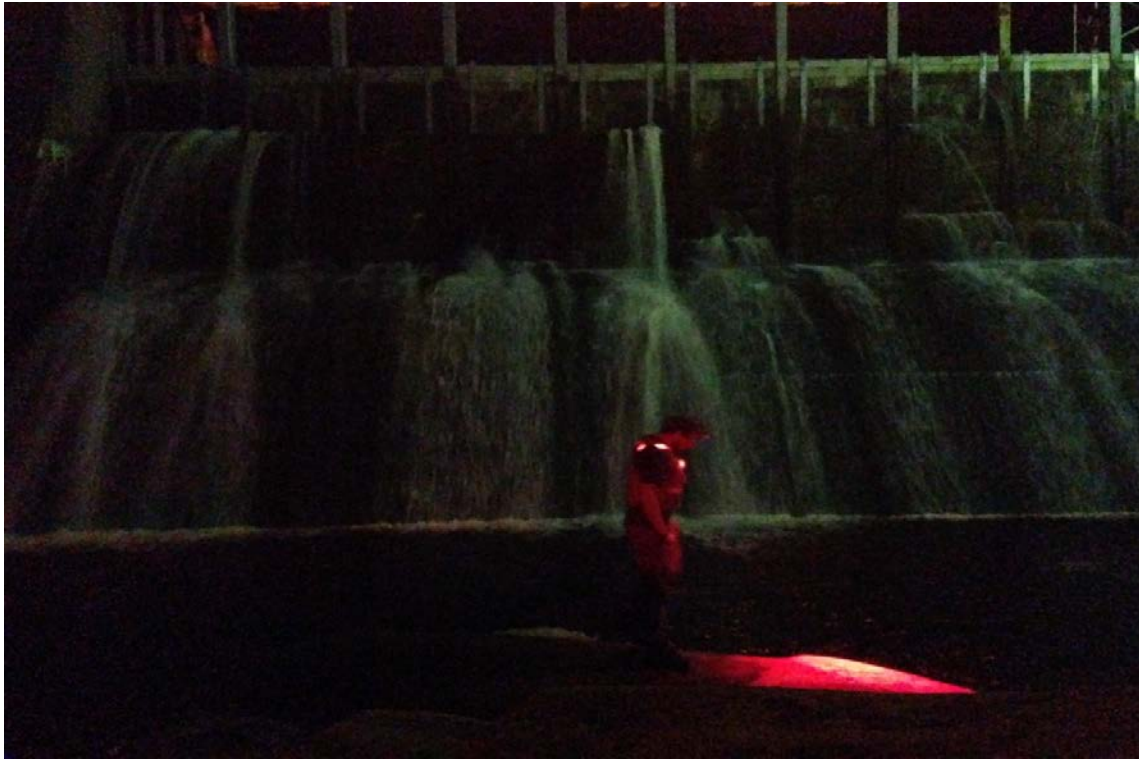
Figure 3.1-5. Systematic night survey on rocks below Bellows Falls dam in the bypassed reach.

on project operations during sampling such as spill gates that were open and/or spill conditions during high flows. Figure 3.1-5 illustrates night survey work.

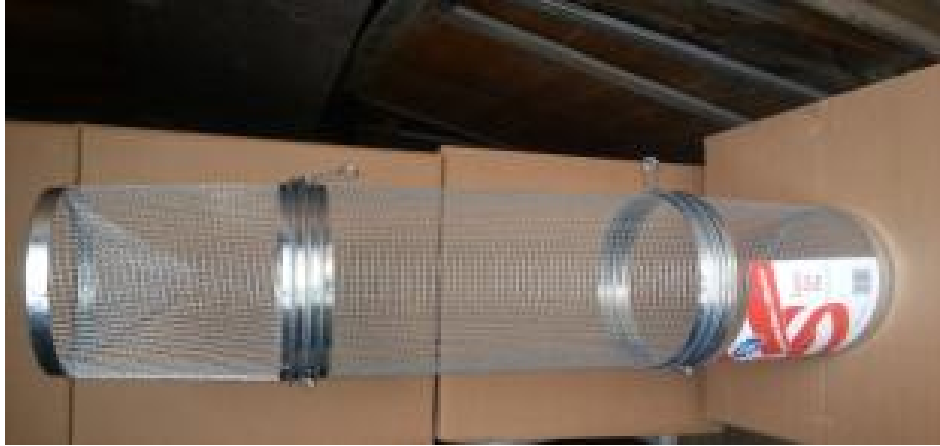
Eel pots (Figure 3.2-1) consisted of standard double-entry, 1/8-inch galvanized wire mesh cylinders approximately 3.5-ft long and weighted to remain on station for the duration of their soak time before retrieval via a float line. Eel pots were loaded with a variety of bait types, each tested in an attempt to increase catch counts. A variety of baits was used in an attempt to increase the number of eels collected. Canned smoked herring (kipper snacks) were used in the pots from May 11 to August 18, with a few exceptions. A variety of fish-based canned cat foods were used in 3 out of the 10 available pots fished from June 29 to July 13 and August 17 to 18. Fresh ocean clams were tested as bait, based on eel potting success in other river systems in 9 of the 10 available pots fished on August 8 at Vernon only

Figure 3.2-1. Standard double entry eel pot with extended middle section.

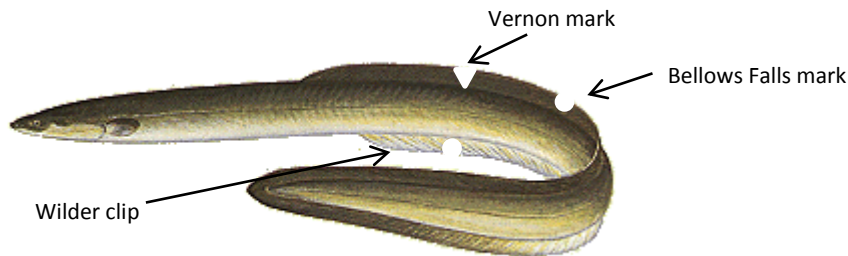
All eels collected from baited eel pots were marked with fin clips so that individuals that had already been captured could be identified to avoid overestimating eel abundance. The RSP had specified the use of elastomer tags, but in an aquatics working group conference call on February 10, 2015, the working group agreed to the use of fin clips as a better alternative. All captured eels were examined for existing fin clips, and all un-marked (> 1 gram wet weight) eels were marked with a project-specific fin clip using a 'V' punch and a standard hole punch. Eels captured at Vernon would get a 'V' punch in the dorsal fin, those at Bellows Falls would get a circle punch in the dorsal fin, and those at Wilder would get a circle punch in the anal fin (Figure 3.2-1). The two eels caught in eel pots were captured at Bellows Falls and were marked with a circle punch in the dorsal fin..

Figure 3.2-1. Fin marking of captured eels.

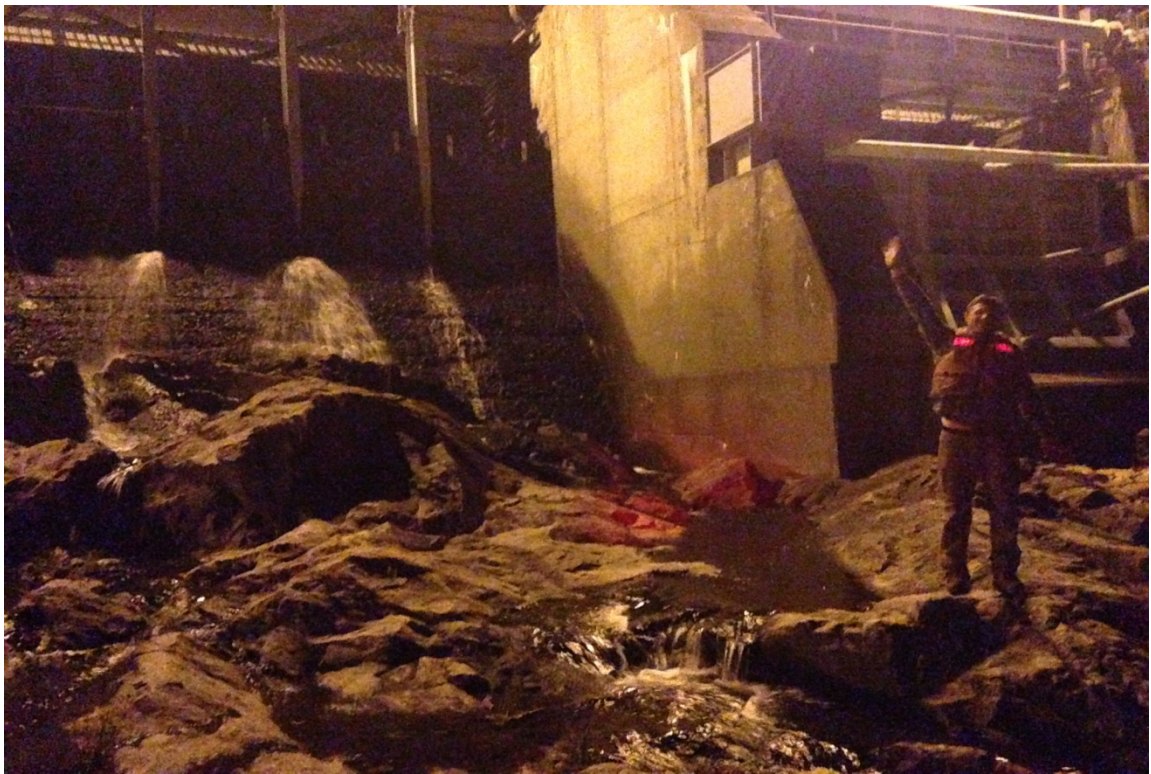
Figure 4.1-1. Systematic night survey crew member locates an eel on the rocks below Vernon dam.

No eels were observed at Wilder during weekly systematic surveys over 24 weeks (Table 4.1-1). At Bellows Falls, only one eel, estimated to be within the 12 to 18 inch size class, was observed during the 24 weekly systematic surveys at site #1 located near the fish ladder entrance (Table 4.1-2). Eighty eels were observed at Vernon dam during weekly visits over 25 weeks of surveys (Table 4.1-3, Figure 4.1-1).

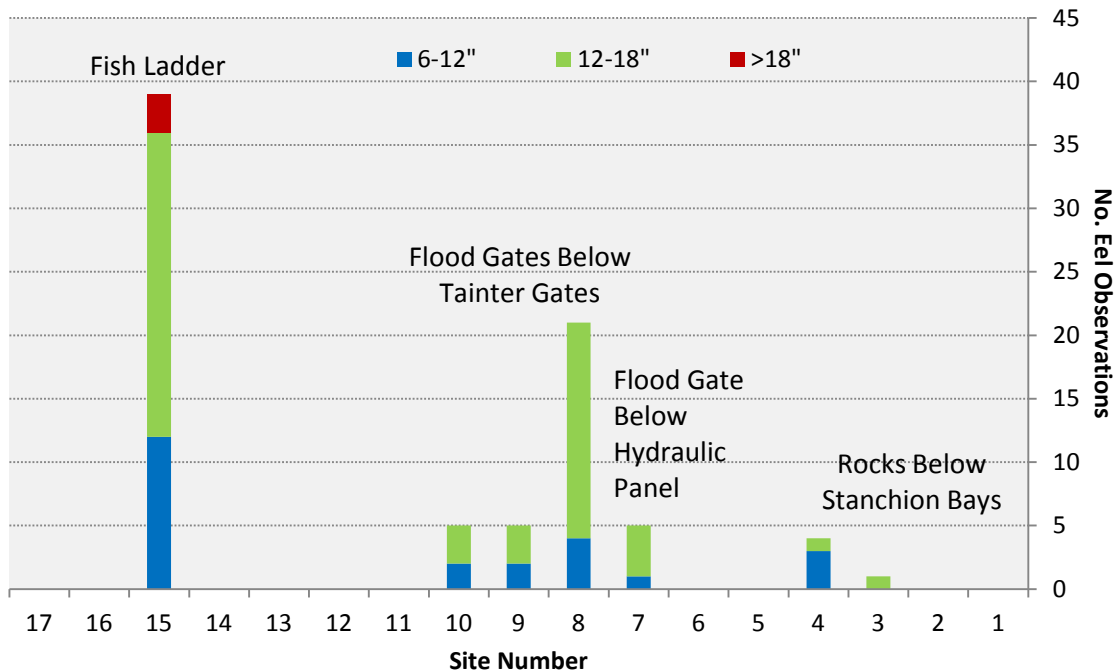
Figure 4.1-2. Vernon eel observations by site numbers and size class.

All three eels observed at Bellows Falls were estimated to be within the 12 – 18 inch size class. Of the 80 eels observed at Vernon 24 (30%) were estimated to be within the 6 to 12 inch size class, 53 (66%) within the 12 and 18 inch size class, and three (4%) within the 18+ inch size class (Table 4.4-1). Given these size ranges, all of the observed eels were larger than the elver or “black eel” phase (2-4 inches) and would fall into the “yellow eel” phase (Bigelow & Schroeder, 1953; Langdon et al., 2006). The Vernon fish ladder (Vernon site #15) was the only site where eels estimated at greater than 18 inches were observed; it also held a significant portion of the 6-12 and 12-18 inch size classes (50% and 45%, respectively).

Most of the remaining Vernon survey sites where eels were observed held only nominal representative individuals in the 6-12 and 12-18 inch size classes. Site #8 in the flood gate area was the only other survey site to hold a notable number of eels (32% of 12-18 inch size class). Collectively, the flood gates (Vernon sites #7-10) accounted for 37% and 52% of the observed eels estimated to be within the 6-12 or 12-18 inch size classes, respectively. The rocks below the hydraulic panels and stanchion bays (Vernon sites #3-6) accounted for 13% of the eels estimated to be in the 6-12inch size class, and 4% of the eels estimated to be within the 12-18 inch size class.

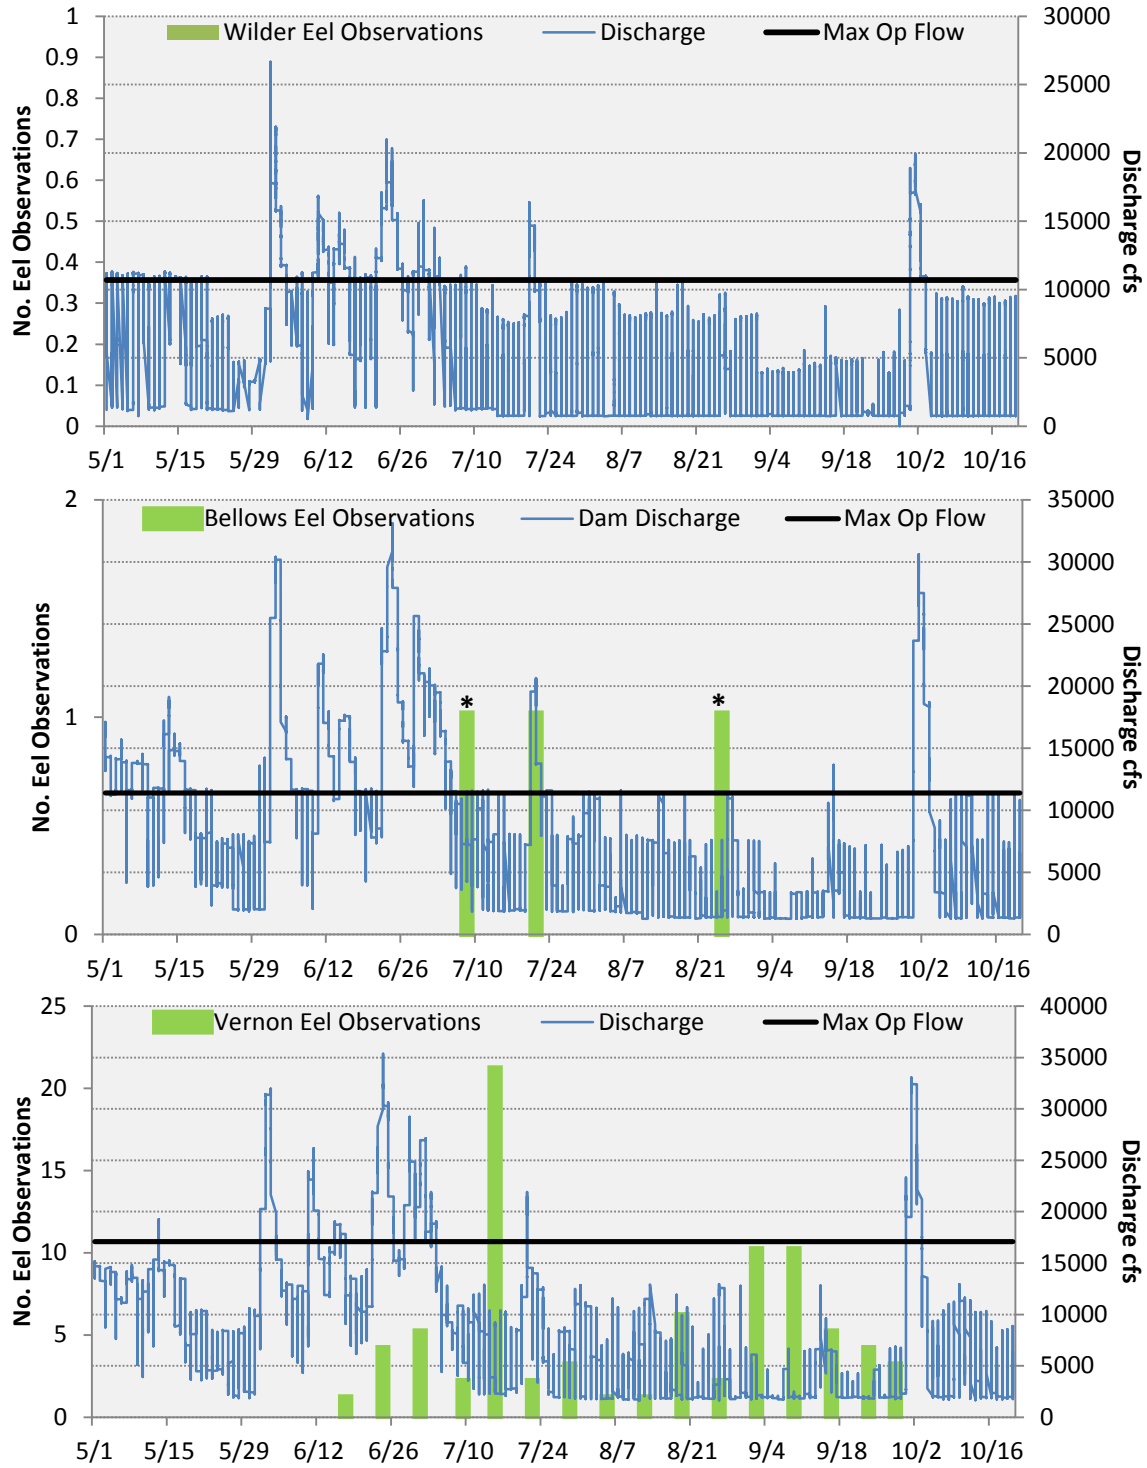
Figure 4.5-2. Discharge below project dams (blue line) with eel observations (bars) and eel potting counts (bars with asterisk). Discharge events greater than the maximum operation capacity (black line) represent spill conditions.

Project discharges were consistently higher during June with frequent, sustained periods of spill while more short-lived spill events occurred at each dam in late July, and near the end of September and into early October. Wilder and Bellows Falls dams often ran near or at spill conditions during May and July, while Vernon mostly operated well below maximum operational flows during both months (Figure 4.5-2).

Vernon was the only project to have eel observations during the month of June. However, despite spill conditions occurring during 60% of the days in June at Vernon, eel observations were minimal (Table 4.5-2, Figure 4.5-2). On the other end of the spectrum, Vernon had spill conditions on only 16% of the days in July but the greatest monthly total of eels observed. Higher flows in June may have attracted eels to migrate upstream where they were observed at Vernon in July.

At Vernon, the month of June had ample discharge and over two weeks of spill days to attract migrating eels (Figure 4.5-2; Table 4.5-2), water temperatures did not exceed 20°C at night and observations were low (Figure 4.5-3, Figure 4.5-4). The drier than normal conditions and discharge levels lower in July than in June (Figure 4.5-1, Figure 4.5-2) coincided with both a rapid rise in temperature from 16.9 to 23.7°C and a surge in observations (33 of 80 or 41%; Figures 4.5-3 and 4.5-4). A second surge of eel observations (32 of 80 or 40%) occurred in September as water temperatures dropped gradually throughout the month. Then, wetter than normal precipitation levels and a significant peak in discharge at the end of September coincided with a rapid drop in temperature from 18.7° to 13.3°C during the first week of October. No eels were observed at Vernon after this time for the remainder of the night surveys.

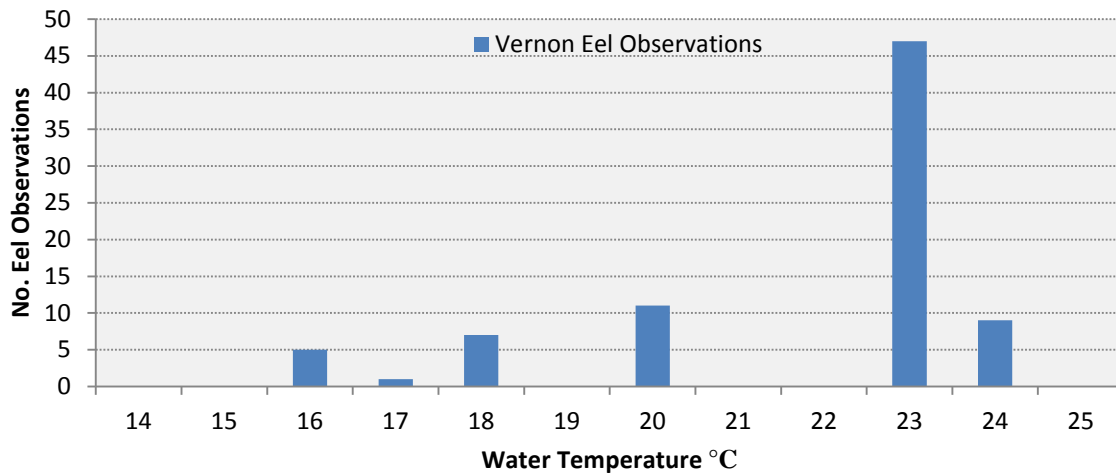
Figure 4.5-4. Vernon eel observations by water temperature. All observations occurred between 16.9 and 24.4°C, with a peak between 23.0 and 23.9°C.

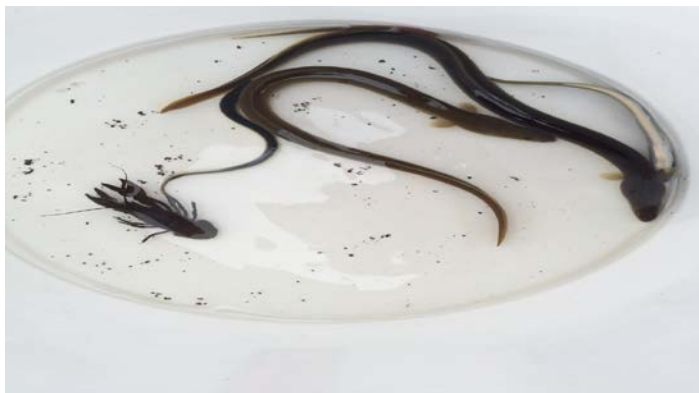
Figure 4.7-1. A crayfish (left), two young eels (center), and a lamprey ammocoete (right) found in the Vernon fish ladder during a shutdown on December 7, 2015.

From April 15 through the final ladder closures of the season (January 6, 2016 at Vernon and Bellows Falls; January 7, 2016 at Wilder) as part of Study 17 - Upstream Passage of Riverine Fish Species, 52 eels were observed passing upstream in Wilder fish ladder and 60 eels were observed passing in the Bellows Falls fish ladder. By far, the greatest number of eels observed in Study 17 was in the Vernon fish ladder with a net total of 1,545 eels observed to be passing upstream. Observations and photographs of small juvenile eels in the Vernon fish ladder from TransCanada staff during a shutdown of the Vernon fish ladder on December 7, 2015 provided further documentation of this structure being used by juvenile eels (Figure 4.7-1).
