LOWER CONNECTICUT RIVER SHORELINE SURVEY REPORT – 2010

WILDER PROJECT (FERC No. 1892)

BELLOWS FALLS PROJECT (FERC No. 1855)

VERNON PROJECT (FERC No. 1904)

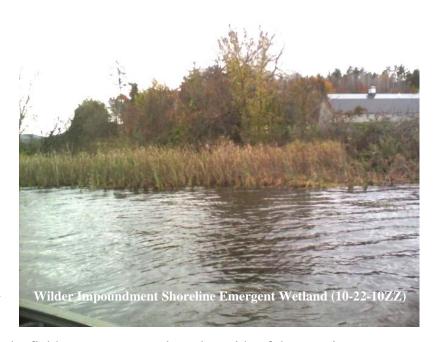
As noted in Table 1 the dominate wetland class observed in the impoundments is characterized as palustrine emergent wetlands. These narrow bands of emergent vegetation typically occurred

along the shallow shoreline and in backwater coves. Broadleaf cattail (*Typa latifolia*) is the dominant wetland emergent species forming monoculture stands along the shoreline. Other wetland features observed to a lesser degree included relatively small areas of willow (*Salix sp.*) palustrine scrub-shrub wetlands and narrow silver maple dominated floodplain / stream side

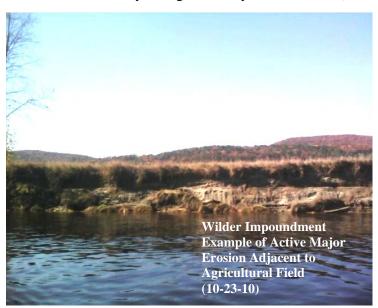
The primary type of erosion noted in all three impoundments is bank slumping. Bare near vertical bank walls are common, with large clumps of vegetated bank slumped below the obvious original location of the vegetation. Bank slumping, sometimes described as mass failure or collapse can occur from various mechanisms, but is most commonly a result of rapid draw down of stream flow following a prolonged period of bank-full flow (high water or flood flows with a relatively rapid reduction in flow) resulting in saturation of bank material. This type of erosion occurs mostly in high-velocity stream flows (often on the outside of stream bends)

resulting in bed scour at the toe of the bank. This type of erosion is exacerbated by land/vegetation clearing that is commonly associated with farming practices observed along the project boundaries.

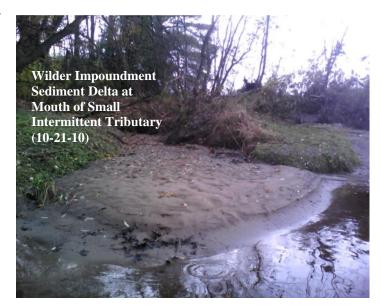
margin. The outwash deposits provide a source of the coarse sediments that rejuvenate the system before the grain size begins to decrease as the valley once again becomes broad and unconfined. Mid-channel bars were found just downstream of points of tributary confluences, and high eroding banks. Bar formation, however, does not generally persist far downstream from these points. Delta bars were

frequently seen forming at the mouths of both large and small tributaries with some sediment emanating from tributaries moving further downstream to form mid-channel bars. Delta bars particularly at the mouths of major tributaries can attribute to conditions rerouting the river flow towards the opposite bank, leading to erosion.

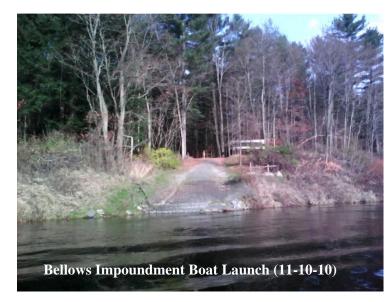
areas, hunting blinds, and icefishing shacks. Also noted along
the banks of the impoundments
are non-water dependent private
and public recreational sites
including: campsites, public
parks, hiking trails, and wildlife
conservation and management
areas. Docks are the most
frequently observed recreation
feature within each reservoir

accounting for 75% of recreation features observed in the Wilder impoundment, 63% in the Bellows Falls impoundment and 76% in the Vernon impoundment. The field survey occurred outside the peak recreation season (Memorial Day through Labor Day) so it is likely that some docks had been removed prior to the survey.
