RE: **Wilder Project, (FERC NO. 1892-026)**

***Study Request:***

***Erosion of Farmland Caused by the Wilder Dam***

DATE: February 25, 2013

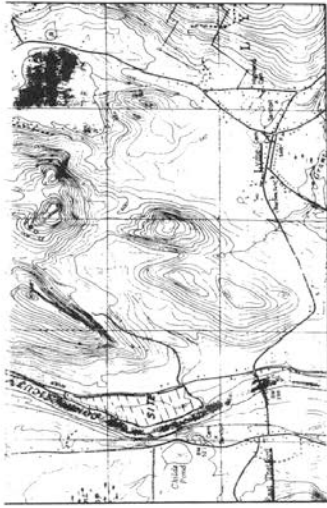
In 1989, when the conservation easement was placed on Fields A & B, LeClair prepared a survey of all three fields, A, B & C. I have been told that we are the only landowner in the area with two surveys that so clearly document the erosion.

The 1961 and 1989 surveys are on the next two pages. The 1961 survey was drawn to a scale of 1" = 60 feet, and is printed on a piece of paper 67" x 33". It may not be very easy to read here. The 1989 survey has also been reduced from its original size.

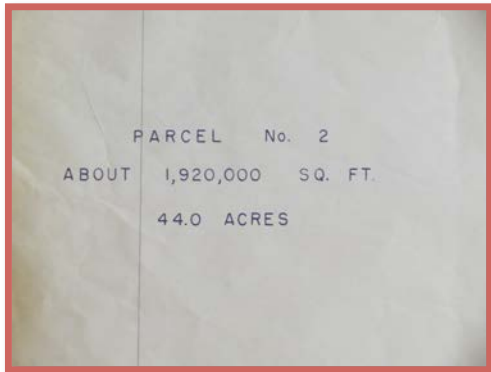
Two details from the 1961 survey map are shown below. In 1961, "Parcel 2" referred to what in 1989 are Fields B & C:

*These details show the acreage of fields B & C and the bearing and distance of the line between fields A & B. This bearing is shown on the 1989 survey as N 74° 54' 30" E, the difference being that magnetic north was used in 1961 and a solar observation was made in 1989— therefore, the magnetic declination of about 16°.*

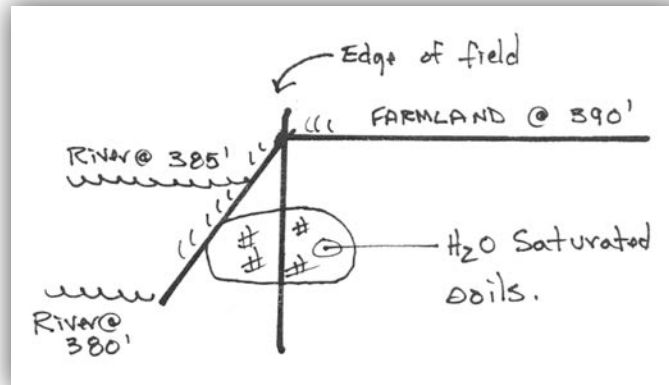
With the construction of the dam, the level of the water fluctuates, but the flowage rights are “not to exceed an assumed elevation of 385 feet.” The deeds granting flowage rights say nothing about the width of the river, just the elevation of the water.

In the above diagram, the water is at the 385' level *and* water has saturated the bank and farmland. The water quickly saturates the Hadley Silt.

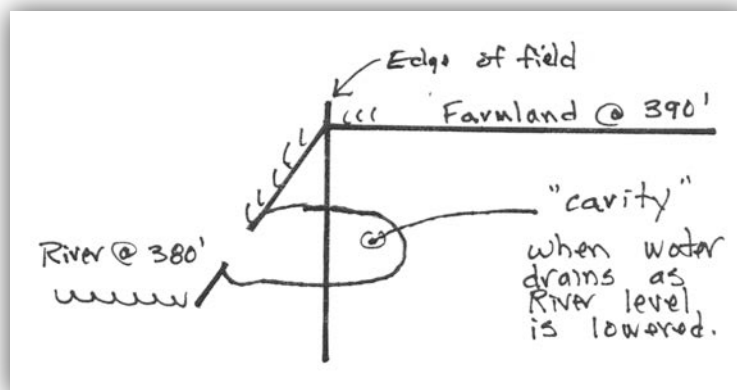
When the water is lowered, the saturated Hadley soils drain, and with the water goes some soil. This continues on a daily basis— a small amount of soil every day. Eventually, a cavity, a hole with perhaps a domed roof, is created below the surface of the ground, out of sight, as shown in the below sketch— piping.

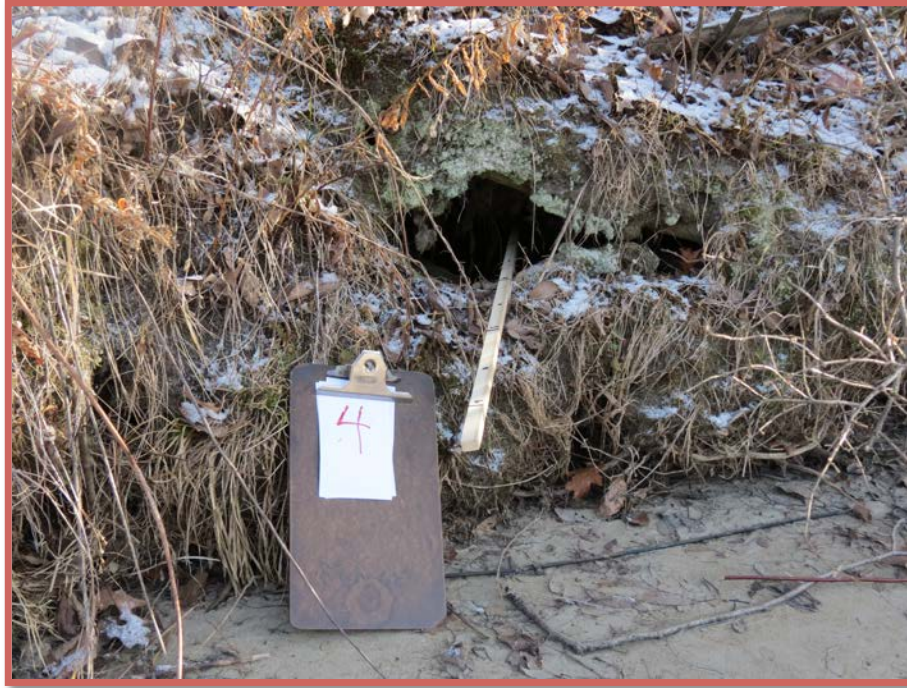
A hole in the riverbank was visible when the river level was low on November 30, 2012, the date of the below photograph. The saturated soil has drained and the soil has been eroded when the river was lowered. This hole is four feet deep. Many such holes are visible when the river is low., These holes are invisible when the water level is high, but they are still there— filled with water.

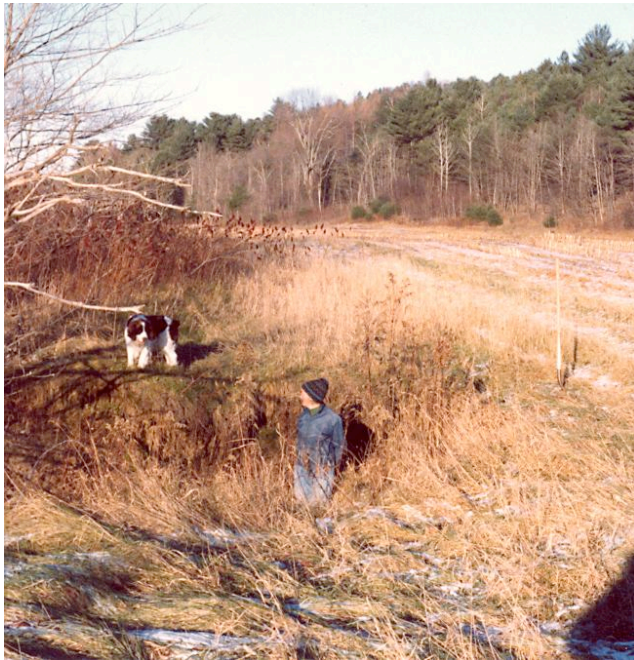
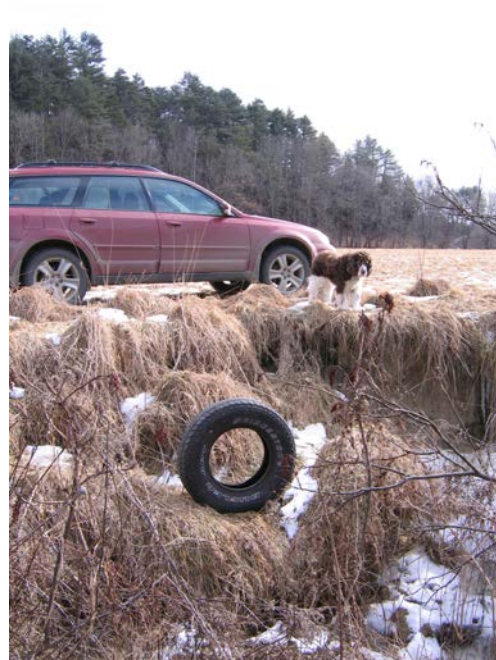
*Late 1970s*

*January 2012*

*Sinkholes in the fields on the edge of the Connecticut River in Lyme, N. H.*

*On the left, Mrs. Eleanor Mudge is standing in a sinkhole, five to six feet deep, that is a result of the erosion, while the family dog appears to be suspicious of the hole.*

*On the right, another family dog, (there have been three Springer Spaniels on the farm), seems suspicious of another sinkhole, also five to six feet deep.*

Sinkholes are not good for prime agricultural land. Some farm equipment has been damaged when a hole has collapsed beneath it. At least one horse has stumbled into one of these holes.

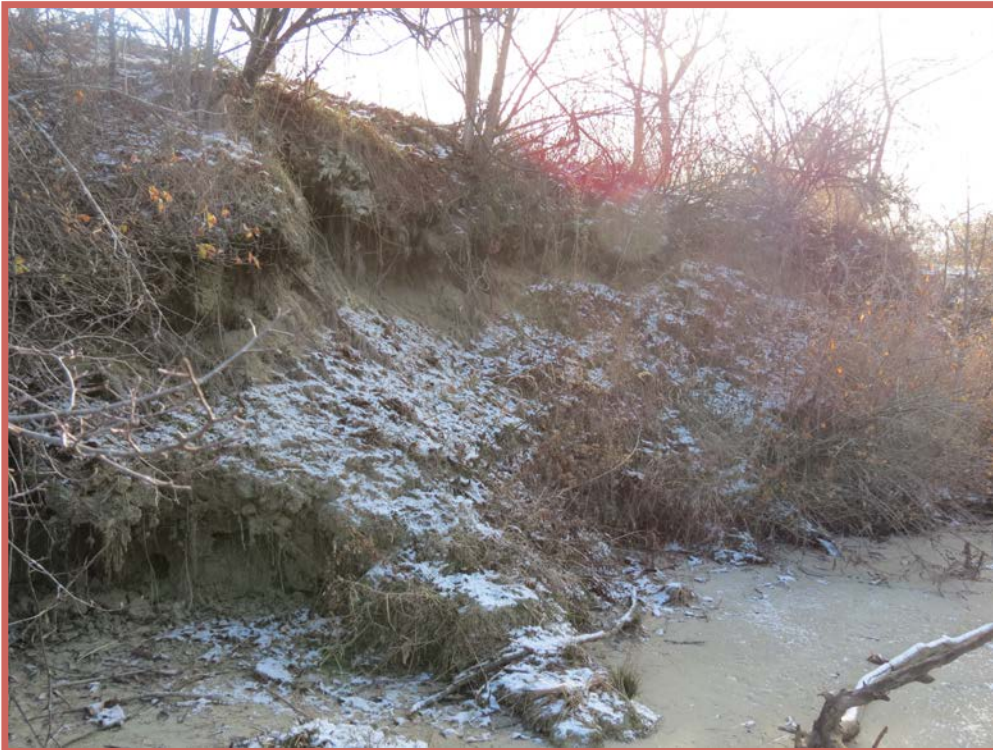
*As shown above, today, November 30, 2012, the riverbank is unstable and there will be continued erosion. This is bank failure as the result of the undercutting of the bank, and there is much slump material that will continue to erode.*

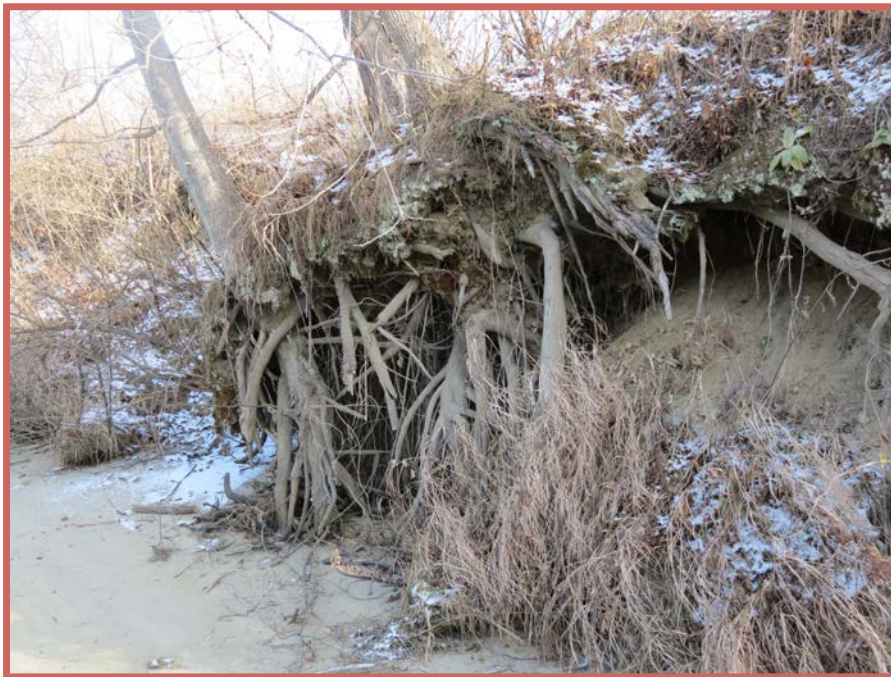
Just as the bank is being undercut, trees growing near it are being undercut.

*These trees will eventually fall into the river and take with them tons of soil.*

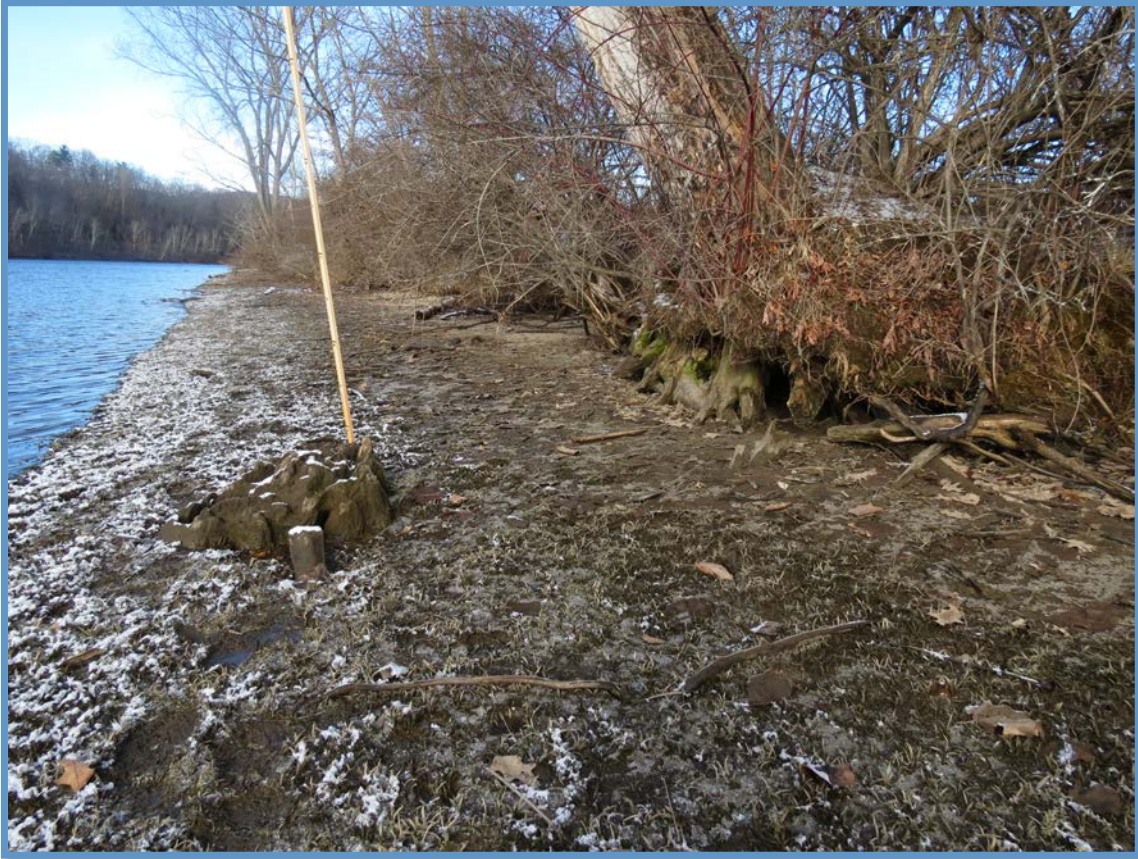
*Visible when the river was very low: The stump of a pre-Wilder Dam tree, the wider river area and the mudflats, the continued undercutting and erosion of the bank caused by the saturation of the soils along the riverbank and the subsequent collapsing and formation of sinkholes that will then continue to erode more and more land.*

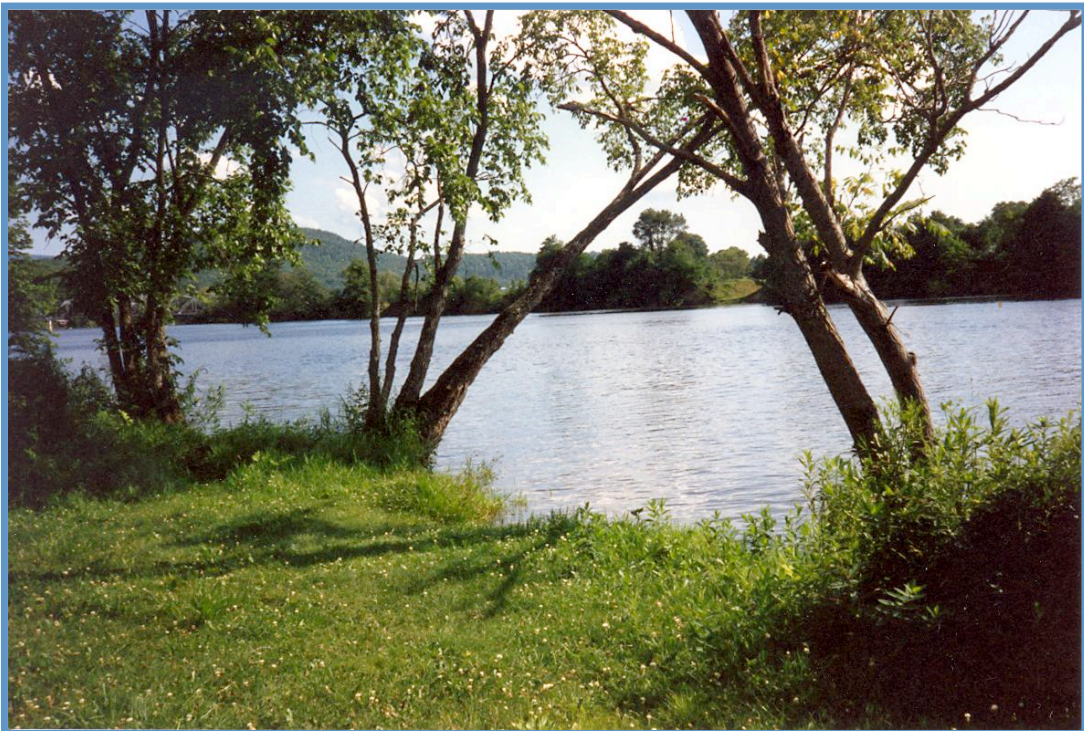
*Once upon a time— Butternut Trees, now gone, growing along the edge of Field A.*

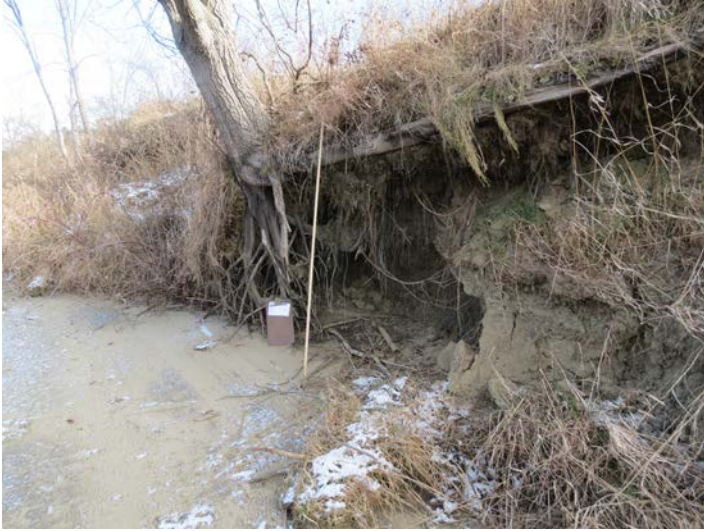
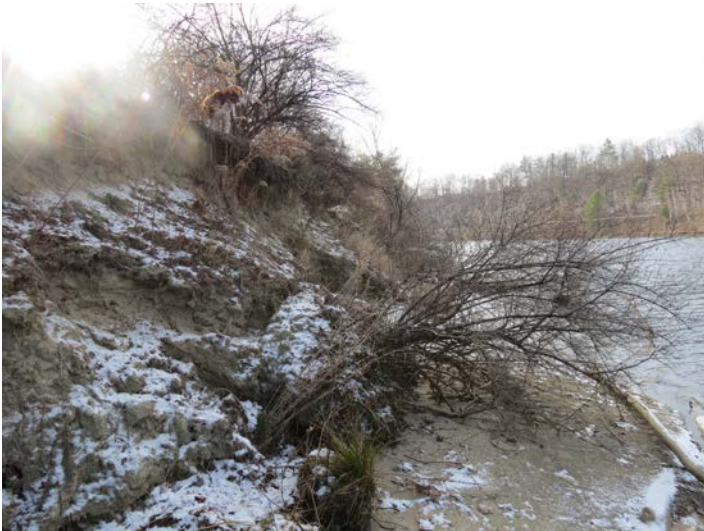
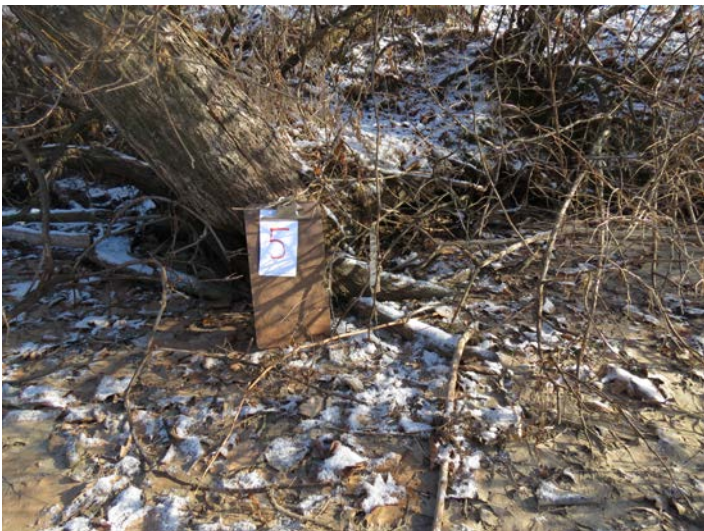
*Three pictures of erosion  
on the Mudge fields,  
Lyme, N. H.  
November 30, 2012.*

*The River's Edge*

*Hole, 5 feet deep.*

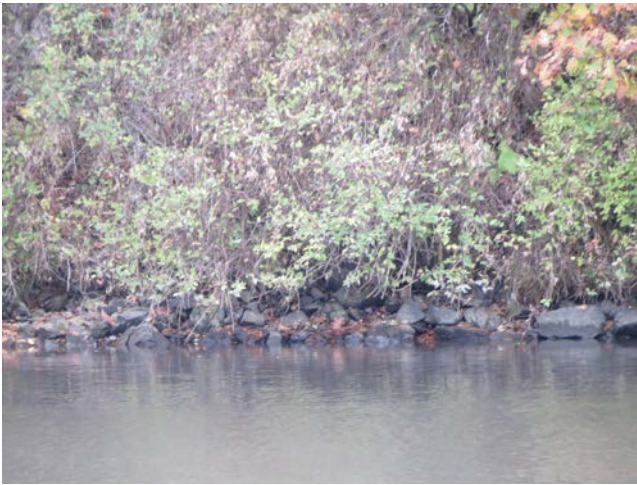
*Rocks below the railroad tracks across from the Mudge fields. Rocks and vegetation are protecting the riverbank.*

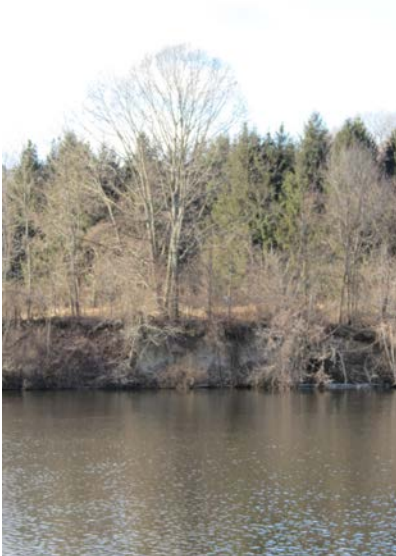
*Trees about to fall into the river in East Thetford, VT, across from the Mudge fields.*

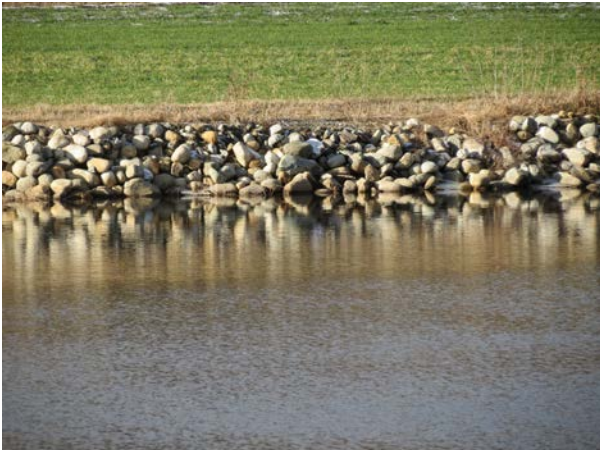
*Protected riverbank in VT.*

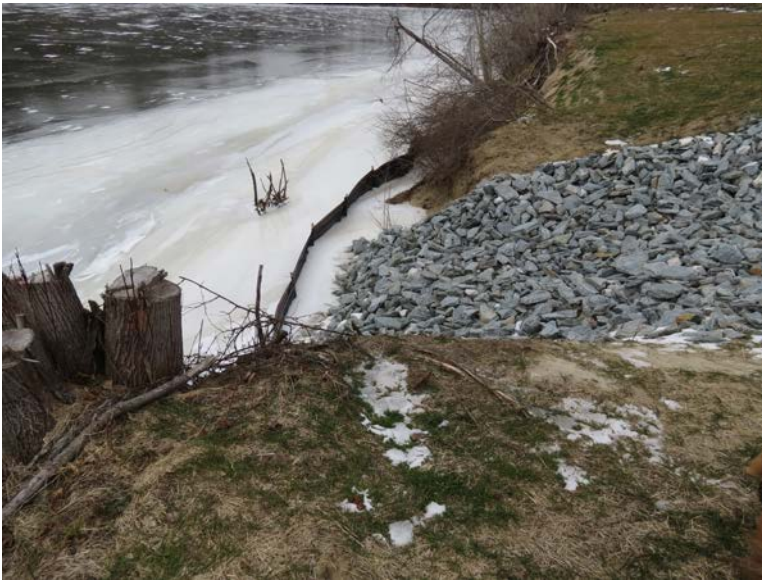
A.

*Two NRCS – U. S. Department of Agriculture projects on the Mudge fields, 2012:*

NRCS (Natural Resources Conservation Services) approved these projects and then NH-DES (New Hampshire Department of Environmental Services) required changes. In Photo A (upper) the rocks go to the water and there is woven geotextile beneath the rocks. In Photo B (lower) NH-DES would not allow the rocks or fiber to extend to the water though the erosion extended to the water. The erosion control work in Photo B will probably fail as the water penetrates underneath the rock that has been laid down and then the rocks will collapse. The erosion control work in Photo A will probably succeed, and there will be vegetation there in future years. Both sites had silt dams. The entire project is intended to prevent the massive silting of the river

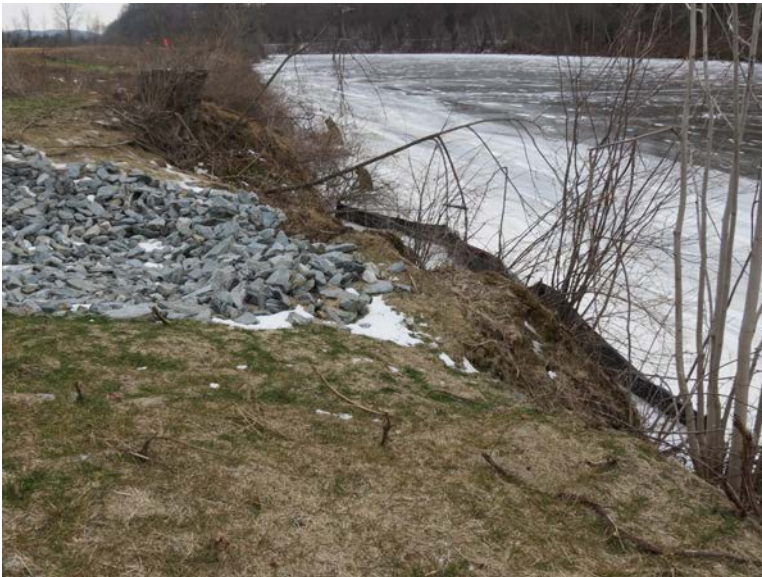
B.

that is caused by the erosion when the water undercuts the bank. The silt being “controlled” by these silt dams is but a tiny fraction of the silt that is being eroded. I believe that landowners and the USDA understand the causes of the erosion. It is important that all parties come to understand what is happening on the banks of the Connecticut River and work together to control it.

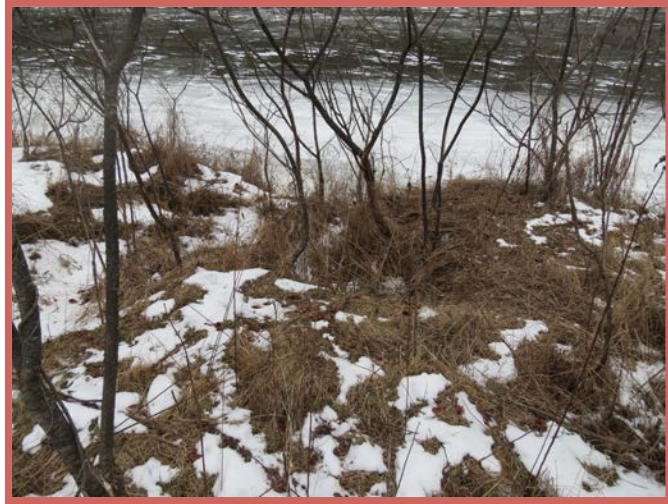
*The above project was probably done in 1996 and clearly shows the vegetation, grass and bushes, that comes back over time.*

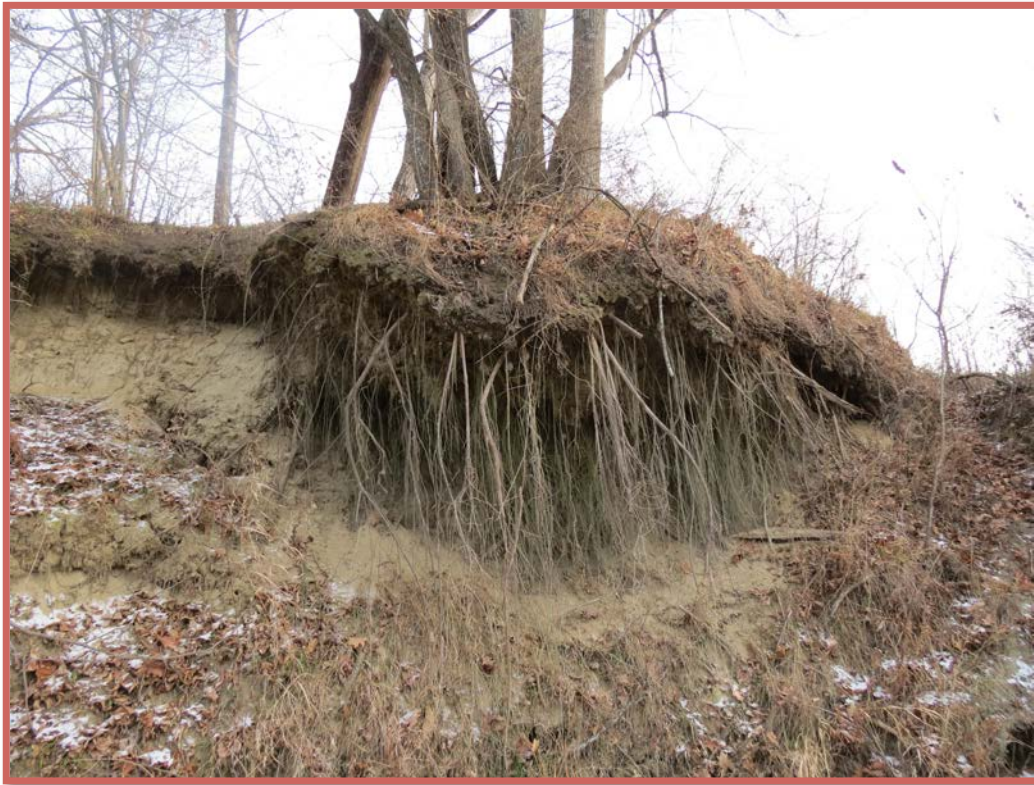
*And lastly, a tree near the riverbank—*

*its root system—*

In a very short period of time this tree will fall into the Connecticut River and take with it tons of soil— prime agricultural soil that is “protected” by conservation easements. Bank erosion. Bank failure. Lost farmland. Sediment in the river.

This is as clear a picture as is possible of the undercutting that is occurring along the entire riverbank. The tree did not grow this way. This erosion has *not* been caused by water running over the field. *The riverbank is being undercut by the operation of the Wilder Dam.*

Today this is the “edge “of the field, but years ago this tree was twenty feet from the edge of the field. I took this picture standing on the mud flats and can remember when there was another larger tree 15-20 feet further to the west, behind me, towards the river. It and many tons of irreplaceable soil are gone.

No amount of planting and attempting to create a riparian buffer at the top of the bank will control this erosion.
