TRANSCANADA HYDRO NORTHEAST INC.

ILP Study 19
American Eel Downstream Passage Assessment
Final Study Report

Wilder Hydroelectric Project (FERC Project No. 1892-026)
Bellows Falls Hydroelectric Project (FERC Project No. 1855-045)
Vernon Hydroelectric Project (FERC Project No. 1904-073)

Normandeau Associates, Inc.
25 Nashua Road
Bedford, NH 03110

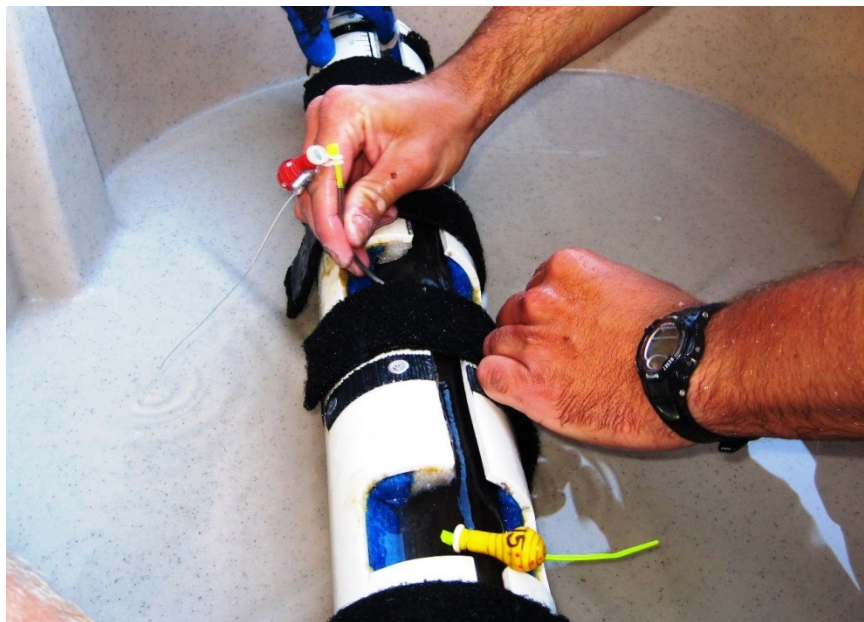
Figure 4.3.3-1. Cannula used to attach HI-Z tags and radio tags to adult American Eels.

In order to bring large adult eels to the surface for rapid recapture, three to six HI-Z balloon tags were attached with a small cable tie through the musculature at two or three locations along the eel's back via a curved cannula needle. Radio tags were attached in combination with one of the HI-Z tags to aid in tracking released eels. Specially designed eel restraint devices developed and built by Normandeau aided in tagging treatment and control eels (Figures 4.3.3-1 and 4.3.3-2).

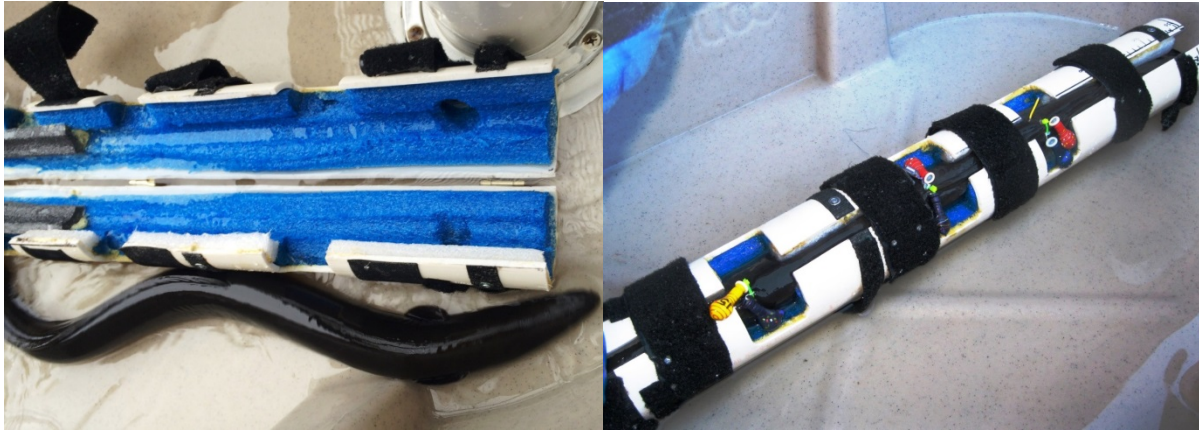
Figure 4.3.3-2. Restraining device used to aid in HI-Z tagging with eel ready for release through the induction system.

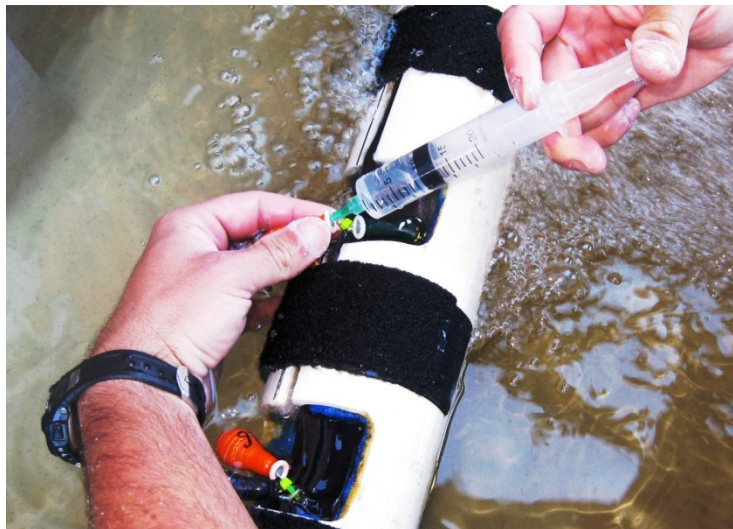
Figure 4.3.3-3. Injecting catalyst into a HI-Z tag attached to an adult American Eel.

Eels were individually marked and identified with small numbered Floy tags. The tubular Floy tags were inserted into musculature near the anterior region of the dorsal fin. Just prior to release, the HI-Z tags were activated by injecting a small amount of water into each HI-Z tag, which causes the tags to inflate in approximately 2 to 4 minutes. Tags were activated while the eel was still in the restraining device (Figure 4.3.3-3).

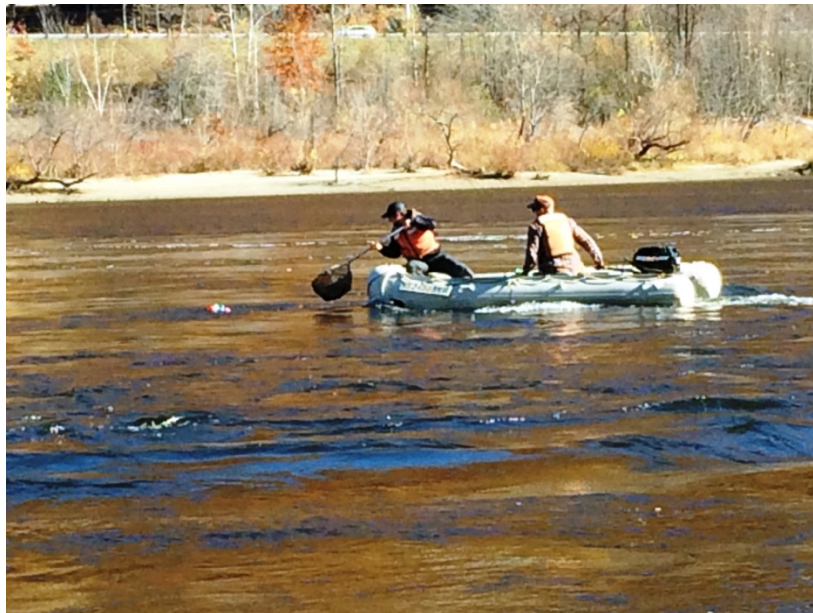
Figure 4.3.4-1. Boat crew retrieving a HI-Z tagged adult eel. HI-Z tagged eel with balloons inflated can be seen in front of the boat.

After release (either as treatment or control), the eels were tracked by radio telemetry and then retrieved when buoyed to the surface downstream of the projects by one of three recapture boat crews. Boat crews were notified of the radio tag frequency of each eel upon its release. Radio signals were received on a loop antenna coupled to an Advanced Telemetry System receiver. The radio signal transmission (48 or 49 MHz) enabled the boat crews to follow the movement of each eel after passage and position the boats downstream for retrieval when eels were buoyed to the surface. Recaptured eels were placed into an on-board holding facility, and all tags were removed with the exception of the Floy tag. Each eel was immediately examined for maladies consisting of visible injuries and loss of equilibrium, and assigned appropriate condition codes. Tagging and data recording personnel were notified via a two-way radio system of each eel's recapture time and condition (Figure 4.3.4-1, Table 4.3.4-1).

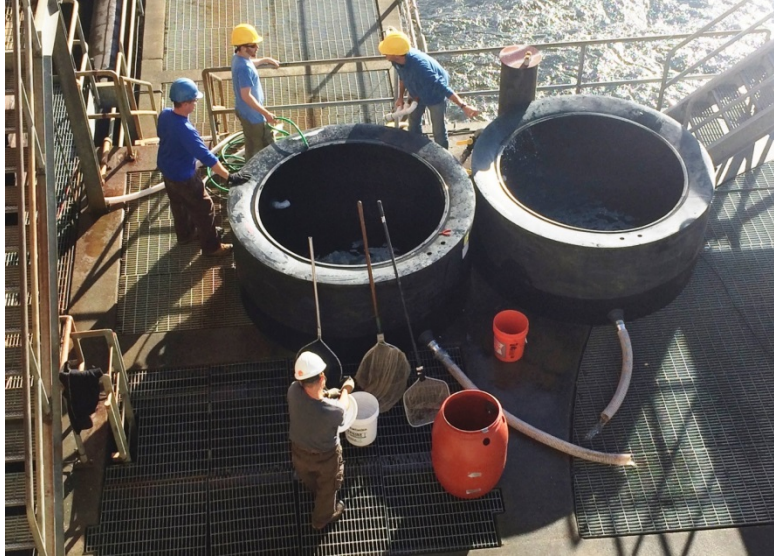
Figure 4.3.4-2. Delayed assessment tanks used to monitor the 48-hour period following recapture of HI-Z tagged adult eels.

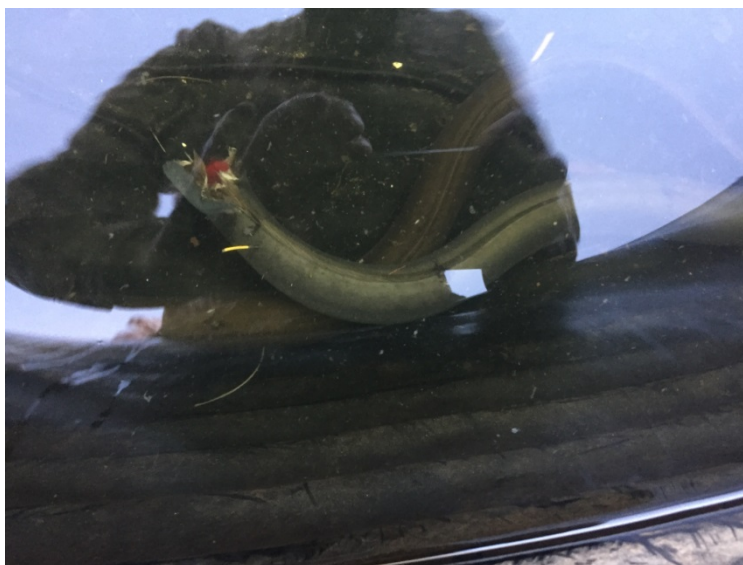
Figure 4.3.7-1. American Eel considered functionally dead. Eel was alive at 48 hours, but had a completely severed tail.

Eels that were still alive at 48 hours but had injuries that would eventually lead to death or prevent them from migrating to the ocean (e.g., tail severed, multiple backbone fractures) were considered functionally dead when calculating the 48-hour survival estimates (Figure 4.3.7-1).

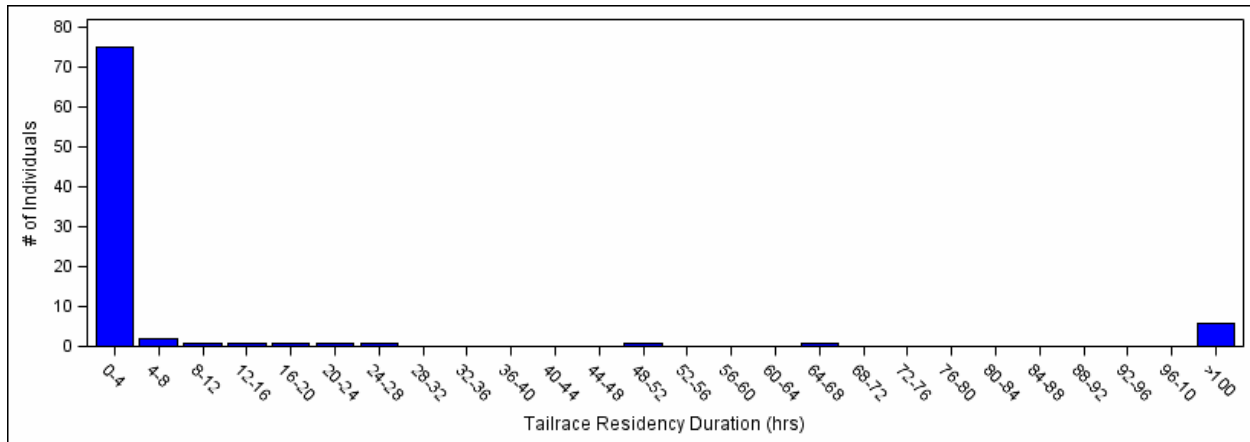
Figure 5.1.2-3. Frequency distribution of Bellows Falls tailrace residency duration (in hours) for radio-tagged silver eels from Bellows Falls impoundment release groups B1-B5, power canal release groups C1 and C2, and Wilder impoundment release groups W1-W5, fall 2015.
