TRANSCANADA HYDRO NORTHEAST INC.

ILP Study 19
American Eel Downstream Passage Assessment
Study Report

Wilder Hydroelectric Project (FERC Project No. 1892-026)
Bellows Falls Hydroelectric Project (FERC Project No. 1855-045)
Vernon Hydroelectric Project (FERC Project No. 1904-073)

Normandeau Associates, Inc.
25 Nashua Road
Bedford, NH 03110

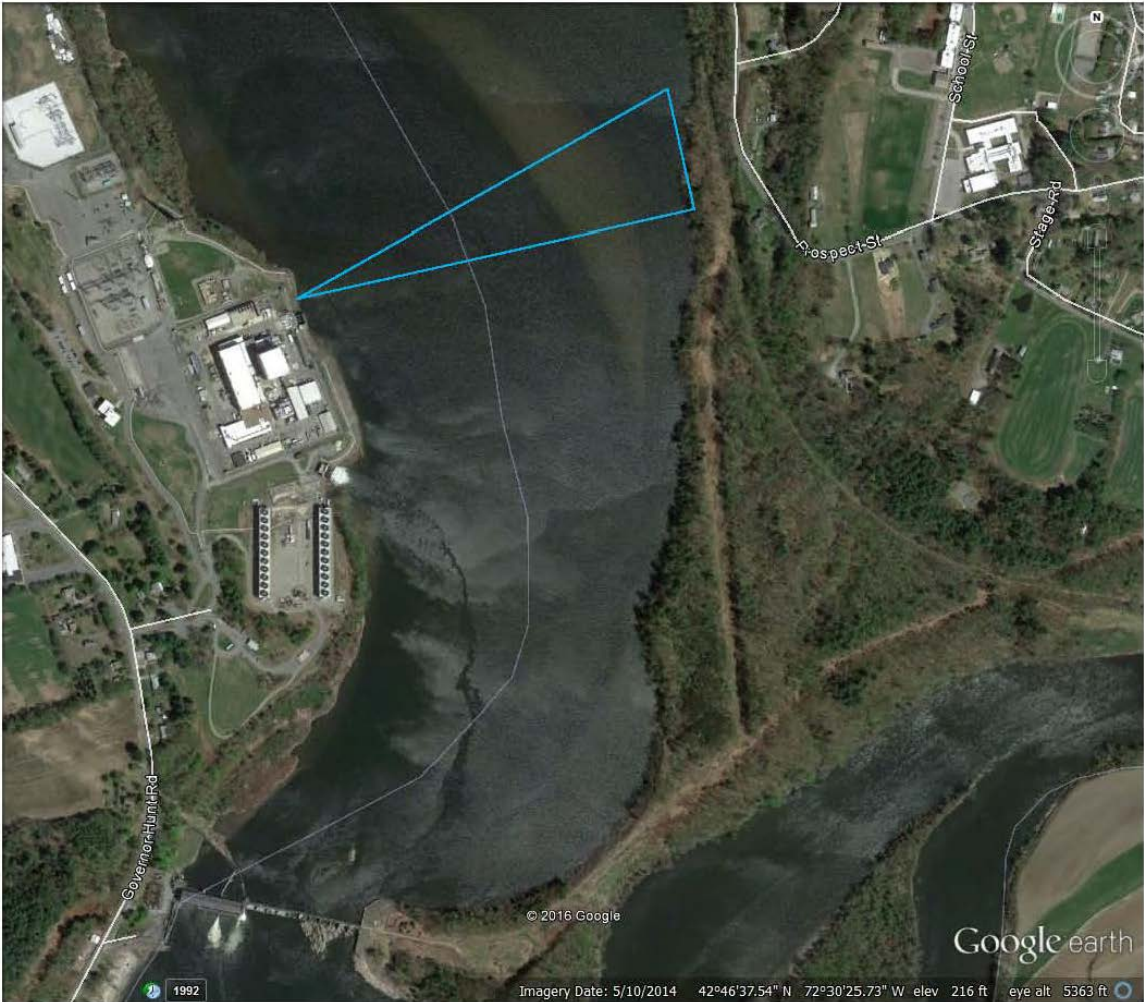
Figure 4.2-4. Vernon upstream telemetry layout and passage routes.

Remote telemetry monitoring occurred at the Vernon forebay, log boom and diversion boom, fish pipe, fish tube, turbines, tailrace, and spillway (Figures 4.2-4 and 4.2-5). Radio receivers capable of monitoring multiple radio channels simultaneously at each location were coupled with appropriate antennas and calibrated to ensure adequate coverage of the individual sites monitored while minimizing overlap between the sites.

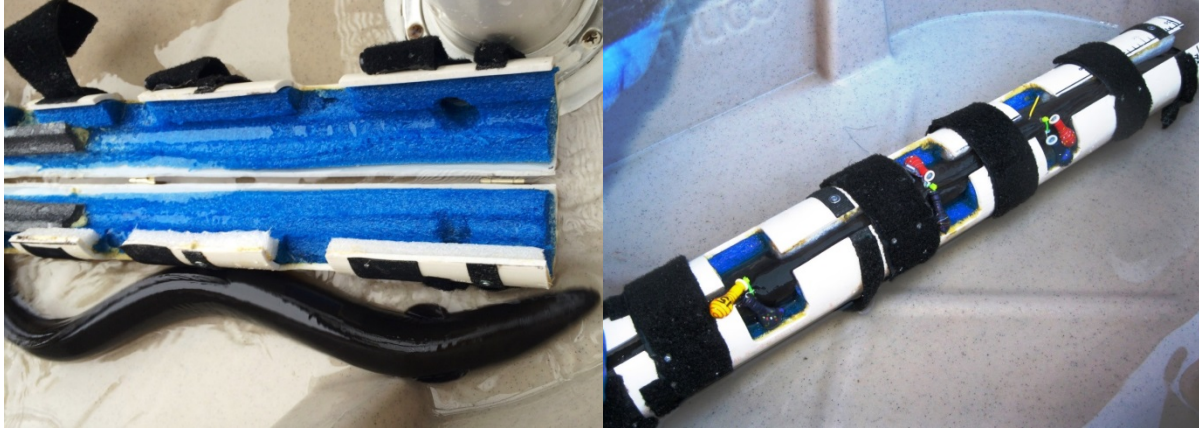
Figure 4.3.3-2. Restraining device used to aid in HI-Z tagging with eel ready for release through the induction system.

Eels were individually marked and identified with small numbered Floy tags. The tubular Floy tags were inserted into musculature near the anterior region of the dorsal fin. Just prior to release, the HI-Z tags were activated by injecting a small amount of water into each HI-Z tag, which causes the tags to inflate in approximately 2 to 4 minutes. Tags were activated while the eel was still in the restraining device (Figure 4.3.3-3).

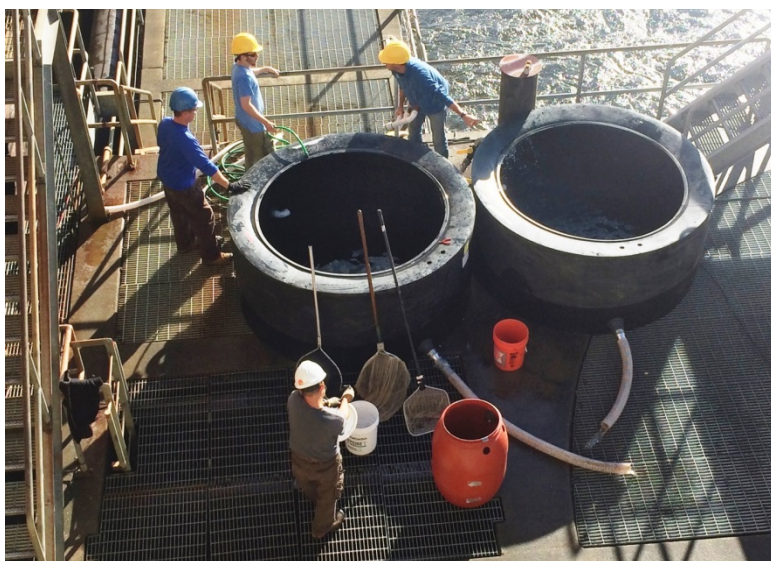
Figure 4.3.4-2. Delayed assessment tanks used to monitor the 48h period following recapture of HI-Z tagged adult eels.

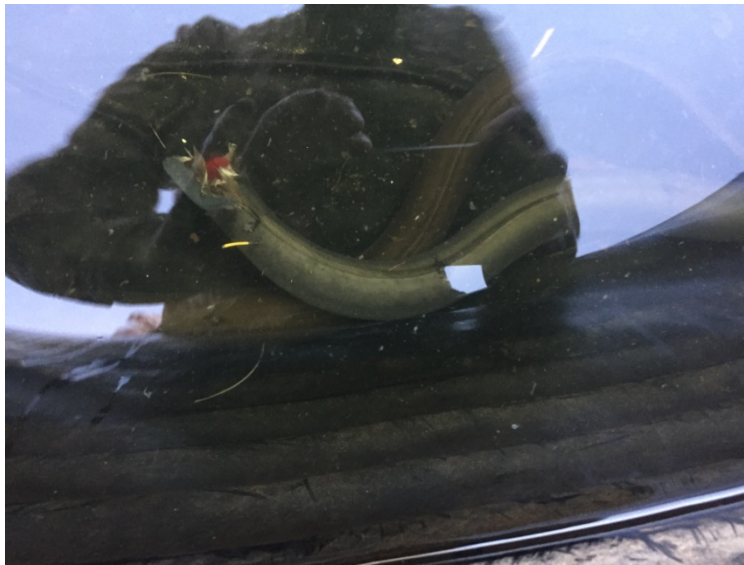
Eels that were still alive at 48 h but had injuries that would eventually lead to death or prevent them from migrating to the ocean (e.g., tail severed, multiple backbone fractures) were considered functionally dead when calculating the 48 h survival estimates (Figure 4.3.7-1).

Figure 4.3.7-1. American Eel considered functionally dead. Eel was alive at 48 hours, but had a completely severed tail.

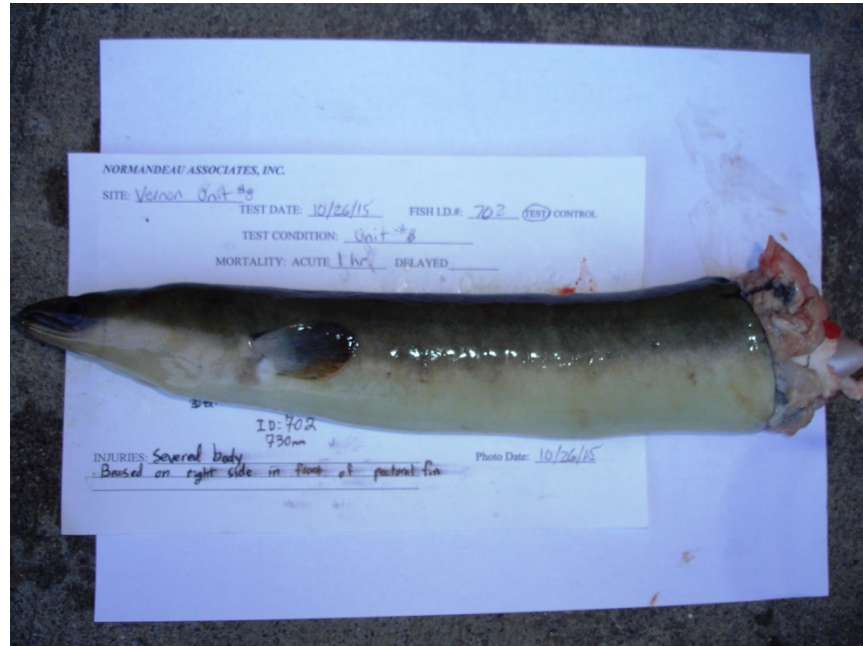
Figure 4.3.8-1. American Eel with severed body after passing through Vernon Unit 8 (1,000 cfs).

Of the 46 recaptured eels through Vernon Unit 8 discharging at 1,000 cfs, thirteen (28.3%) had visible injuries. Scrapes and bruises accounted for 10.9%, fin damage for 8.7%, decapitation or severed body for 6.5% and internal damage for 2.2% of the remaining passage related visible injuries.

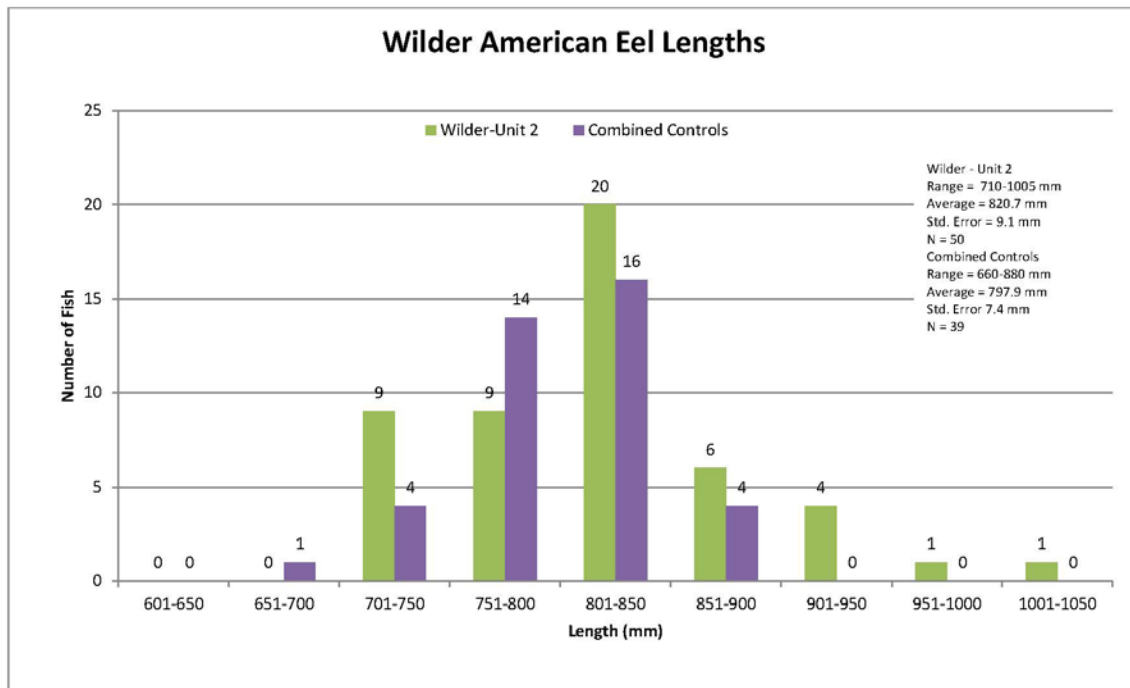
Treatment eels were released through Kaplan Unit 2 and Francis Unit 3 (minimum flow unit) approximately 5 ft below the ceiling of the turbine intake. Unit 2 eels were released through a head gate slot and Unit 3 through a vent pipe (Figure 4.3.3-4). Testing at Unit 3 was curtailed after the release of 10 eels when it was determined that most of the discharge from this unit was directed into the fishway and the features within the fishway prevented the recapture of seven of the ten eels. After consultation with TransCanada personnel, it was deemed that the present egress pattern at Unit 3 would not permit the determination of reliable survival/injury estimates. The aquatics working group was notified of this study plan variance on November 13, 2015. The 50 treatment eels released to Unit 2 ranged in length from 710 to 1,005 mm, with an average of 821 mm. The 39 combined control eels released at Wilder, Bellows Falls, and Vernon ranged in length from 660 to 880 mm, with an average of 798 mm (Figure 4.4.1-1).

Figure 4.4.1-1. Length frequency for HI-Z tagged adult American Eels released at Wilder Station. Combined controls released at the three projects.

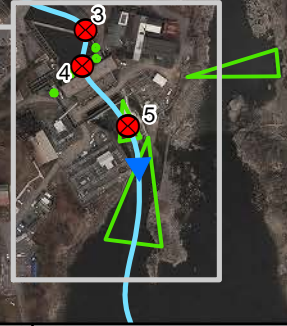
**TransCanada Hydro Northeast Inc.
ILP Study 19
Bellows Falls Dam**

Timetable		
Detection	Date	Time
1	11/3/2015	21:33
2	11/3/2015	21:58
3	11/3/2015	22:03
4	11/3/2015	22:04
5	11/4/2015	22:38

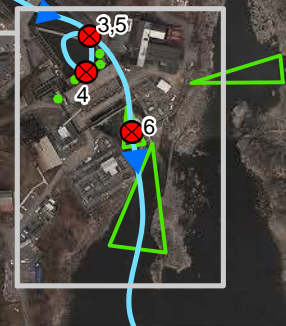
**TransCanada Hydro Northeast Inc.
ILP Study 19
Bellows Falls Dam**

Timetable		
Detection	Date	Time
1	11/2/2015	20:11
2	11/2/2015	20:29
3	11/2/2015	20:34
4	11/2/2015	20:36
5	11/2/2015	20:36
6	11/2/2015	20:36

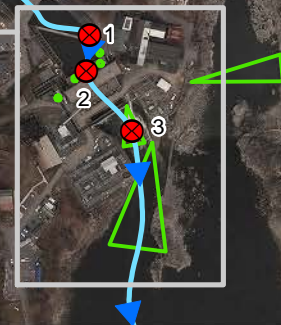
**TransCanada Hydro Northeast Inc.
ILP Study 19
Bellows Falls Dam**

Timetable		
Detection	Date	Time
1	10/29/2015	18:23
2	10/29/2015	18:23
3	10/29/2015	18:23

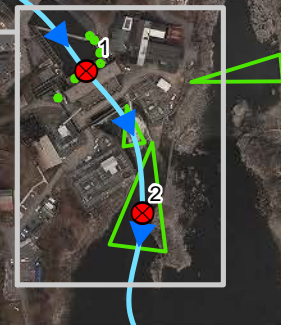
**TransCanada Hydro Northeast Inc.
ILP Study 19
Bellows Falls Dam**

Timetable		
Detection	Date	Time
1	10/29/2015	20:08
2	10/29/2015	20:10

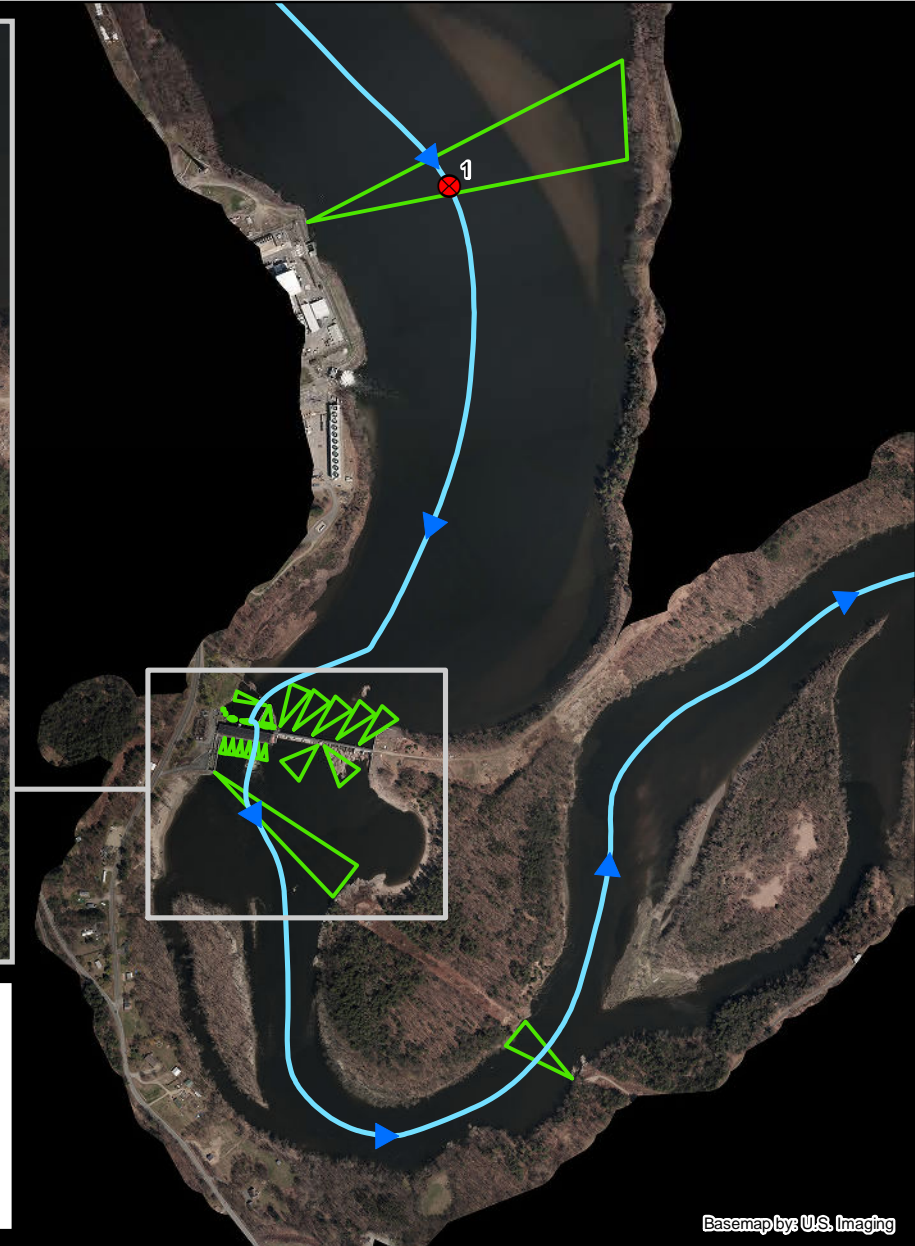
**TransCanada Hydro Northeast Inc.
ILP Study 19
Vernon Dam**

Receiver Zones
