**TRANSCANADA HYDRO NORTHEAST INC.**

**ILP Study 29  
Northeastern Bulrush Survey**

***Study Report***

Wilder Hydroelectric Project (FERC Project No. 1892-026)  
Bellows Falls Hydroelectric Project (FERC Project No. 1855-045)  
Vernon Hydroelectric Project (FERC Project No. 1904-073)

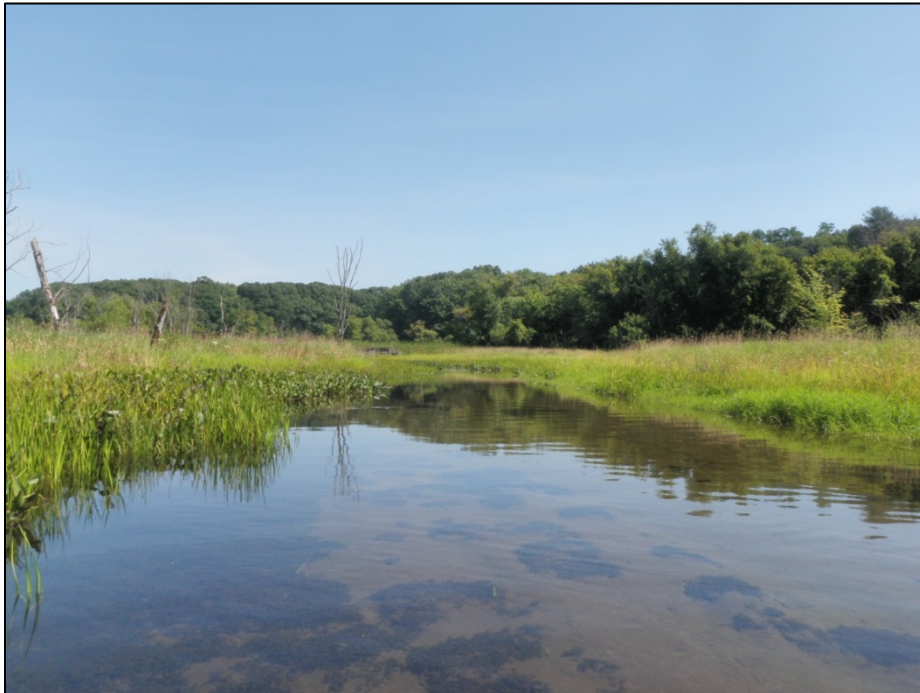
Figure 5.3. Site 29-02 interior.

Site 29-02 (Figure 5.3) is located in the Bellows Falls impoundment in Charlestown, New Hampshire. The site is characterized by a series of small beaver impoundments along a perennial stream. Upon entering the site, it was determined to have high potential for northeastern bulrush habitat due to its hydrology driven by the beaver dams and a high degree of structural diversity in the herbaceous layer, ranging from submerged aquatic species such as bullhead pond-lily (*Nuphar variegata*) to species associated with mesic sites (e.g. *Solidago rugosa*). A canoe was used to access the interior of the site, and vegetation communities were investigated on foot.

The vegetation community is comprised of many species associated with northeastern bulrush occurrences in the northern portion of its range (FWS, 1993). Dominant species within the site include rice cut grass (*Leersia oryzoides*), reed canary grass (an invasive species), pickerelweed (*Pontederia cordata*), woolly bulrush, soft rush (*Juncus effusus*), bur-reed (*Sparganium* sp.), and swamp yellow-loosestrife (*Lysimachia terrestris*). Large stands of plants phenotypically similar to northeastern bulrush were investigated, but all were conclusively determined to be common species, such as woolly bulrush or dark-green bulrush.

The beaver dams appear to be stable, and 1 to 2 feet above the upper operational level of the Bellows Falls project as observed by the observed high water mark on the downstream (free-flowing) side of the beaver dams. This estimation was performed by observing visual clues as to the typical maximum water surface elevation, such as wrack lines, scour, wrested vegetation, and changes in plant

community. These observations were based on direct field observations although not supported by direct elevation measurement at the time of field surveys. The vegetation density within these beaver impoundments exceeds 90% where water depth allows for emergent vegetation. This observed vegetation density provides little ecological space available for newly established northeastern bulrush individuals, resulting in minimal suitable habitat. The opening of bare substrate in these communities by such forces as muskrat and beaver activity, artificial impoundment, or atypically large storm events is needed to allow for a greater extent of northeastern bulrush habitat.

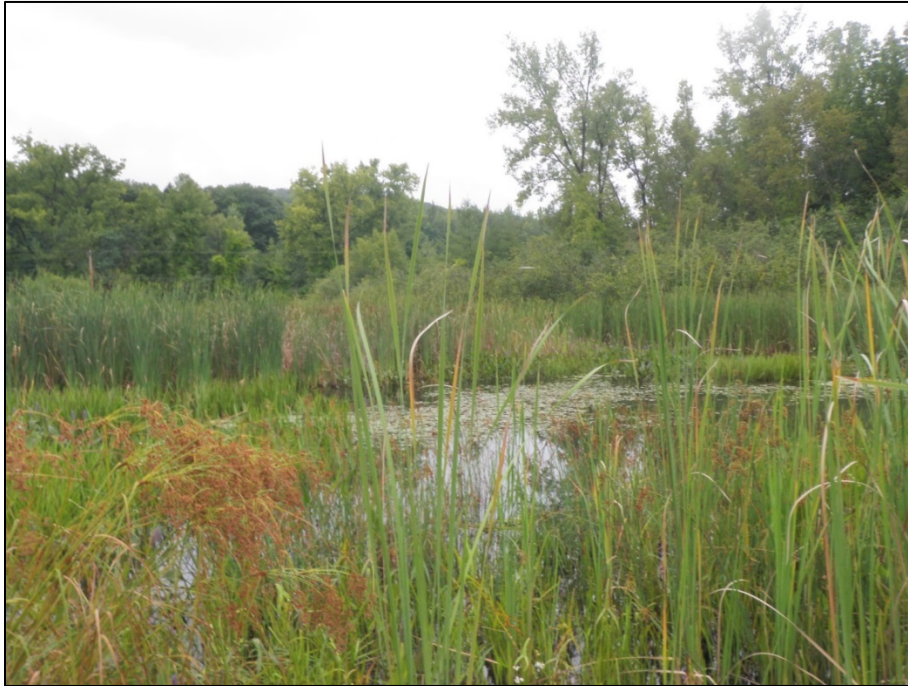
Figure 5.6. Site 29-08 interior.

Site 29-08 (Figure 5.6) is a series of ponds located near the outlet of a perennial stream in the Vernon impoundment, in Vernon, Vermont. The ponds are caused by both beaver dams and anthropogenic sources, including old excavations and a railroad embankment. A large area of the site is dominated by a monotypic stand

of common cattail which provides little habitat for other herbaceous species; however, the margins of several ponds are very diverse and provide potentially suitable habitat for northeastern bulrush.

The vegetation structure and community types varies widely throughout the site, ranging from submerged aquatic species such as bullhead pond-lily, water-milfoil (*Myriophyllum* sp.), and pondweeds (*Potamogeton* spp.), to well established stands of speckled alder (*Alnus incana* ssp. *rugosa*). Dominant species in areas of greatest potential habitat include woolly bulrush, dark-green bulrush, soft rush, pickerelweed, common cattail, spotted touch-me-not (*Impatiens capensis*), and a variety of sedges (*Carex* spp.).

Multiple low beaver dams impounded small areas of water at this site, resulting in many small (less than 200 sq. ft.) pools that may provide potential northeastern bulrush habitat. Based on the presence of established woody vegetation, the ages of the dams were estimated to range from less than one year to more than five years. The variable age of the dams implies that they can be breached on occasion or abandoned, leading to variable water levels in the resultant pools. This cycle of impoundment and abandonment by beavers may provide ideal habitat for northeastern bulrush in some portions of this site.

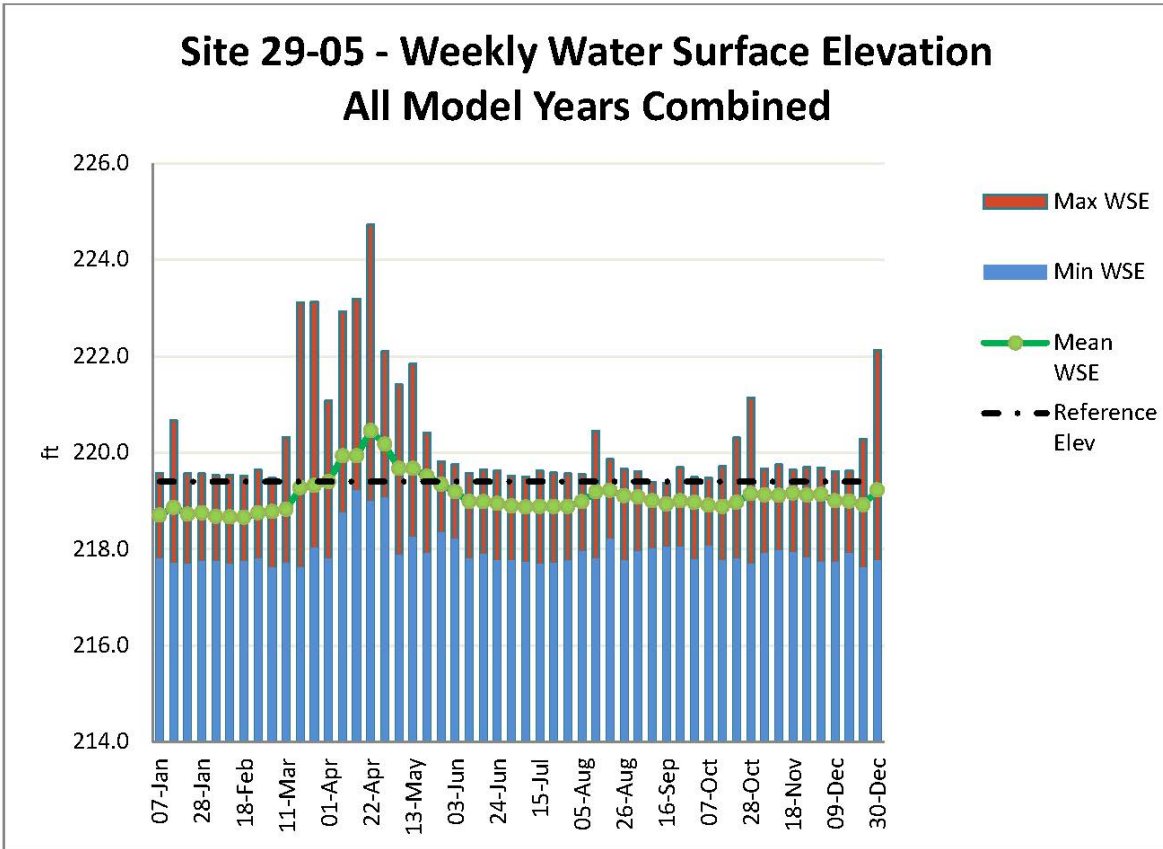
Figure 6.1. Site 29-05 weekly water surface elevation – all modeled hydrologies.

Output from the Operations Model was used to further analyze the timing, frequency, and duration of water level fluctuations at Sites 29-05 and 29-08. Weekly minimum, maximum, and mean WSEs for all five modeled annual hydrologies combined (including high flows and high WSEs above normal project operations) were plotted along with the reference habitat elevations (beaver dam height measured in 2015 with an RTK) for each site. Figures 6.1 to 6.2 present the modeled WSE data.

Site 29-05 had mean weekly WSEs higher than the reference elevation only during spring (mid-March to mid-May) and weekly mean WSE did not exceed the reference elevation throughout the rest of the year although the site was inundated (spikes above reference elevation, Figure 6.1) in at least one modeled hydrology, at least once in most weeks of the year. These results agree with field observations (Section 5.2) which indicate only marginal suitable habitat. Due to the presence of beaver dams largely responsible for maintaining a sustained inundated condition and the data suggesting only spring runoff conditions or high water events periodically over topping the beaver dam reference elevation, it is unlikely that inundation under normal project operations is responsible for the hydrologic influence controlling the vegetation community and the absence of northeastern bulrush at Site 29-05.

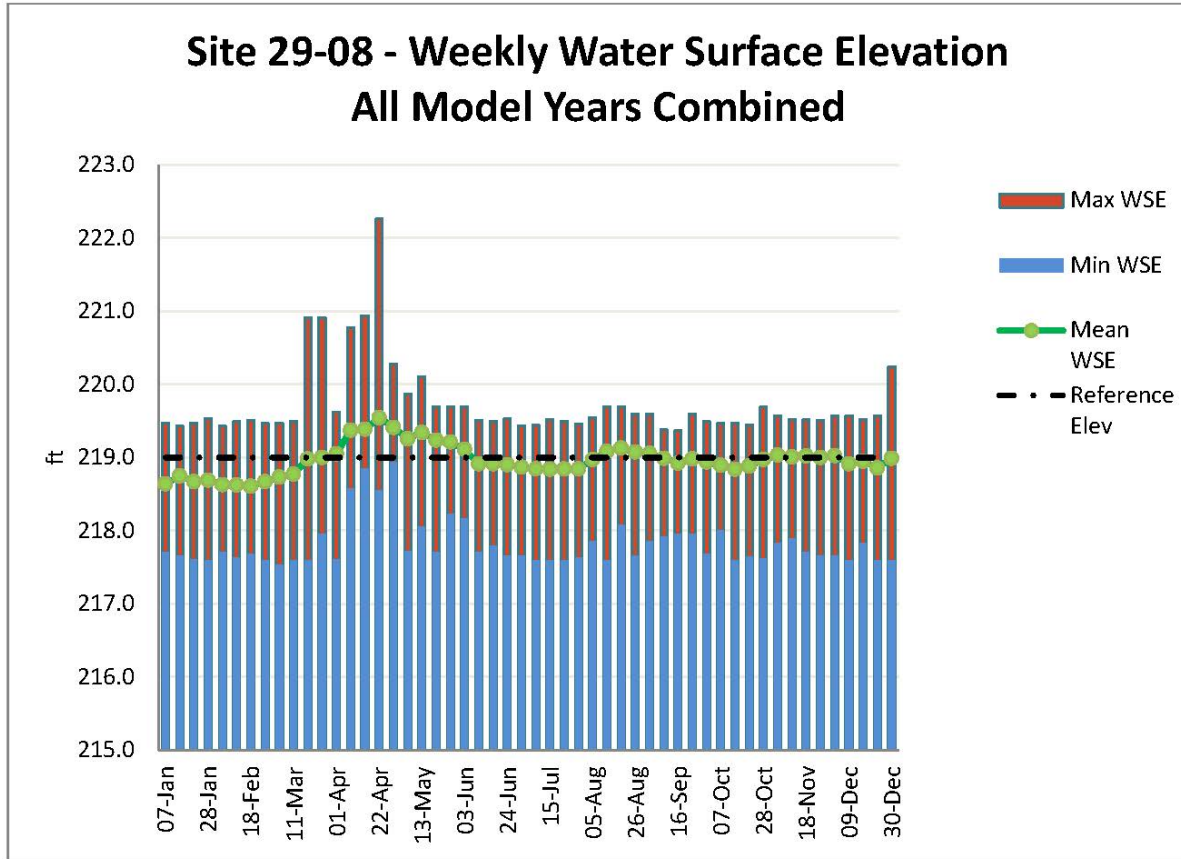
Figure 6.2. Site 29-08 weekly water surface elevation – all modeled hydrologies.

Similarly, Site 29-08 had mean weekly WSEs higher than the reference elevation in spring and slightly higher than the reference elevation periodically throughout the rest of the year (Figure 6.2). The beaver dams at this site appeared to be variable in age (Section 5.2) indicating that that they are frequently breached or abandoned, leading to variable water levels in the resultant pools. This cycle of impoundment and abandonment by beavers may provide ideal hydrology for northeastern bulrush in some portions of this site, although the species was not observed during field surveys. Due to the presence of beaver dams largely responsible for maintaining a sustained inundated condition, it is unlikely that inundation under normal project operations is responsible for the hydrologic influence controlling the vegetation community and the absence of northeastern bulrush at Site 29-05. It is possible that occasional overtopping of the beaver dam, based on the reference elevation and mainstem WSE's, whether due to high water or when the impoundment is at its upper operating range, may actually encourage periodic dam failure or abandonment and thus provide valuable colonization opportunity.
