TRANSCANADA HYDRO NORTHEAST INC.

**ILP Study 32
Bellows Falls Aesthetic Flow Study**

Study Report

Wilder Hydroelectric Project (FERC Project No. 1892-026)
Bellows Falls Hydroelectric Project (FERC Project No. 1855-045)
Vernon Hydroelectric Project (FERC Project No. 1904-073)

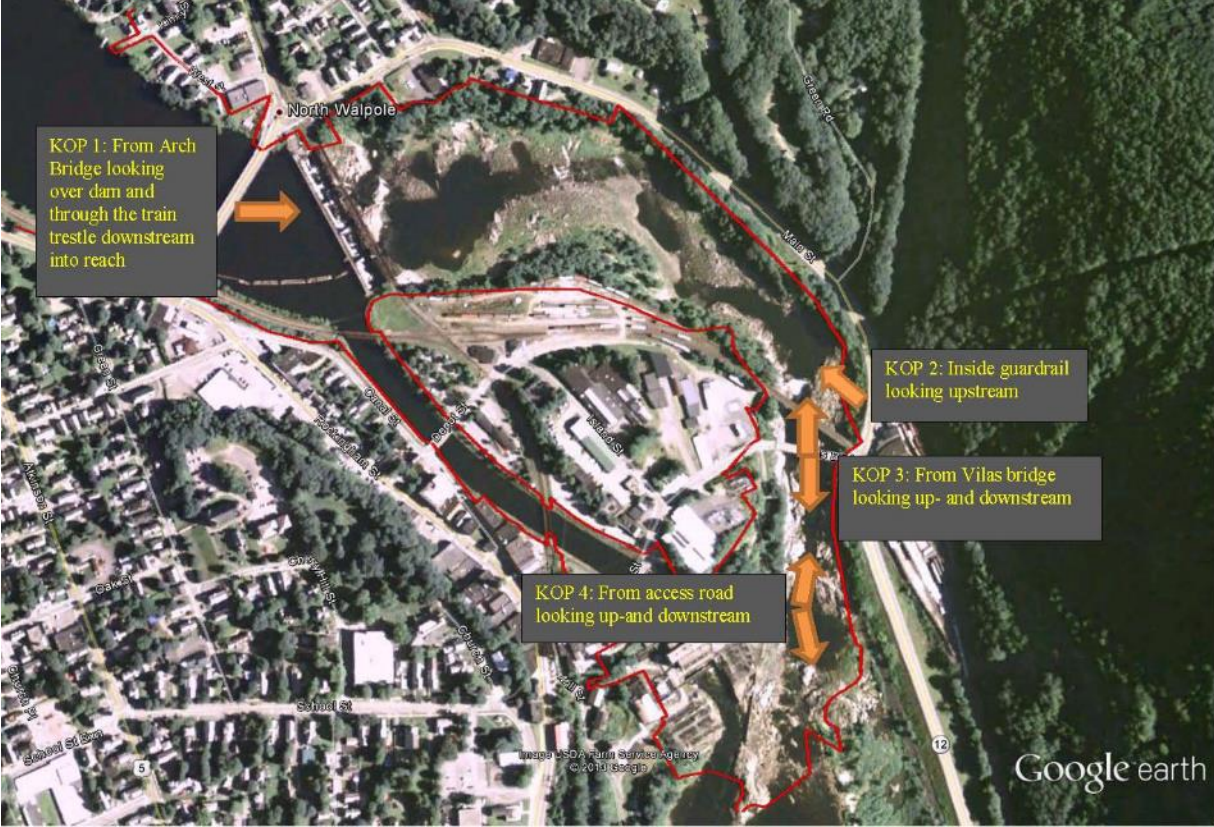
Figure 1-1. Locations of key observation points for Bellows Falls aesthetic flow study.

The study area included the Bellows Falls bypassed reach from the base of the dam to the confluence with the powerhouse tailrace. The bypassed reach was assessed from representative observation points under different flow conditions. Review of site conditions prior to field investigations during the study plan development suggested publicly accessible direct views into the bypassed reach were very limited. Figure 1-1 shows the public Key Observation Points (KOPs), which include (from upstream to downstream): KOP-1: Arch Bridge, from the sidewalk looking over the dam into the bypassed reach¹; KOP-2: along New Hampshire Route 12 (River Street or Main Street); and KOP-3: the now-closed Vilas Bridge (Bridge Street)². The RSP identified a fourth possible KOP based on aerial photography (KOP-4: from the access road downstream of the fish barrier dam on the Vermont shore overlooking the downstream portion of the bypassed reach). Evaluation of this KOP-4 in the field presented poor viewing angles and inconclusive evidence of user created trails to view the bypassed reach from this area. Given the challenges of photographing flows from this location presented during field verification this location was not photographed for inclusion in the study. This represents a variance from the RSP. The RSP was developed in consultation with the study group which at that time, was presented with the potential that sites identified on aerial

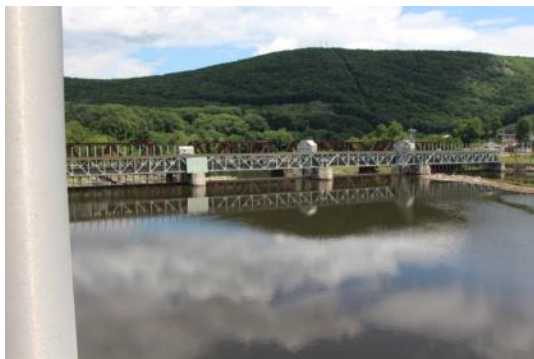
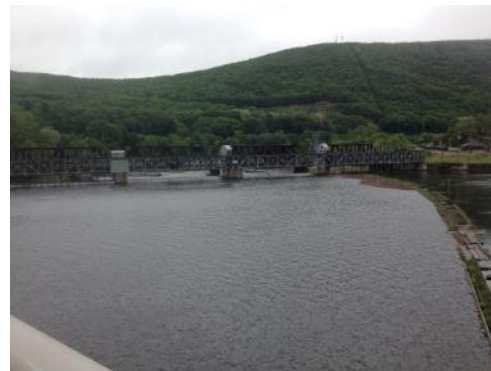
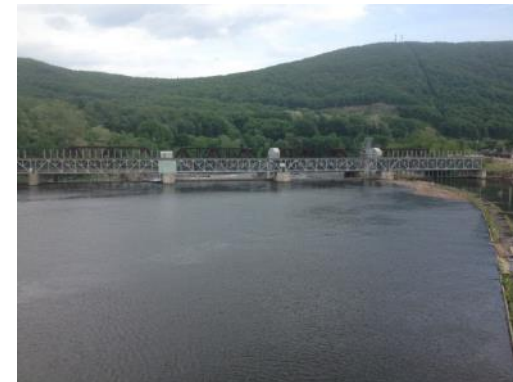
Figure 3-1. Representatives photographs of low, medium, and high flows from KOP 1. Note: The bypass reach is largely obscured by the pool and associated dam in the foreground of each picture.

KOP 1 is located at the Arch Bridge looking over the top of the dam through the train trestle, downstream into the reach. Pedestrian access is not limited at this KOP. Between Demo Flow 1 and Demo Flow 3 (125 and 2,370 cfs, respectively) there was an increase in the average overall aesthetic rating, with Demo Flow 3 having the highest average rating of 1.5 which is between 'acceptable' and 'slightly acceptable'. Average scores for the overall aesthetic rating condition dropped to a low of 0.5, between 'neutral' and 'slightly acceptable' for Demo Flow 5 (4,370 cfs) and rose to an average rating of 1.2, 'acceptable' for Demo Flow 6 (5,560 cfs).

Flow no. 1 – Low (125 cfs)

Flow No. 3 – Medium (2,370 cfs)

Flow No. 6 – High (5,560 cfs)

Participants generally commented that Demo Flow 1 (125 cfs leakage flow) was an acceptable amount of water, a nice quiet pool, and a somewhat below average flow amount. Participants noted that there were not significant or material aesthetic differences between Demo Flow 1, Demo Flow 2, and Demo Flow 3. Only one participant noted that Demo Flow 3 looked slightly higher than the previous flow amount in Demo Flow 2. Demo flow 4 (3,300 cfs) was the first flow a participant labeled as being a slightly higher flow than the previous flow amount.

Participants generally commented that Demo Flow 5 and Demo Flow 6 looked about the same as Demo Flow 4, but the average ratings of these flows dropped relative to Demo Flows 1, 2 and 3. Overall, views into the bypassed reach from this area are severely obstructed by the train trestle providing only a slim viewing window between the top of the dam and the bottom of the trestle to view the bypassed reach. Table 3-1 presents the average participant rating for all study attributes for all flows observed from KOP 1. Figure 3-1 shows representative photos from KOP 1 at low (125 cfs), medium (2,370 cfs), and high flows (5,560 cfs). A complete portfolio of photos from each KOP at each flow appears in [Appendix B](#).

1. Views from KOP 1 showed very little difference between low and high flow. At higher flows, participants could see some mist (spray) beyond the dam. Very little of the bypassed reach could be seen from KOP 1 and the views of the impoundment in front of the dam did not change significantly from the lowest to the highest flows.

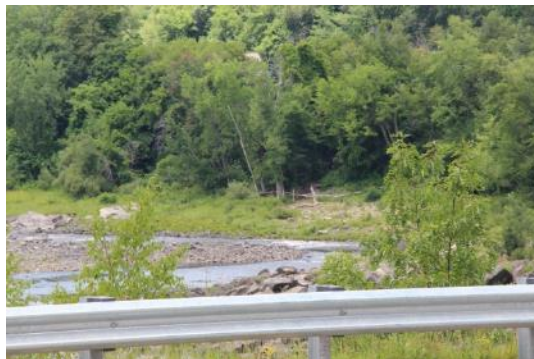
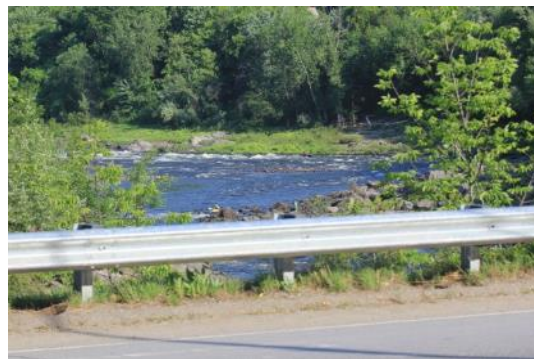
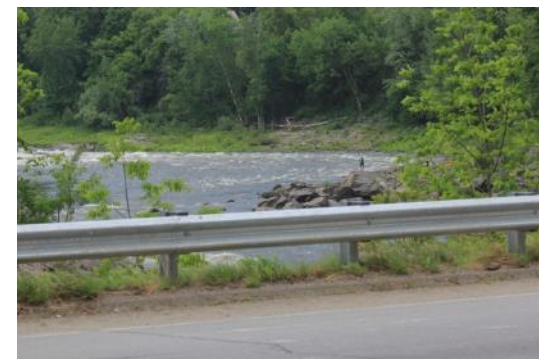
Figure 3-2. Representative photographs of low, medium, and high flows from KOP 2.

KOP 2 is located along New Hampshire Route 12 looking upstream, and is the most common view from vehicles traveling north along Route 12. Route 12 is a well-traveled state road that goes from 50 miles per hour a mile south of the KOP to 30 miles per hour as the road enters the small community of North Walpole. The viewing opportunity window for passengers in vehicles is limited to this brief section of road estimated to be about 150 feet. There is a sidewalk on the opposite side of the road as the bypassed reach but not along the river side of the road. Both vehicular and pedestrian views are available year round; however the viewing window is limited to the short segment described above as the remainder of the road and sidewalk views are obstructed by residences and vegetation.

Flow no. 1 – Low (125 cfs)

Flow No. 3 – Medium (2,370 cfs)

Flow No. 6 – High (5,560 cfs)

Demo Flow 1 (125 cfs) was the lowest rated flow at this KOP, with an average overall aesthetic rating of 0.7, below 'slightly acceptable'. Demo Flows 2 (1,580 cfs) through 6 (5,560 cfs) however, were all given an average overall aesthetic rating over 1.0, 'slightly acceptable' with Demo Flows 2, 3, and 4 (1,580 – 3,300 cfs) having the highest average rating of 1.7, between 'slightly acceptable' and 'acceptable'. Overall, participants commented that they could see the water better at KOP 2 compared to KOP 1, but were unable to agree on a preferred flow amount.

A majority of the participants commented that since higher flows are more common in the spring, they preferred to see the bypassed reach with less flow other times of the year, and some variation by season. One participant liked the aesthetic of the bypassed reach without any flow. Overall, the participants preferred a variability of flow from this KOP that followed the natural hydrograph where there would more water in the spring and less during the summer and fall. Generally, participants commented that there was some observable difference between Demo Flow 1 (125 cfs) and Demo Flow 2 (1,580 cfs), noting that at each higher flow there was less pooling and fewer rocks seen in the bypassed reach. Table 3-2 presents the average participant rating for all study attributes for all flows observed from KOP 2. Figure 3-2 shows representative photos from KOP 2 at low, medium, and high flows. A complete portfolio of photos from each KOP at each flow appears in [Appendix B](#).

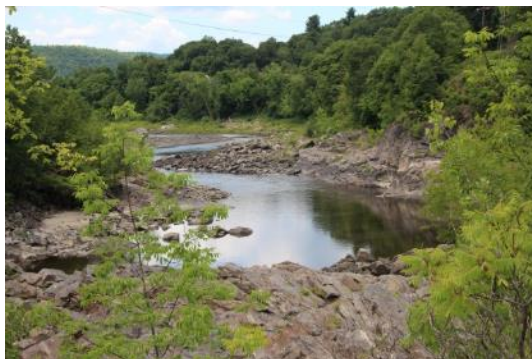
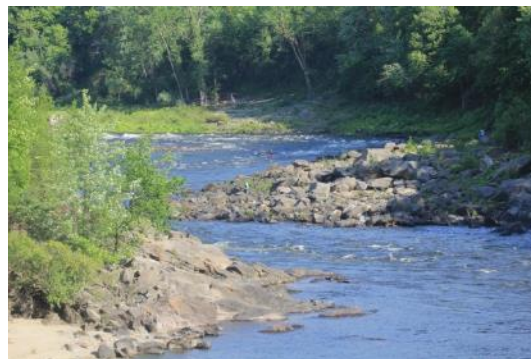
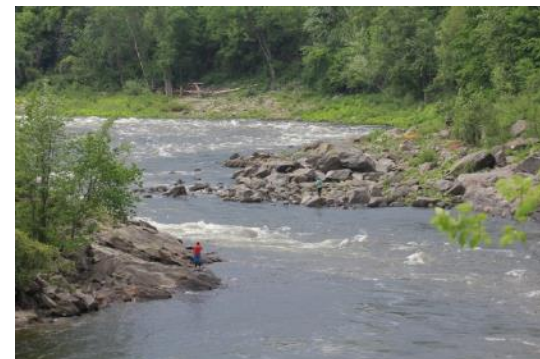
Figure 3-3. Representatives photographs of low, medium, and high flows from KOP 3.

KOP 3 is located on the now-closed Vilas Bridge looking downstream. Pedestrian access is limited at this KOP by the presence of large concrete 'jersey' barriers and signage prohibiting public use, but the bridge is used illegally by a small number of local residents. The average overall aesthetic rating for all demo flows at this location was over 1.0, 'slightly acceptable'. Interestingly, Demo Flow 1 (125 cfs) had the highest average overall aesthetic rating of 1.7, just under 'acceptable' followed by Demo Flows 2 (1,580 cfs) and 6 (5,560 cfs).

Flow no. 1 – Low (125 cfs)

Flow No. 3 – Medium (2,370 cfs)

Flow No. 6 – High (5,560 cfs)

Overall, participants agreed that there was a noticeable increase in the volume of water in the bypassed reach, and an increase in the size of waves and ripples. All participants except one liked the view of the leakage (125 cfs) flow at this KOP. Additionally, the participants agreed that they were able to observe noticeable changes between incremental flows as compared to the other KOPs. Table 3-3 presents the average participant rating for all study attributes for all flows observed from KOP 3. Figure 3-3 shows representative photos from KOP 3 at low, medium, and high flows. A complete portfolio of photos from each KOP at each flow appears in [Appendix B](#).

2. Of the three KOPs, the participants were able to notice the most difference between flows at KOP 3, where they noted more rocks and pools exposed at the lower flow and bigger waves and faster water at higher flows.
