**TRANSCANADA HYDRO NORTHEAST INC.**

**Wilder Hydroelectric Project (FERC Project No. 1892-026)**  
**Bellows Falls Hydroelectric Project (FERC Project No. 1855-045)**  
**Vernon Hydroelectric Project (FERC Project No. 1904-073)**

**Updated Study Report**  
**Volume III – Containing Sub Volumes III.A – III.B**

**Study 13 – Tributary and Backwater Fish Access and Habitats**  
**Study Report**

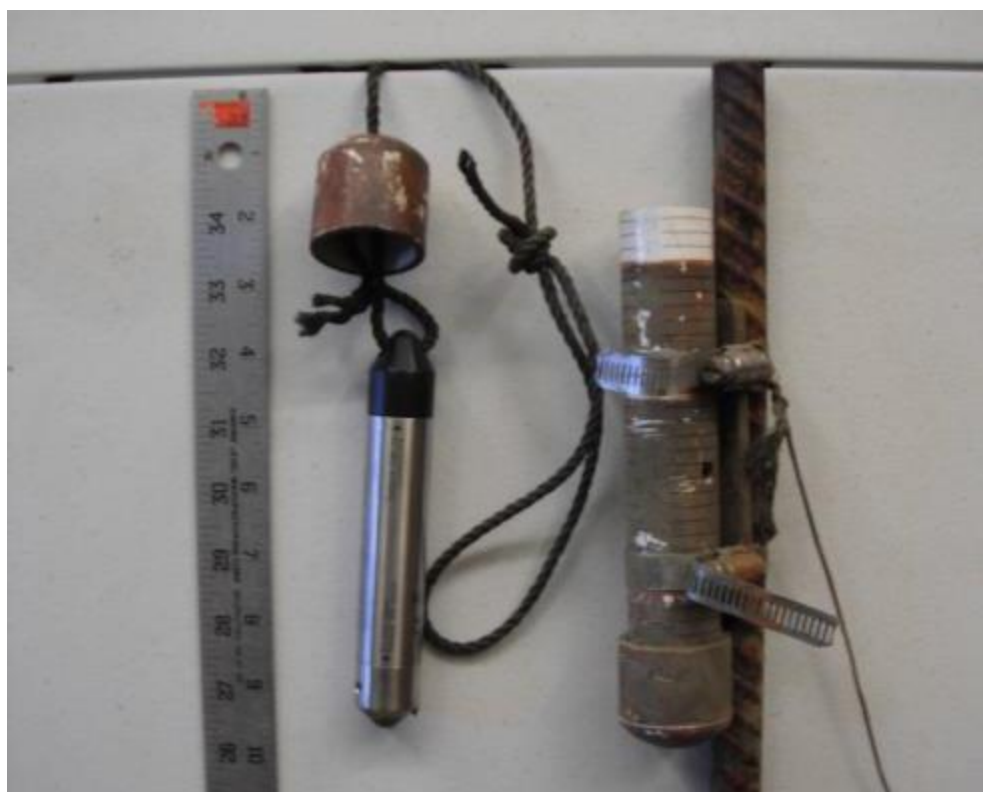
Figure 4.1-1. Installation set-up used for HOBOWare water level loggers.

Each site was then visited once monthly during August and September, with a final visit during October or November 2014. Following each download, the level logger was returned to the well pipe. The “pull” and “set” times bracketing the period of time the level logger was out of water were recorded. The same suite of parameters recorded during the initial site visit was also collected (i.e., date-time of visit, cross section water depths at the confluence with mainstem, water quality parameters, and condition photographs). During the final visits, level loggers were

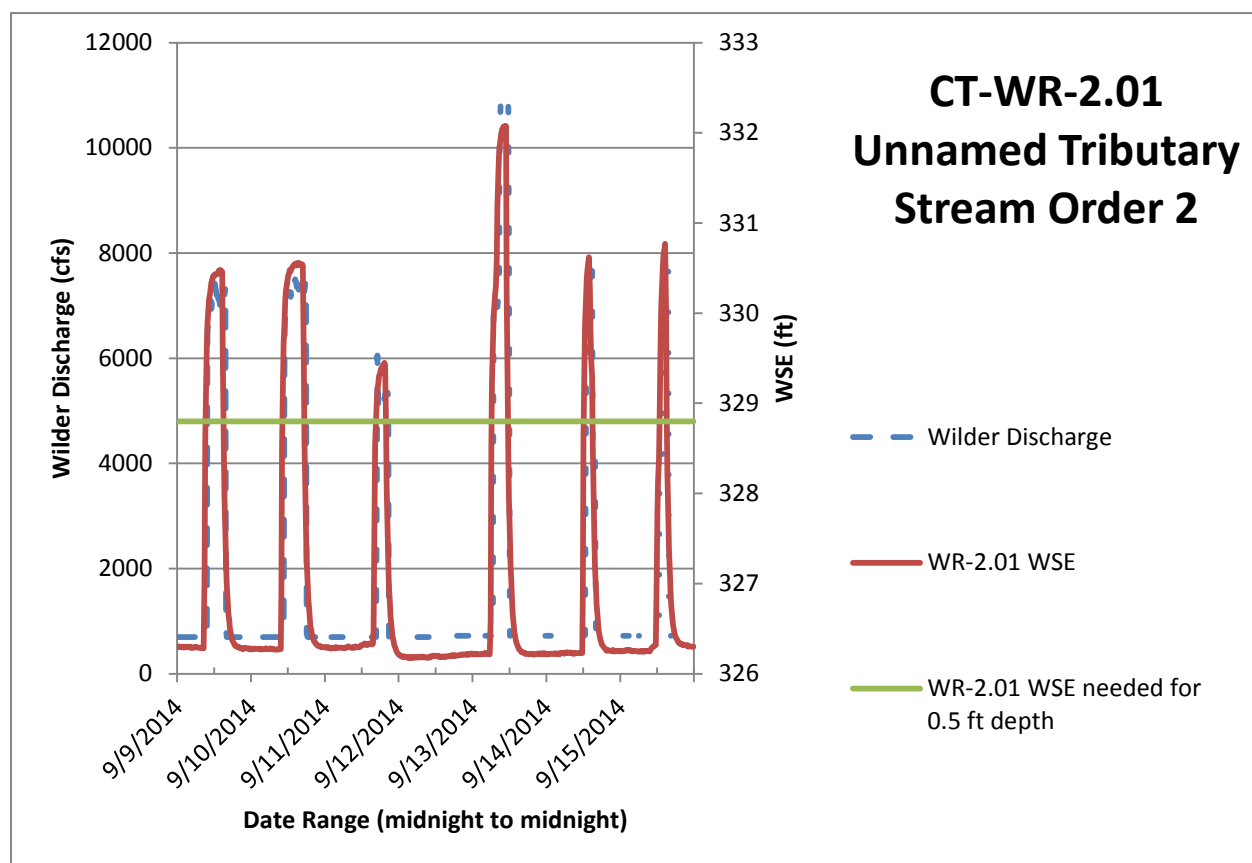
Site CT-WR-2.01 is a stream order 2 tributary located approximately 0.4 mi downstream from the Wilder Project. A perched culvert is present (see photographs in [Appendix A](#)) and the project-affected reach extends approximately 45 ft into the tributary from the cross section to an elevation of 332.7 ft, slightly above the culvert bottom sill elevation (at elevation 332.4). The minimum mainstem WSE needed to achieve 0.5 ft of water depth at the cross section is 328.8 ft. Water depth at the confluence cross section was < 0.5 ft about 70% of the time during the period of record, and ranged from 0.2 to 0.7 ft as measured at site visits. Water depth at the tributary logger location ranged from 0.0 to 3.8 ft based on limited tributary data. Figure 6.1-1 illustrates that mainstem water levels at the site closely track Wilder discharge flows. The thalweg profile within the project-affected reach is gradual without apparent stranding spots. It is likely that channel depths within the tributary are limited as part of its natural flow regime. As a result, potential access for fish into this small tributary is likely limited more by its own specific characteristics (i.e., limited outflow) than by TransCanada operations.

Figure 6.1-1. Representative operating conditions at Site CT-WR-2.01.

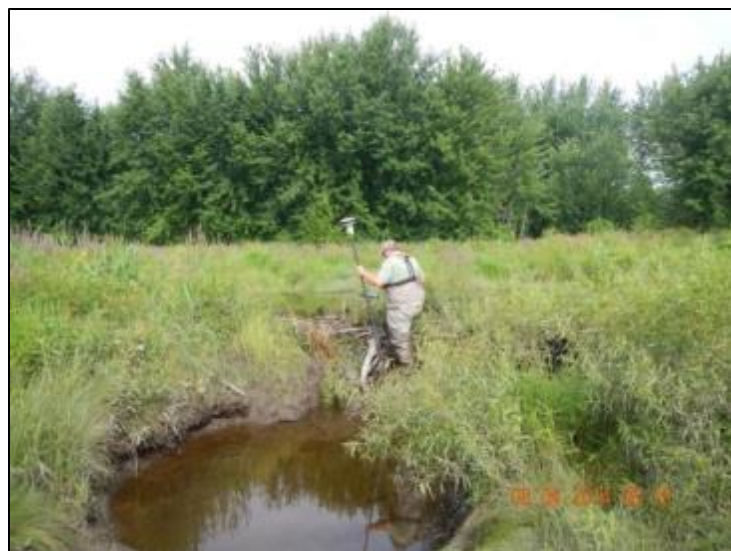
Beaver dam at Harriman Brook, site CT-W-1.01.

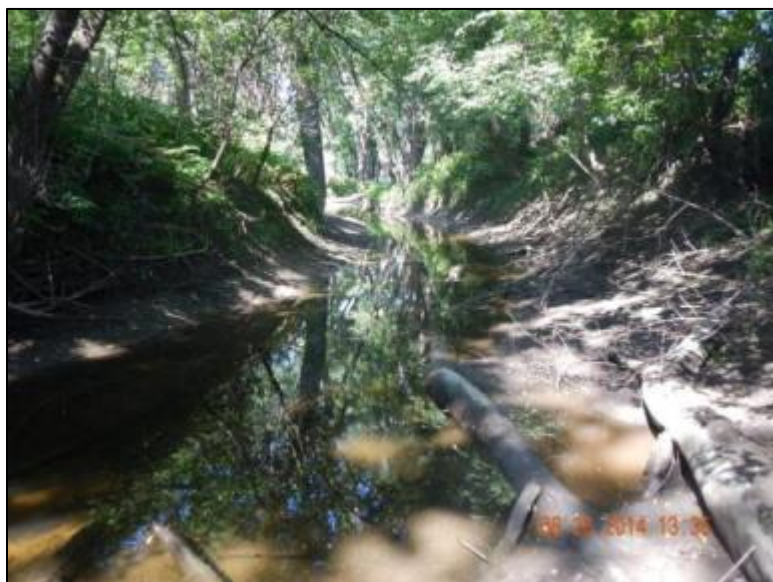
View within the access channel connecting mainstem to backwater at Site CT-W-1.05 showing numerous downed logs creating potential blockage during low flow conditions.

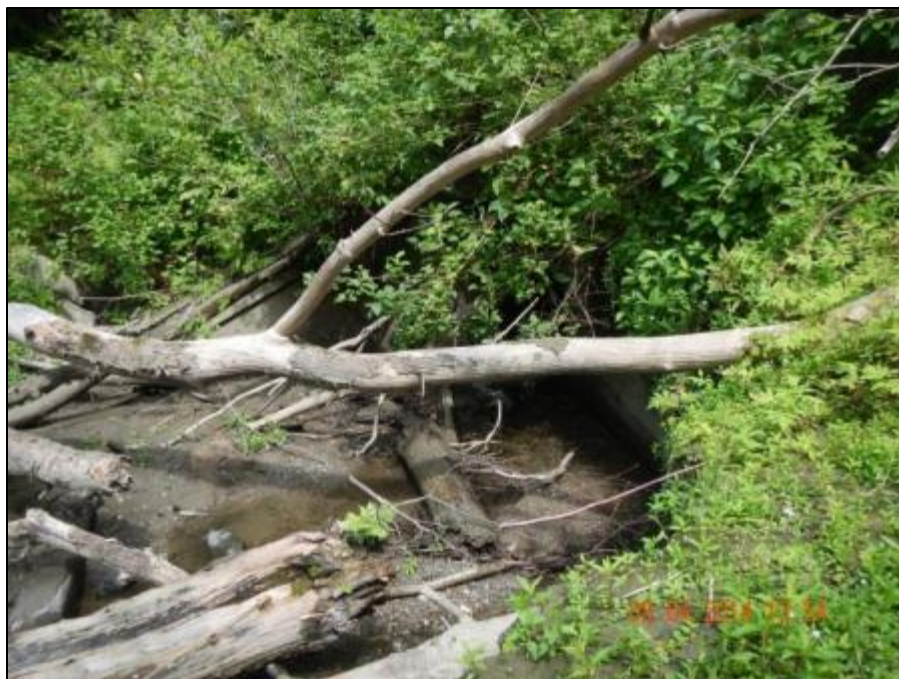
View of the end of project-affected reach within site CT-W-1.06.

The project-affected portion of tributary CT-W-1.06 is relatively short (136 ft) with the majority of the reach lying within a culvert tunnel and offering limited aquatic habitat (see photo below). The downstream edge of the culvert is located at an elevation of 383.6 ft, and based on the recorded range of mainstem WSE values is submerged 0.4 ft at least 75% of the time. As indicated by the minimum WSE recorded at the mainstem level logger location (383.1 ft), water depth at the downstream edge of the culvert may be limited to only natural stream outflow under low mainstem and tributary conditions (13.6% of data occurrences < 0.5 ft of depth at the confluence).

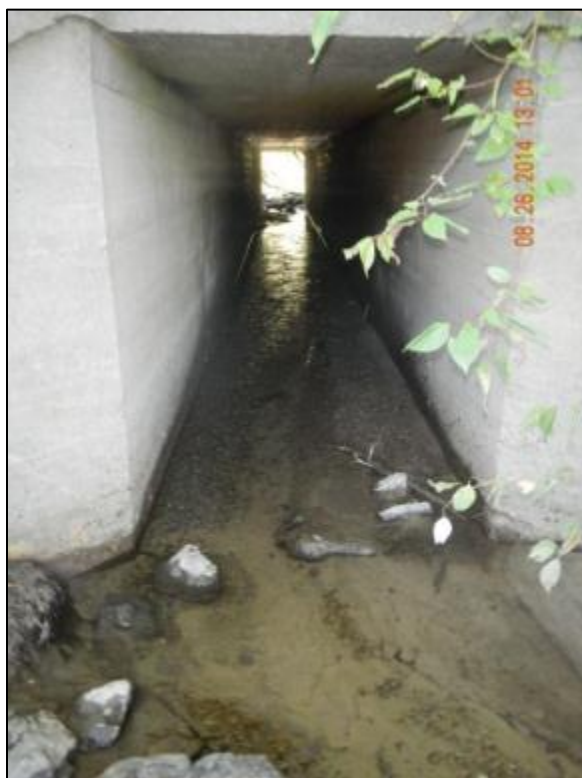
View looking upstream through tunnel at site CT-W-1.06.

Tributary CT-W-1.06 converges with the mainstem Connecticut River just downstream of an approximately 90-ft-long tunnel underneath the railroad (see photo section below). The tributary level logger was installed on the upstream side of the tunnel, approximately 100 ft above the confluence. During the initial site visit, the field crew visually determined that the mainstem influence extends approximately 137 ft up into tributary to a large blockage with a crest elevation of 385.3 ft. A minimum of 75% of the time, project-affected water levels remain below the project-affected elevation (75% occurrence = 384.6 ft /project extent = 385.3 ft). However, the maximum operational WSE (386.5 ft) recorded by the mainstem level logger indicates that the project-affected extends farther up into the tributary on occasion. Flow was present in the tributary during each of the four visits. Water depth at the confluence cross section was measured during each visit and the maximum water depth ranged from 0.5-1.0 ft. Water depths were measured along the channel thalweg and ranged between 1.0 and 0.3 ft (mean = 0.6 ft) with shallow depths present towards the upstream end of the suspected project-affected reach.

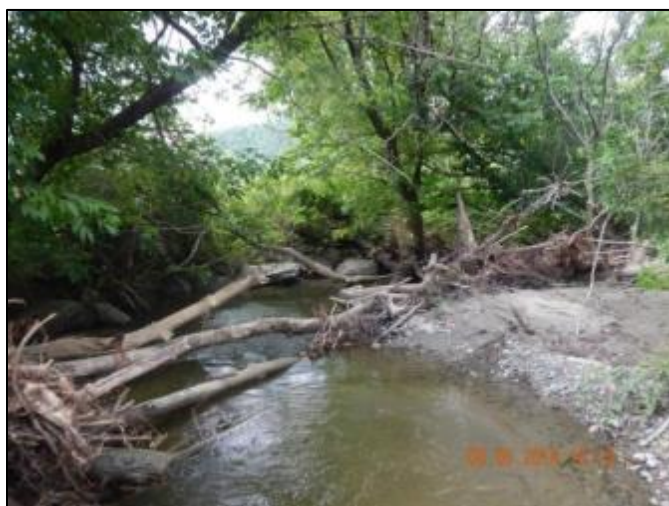
View looking from upstream to downstream of in-stream obstruction creating shallow-water shoal area within the project-affected portion of Indian Pond Brook approximately 1,000 ft upstream from the confluence with mainstem river during 2014.

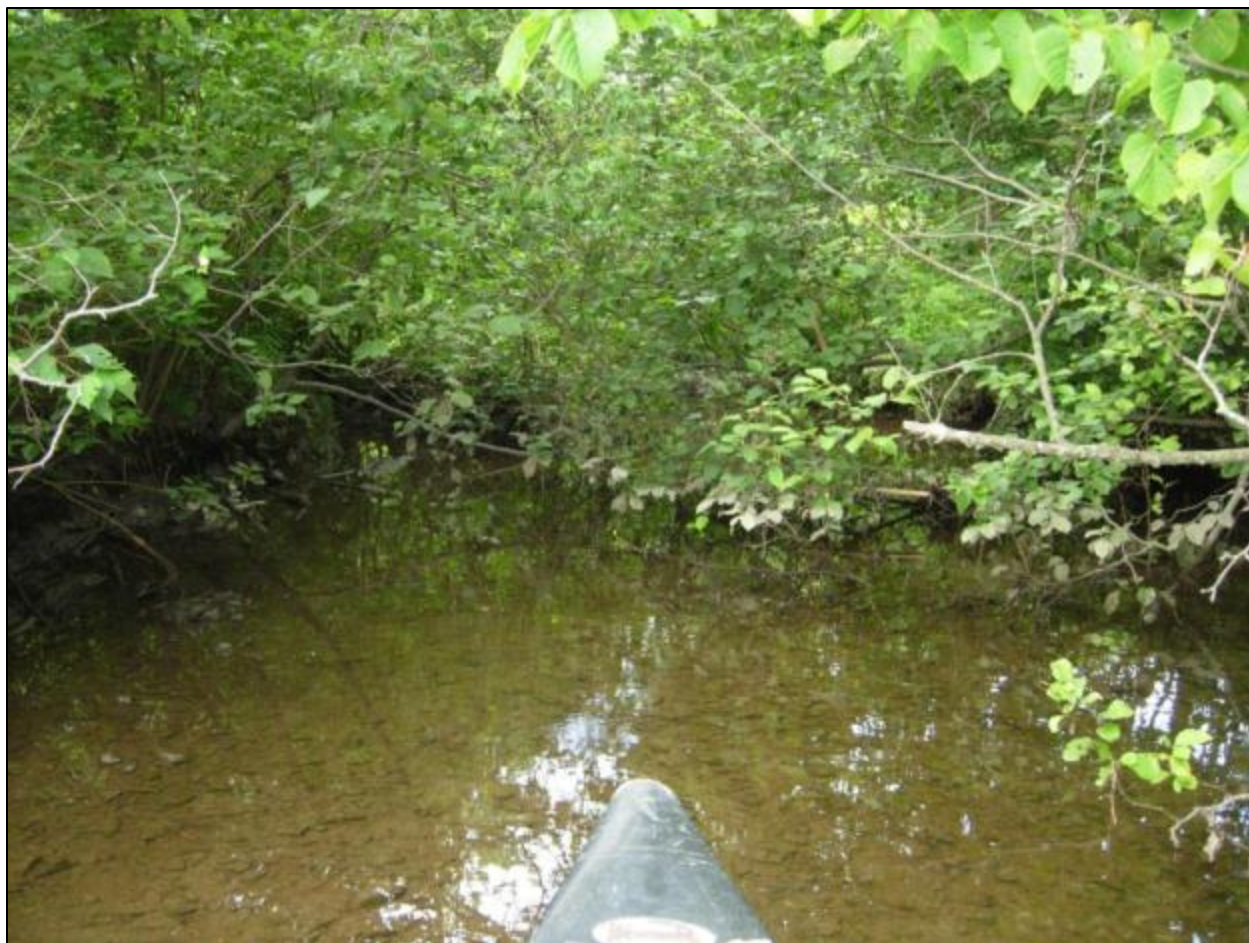
Upstream extent of project-affected area associated with backwater Site CT-W-1.44 as determined by visual observations, August 2014.

The small feeder stream covered the upper 400 ft of the project-affected reach. Water was present within backwater Site CT-W-1.44 during each of the four visits. Water depth at the confluence cross section was measured during each visit and ranged from 8.8 to 9.8 ft. Water depths were measured during the initial site visit across the ponded backwater area and up the small feeder stream located along the western bank of the backwater. Water depths within the feeder stream ranged between 0.3 and 3.2 ft (mean = 1.9 ft) with shallower readings at the upper extent of the project-affected area. Water depths measured within the ponded backwater area primarily ranged from 1-3 ft with deeper areas up to 4-5 ft.

Review of the range of WSE values recorded by the mainstem level logger indicates that under all observed conditions (i.e., min through max values) water depth within the culvert located at the confluence ranged between 8.3 and 11.1 ft and will provide adequate upstream access. As evidenced by the thalweg profile bottom elevations vary from the confluence across the backwater and up the feeder stream. When the range of WSE values recorded by the backwater level logger is considered, under all observed conditions (i.e., min through max values) WSEs were sufficient to cover the thalweg point within the ponded backwater area with the greatest elevation (380.7 ft) with 0.5 ft of water depth. When the bed elevation at the upstream extent of the feeder stream was compared to the range of WSE values recorded by the backwater level logger, that location was inundated with at least 0.4 ft of water under most conditions (i.e., 25<sup>th</sup> through 75<sup>th</sup> percentiles; WSE values of 382.8 ft and 383.4 ft (with 0% of data occurrences < 0.5 ft of depth at the confluence). As indicated by the minimum WSE recorded at the backwater level logger location (381.2 ft), water depth at the upstream end of the feeder stream may be limited to natural stream outflow under low mainstem conditions.

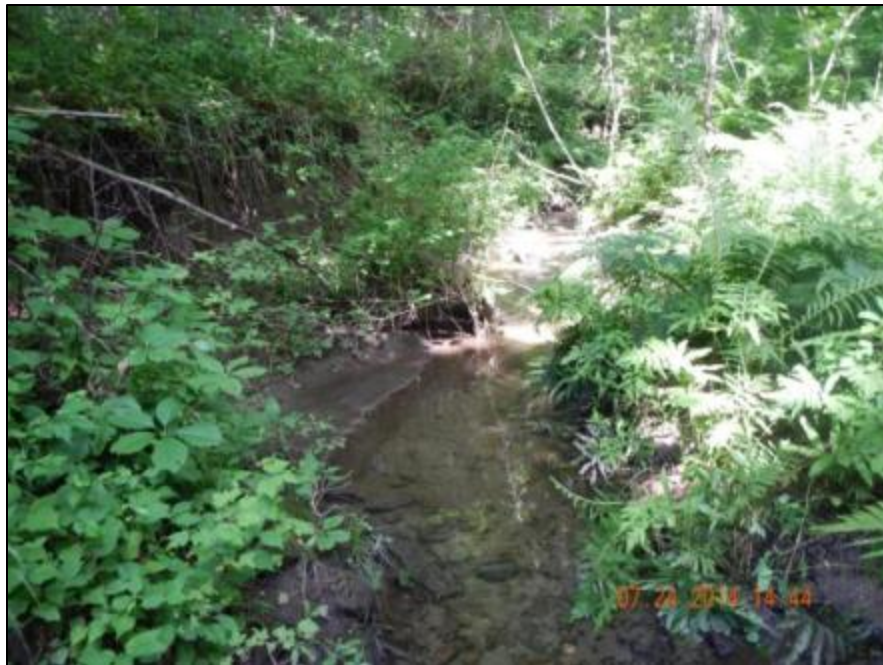
Upstream extent of project-affected area associated with Site CT-W-1.47 as determined by visual observations, July 2014.

The tributary level logger was installed approximately 123 ft upstream from the confluence with the mainstem. During the initial site visit, the field crew visually determined the extent of project effects to extend approximately 683 ft, later confirmed by evaluation of WSE data, up into the tributary to a section where bank vegetation did not indicate significant fluctuating water levels (see photo below). The maximum mainstem WSE (384.9 ft) indicates that the mainstem influence extends farther up into the tributary than the project-affected reach (384.7 ft elevation). Flow was present in the tributary during each of the four visits. Water depth at the confluence cross section was measured during each visit and the maximum water depth ranged from 1.8 to 2.9 ft. Water depths were measured along the channel thalweg during the July 24<sup>th</sup> site visit and ranged between 0.3 and 3.9 ft (mean = 1.8 ft). Thalweg water depths of  $\leq 0.5$  ft were limited to the upper 40-50 ft of the project-affected reach.

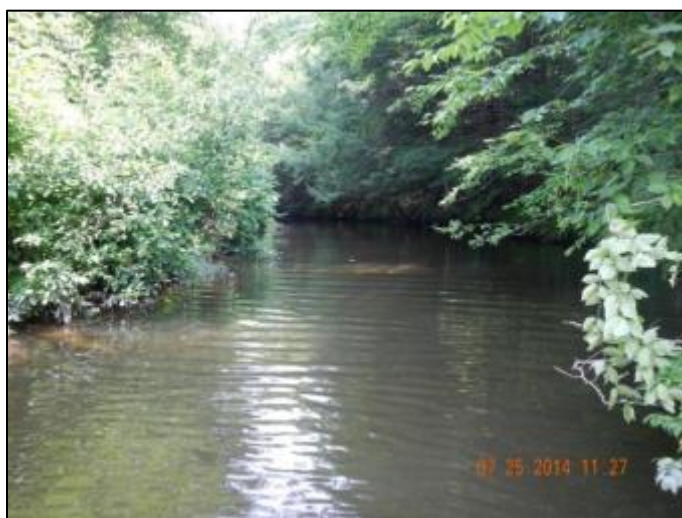
Upstream extent of project-affected area associated with Site CT-W-1.48 as determined by visual observations, July 2014.

The tributary level logger was installed approximately 810 feet upstream from the confluence with the mainstem and just on the upstream side of the River Road bridge. During the initial site visit, the field crew visually determined the extent of project effects to extend approximately 2,284 ft up into Grant Brook to a section of the tributary where bank vegetation did not indicate significant fluctuating water levels (see photo below). Review of the WSE values recorded by the mainstem level logger indicates that the project-affected reach extends to approximately 3,338 ft, and the maximum mainstem WSE (384.7 ft) indicates that the mainstem influence extends farther up into the tributary than the project-affected reach (384.5 ft). Project-affected water levels remain below the end of project elevation (383.6 ft) between 25-50 percent of the time (25% occurrence = 383.5 ft / 50% occurrence = 383.9 ft).

Flow was present in Grant Brook during each of the four visits. Water depth at the confluence cross section was measured during three of the four visits and the maximum water depth ranged from 5.7 to 6.6 ft. Water depths were measured along the channel thalweg during the initial site visit on July 25<sup>th</sup> and ranged between 0.6 ft and 8.3 ft (mean = 3.9 ft). The shallowest water depth on the date of measurement was located at the upstream extent of the project-affected reach and access should be adequate (0% of data occurrences < 0.5 ft of depth at the confluence).

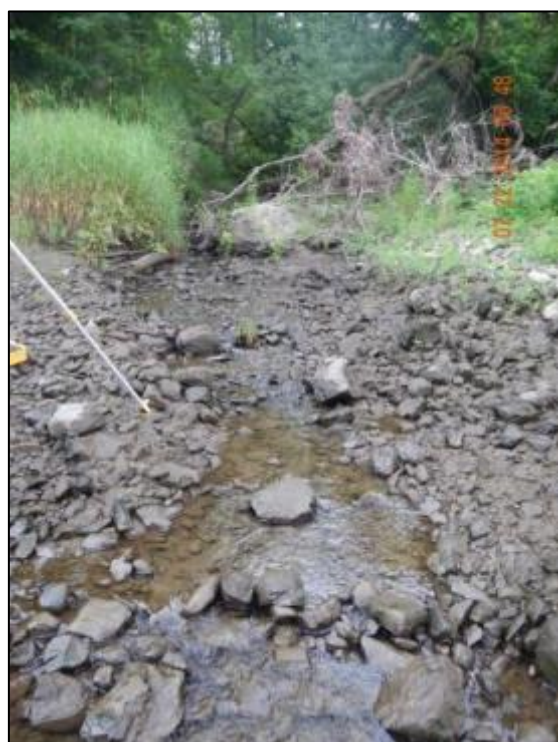
Site CT-WR-2.07 flow through lower end of tributary.

The tributary level logger was installed in the vicinity of the confluence with the mainstem. The project-affected reach was estimated at approximately 35 ft; however, the maximum operational WSE value recorded by the mainstem level logger (320.8 feet) indicates that the project-affected reach ends approximately 1 ft downstream of the visually determined confluence cross section. The maximum mainstem WSE (321.9 ft) indicates that the mainstem influence extends farther up into the tributary than the project-affected reach. Flow was present in Site CT-WR-2.07 during each of the four visits. Water depth at the confluence cross section was measured during each visit and the maximum water depth ranged from 0.3 to 0.4 ft (see photo below). Water depths were measured along the channel thalweg during the final site visit on November 6<sup>th</sup> and ranged between 0.1 and 0.3 ft. Channel depths within the tributary are limited as part of the stream's natural flow regime and access can be limited under virtually all mainstem and tributary conditions (95.8% of data occurrences < 0.5 ft at the originally presumed confluence).

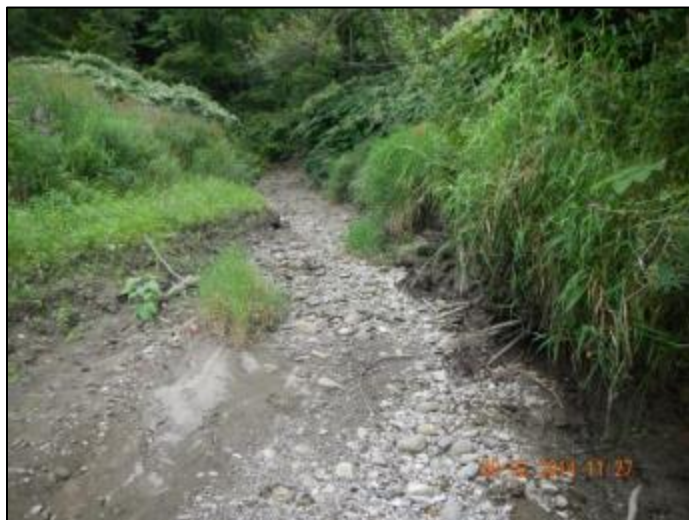
Upstream extent of project-affected area associated with McArthur Brook as determined by visual observations, 2014.

The tributary level logger was installed in the vicinity of the confluence with the mainstem. During the initial site visit, the field crew visually determined the extent of project effects to extend approximately 160 ft up into McArthur Brook to a section of the tributary where bank vegetation did not indicate significant fluctuating water levels, later confirmed by evaluation of WSE data (see photo below). Review of the WSE values recorded by the mainstem level logger indicates that a minimum of 75% of the time, project-affected water levels remain below the suspected extent of project effects (75% occurrence = 303.9 ft / suspected upper extent = 305.5 ft). The maximum mainstem WSE (307.3 ft) indicates that the mainstem influence extends slightly farther up into the tributary than the project-affected reach elevation (307.2 ft). Flow was present in McArthur Brook during one of the three visits. Water depth at the confluence cross section was measured during the November 7<sup>th</sup> visit and was 2.0 ft at its deepest point. Bed elevations were recorded from the dry channel bed during the September 24<sup>th</sup> site visit. It appears that McArthur Brook only seasonally provides a flow contribution to the mainstem river. Based on its intermittent nature, channel depths within McArthur Brook are limited as part of the natural flow regime in that tributary. However, access is adequate under some conditions (58.2% of data occurrences < 0.5 ft at the confluence).

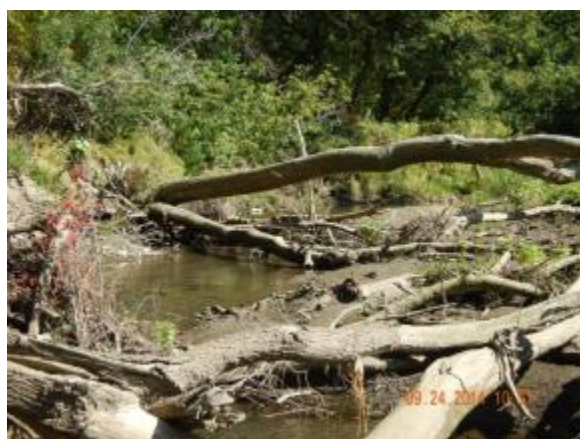
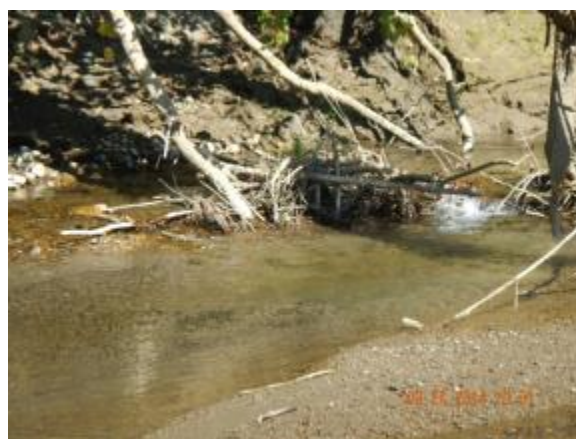
Examples of scour and depositional areas associated with the abundant woody debris present in Lulls Brook.

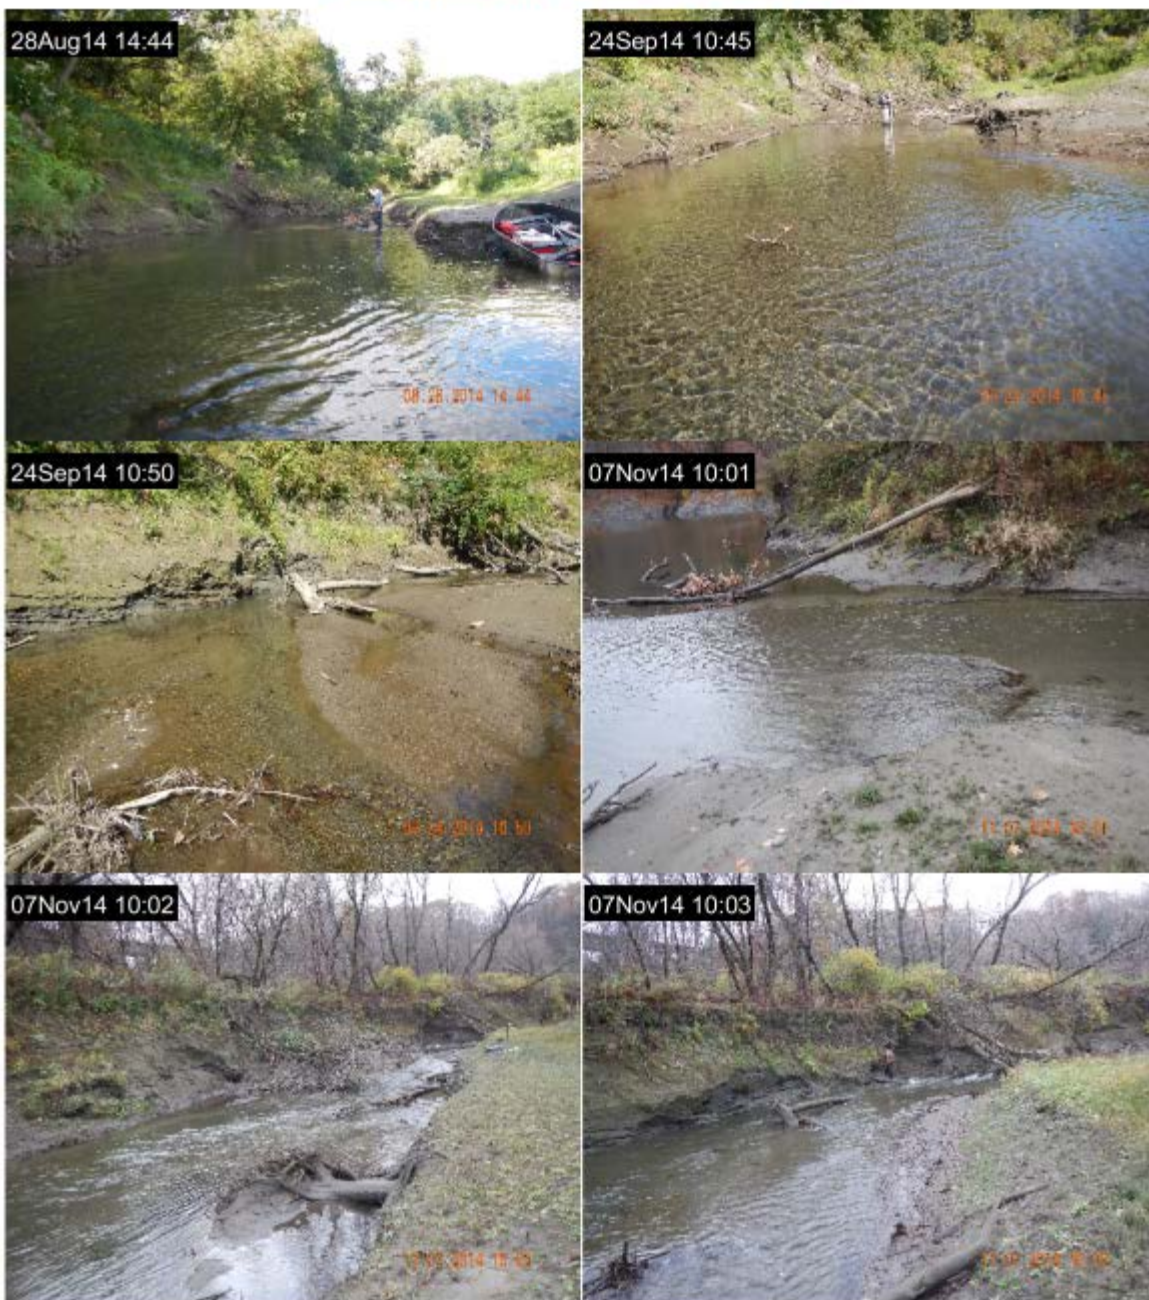
**Site ID: CT-WR-2.11**

*Lulls Brook, Major tributary, Stream Order 3*

Review of the range of WSE values recorded by the mainstem level logger indicates that under all observed conditions (i.e., min through max values) water depth at the thalweg within the immediate confluence area ranged between 0.9 and 6.1 ft and will provide adequate upstream access. As evidenced by the thalweg profile, bottom elevations show an increase-decrease pattern with distance moved upstream. It is possible that under low mainstem and tributary flow conditions, areas of significant woody debris may hinder upstream movement; however there were no data occurrences of < 0.5 ft depth at the confluence.

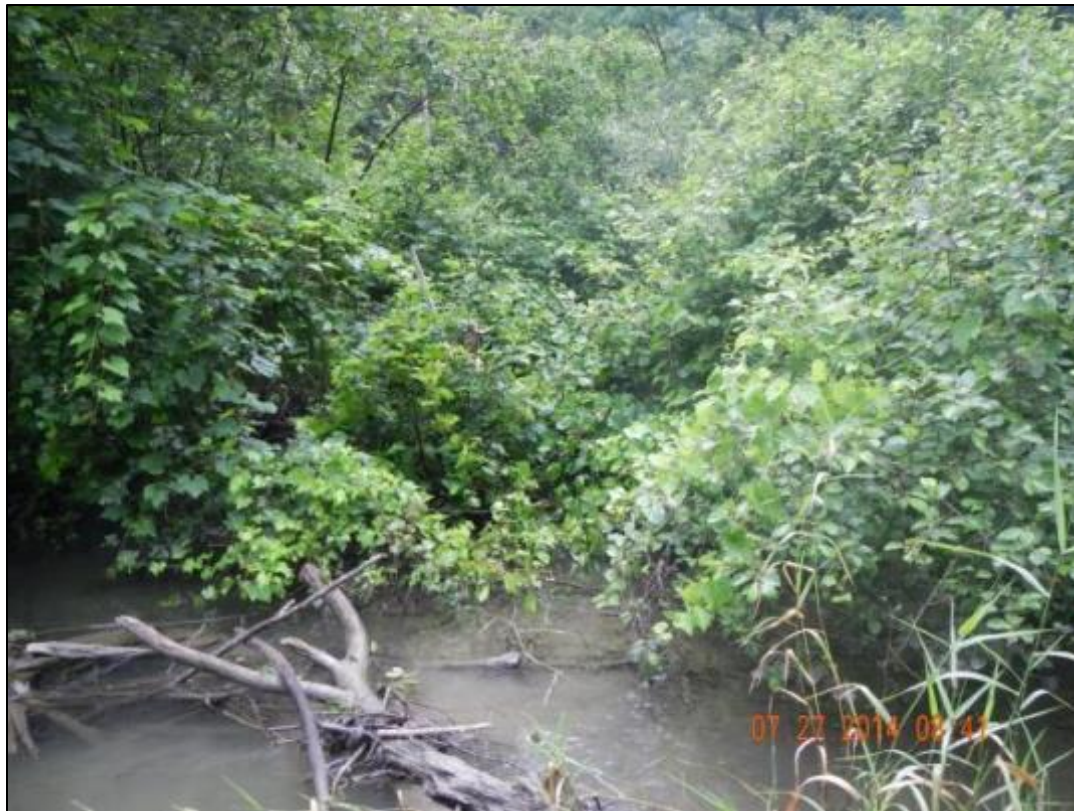
Upstream extent of mainstem influenced area associated with Commissary Brook as determined by visual observations, 2014.

The tributary level logger was installed in the immediate vicinity of the confluence with the mainstem. During the initial site visit, the field crew visually determined that project effects extend approximately 200 ft upstream to a point where the tributary narrowed greatly and had dense canopy cover (see photo below). Additional bed elevation data for this location was collected in association with Study 7 during 2013 and upon review of that data for this report and WSE data the thalweg profile was extended to a point approximately 455 ft upstream of the confluence (290.9 ft elevation). Flow was present in Commissary Brook during each of the four visits. Water depth at the confluence cross section was measured during each visit and the maximum water depth ranged from 1.0 to 2.1 ft. Water depths were measured along the lowermost 200 ft of the channel thalweg during the initial site visit on July 27<sup>th</sup> and ranged between 1.4 ft and 2.3 ft (mean = 1.9 ft).

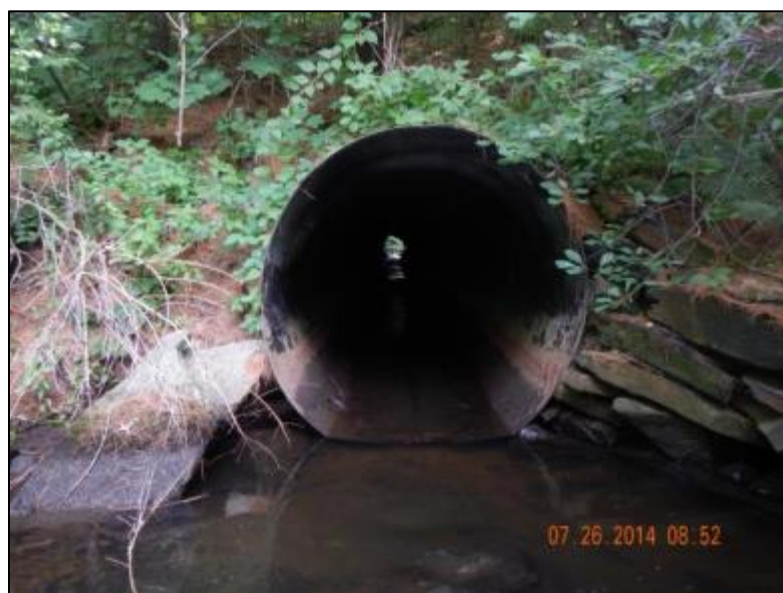
Culvert near upstream extent of project-affected area associated with Site CT-B-3.35 as determined by visual observations, 2014.

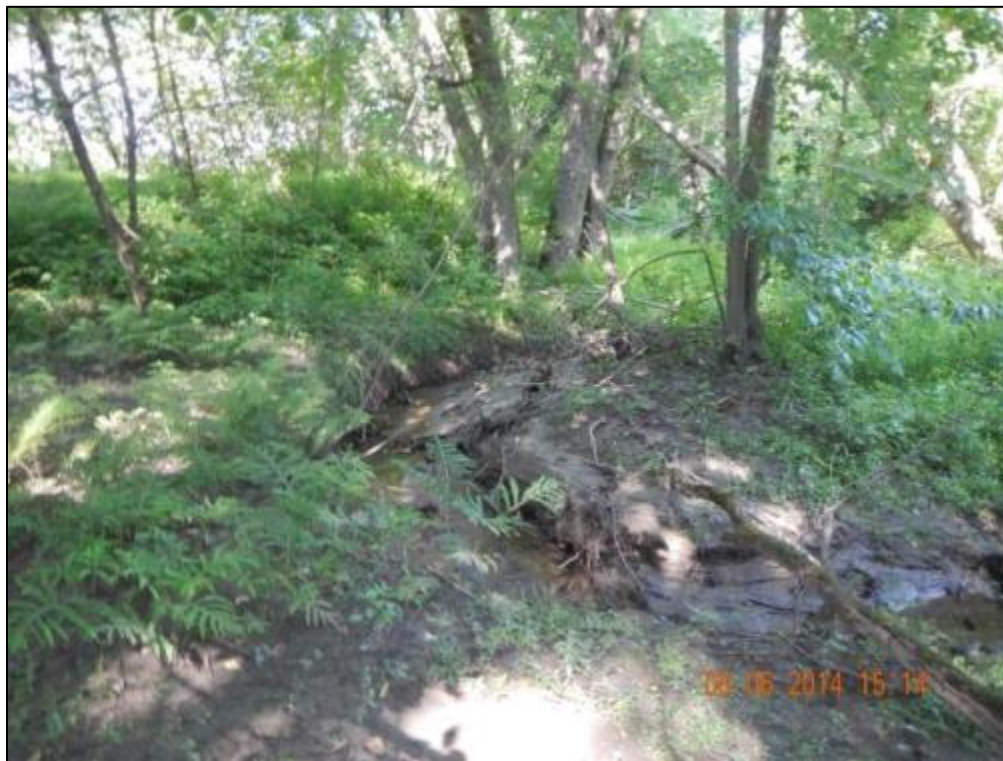
Upstream extent of project-affected area associated with Site CT-V-5.19 as determined by visual observations, 2014.

The tributary level logger was installed approximately 51 ft upstream from the confluence with the mainstem. During the initial site visit, the field crew visually determined that project effects extend approximately 100 ft up into the tributary to a section where bank vegetation did not appear to indicate significant fluctuating water levels, later confirmed by evaluation of WSE data to be 99 ft (see photo below). The maximum mainstem WSE (220.8 ft) indicated that the mainstem influence extends farther up into the tributary than the project-affected reach (220.4 ft elevation). Flow was present in tributary CT-V-5.19 during each of the three visits. Water depth at the confluence cross section was measured during each visit and the maximum water depth ranged from 0.1 to 0.8 ft. Water depths were measured along the channel thalweg during the November 11<sup>th</sup> site visit and ranged between 0.2 and 1.1 ft (mean = 0.7 ft) with shallower depths located towards the upstream end of the project-affected reach.

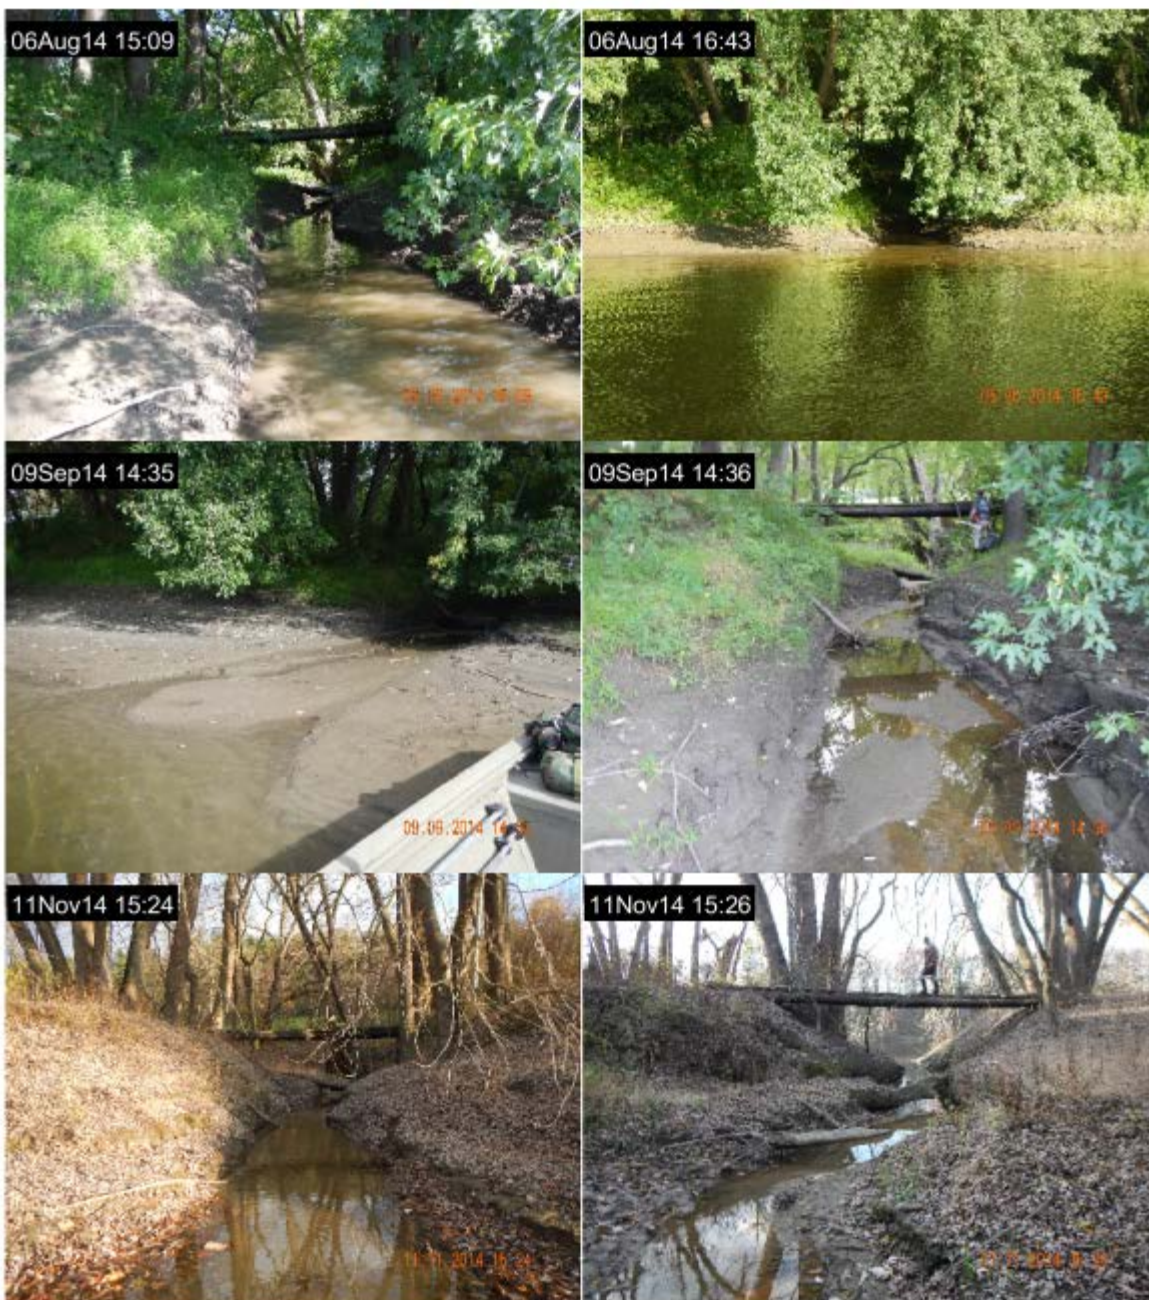
Site ID: CT-V-5.19

Unnamed minor tributary, Stream Order 1

Review of the frequency distribution of water depth recorded by the mainstem level logger indicates that under most conditions (i.e., 25<sup>th</sup> through 75<sup>th</sup> percentiles) water depth at the thalweg elevation of the cross section confluence (217.9 ft) ranged between 1.1 and 1.4 ft. Under low mainstem WSE conditions (minimum value recorded = 218.1 ft), the tributary is minimally inundated by mainstem water (see photograph time stamped 14:35 09Sep14 below) and is primarily limited to only its own natural outflow. Under those conditions, access may be limited for larger fish as evidenced by the minimum water depth recorded by the tributary logger during the study period (water depth = 0.3 ft); however, only 1.1% of data occurrences were < 0.5 ft of depth at the confluence.

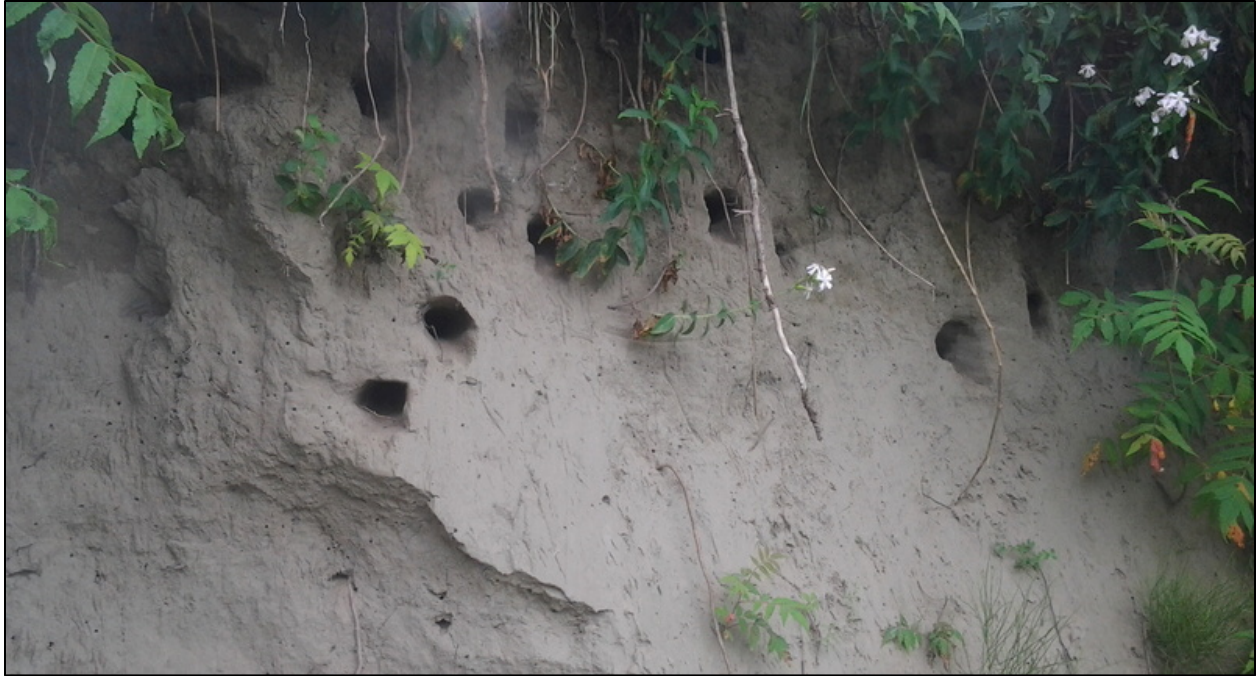
Figure 5.7-1. Bank swallow holes established in an eroded riverbank in Vernon impoundment.

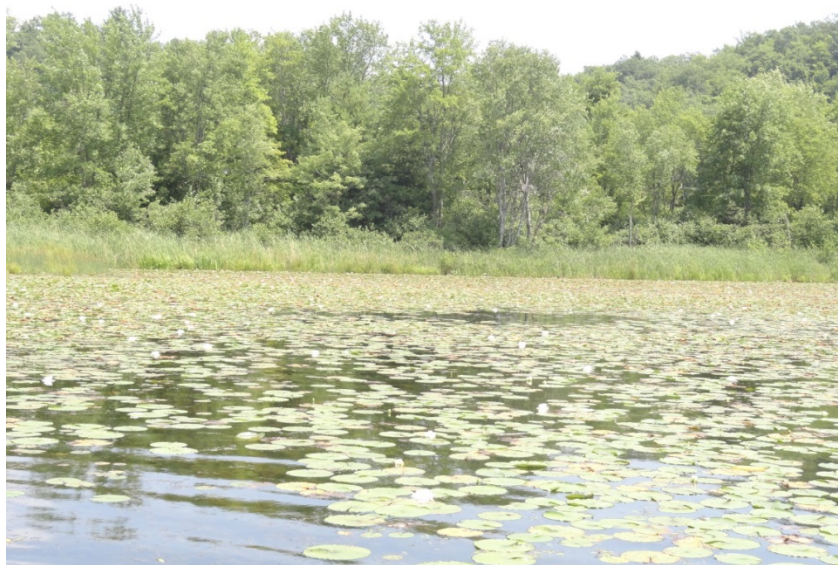
Figure 6.4. An example of zonation along the hydrologic gradient of aquatic, emergent and scrub-shrub communities in Hinsdale cove, lower Vernon Project.

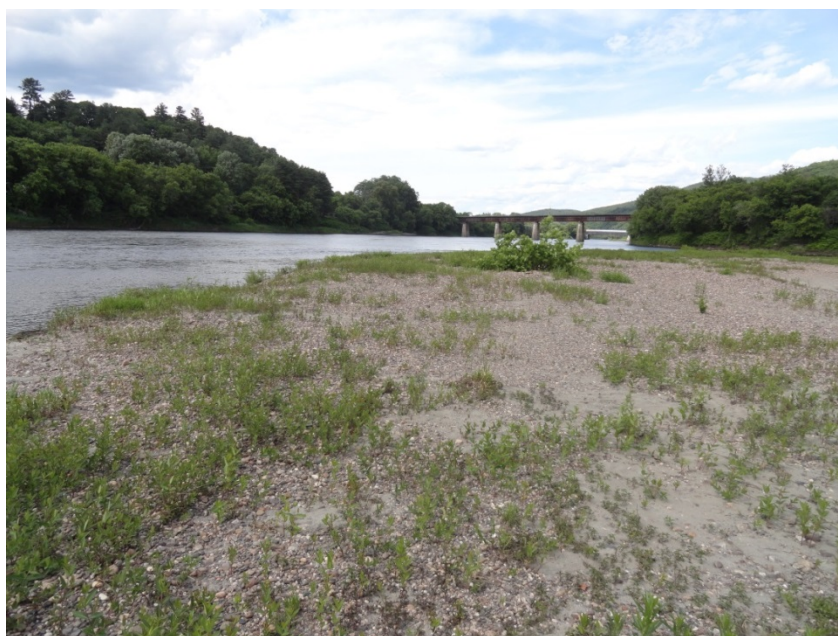
Figure 6.5. An example of sparse scrub-shrub habitat observed to be frequently flooded on Chase Island in the upper Bellows Falls Project

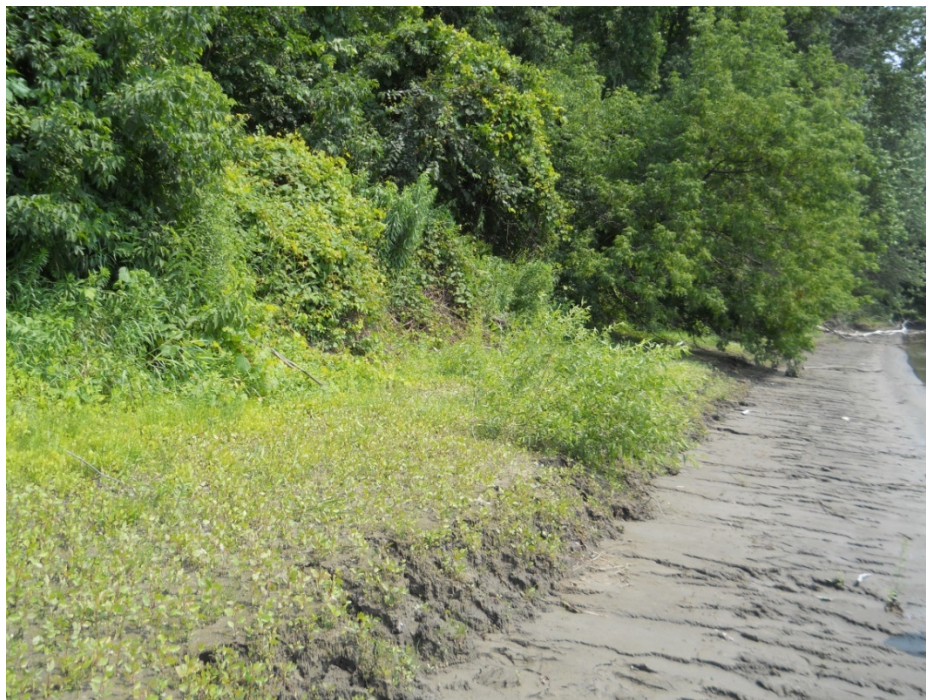
Figure 6.7. Upland riverbank community in Vernon, showing zonation of vegetation approximately associated with water level fluctuations. The effects of periodic flooding and scour are evident in the lower portion of the bank and absent in the upper.

The remainder of undeveloped habitats bordering the river were clearly above areas that are affected by normal project operations. These include upland riverbanks, riparian habitats, and agricultural fields (Figures 6.7 and 6.8). The vegetation in these habitats is not adapted to frequent inundation or scour, but it can generally tolerate floods and infrequent scour. These communities provide important substrate stabilization when such events occur.

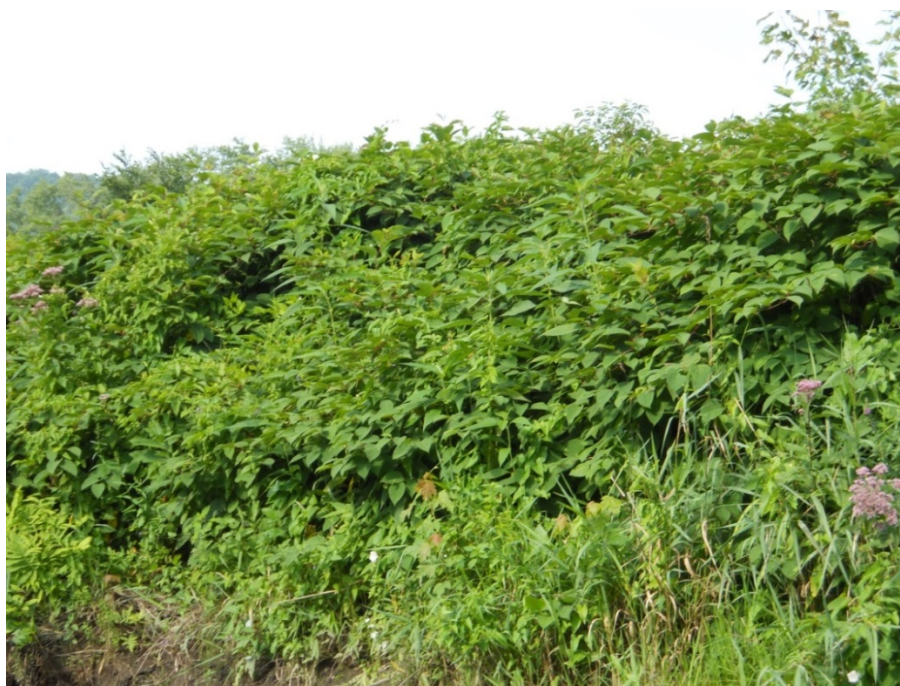
Figure 6.8. Japanese knotweed-dominated upland riverbank community bordering agricultural fields in the Wilder Project.

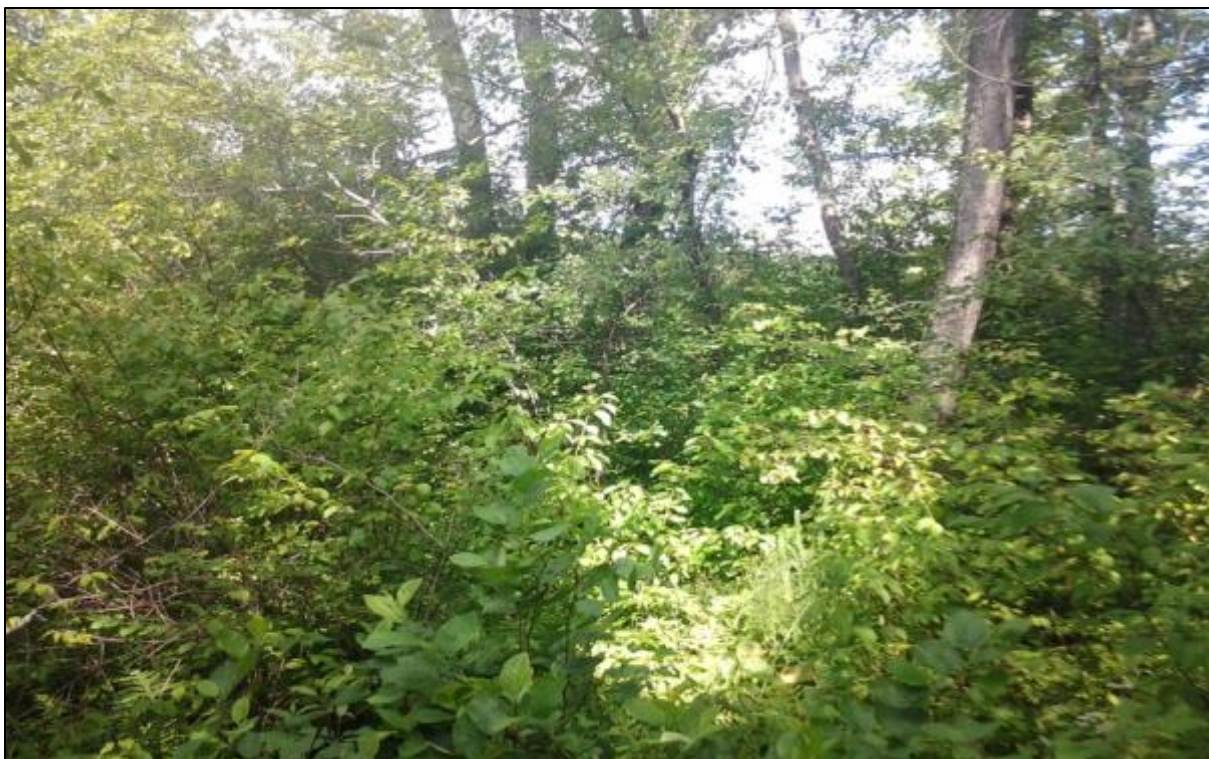
Scrub-shrub wetland, Westmoreland, NH. 7/26/2014

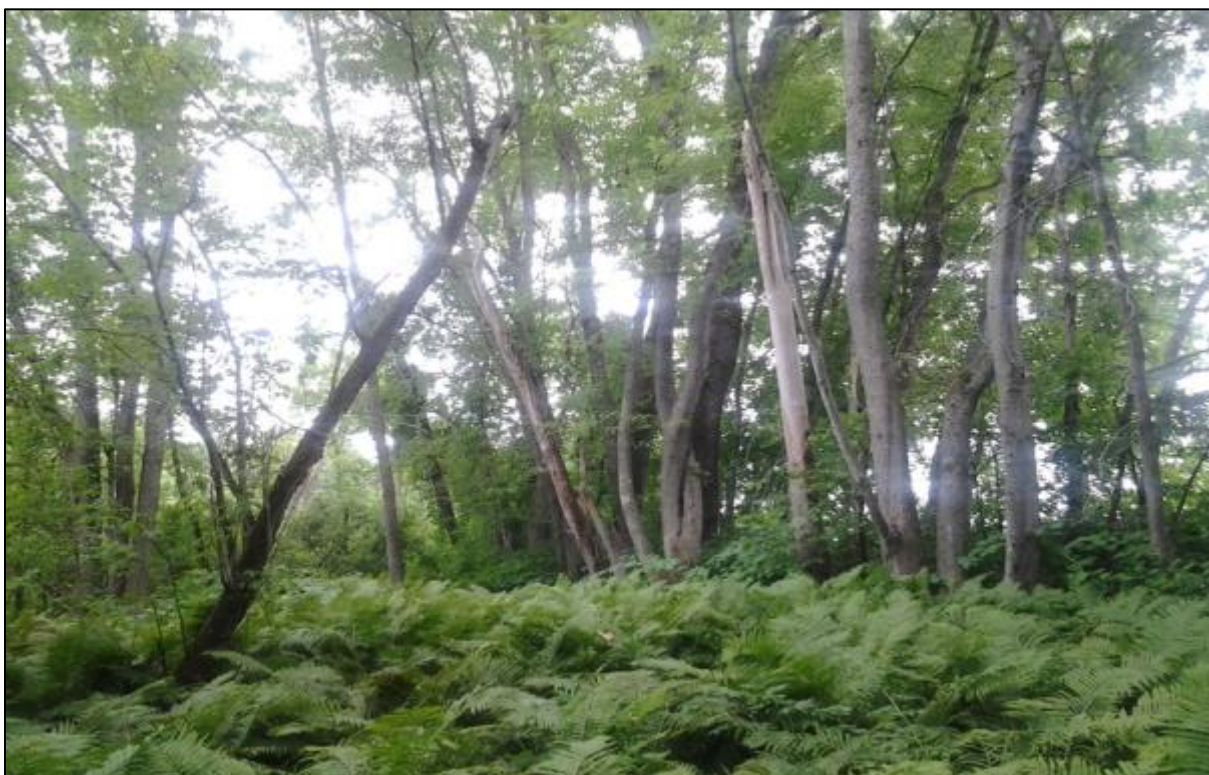
Deciduous forested/scrub shrub wetland, Rockingham, VT. 7/29/2014
