**TRANSCANADA HYDRO NORTHEAST INC.**

**Wilder Hydroelectric Project (FERC Project No. 1892-026)**  
**Bellows Falls Hydroelectric Project (FERC Project No. 1855-045)**  
**Vernon Hydroelectric Project (FERC Project No. 1904-073)**

**Updated Study Report**  
**Volume III – Containing Sub Volumes III.A – III.B**

**Study 13 – Tributary and Backwater Fish Access and Habitats**  
**Study Report**

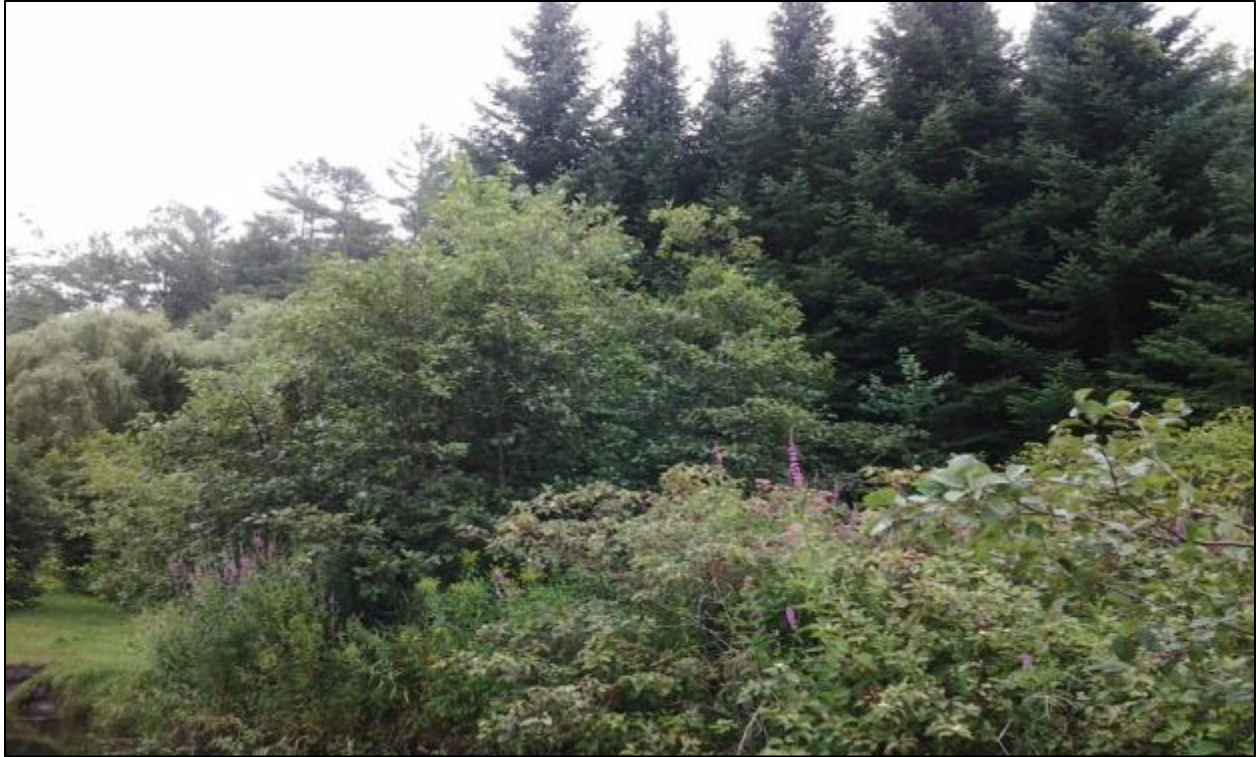
Deciduous forested wetland, Charlestown, NH. 7/29/2014

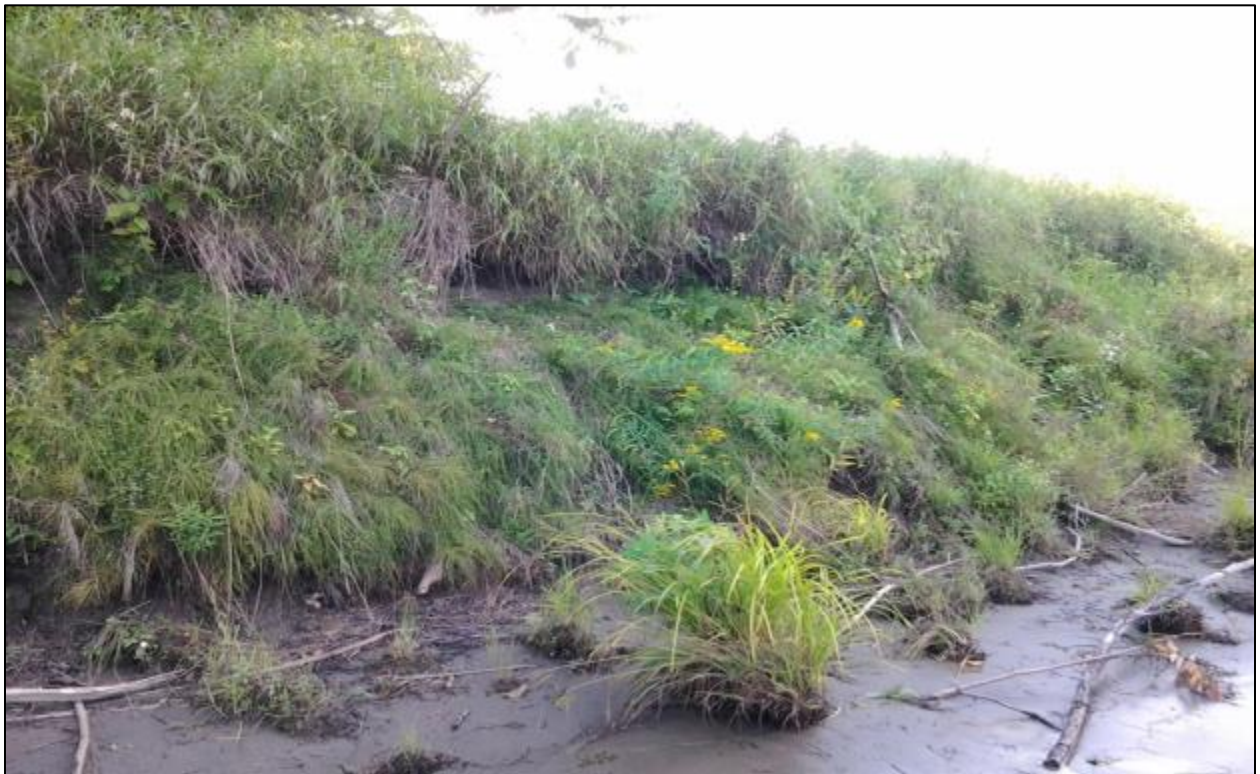
Mixed deciduous-conifer wetland, Lyme, NH. 8/8/2014

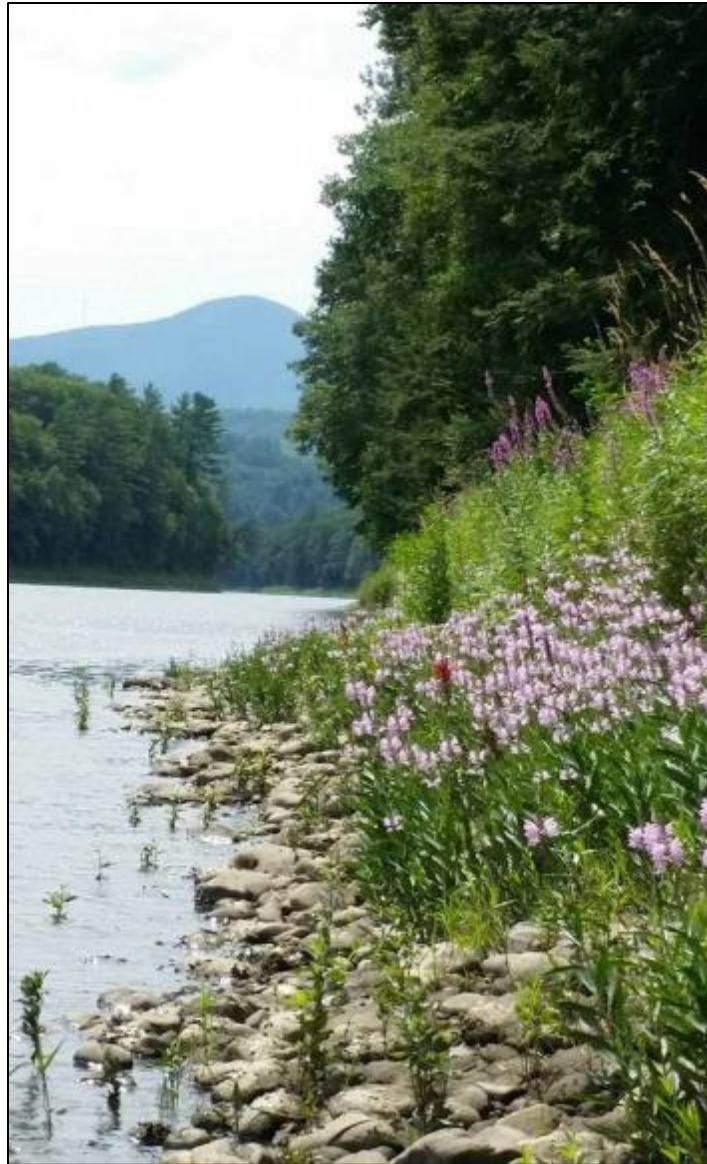
Riverbank below agricultural field, Fairlee, VT. 8/9/2014

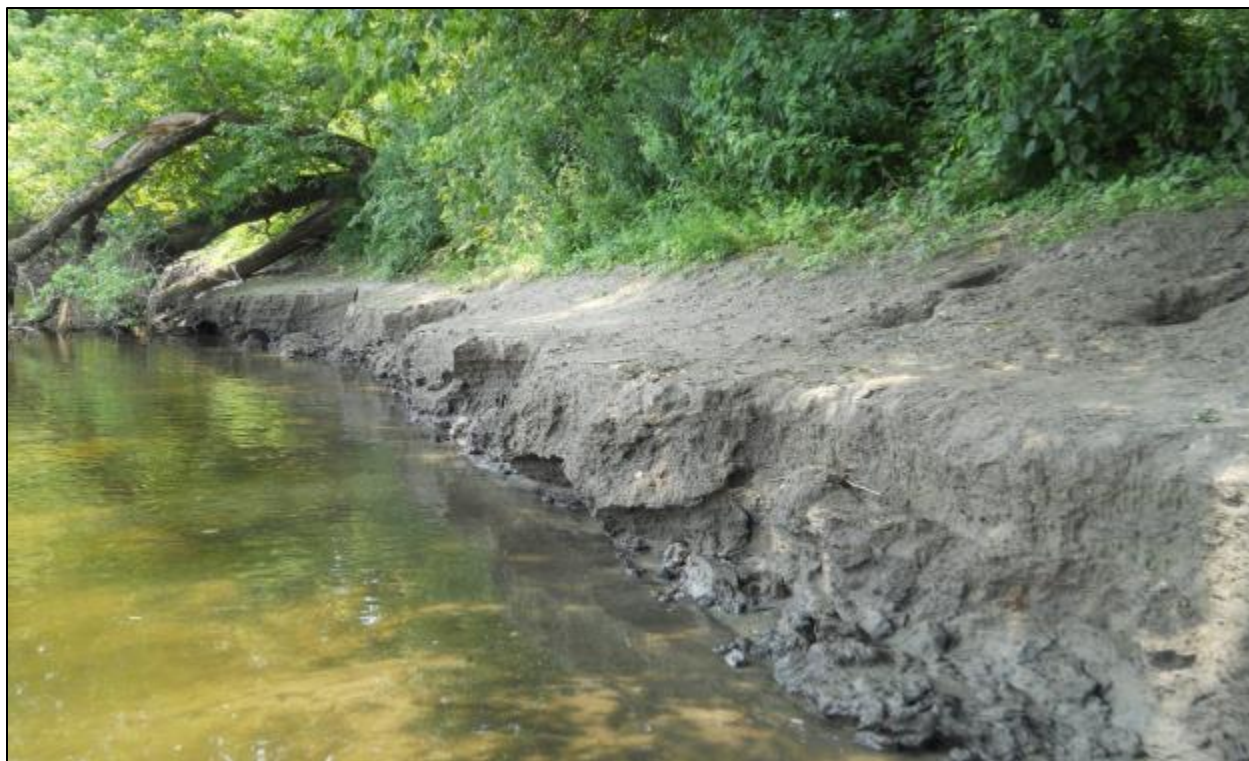
Riverbank, Harts Island. August 12, 2014

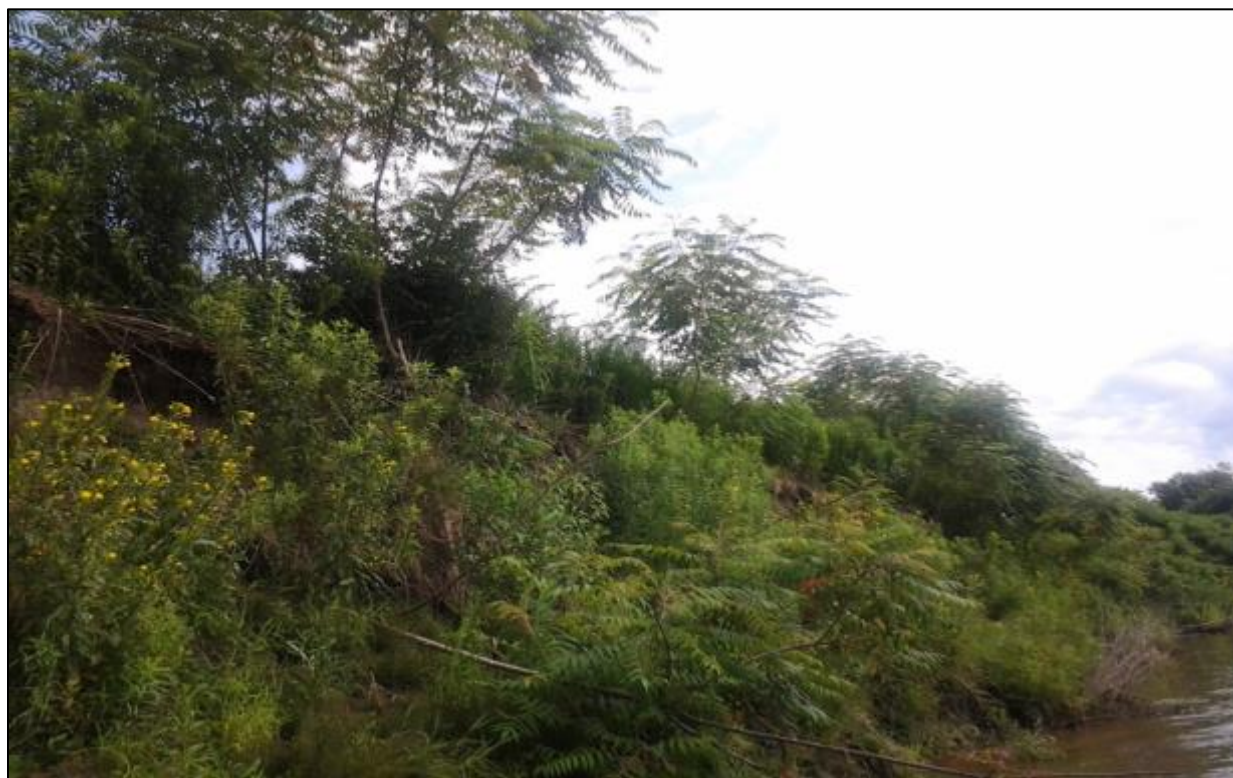
Riverbank, Westmoreland, NH. 7/25/2014

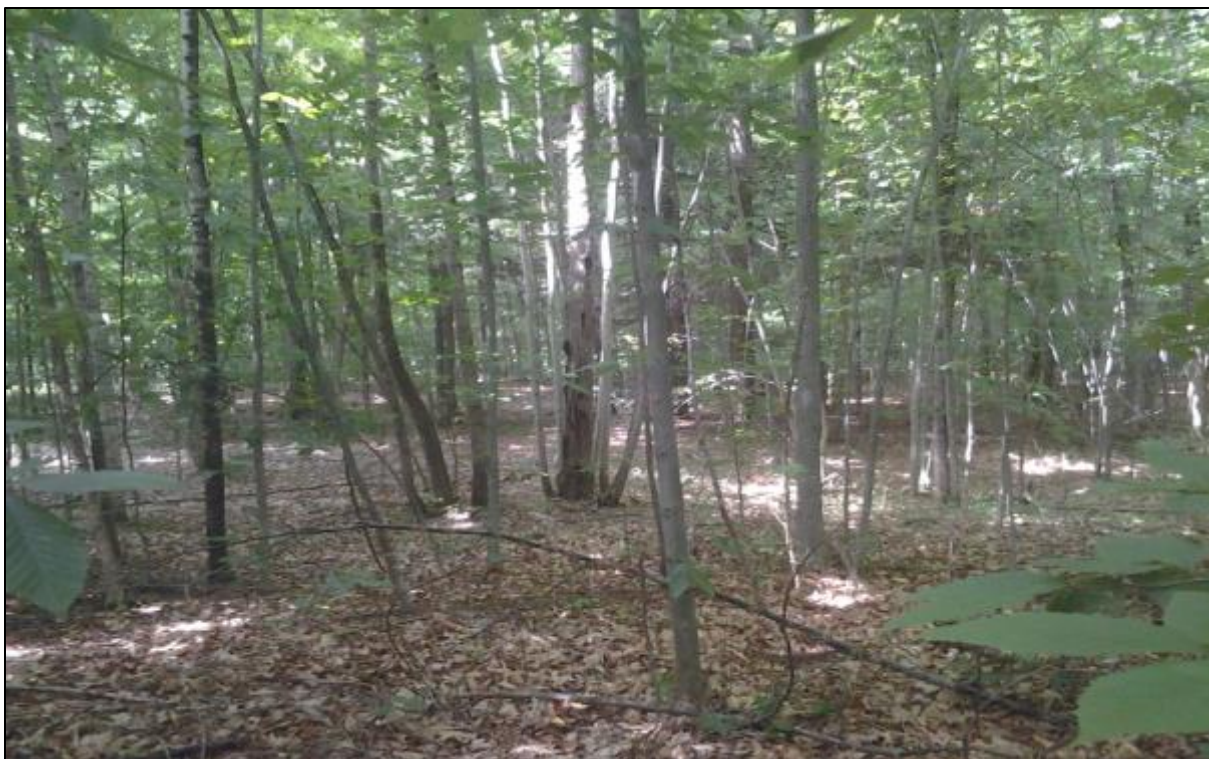
Shrub dominated riverbank, Charlestown, NH 7/30/2014

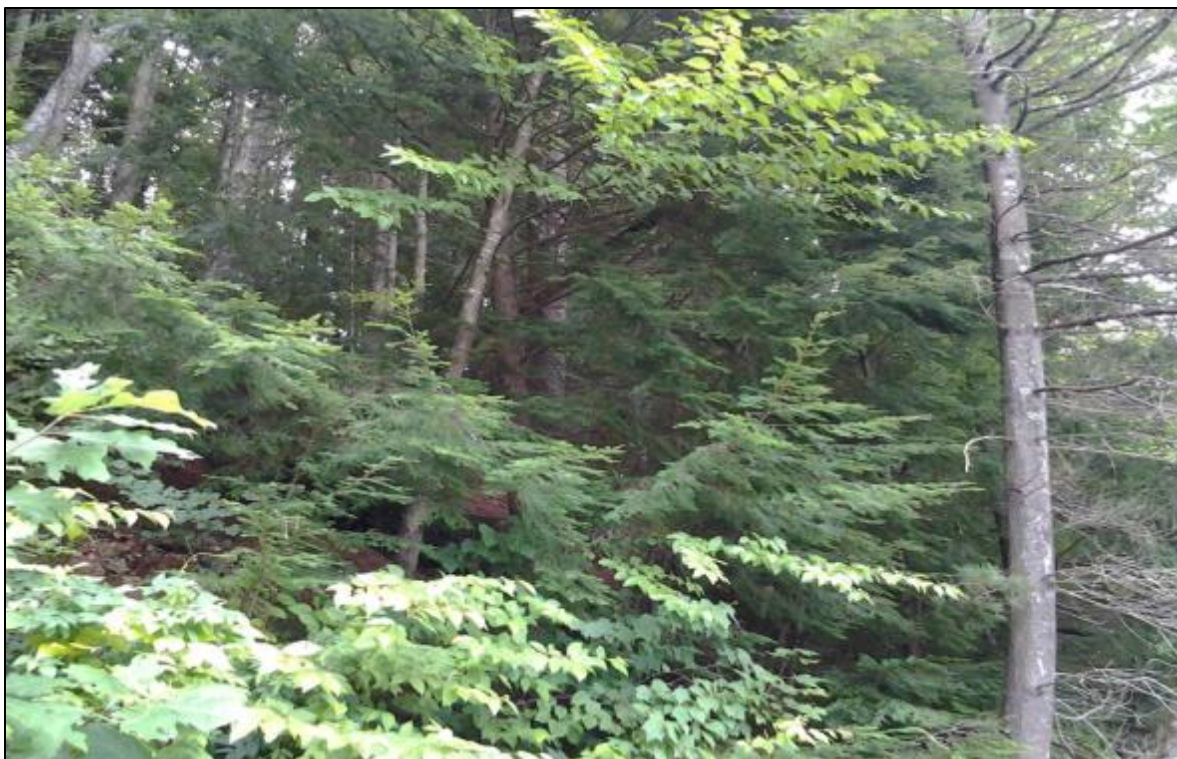
Hardwood forest on Bellows Falls riverine section. Westminster, VT. 8/20/2014

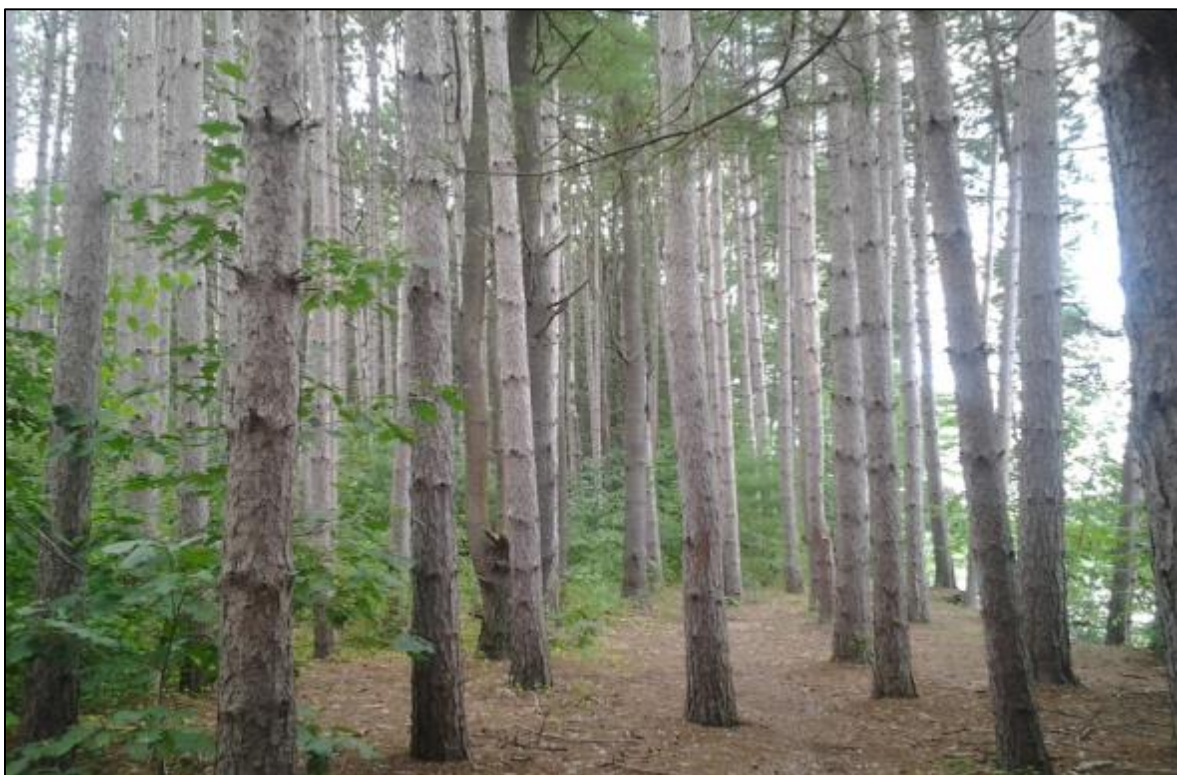
Hardwood/softwood forest, Charlestown, NH. 7/30/2014
