**TRANSCANADA HYDRO NORTHEAST INC.**

**ILP Study 2 and Study 3  
Riverbank Transect and Riverbank Erosion Studies**

***Final Study Report***

Wilder Hydroelectric Project (FERC Project No. 1892-026)  
Bellows Falls Hydroelectric Project (FERC Project No. 1855-045)  
Vernon Hydroelectric Project (FERC Project No. 1904-073)

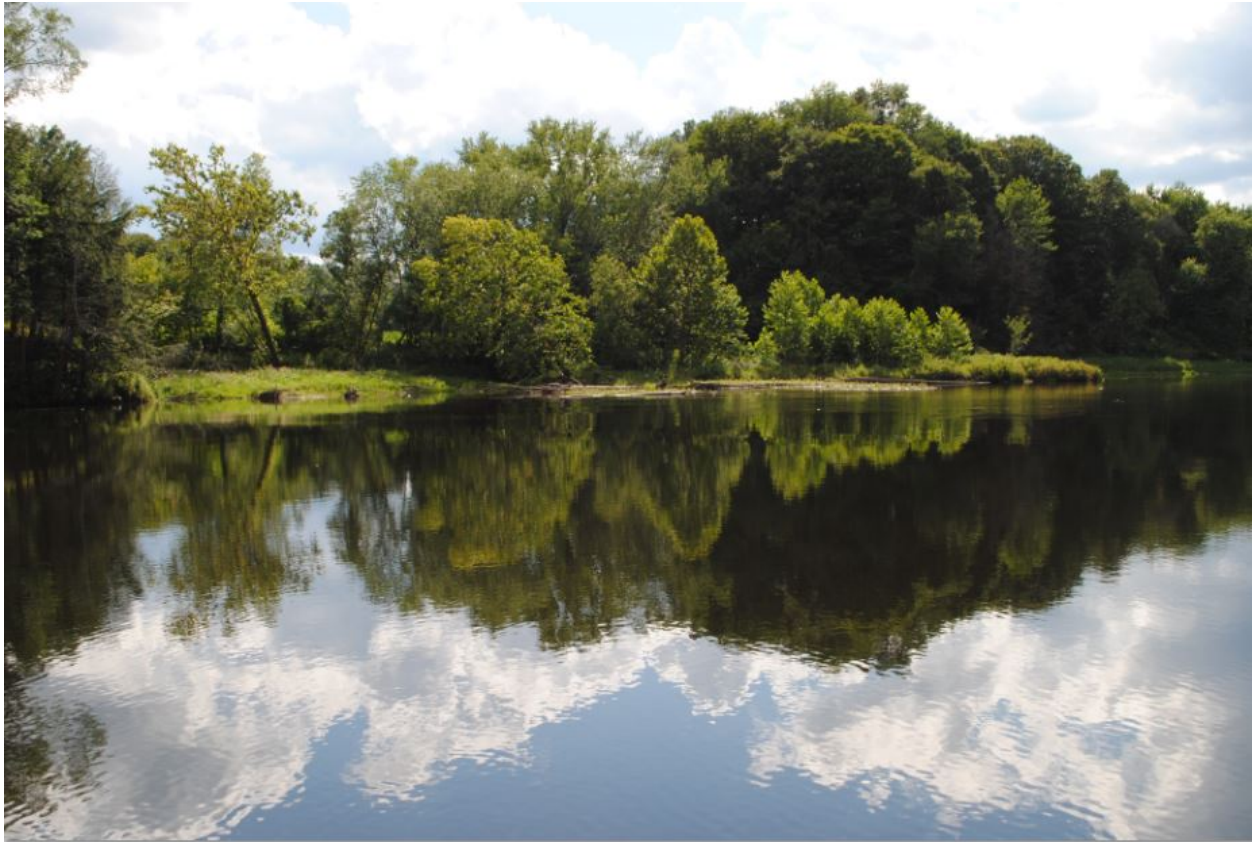
Figure 5.2.1-1. Delta building out from a small tributary into Vernon impoundment.

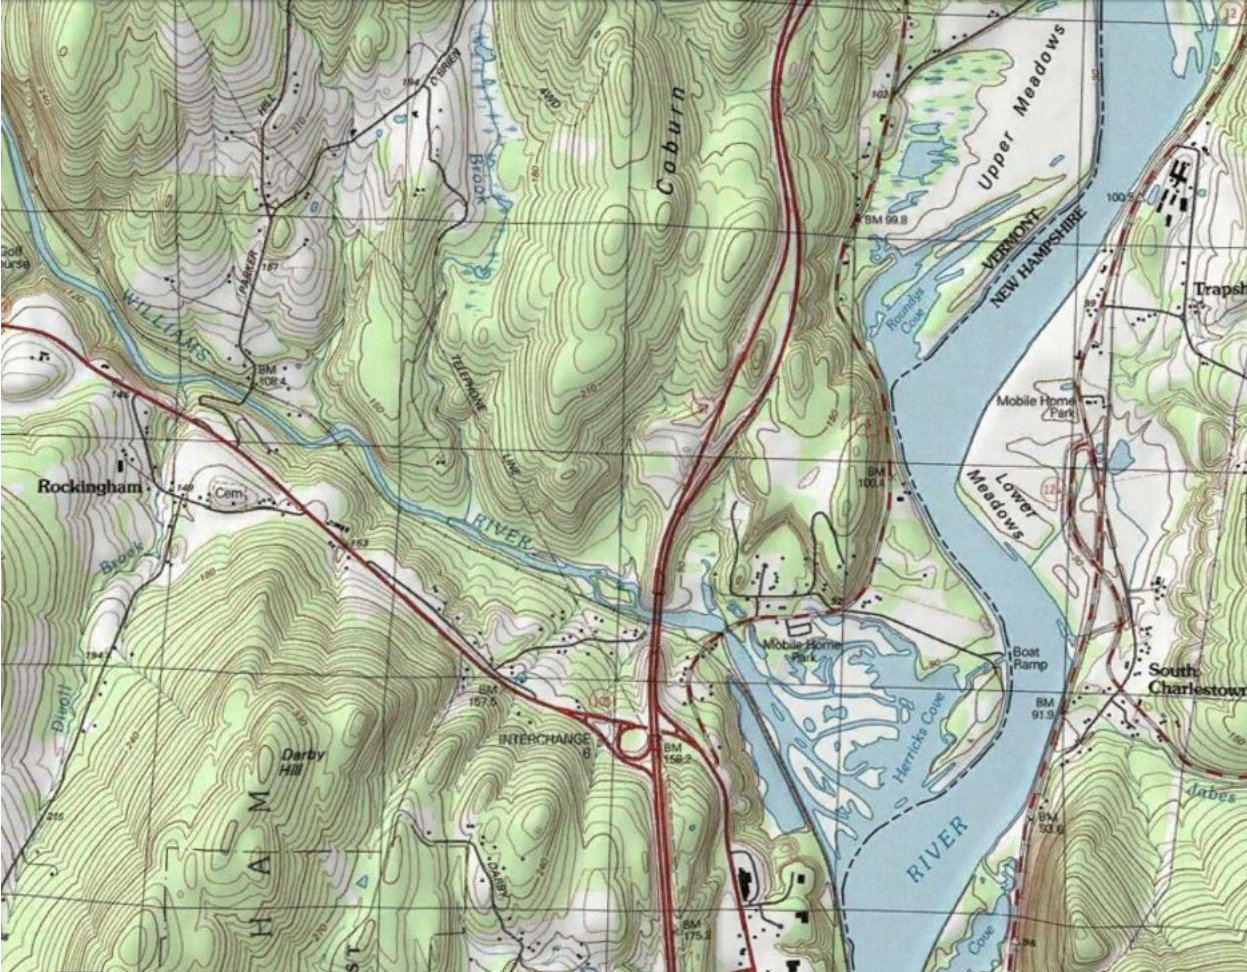
Figure 5.2.1-2. Williams River delta in Rockingham, Vermont forces river to opposite valley wall and backwaters upstream to form low meadows.

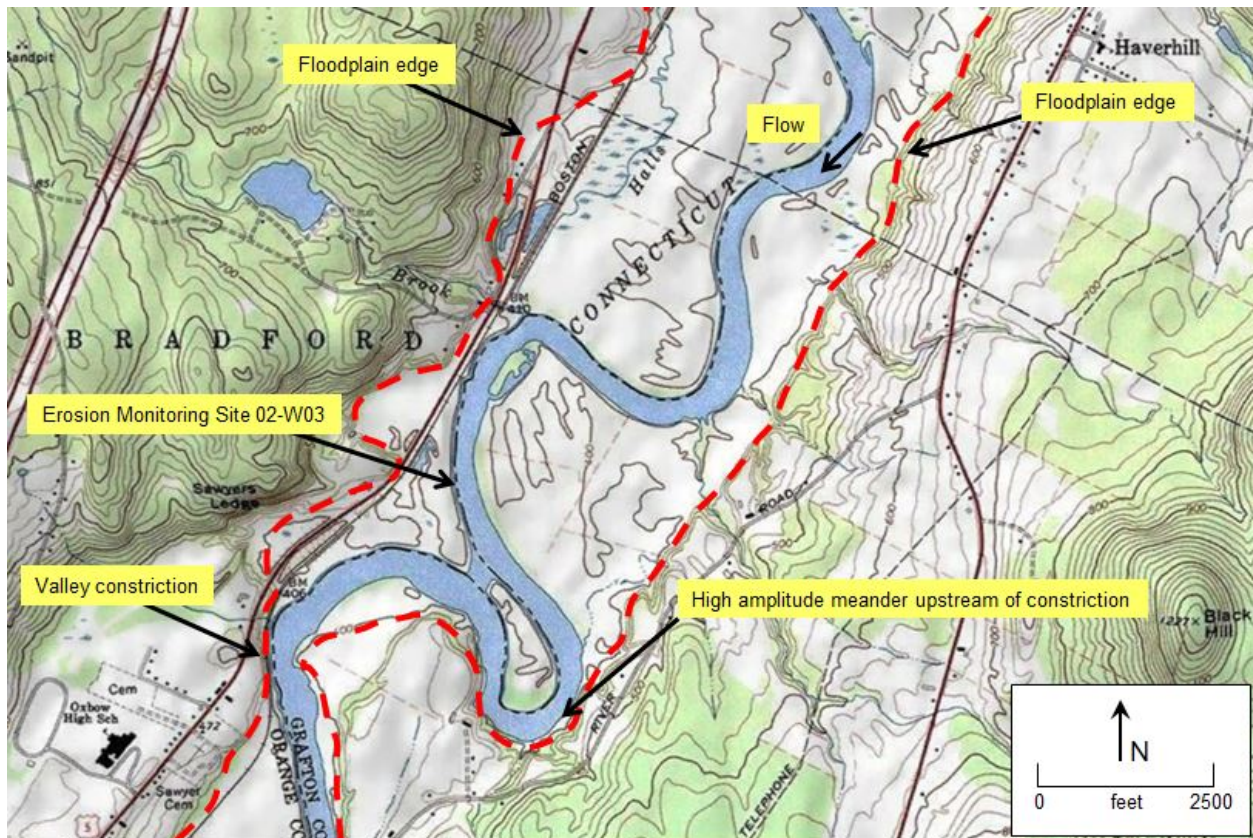
At several locations in the study area, the river is constrained by mountainous valley side slopes or by the high banks of stream or glacial terraces, thereby creating natural constrictions along the river relative to areas immediately upstream where a wide floodplain is present (Figure 5.2.2-1). At least 36 significant constrictions were identified in the study area by carefully inspecting topographic maps and a GIS point shapefile (Appendix C, filed separately in ArcGIS [zipfile] format) created to show their locations. Flood flows encountering a constriction like these will back up on the wider floodplain upstream before passing through the narrower constricted valley. Deposition often results upstream of the constriction in response to the backwatering and associated reductions in flow velocities. The deposition, in turn, results in flow deflection into the riverbanks and consequent bank erosion. These processes ultimately lead to the growth of the high amplitude meanders that are evident at many valley constrictions in the study area (Figure 5.2.2-1). Although developed over long periods of time (i.e., decades or centuries), the presence of these meanders is evidence that the constrictions are capable of altering the passage of flood flows down the valley, so are likely to govern the distribution of depositional features and bank erosion near the constrictions.

Figure 5.2.2-1. Valley constrictions are often associated with upstream deposition, meander formation, and bank erosion.

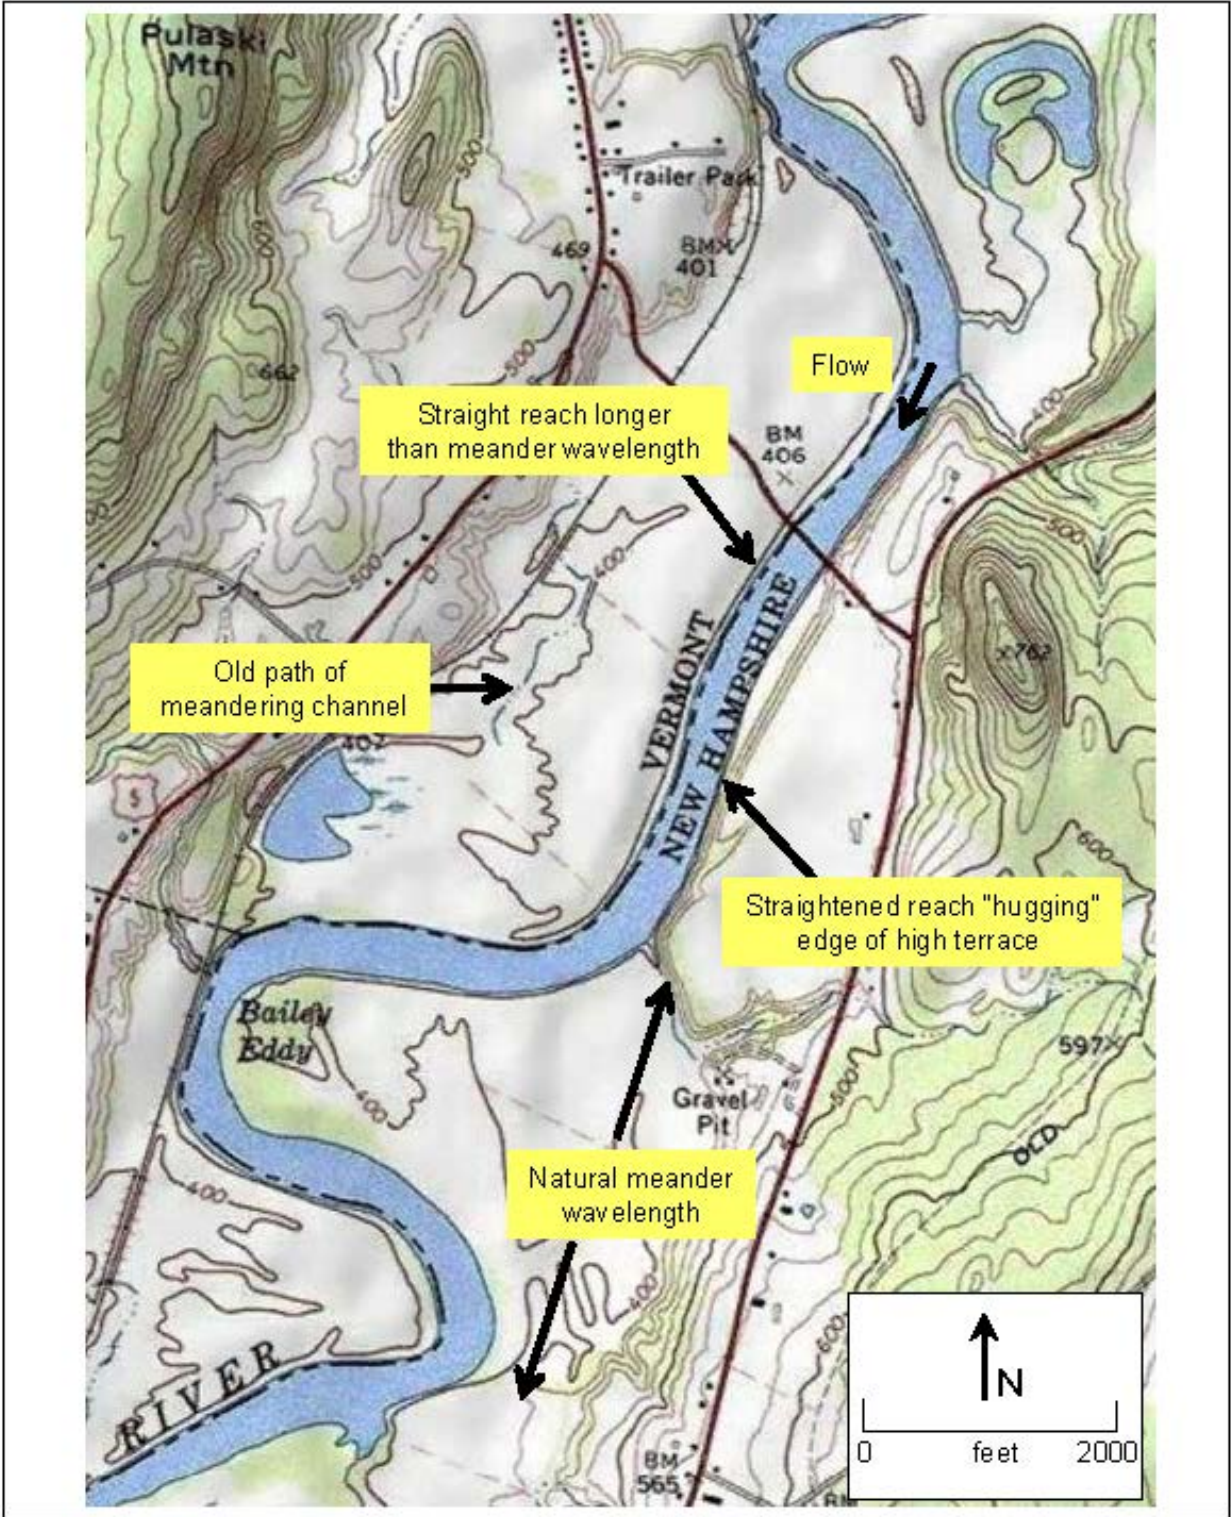
Human activities in the watershed and in the channel have also impacted channel conditions and the distribution of bank erosion. On the upper Connecticut River upstream of the study area, evidence drawn from maps and field studies suggests more than 30% of the river channel was artificially straightened and is considered a primary cause for erosion today (Field, 2004) even though much of that straightening was due in large part to large log drives that occurred throughout the late 19<sup>th</sup> and early 20<sup>th</sup> centuries (Gove, 2003); and railroad construction in the latter half of the 19<sup>th</sup> century. The evidence for straightening is ubiquitous on rivers and streams throughout New England (Field, 2007a). Straightening is more difficult to confirm within the study area due to the river's large size, the presence of impoundments which may obscure evidence of straightening, and extensive valley confinement (where the channel could be naturally straight). In the upper Wilder impoundment where the floodplain is at its widest, some straightening can be observed on topographic maps (Figure 5.2.3-1). At least one of three features should be present to verify channel straightening: 1) a straight reach longer than the wavelength of nearby meanders; 2) a channel position that "hugs" the edge of the valley; and 3) the presence of the original meandering channel in some form on the adjacent floodplain. Figure 5.2.3-1 shows possible evidence for all three features and also shows how railroad construction cut off the apex of a meander, a type of partial straightening (or channel shortening) seen at multiple locations in the study area. The shortening of the channel resulting from straightening increases the channel slope and flow velocity which in turn, often results in bank erosion as the channel adjusts in response to the alteration of its natural form.

Figure 5.2.3-1. Evidence for channel straightening near Newbury, VT.

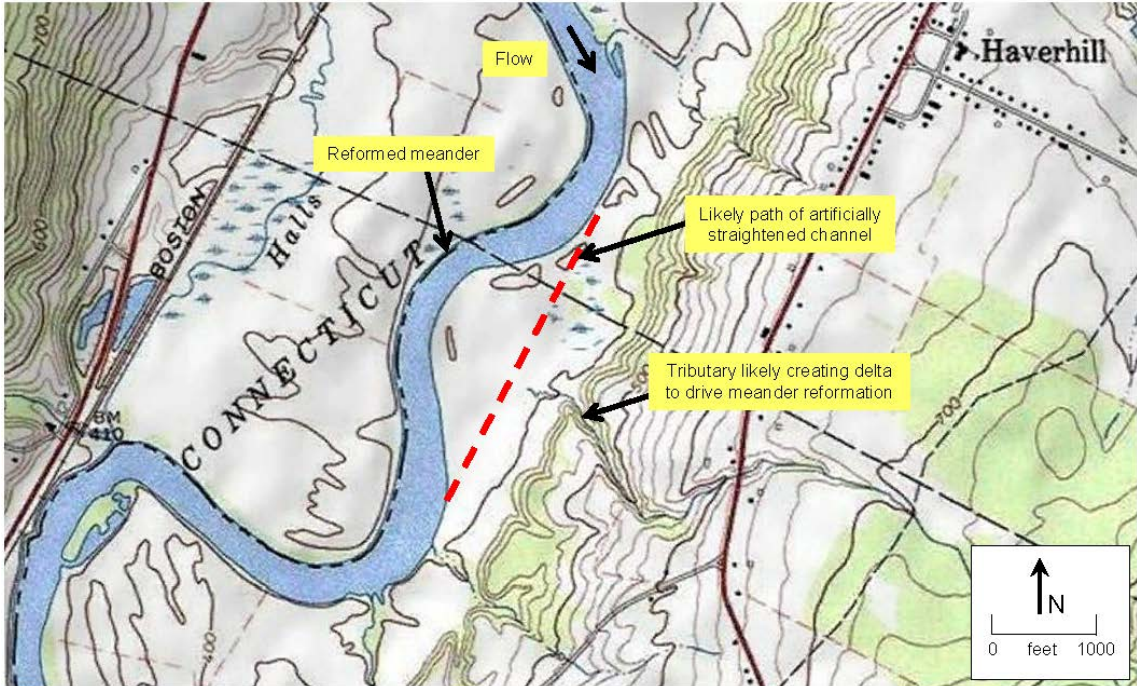
The channel adjustments following straightening ultimately lead to the reformation of meanders along artificially straightened channels (Field, 2007b). Evidence for this is also seen in upper Wilder impoundment on the Haverhill/Piermont, New Hampshire town line where a small unnamed tributary built out sediment into a straightened reach of channel to form a symmetrical meander (Figure 5.2.3-2). Although the meander formed prior to 1935 (as seen on an historic topographic map), topographic surveying of the area as part of this study confirms a low area along the bank where the delta built out into the channel several decades ago (see data presented in Section 5.7). Very rapid meander formation, and as a result rapid bank erosion, can occur where considerable sediment enters the channel at tributary confluences. This is enhanced where the tributary passes through easily erodible clay deposits, producing high sediment loads. At the mouth of Clark Brook near North Haverhill, New Hampshire, after flowing for over 2.5 miles through clay deposits, well stratified bank sediments on the Connecticut River show evidence for the rapid growth of a point bar that has now developed into a low floodplain surface (5.2.3-3). Slowly deposited bank sediments are often homogenized through disturbance by animals (e.g., burrowing) and plant growth (e.g., roots), so the preservation of point bar features in the bank is an indication of rapid bar growth.

Figure 5.2.3-2. Meander reformed on straightened reach at Piermont/Haverhill, NH town line where tributary enters Connecticut River valley.

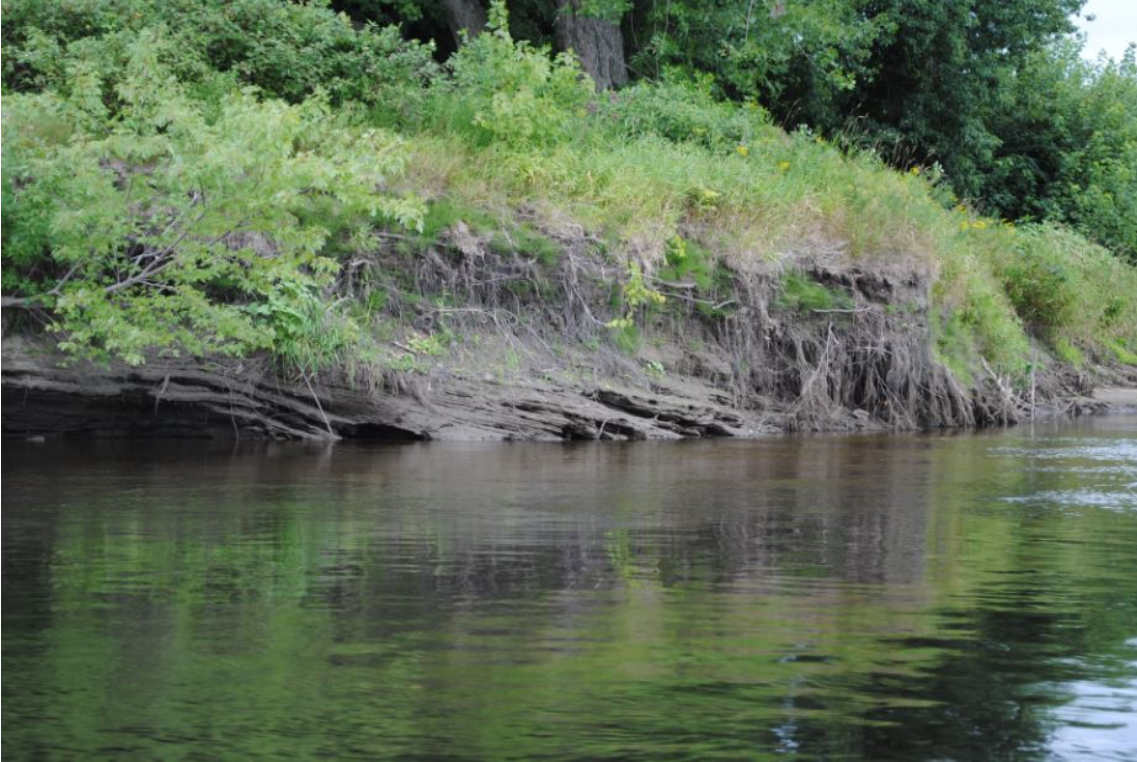
Figure 5.2.3-3. Bank sediments preserving rapidly deposited point bar near North Haverhill, NH.

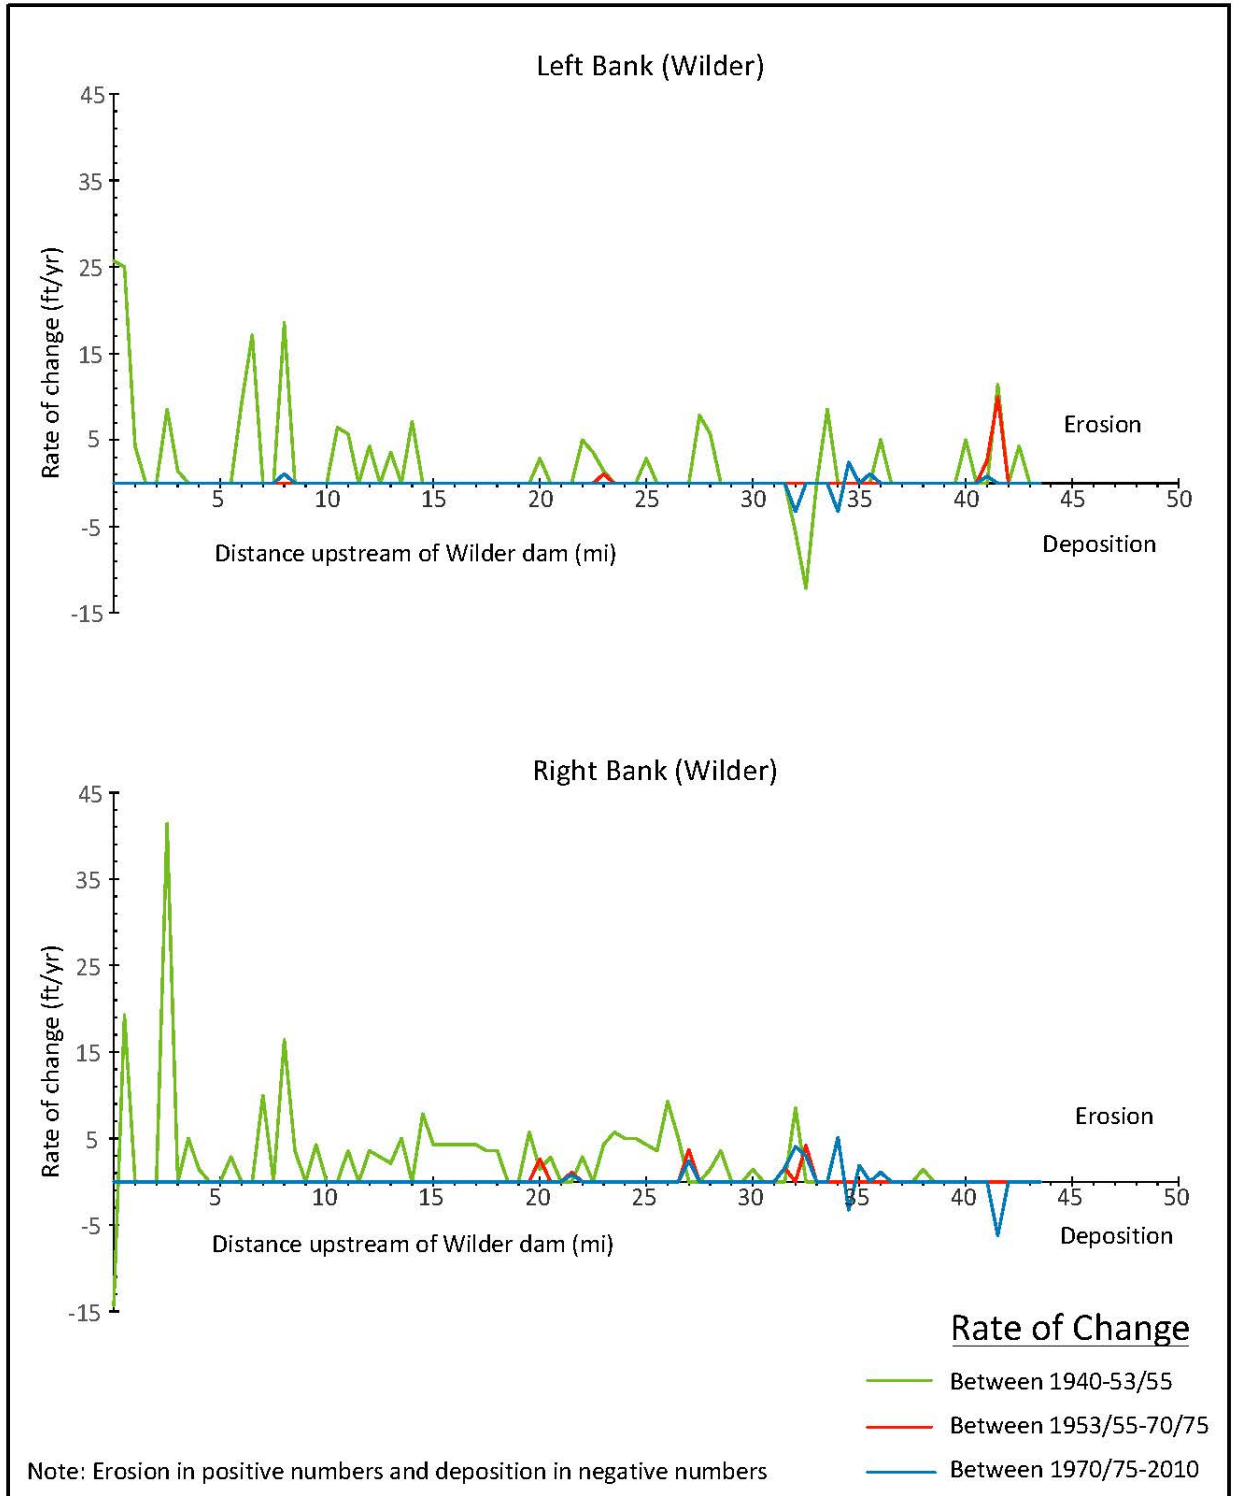
Upstream of Wilder dam, considerable change occurred between the 1939/40 and 1953/55 sets of aerial photographs. Changes observed on the historical aerial photographs are most dramatic in the lower Wilder impoundment between the 1939/40 and 1953/55 photographs. Although displayed as a rate of change in Figure 5.3-1a, these changes are the result of inundation caused by the raising of Wilder Dam in 1950, likely happened in less than a year, and are not the result of erosion. Actual erosion seems likely around mile 32 above the dam on the right bank (as shown on Figure 5.3-1a) as matching deposition is present on the left bank, whereas at other locations the changes occur on both banks simultaneously, a trend consistent with the inundation up and perhaps over the banks. The actual change due to the raising of the dam in 1950 likely occurred in less than one year but expressing the change as a rate over the whole time period enables more meaningful comparisons with the rest of the data set. The rapid spatial changes expressed by spikes on the graphs in Figure 5.3-1 with large changes at one 0.5-mile point and no change at an adjacent 0.5-mile point may reflect changes in bank height (as a steep vertical bank would reflect little change in position in response to the raising of the dam) and bank composition or armoring (as a resistant bank would be less likely to recede even if the erosive forces are the same over a mile long reach of river). After the 1953/55 series very little change is documented through the historical aerial photograph analysis and what change is observed is almost exclusively restricted to the upper half of the Wilder impoundment. The lack of change in the lower impoundment is likely due to the extensive bank armoring in that area (see Section 5.6).

Figure 5.3-1a. Rates of change in riverbank position through time upstream of Wilder dam.

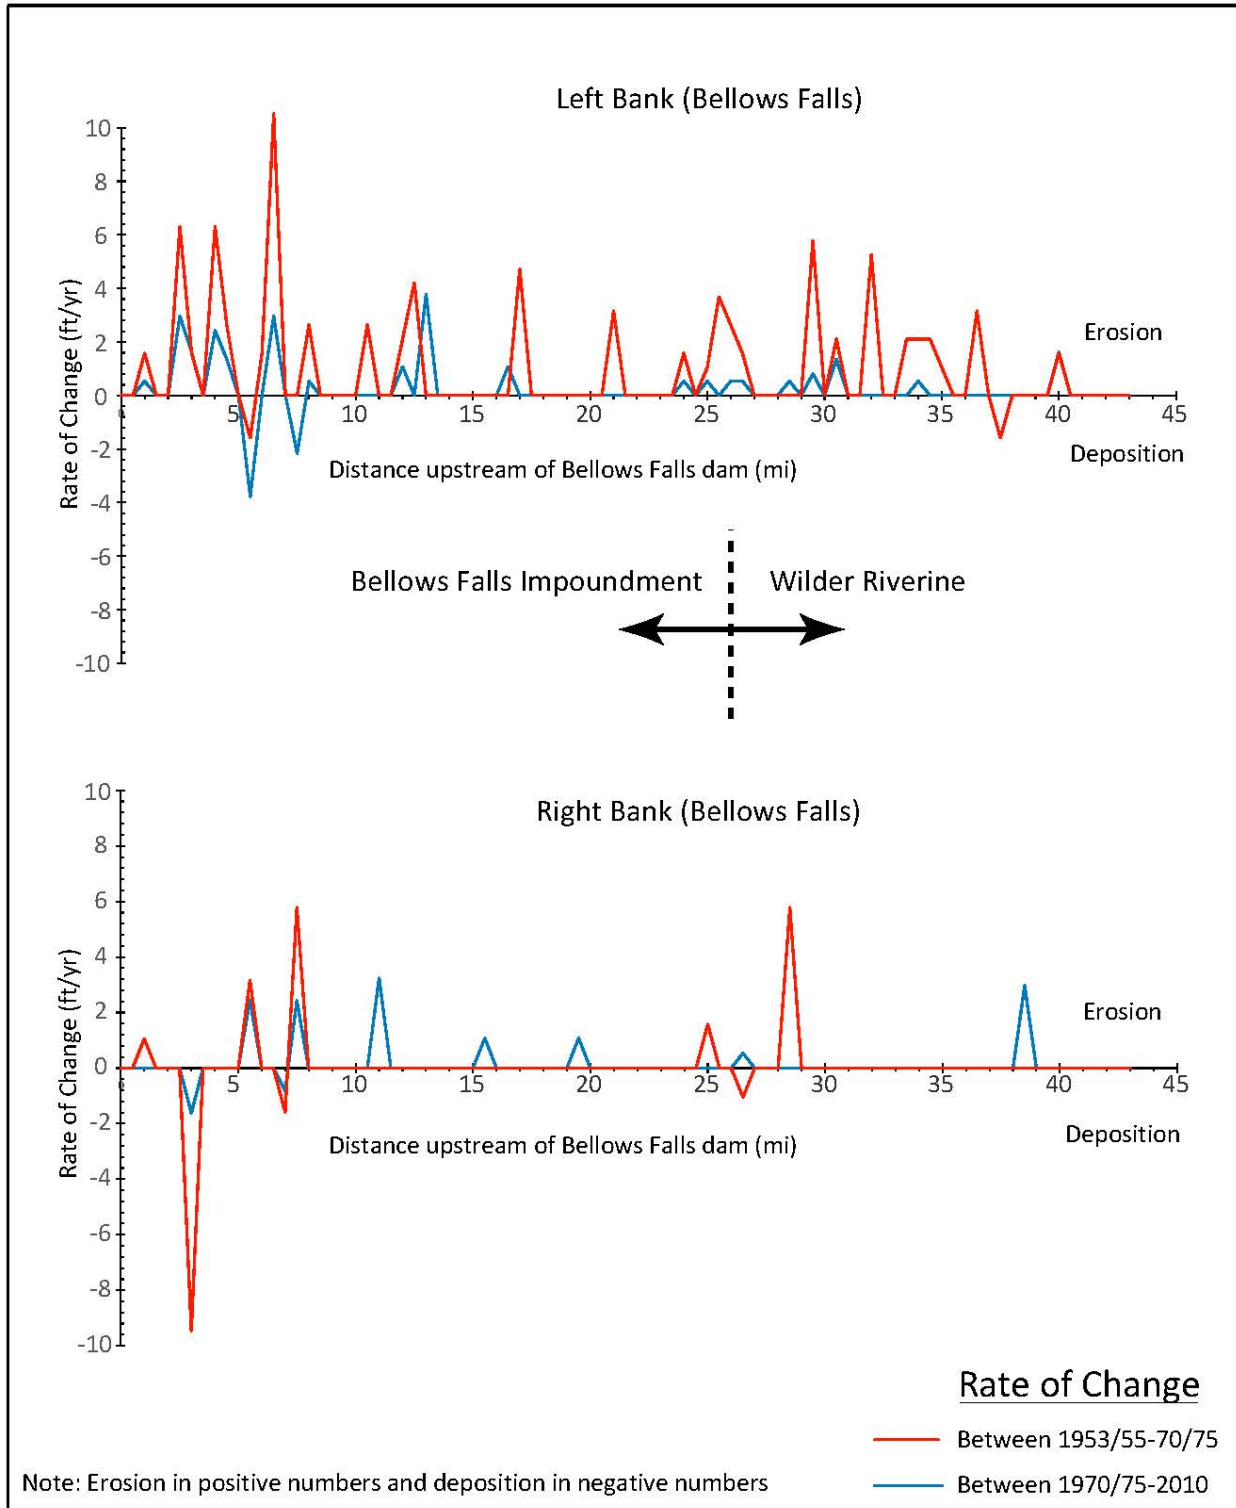
The channel through the Bellows Falls impoundment appears to have experienced far more bank erosion and deposition than Wilder (and Vernon) impoundments through time (Figure 5.3-1b). Ground evidence such as sand bars in the channel, scroll bars on the low floodplain (i.e., subtle ridge and swale topography formed by meander migration), and the most significant bank retreat at any of the 21 monitoring sites throughout the study area (see Section 5.4) all corroborate the finding that significant changes have occurred. Spatially, the rate of erosion in the lower Bellows Falls impoundment in general, has been higher through time than in the upper impoundment or Wilder riverine reach. This may be due to the backwatering effects upstream of the Williams River confluence that could enhance erosion in the lower impoundment (as described in Section 5.2.1). Temporally, the rate of erosion appears to have declined through time as expressed in Figure 5.3-1b by the shorter peaks of the 1970s-2010 time interval nested inside the taller peaks of the 1950s-1970s time interval. Very few aerial photographs from the 1939/40 series were available downstream of Wilder dam so were not included in those analyses below Wilder dam. The rate of erosion has declined by 50% or more since the 1970s at many locations. As described in Section 5.4, one Study 2 erosion monitoring site (Site 02-B07) along the left bank (looking downstream) in the lower Bellows Falls impoundment experienced more than 7 ft of bank recession over a two year period. Based on the approximately 3 ft/yr erosion rate derived from the historical photo analysis at many sites in the lower impoundment for the 1970s-2010 time interval, additional bank recession at that monitoring site seems possible every few years.

Figure 5.3-1b. Rates of change in riverbank position through time upstream of Bellows Falls dam.

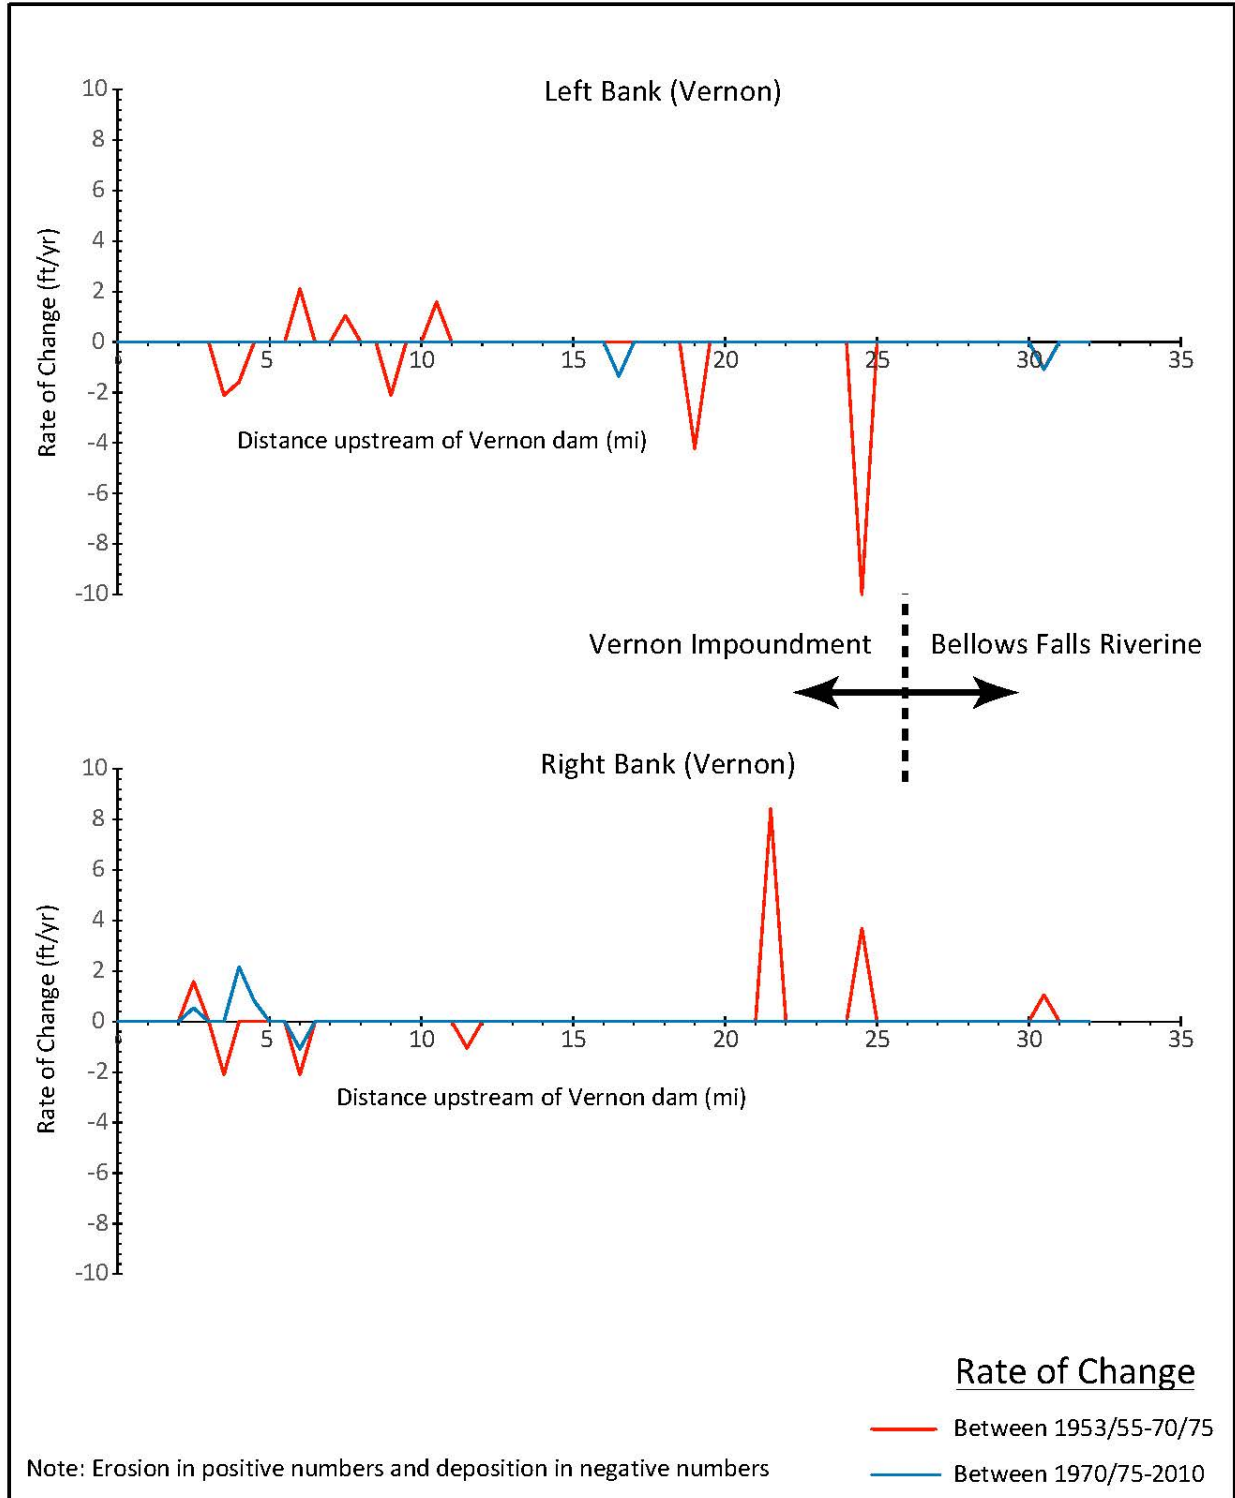
In contrast to the significant changes in the Bellows Falls impoundment and Wilder riverine reach, the Vernon impoundment and Bellows Falls riverine reach show relatively little change in bank positions since the 1950/55 aerial photographs (Figure 5.3-1c). Although more locations in the lower Vernon impoundment show change, the rate of change appears higher in the upper impoundment, perhaps because of the extensive slackwater (i.e., low velocity current) areas in the lower impoundment. Very little change is documented in the Bellows Falls riverine reach. As with the Bellows Falls impoundment, the rate of change in Vernon impoundment appears to have decreased through time. In fact, most of the change observed occurred during the 1950s-1970s interval, with what little erosion did occur in the 1970s-2010 interval occurring mostly in the lower impoundment.

Figure 5.3-1c. Rates of change in riverbank position through time upstream of Vernon dam.

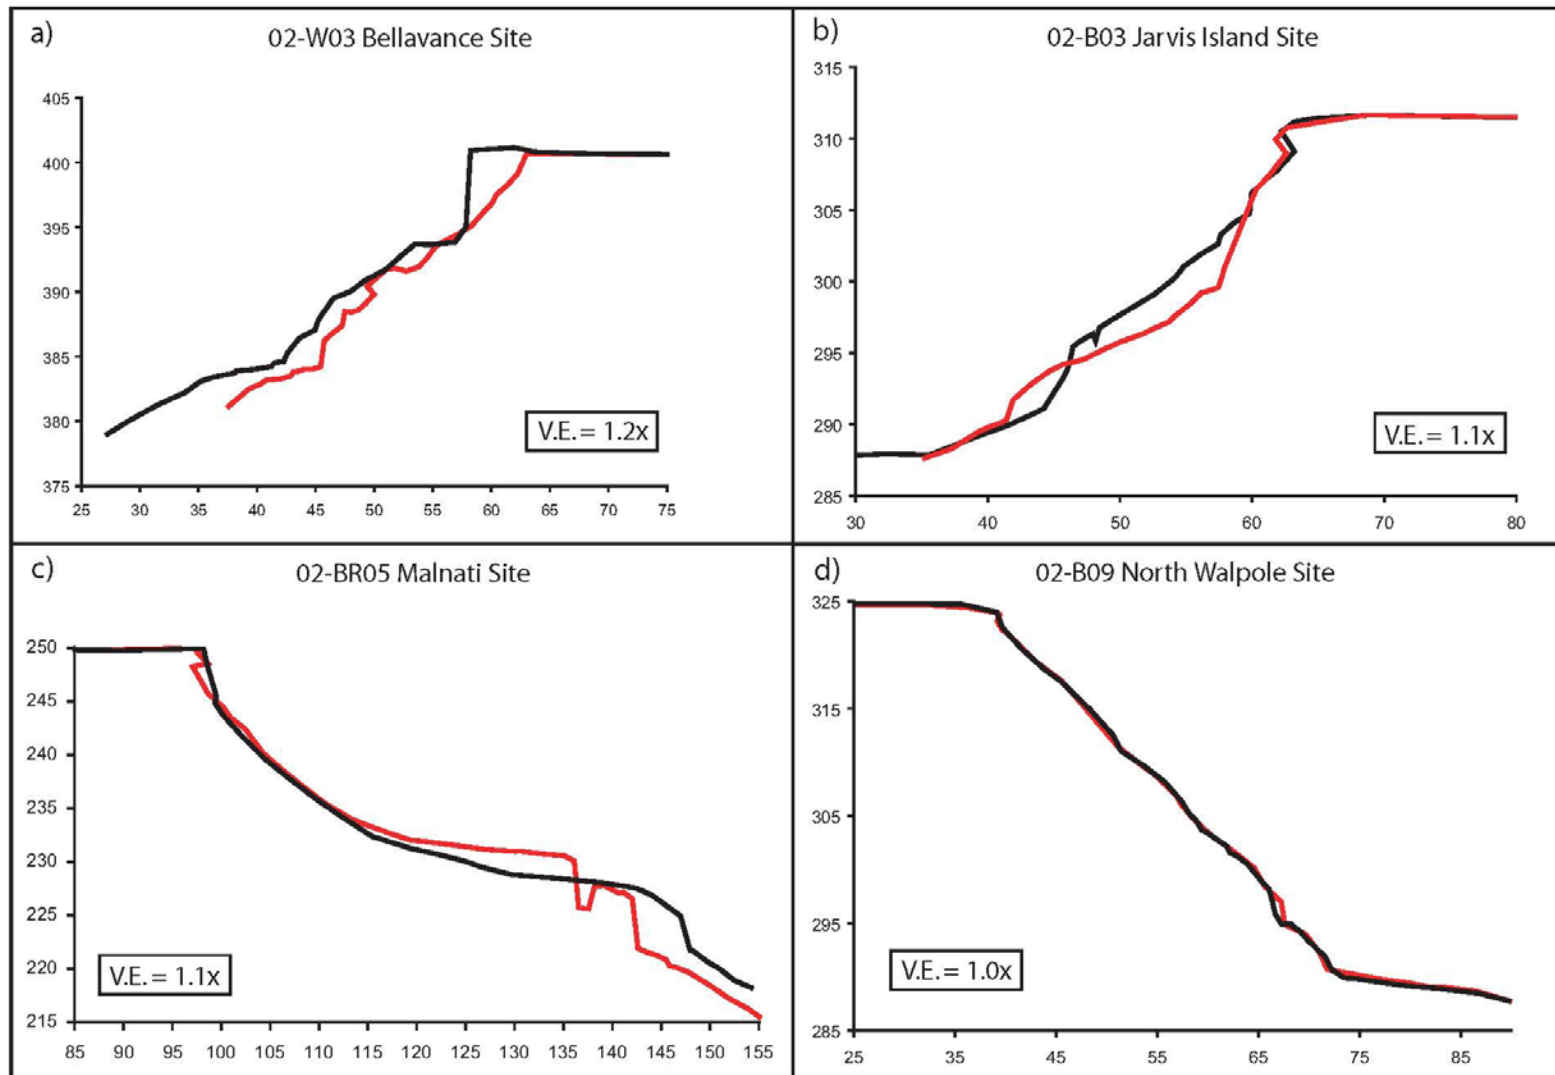
Four general conditions were observed along the transects during the two-year monitoring period: 1) bank recession at the top of the bank, 2) changes on the bank slope, 3) loss or accumulation of bank material at the bank toe slope (y = some change, n = no change, add = material added to that portion of the bank), and 4) no change (Figure 5.4.2-1 and Figures 5.4.2-2a and 5.4.2-2b). Note that two or more of the above conditions reflecting bank change could occur along a single transect (even during a single interval between monitoring periods) and that change may have occurred during only one monitoring interval with no other change observed during the rest of the monitoring period (Table 5.4.2-1).

Figure 5.4.2-1. The types of conditions observed on the monitoring transects included a) top of bank recession, b) bank slope changes, c) bank toe accumulation or loss, and d) no change.

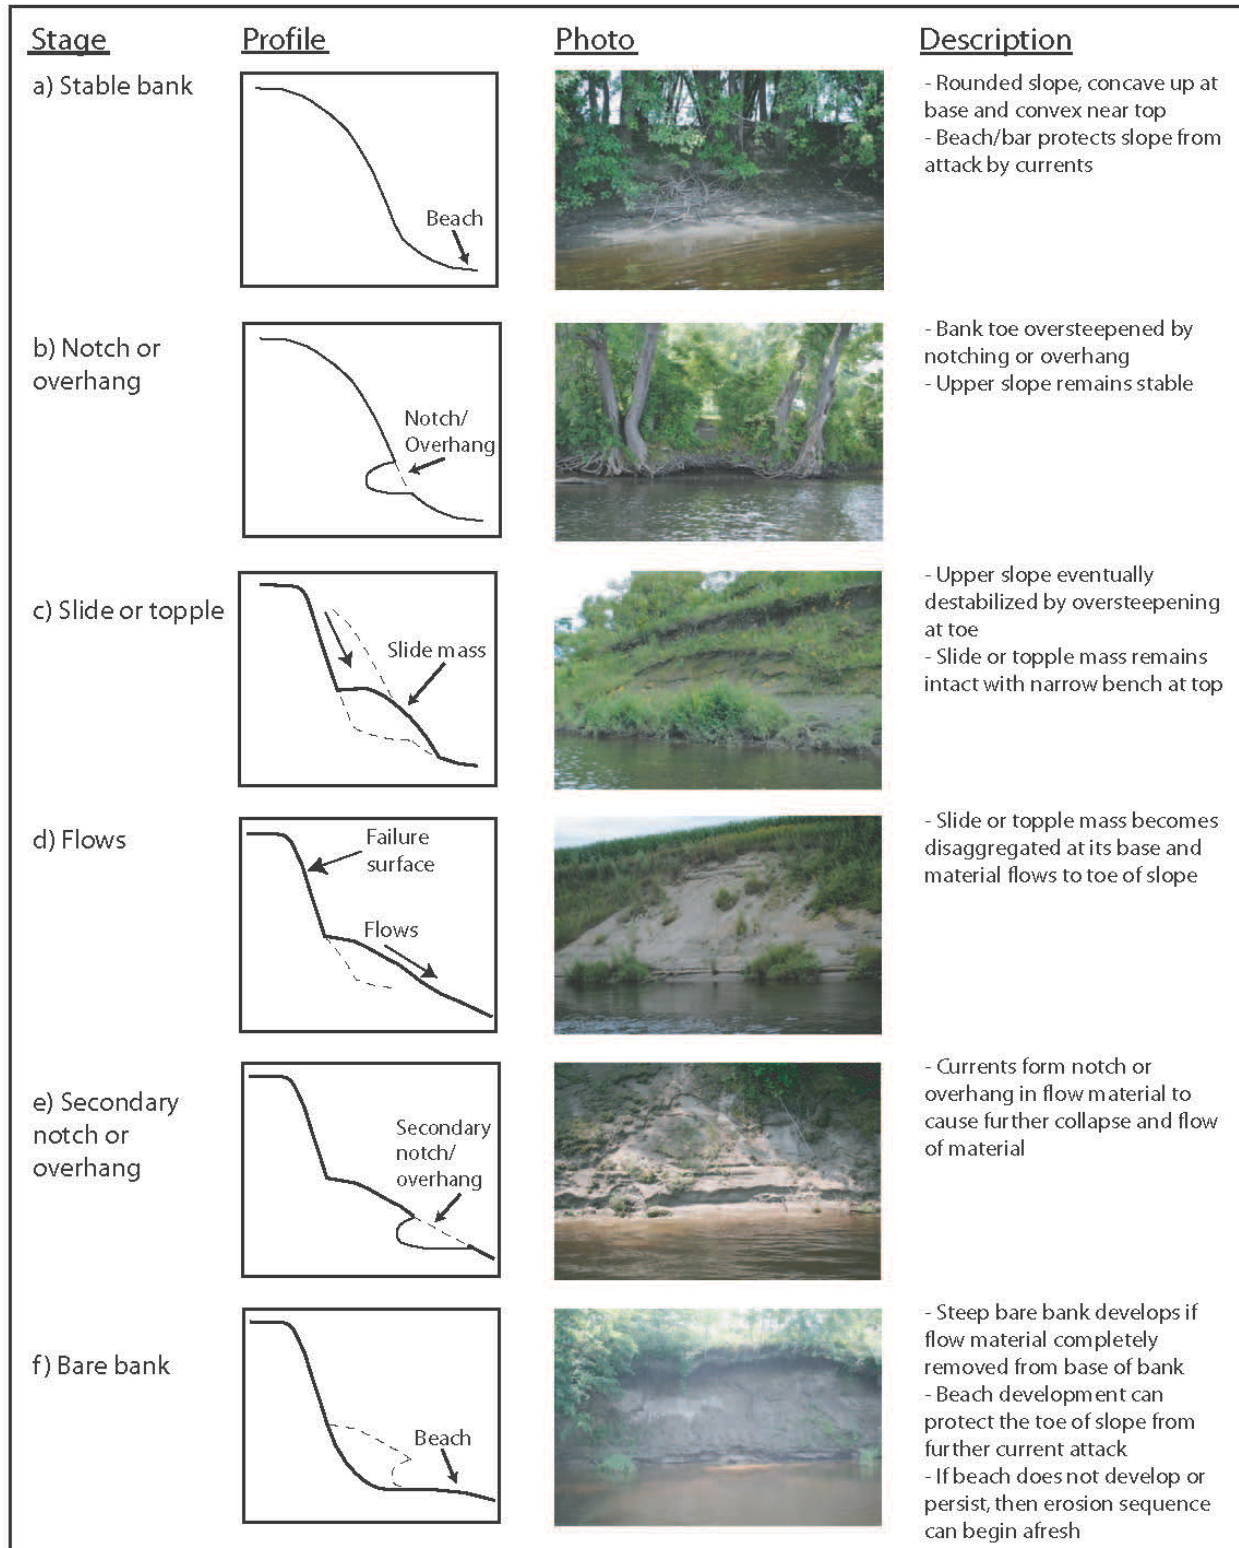
A stable bank can become destabilized by the removal of material at the base that ultimately leads to the creation of a notch or overhang (Figure 5.6.2-1a). As the notch grows taller and steeper by advancing further into the bank or the overhang becomes deeper and higher through falls from the “roof” of the overhang, the driving gravitational forces will eventually exceed the bank’s resisting forces. As a result, further erosion will eventually occur higher on the bank slope by either topples or slides (Figure 5.6.2-1b). The mass of sediment moved downslope temporarily buttresses the bank from further failure and the bank will stabilize with no further erosion if this accumulated material is not removed from the base of the bank. Sediment flows develop at the base of slide (or topple) masses that have moved only partially down the slope (Figure 5.6.2-1c), resulting from the additional gravitational stress acting on the steeper base of the slide mass. These sediment flows create thin sheets of colluvial material that move further down the bank face. In many instances, sediment flows might not occur but the slide (or topple) mass will become disassociated into individual particles and carried away from the bank by water currents. If the material that has accumulated at the base of the bank is carried away by currents in the river, a steep bare bank face is all that remains (Figure 5.6.2-1d-f). The near-vertical bare slope, a condition typically associated with an eroding bank, arises only at the end of a longer sequence of erosional processes (Figure 5.6.2-1a-c). Continued recession of the bank is dependent on the development of new notches or overhangs that can begin the “cycle of erosion” afresh.

Figure 5.6.2-1. Model idealizing steps in the cycle of erosion. Different stages of erosion can be occurring adjacent to each other along a long, continuously eroding bank (adapted from Field, 2007a).

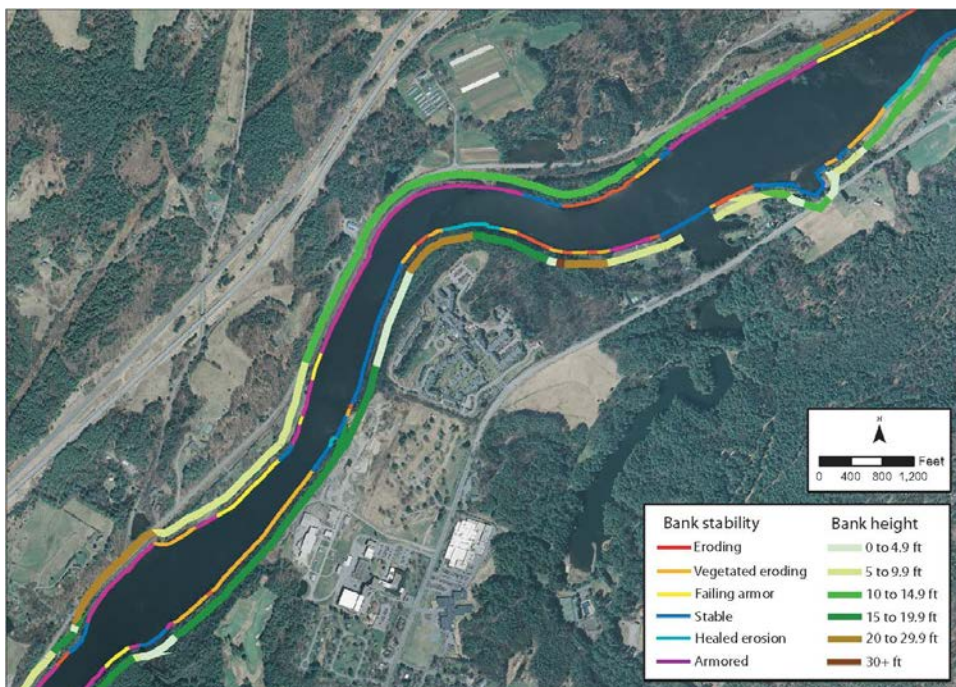
The results of the bank features mapping are presented in Appendix C (filed separately) as GIS shapefiles. Within GIS, the bank conditions at any location can be shown and compared with other bank features such as bank stability and bank height (Figure 5.6.4-1). Considering bank stability for the study area as a whole, 11% of the banks were mapped as eroding, 22% as vegetated eroding, and 6% as failing armor, resulting in a total 39% of bank length that can be considered unstable (Figure 5.6.4-2). In contrast, 61% of the banks are either stable (42%), armored (15%), or no longer eroding (i.e., healed erosion) (4%). For comparison, mapping along 85 miles of the upper Connecticut River outside of the study area found that 49% of the banks were unstable (Field, 2004). Both the mapping of the upper Connecticut River and within the study area in 2014 had a similarly defined “eroding” category. The “moderately eroding” category in the upper Connecticut River study represented eroding banks with vegetation like the “vegetated eroding” category of Study 3 with the name change merely representing an acknowledgement that banks in the previously-named “moderately eroding” category may have been just as susceptible to erosion as the “eroding” banks despite the presence of vegetation. Banks with failing armor were simply mapped as “eroding” in the upper Connecticut River study such that a combination of the “eroding” and “moderately eroding” category of the upper Connecticut River study represents unstable banks as does the combination of the “eroding”, “vegetated eroding”, and “failing armor” categories of the Study 3 mapping. As with Study 3, banks along the upper Connecticut River exhibiting notching and overhangs but no other signs of erosion were categorized as stable banks. Given the above, a comparison of these two mapping efforts is considered valid.

Figure 5.6.4-1. Map of a short portion of the study area (in lower Wilder impoundment) comparing bank stability and bank height.

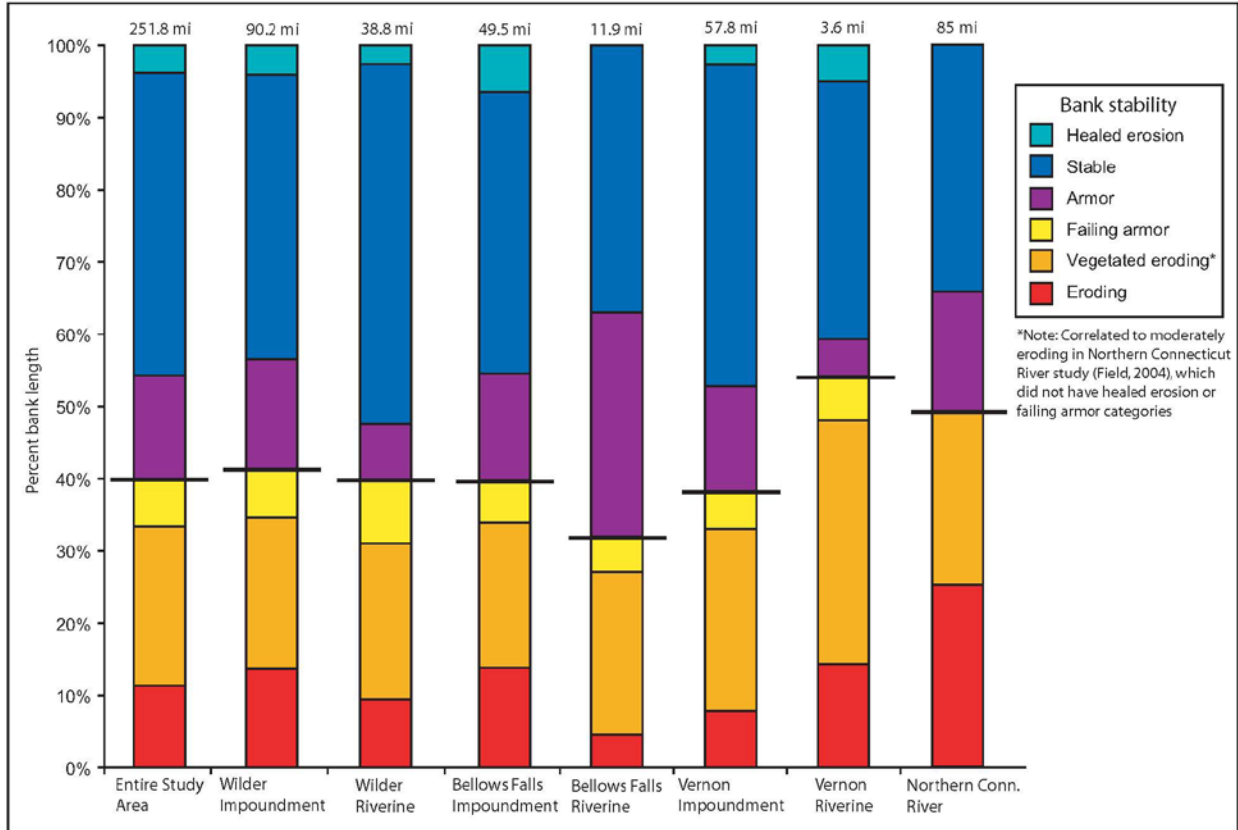
Figure 5.6.4-2. Percentage of mapped bank stability by study reach. The three unstable categories are illustrated below the bold line across each bar in the plot. The right hand bar shows the upper Connecticut River for comparison from Field (2004).
