**TRANSCANADA HYDRO NORTHEAST INC.**

**ILP Study 2 and Study 3  
Riverbank Transect and Riverbank Erosion Studies**

***Final Study Report***

Wilder Hydroelectric Project (FERC Project No. 1892-026)  
Bellows Falls Hydroelectric Project (FERC Project No. 1855-045)  
Vernon Hydroelectric Project (FERC Project No. 1904-073)

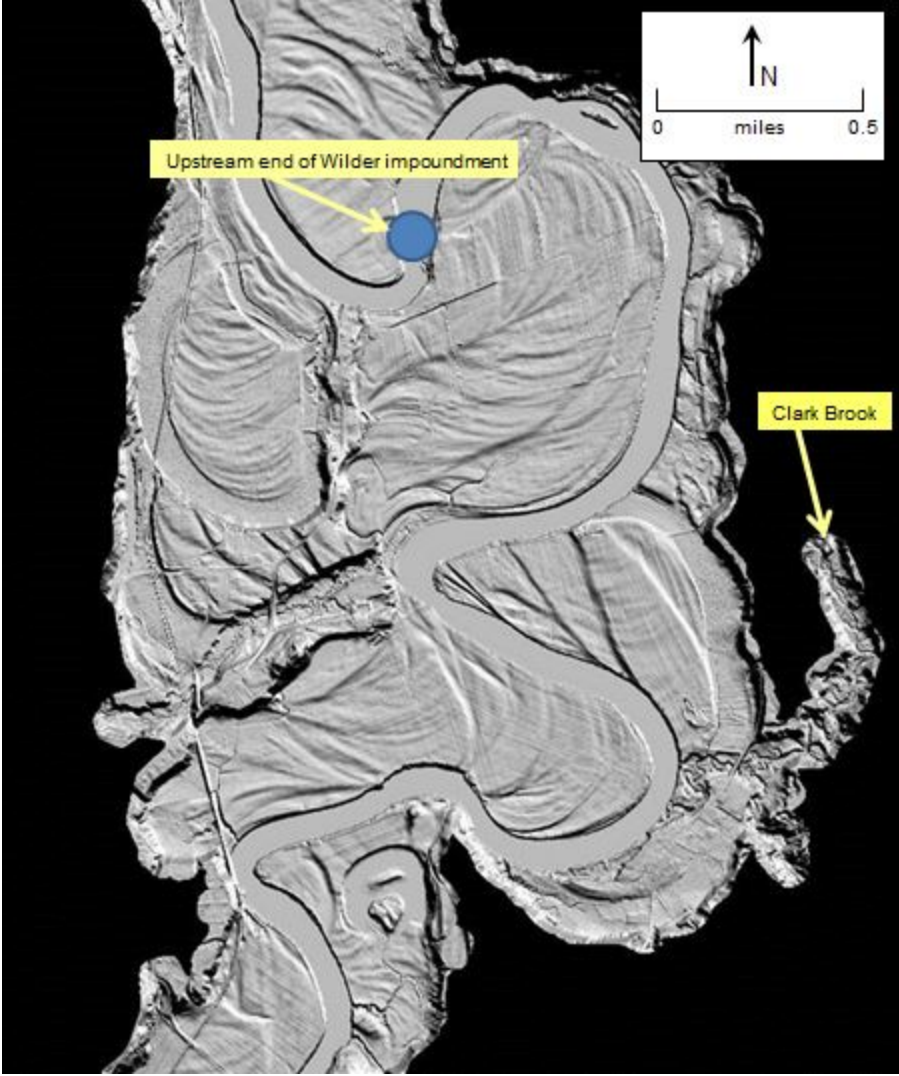
Several independent sources of information provide an indication for the rates of erosion and deposition for certain widely spaced locations in the study area, but determining rates of erosion for the entire study area with a high level of confidence is not possible. Remote sensing and field evidence provides an indication that rapid change can occur along the river. Portions of the channel in the upper Wilder impoundment appear to have been artificially straightened, most likely in the latter half of the 19<sup>th</sup> century, and near the Haverhill-Piermont, New Hampshire town line a meander had reformed along a straightened reach by 1930 that implies over 1,200 ft of erosion may have occurred in less than a century (i.e., a possible erosion rate of more than 12 ft/yr) and prior to the raising of Wilder dam in 1950 (see Section 5.2). Well preserved scroll bars on the low floodplain near Charlestown, New Hampshire are also suggestive of very rapid rates of channel migration (and associated erosion and deposition) over a long time period (Figure 5.4.2-4) and is consistent with 7 ft of bank recession documented at the Charlestown monitoring site (Site 02-B07) over a two-year period (see Section 5.4) implying a short-term erosion rate of as much as 3.5 ft/yr at this location. Examination of the digital elevation layer developed by the sub-meter accurate LiDAR dataset suggests that channel migration has occurred historically throughout large portions of the floodplain. Shaded relief maps created from this data show numerous scroll bars (appearing as arcuate or curved ridges) and abandoned channels across the entire floodplain, indicating that channel migration and associated bank erosion has occurred along the river for decades if not centuries (Figures 5.6.5-6 and 5.6.5-7).

Figure 5.6.5-6. Hillshade relief map of upper Wilder impoundment generated from LiDAR data showing evidence of historical channel migration on floodplain.

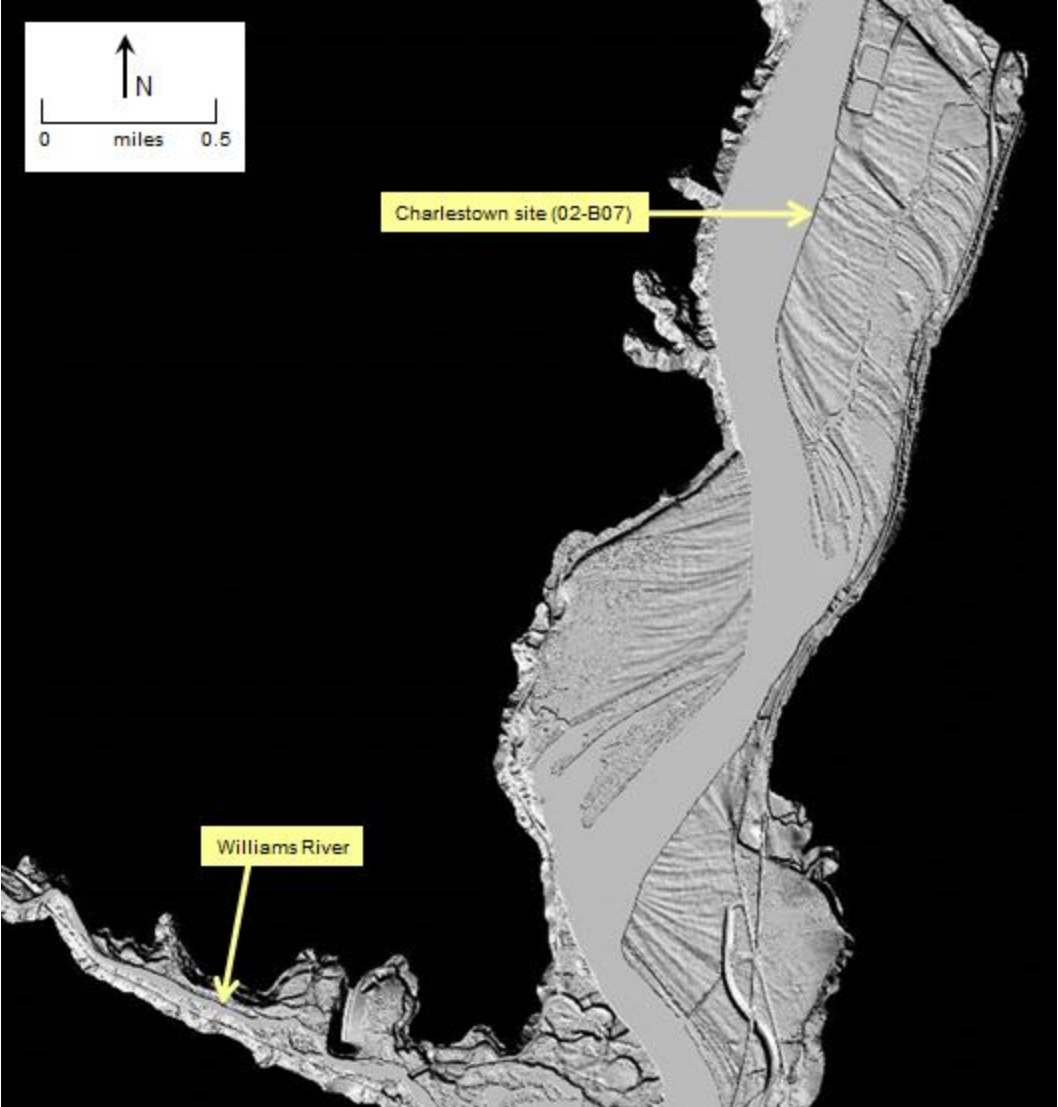
Figure 5.6.5-7. Hillshade relief map of a portion of Bellows Falls impoundment generated from LiDAR data showing evidence of historical channel migration on floodplain. (Compare with Figure 5.4.2-4.)

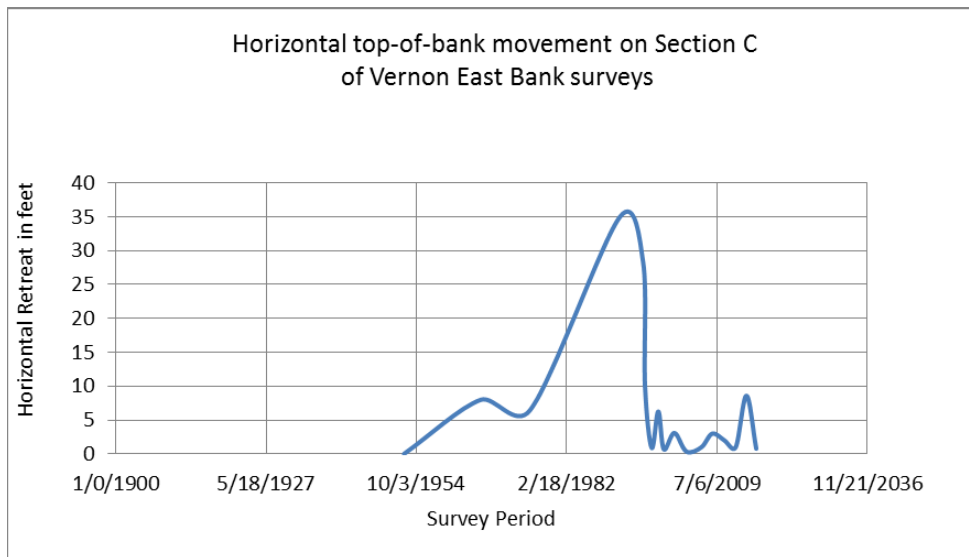
In addition, the monitoring site 02-VR01, a high eroding bank immediately downstream of Vernon dam on the left bank, has been extensively surveyed every two years along the entire bank including submerged portions since 1991 as part of long term monitoring conducted by TransCanada independent of this study. Twenty-five years of monitoring on a 73-ft high bank immediately downstream of Vernon dam on the left bank (of Vernon Neck so-called) documents an average erosion rate of approximately 2.6 ft per year. Based on aerial photographic evidence indicating the top of bank in 1952, 1966, and 1975 and survey monitoring from 1991 until present, it is apparent that rates of erosion have varied over the 61-year period (Figure 5.6.5-8). The greatest rate of top-of-bank retreat corresponds with the period between 1975 and 1991. It was at the start of this time frame that the Northfield Mountain Pumped Storage Project commenced operation which included increasing the Turners Falls dam WSE by 5.4 ft. This change in turn, resulted in an increase of WSE at the base of Vernon dam and the Vernon Neck east bank, causing a consistently higher WSE-bank interface.

Figure 5.6.5-8. Vernon East Bank historical top-of-bank movement.

High water events, combined with the higher WSE acting on the high bank, appear largely responsible for the increased rate of erosion. In 1986, as part of the Vernon Project’s spillway crest control and gate modifications, bedrock was removed below the tainter gates on the left bank to re-direct flow into the center river channel and reduce the whirlpool effect in the pool below the Vernon Neck east bank. This action may be in part supportive of the development of the beach at the base of the steep bank. Monitoring of the east bank included hydrographic monitoring of the submerged pool below and confirmed the gradual development of a submerged bench and beach at the base. Since 2006, despite annual high flow events with the exception of Tropical Storm Irene in 2011 causing a slight increase in slope failure immediately following that event, biennial surveys indicate little change in the top-of-bank and erosion has remained uniform and slight along the entire length of the bank. The toe-of-slope also shows little change along the entire length of the base of the bank and only minor and normal settling, a common phenomenon in open sloped areas composed primarily of sandy soils.

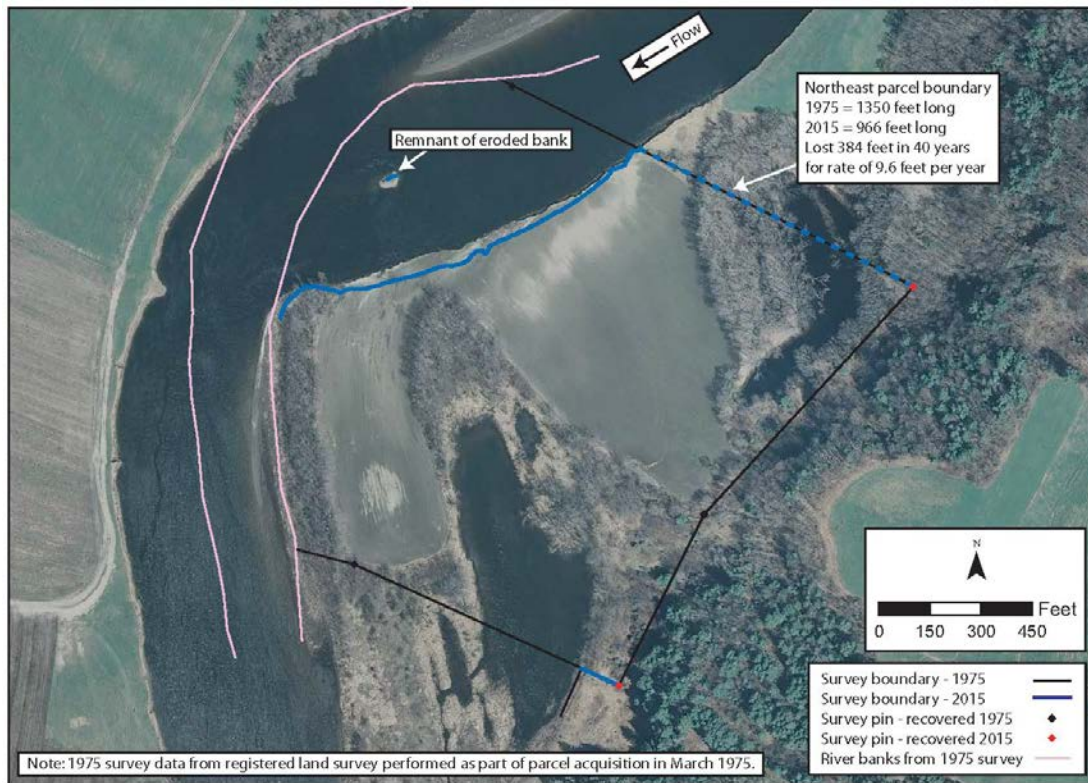
For the Wilder impoundment sites, the upstream most location is near the Haverhill-Piermont, New Hampshire town line (and just upstream of the reformed meander discussed in Section 5.2.3) with the original survey from 1975 showing the east bank of the Connecticut River extending 384 ft further west than in the 2015 survey, suggesting bank recession has occurred at a rate of 9.6 ft/yr in the past 40 years (Figure 5.6.5-9).

Figure 5.6.5-9. Comparison of 1975 and 2015 surveys of the Lewis property on the Haverhill/Piermont town line.

This is less than the 11 ft/yr established by comparing historical aerial photographs of the same area and presented in the Study 1 report but, along with erosion rates of 12 ft/yr implied by long-term meander development, corroborate rapid channel migration rates in this area. Two previous property surveys from 1961 and 1989 were also conducted in the area surrounding the Mudge monitoring site (Site 02-W09). Along one survey transect, 24 ft of erosion occurred between 1961 and 1989 documenting an erosion rate of 0.9 ft/yr. A resurvey of the same line in 2015 indicates an additional 8 ft of erosion has occurred since 1989, suggesting the erosion rate has decreased to less than 0.3 ft/yr. An erosion rate of less than 1.0 ft/yr is consistent with the lack of any recorded bank recession at Site 02-W09 over the two-year monitoring period, although more than a foot of bank recession did occur nearby (Figure 5.4.2-5).

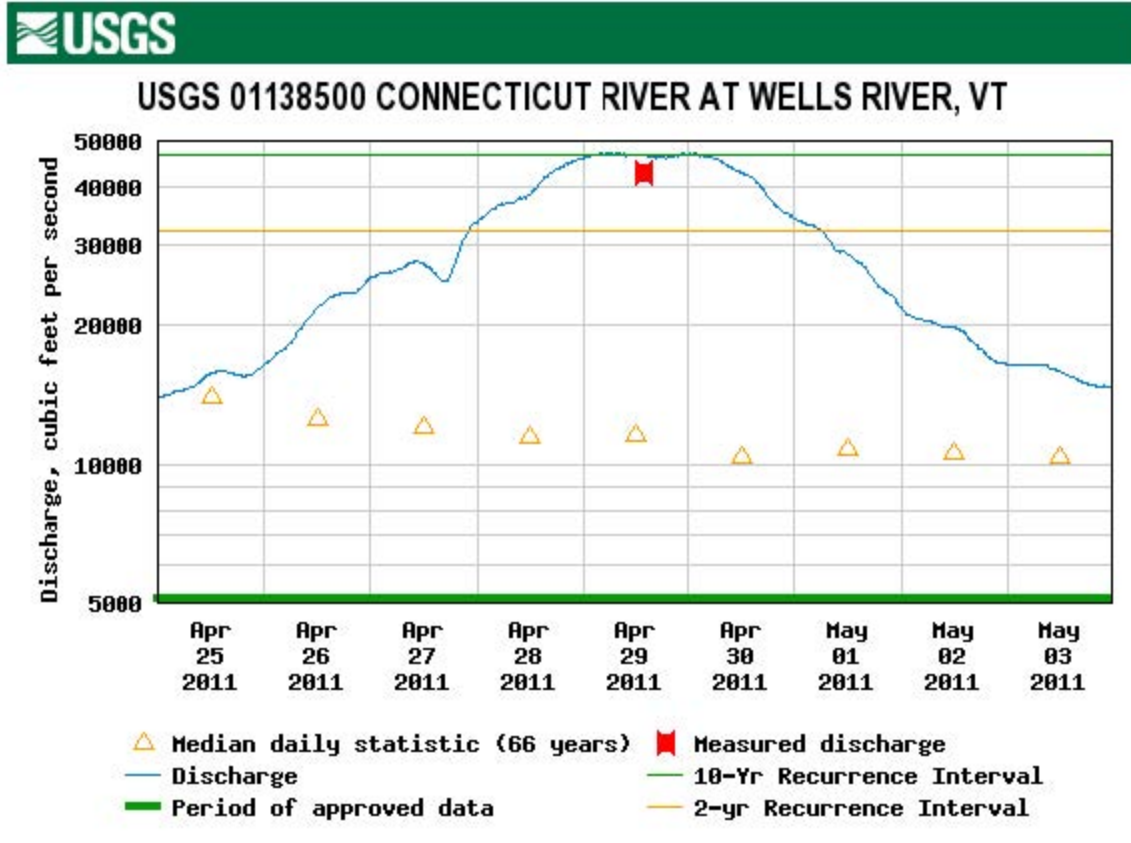
A 1,000-foot section of River Road in Lyme, NH in the Wilder impoundment was damaged due to bank failure that occurred during the weekend of April 30 – May 1, 2011. High flows persisted for 2.5 days prior to this bank failure as recorded upstream at a gauge on the Connecticut River in Wells River, VT (Figure 6.0-1). Although a July 2016 bank collapse farther south along Route 10 in Hanover, NH demonstrates that bank recession does not always occur in the winter or spring months (John Mudge, email communication, July 15, 2016 to the Connecticut River Joint Commissions Upper Valley Subcommittee), the erosion monitoring data appear to demonstrate that significant bank recession is more likely to occur in the winter or during the spring freshet.

Figure 6.0-1. USGS gage data upstream of Wilder impoundment, April 25 – May3, 2015.

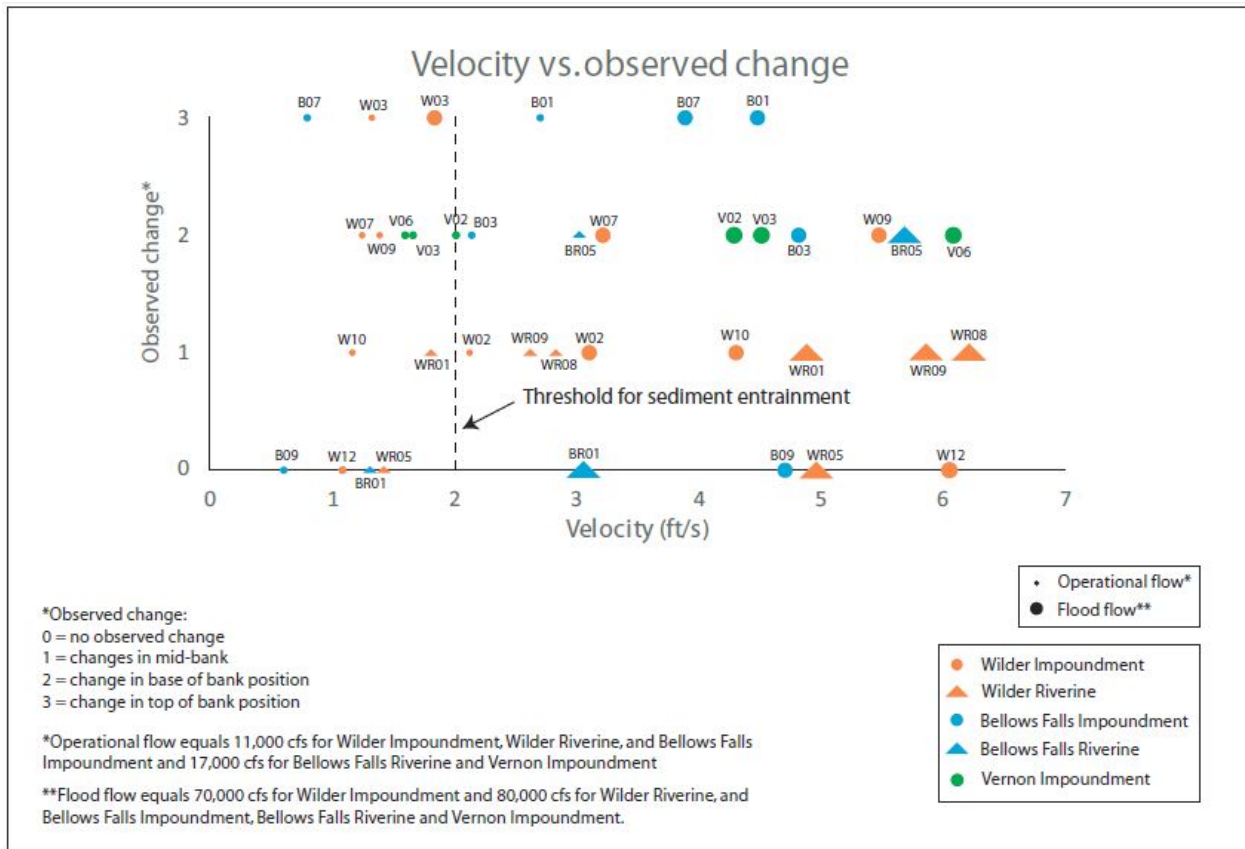
To establish if any pattern is present between flow velocities and observed changes at the 21 erosion monitoring sites only modeled flow velocities were available as ADCP velocity measurements were made at only six of the monitoring sites. Flows at the upper end of the normal operating range at the 21 monitoring sites generally fall below the minimum entrainment threshold of 2 ft/s and in all cases are below 3 ft/s (Figure 6.1-1). In contrast, velocities for the modeled flood flows exceed the minimum entrainment threshold at all but the Bellavance Site (O2-W03). The degree of change at the monitoring sites does not appear to be related to flow velocities as some of the sites with the highest flow velocities experienced no or little change during the two year monitoring period as illustrated by the numerous sites in the lower right corner of Figure 6.1-1. Similarly, some of the sites with the lowest flow velocities experienced the greatest amount of change during the two years of monitoring as at the Bellavance Site. The comparison between flow velocity and documented change at the monitoring sites shows no strong relationship and indicates that other factors, such as bank composition and vegetation, may also exert some control on the location of bank changes.

Figure 6.1-1. Comparison of modeled flow velocities with observed changes at the Study 2 erosion monitoring sites.

While multiple factors affect sediment entrainment thresholds, the velocity data suggest that removal of the material accumulating at the base of the banks along the shore of the impoundments is attributable to high flow events outside of normal project operations. Along the riverine reaches, removal of material at the base of the banks is almost exclusively attributable to high flow events but may occur at some sites for short durations during higher generating flows depending on local bank composition and particle size. Flow velocities at or above the threshold entrainment value do not necessarily mean that erosion is continuously occurring at a given site. Preferential removal of the most easily moved particles (i.e., fine sand) will lead to armoring at the base of the bank by coarser particles that are not entrained, and over time, will reduce erosion of finer particles at a given flow velocity. Furthermore, removal of any material accumulating at the base of the riverbanks from upslope erosion caused by the processes described in Figure 5.6.2-1 must occur before further erosion of the bank itself can continue.

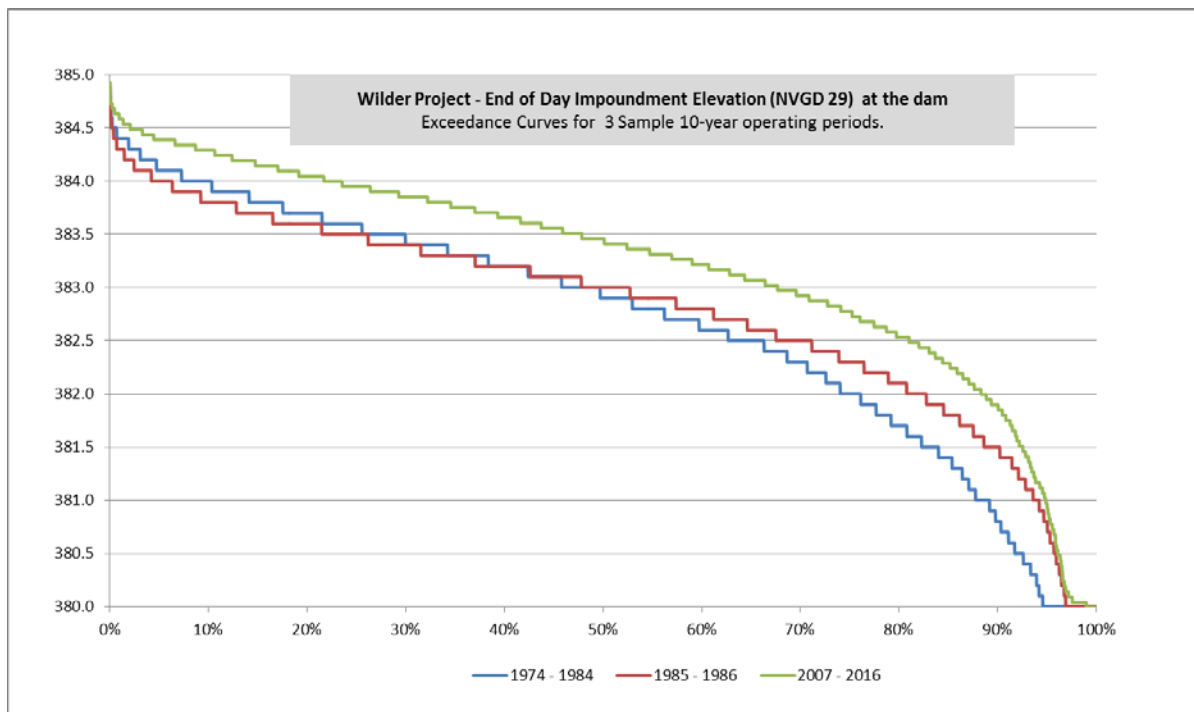
As Figure 6.3-1 for Wilder shows, there is a distinct shift in the fluctuation range of the impoundment from a wider range in the earlier years of the current license to a narrower range associated with the past 10 years. There are specific reasons for why this has happened. The introduction of minimum flows at the upstream Fifteen Mile Falls Project in April 2002, where there were none prior, provided an increased and constant inflow into the Wilder project that exceeded the minimum flow at Wilder dam. The most obvious benefit in terms of WSE and impoundment storage operation would be over low energy demand, two or three-day weekends when prior to the upstream minimum flows, generation might have largely been curtailed at the upstream plants, resulting in use of Wilder impoundment storage to provide the Wilder minimum flow. Another major factor was automation of the remaining staffed Connecticut River plants: Comerford (Moore-McIndoes), Wilder, Bellows Falls and Vernon) and consolidation of controls for all of the plants into a single

Figure 6.3-1. Comparison of Wilder dam WSE over the current license term.

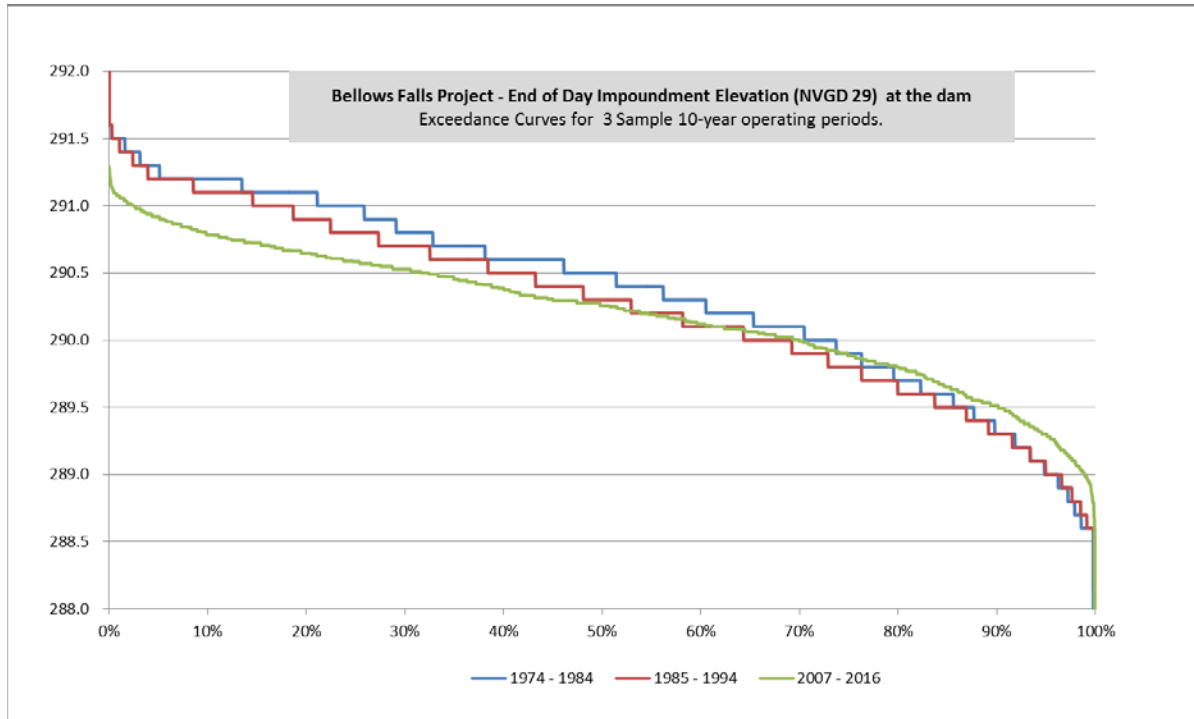
Figure 6.3-2 for Bellows Falls shows a slightly different but similarly trend toward narrowing of the normal impoundment operating or daily WSE fluctuation range. The most recent 10-year curve is notably a flatter than prior years. This is likely to be a result of mainly the automation and consolidated, improved coordinated hydro system that largely completed for the Connecticut River hydro projects in 1998.

Figure 6.3-2. Comparison of Bellows Falls dam WSE over the current license term.

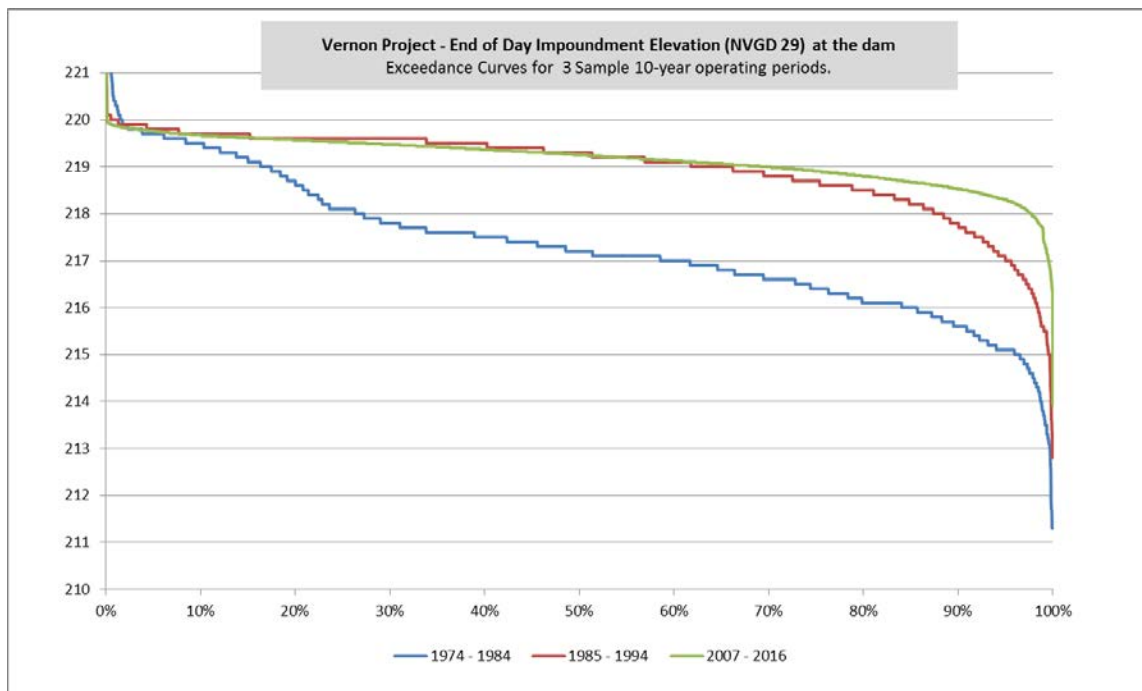
Figures 6.3-3 and 6.3-4 for Vernon show the most significant change in project operations over the course of the current license. Station generation dispatch, similar to Wilder and Bellows Falls, remained the same – responding to energy demand and price signals and values, during periods covering both pre-deregulation and post-deregulation of the wholesale generation market. In addition, the re-powering of Vernon by replacing Units 5-8 with more efficient turbine-generator units with slightly higher discharge capacity also does not appear to be a significant factor in the observed changes in impoundment operation and WSE fluctuation range. The major reasons for the shift over the term of the present license were the significant civil changes to the dam’s spillway crest control that were completed sometime in 1986 and the automation and consolidated central control center completed in 1998. Prior to completing the crest control project, the Vernon spillway was largely an ogee dam crest with eight feet of pin-type flashboards across the entire length of the spillway. Water elevations had to rise to a significant height above the board to cause them to fail as low as the crest (Elevation 212 ft m.s.l. NGVD29) and then the WSE of the impoundment would have to drop to control elevation based on board failure to rebuild the boards and restore the impoundment level. The crest control improvements at Vernon brought significant tainter gate capacity, hydraulic and stanchion flashboards and eliminated the re-occurring pin-flashboard failure operation. High flows can be passed through the project while managing WSE by this much improved tainter gate crest control. As mentioned above, significant improvement in water management and coordination between Vernon and upstream projects brought about by station automation and consolidation of operating staff and controls into a single control center accounted for a significant reduction in the normal impoundment operating or daily WSE fluctuation range.

Figure 6.3-3. Comparison of Vernon dam WSE over the current license term.

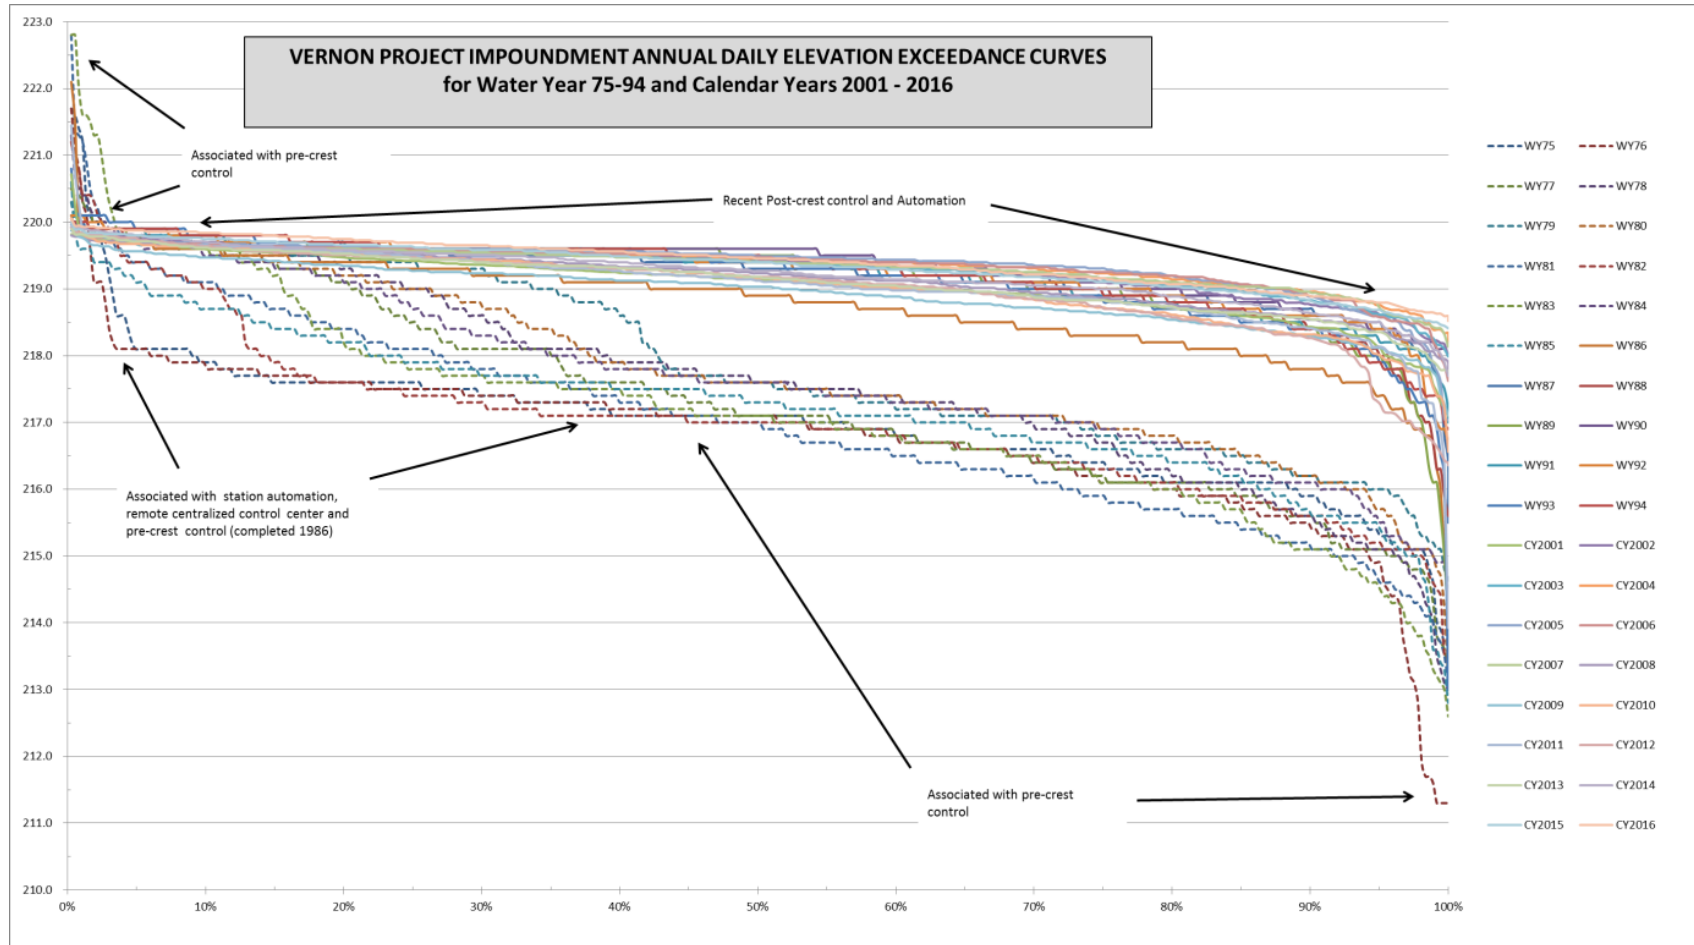
Figure 6.3-4. Vernon dam daily elevation exceedance curves over the current license term.

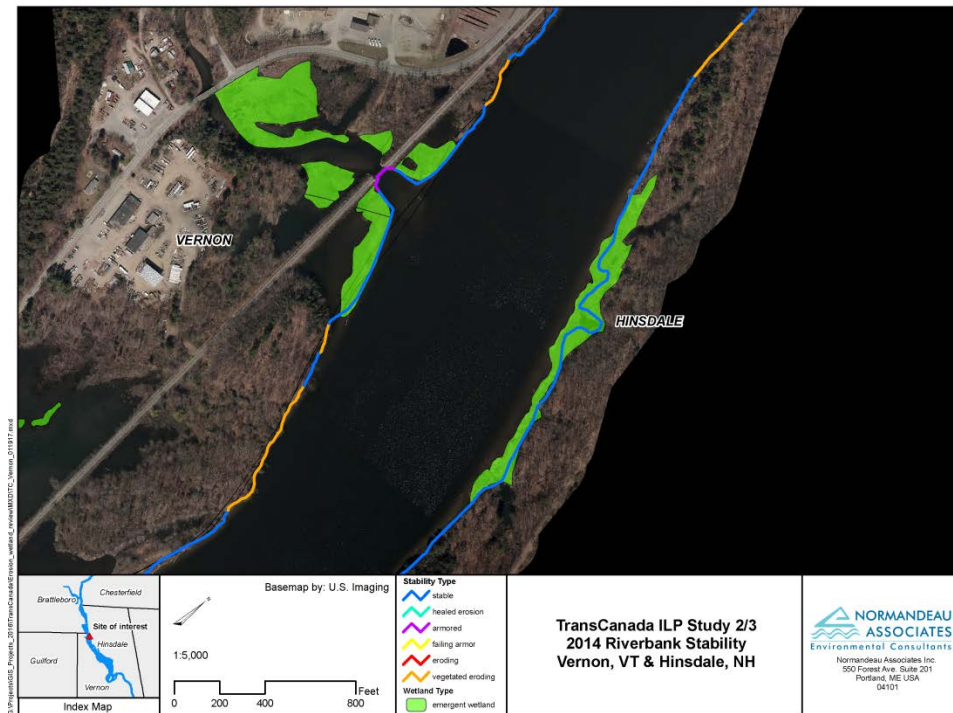
Figure 6.4.3-1. Example of emergent wetland associated with stable bank (Hinsdale NH side).

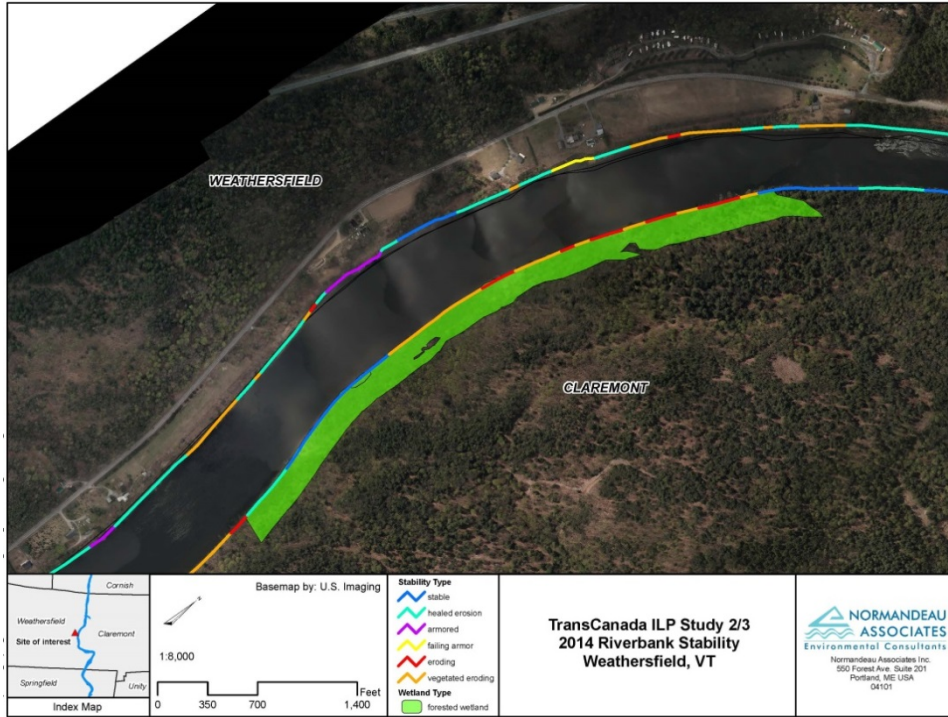
Figure 6.4.3-2. Example of forested wetland associated with both stable and unstable bank.

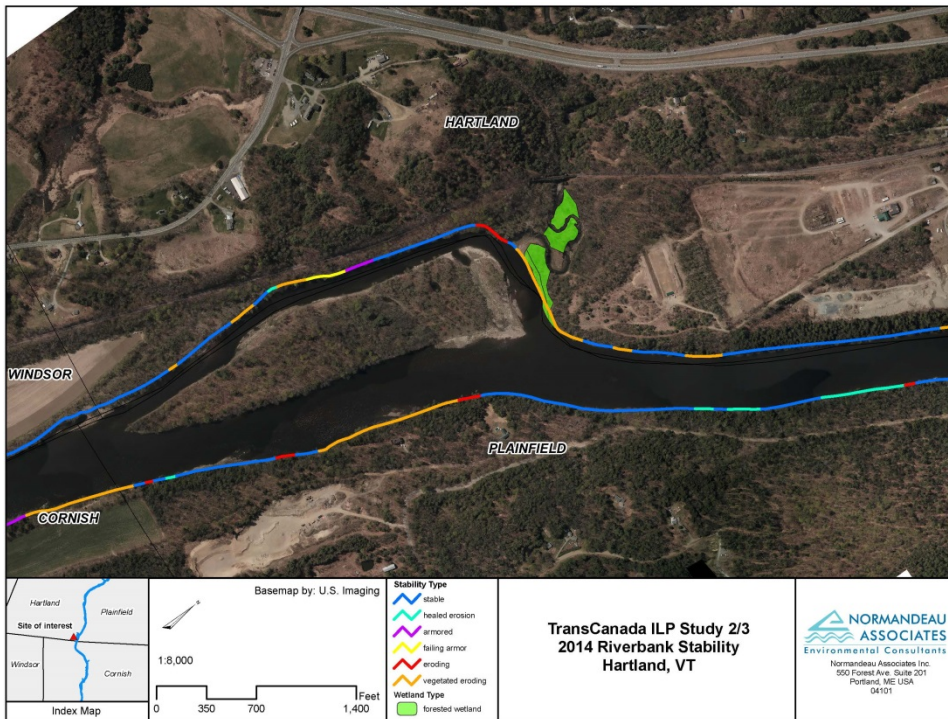
Figure 6.4.3-3. Example of forested wetland associated with unstable bank.

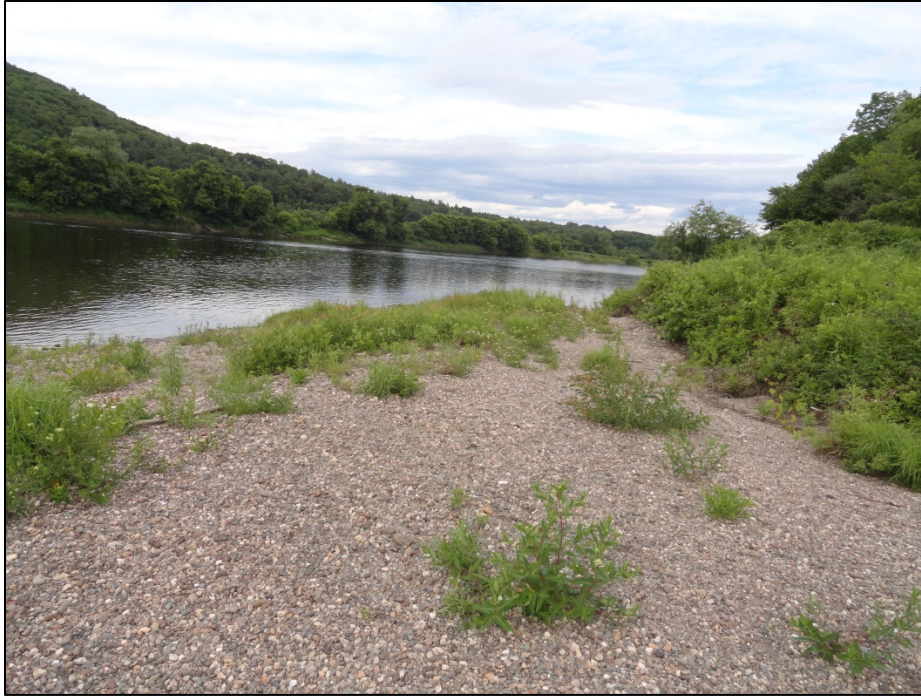
In the 2014 field surveys conducted for Study 26, cobblestone tiger beetles were observed within the identified study transects at seven of the 14 study sites. Individuals were also incidentally observed outside of the study transects at one additional site. Of the 14 study sites, only five were mapped for erosion (two sites were outside of project influence in tributaries and seven were on unmapped islands). All five riverbank study sites mapped for erosion were categorized as stable banks and contained exposed beaches below the riverbank elevation that was mapped. Of those riverbank sites, two had cobblestone tiger beetle observations (one with prior record of occurrence and one being a new record), two sites did not have observations, and one site had a possible occurrence but with low certainty. Of the seven island study sites that were not mapped for erosion, five had cobblestone tiger beetle observations (all with prior records), one site did not, and one site had a possible occurrence with low certainty. Figure 6.4.3-4 illustrates island habitat where the species was observed.

Figure 6.4.3-4. Example of island habitat with cobblestone tiger beetle observations.

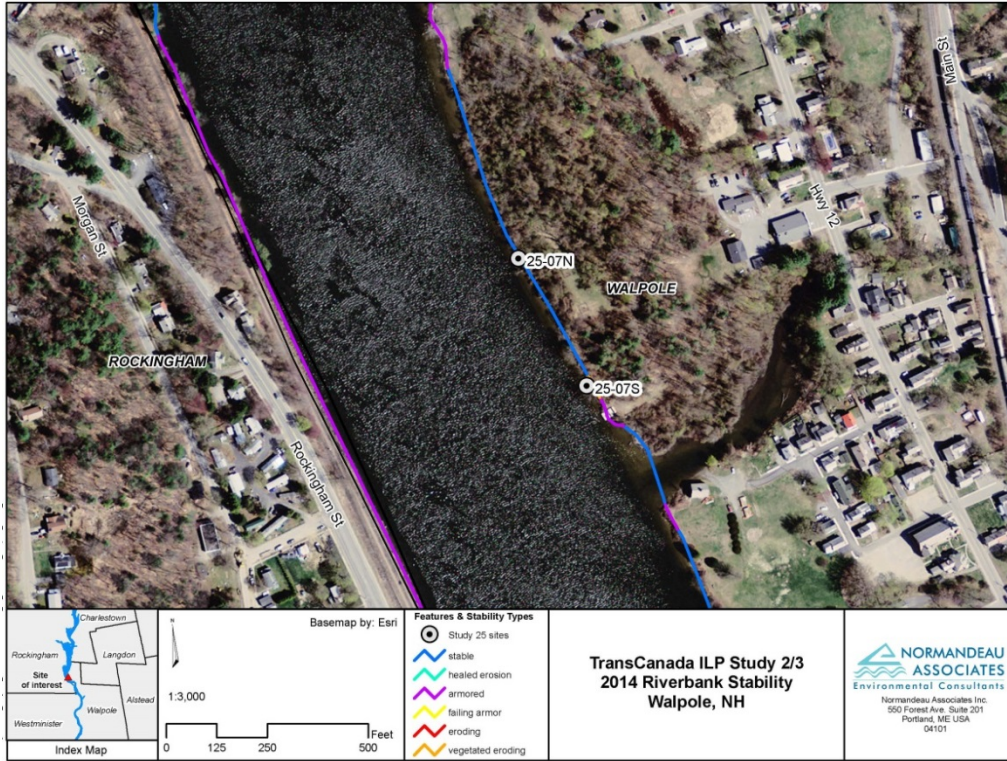
Collectively the four sites with unstable banks (two in impoundments and two in riverine sections) had the majority (73 percent) of SGCN species and a slight majority (50.5 percent) of all species observations. A further comparison of bank stability was made between two impoundment sites with similar numbers of all species, all individuals, SGCN species, and SGCN individuals. The two sites were different with one, Site 25-07 (Figure 6.4.3-5), located at a mostly stable bank and another, Site 25-09 (Figure 6.4.3-6), located at an unstable (sub category “eroding”) site.

Figure 6.4.3-5. Example of Odonate site mapped with stable banks.

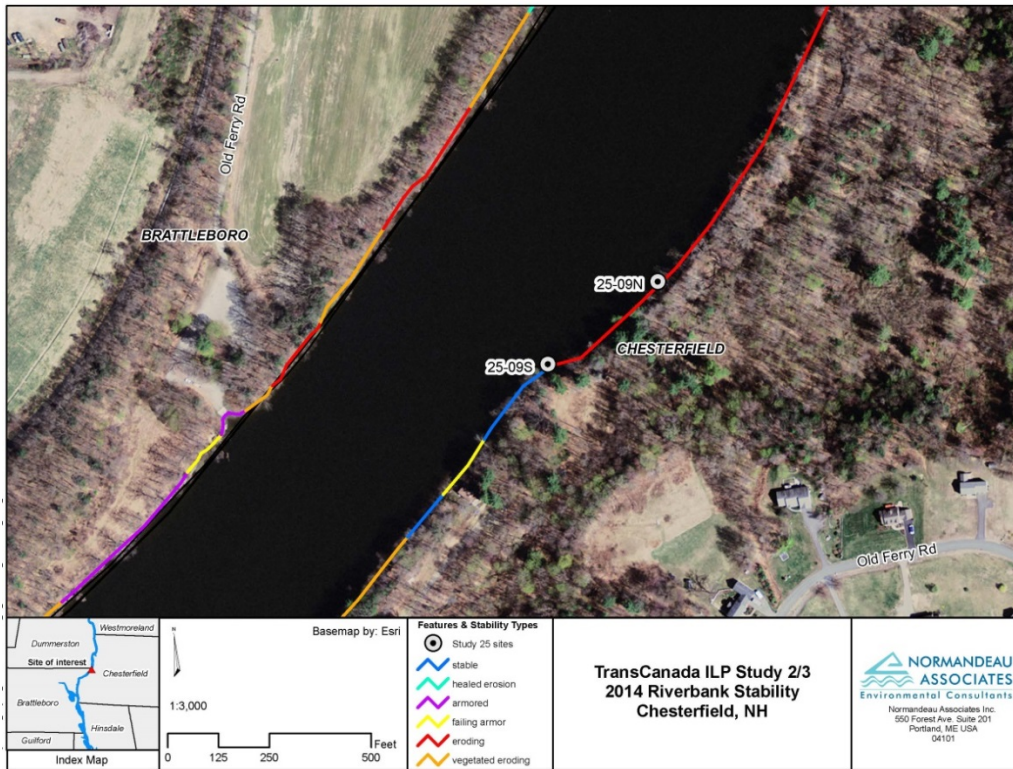
Figure 6.4.3-6. Example of Odonate site mapped with unstable banks.

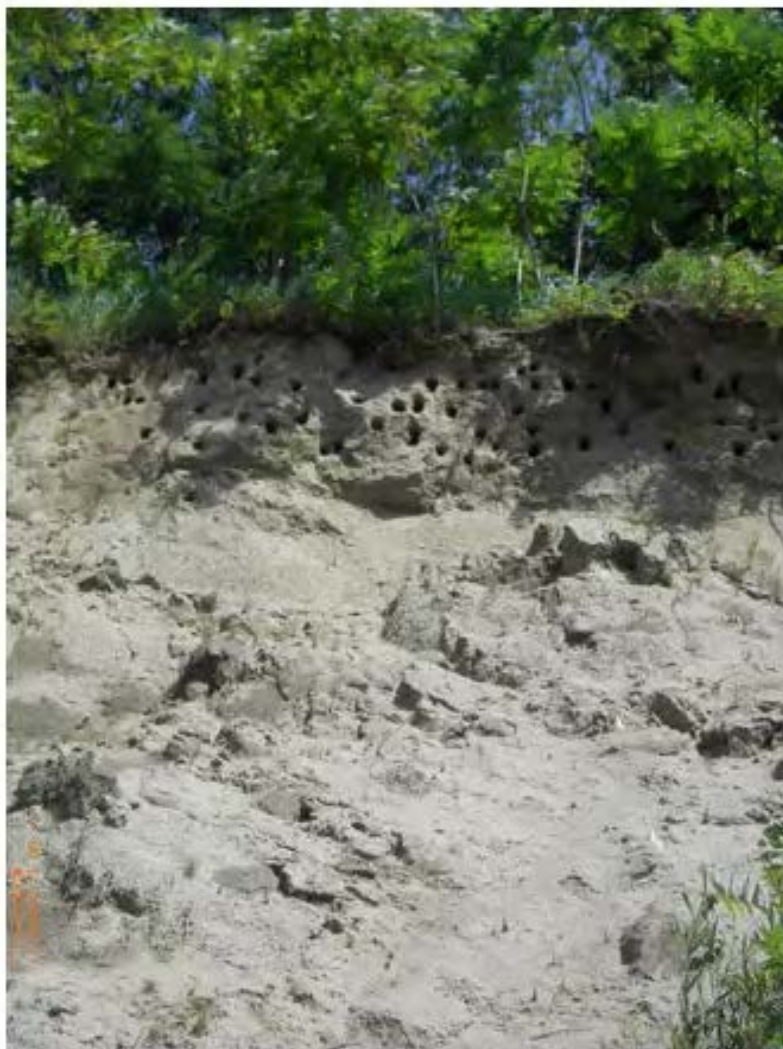
Bank swallows (*Riparia riparia*) require banks with large expanses of exposed substrate for nesting (Figure 6.4.3-7). These expanses are created by eroding banks, and attempts to stabilize banks have eradicated bank swallow colonies along the Connecticut River (Silver and Griffin, 2009). Incidental observations of five bank swallow colonies within the study area during 2014 terrestrial habitat mapping were located exclusively along banks that were mapped as unstable. Bank swallow is listed as a SGCN in New Hampshire and modifications to banks for erosion control is identified as a high priority threat (NHFGD, 2015). Erosion within the study area may be having a positive effect on bank swallow colonies by creating and maintaining suitable habitat, similar to that observed by Silver and Griffin (2009). Belted Kingfishers (*Megaceryle alcyon*) also rely on eroded banks for nesting; however, their solitary nesting behavior and low density distribution appear to make them less sensitive to loss of individual nest sites (Silver and Griffin, 2009).

Figure 6.4.3-7. Bank swallow holes established in an eroded riverbank at the Lipfert Site (02-B01, see Appendix A).

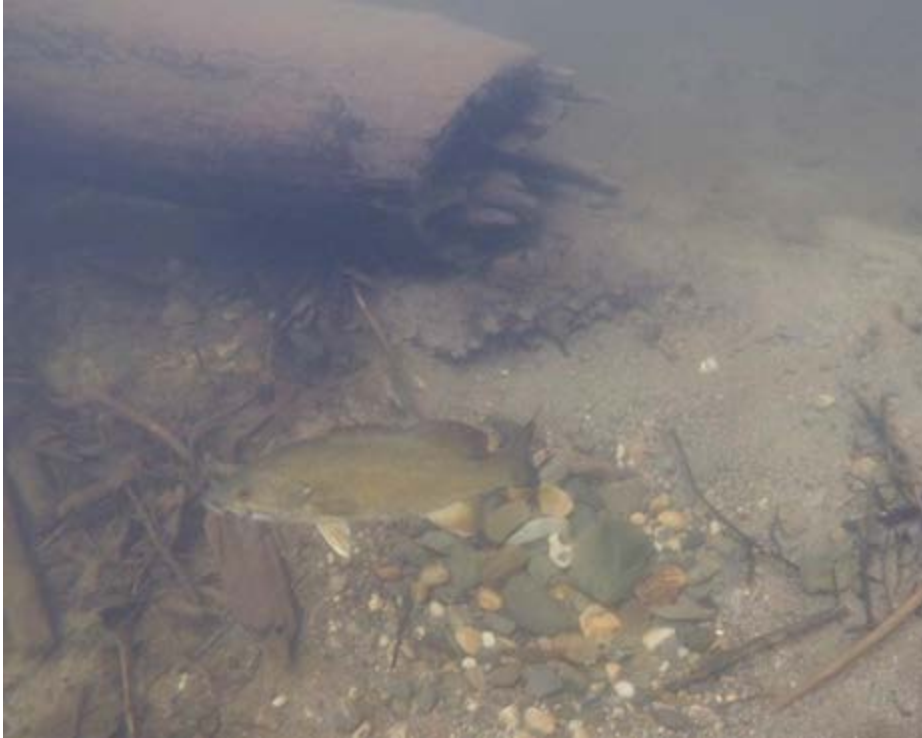
Figure 6.4.4-1. Smallmouth Bass nest with attending adult. Note large woody debris and fines.

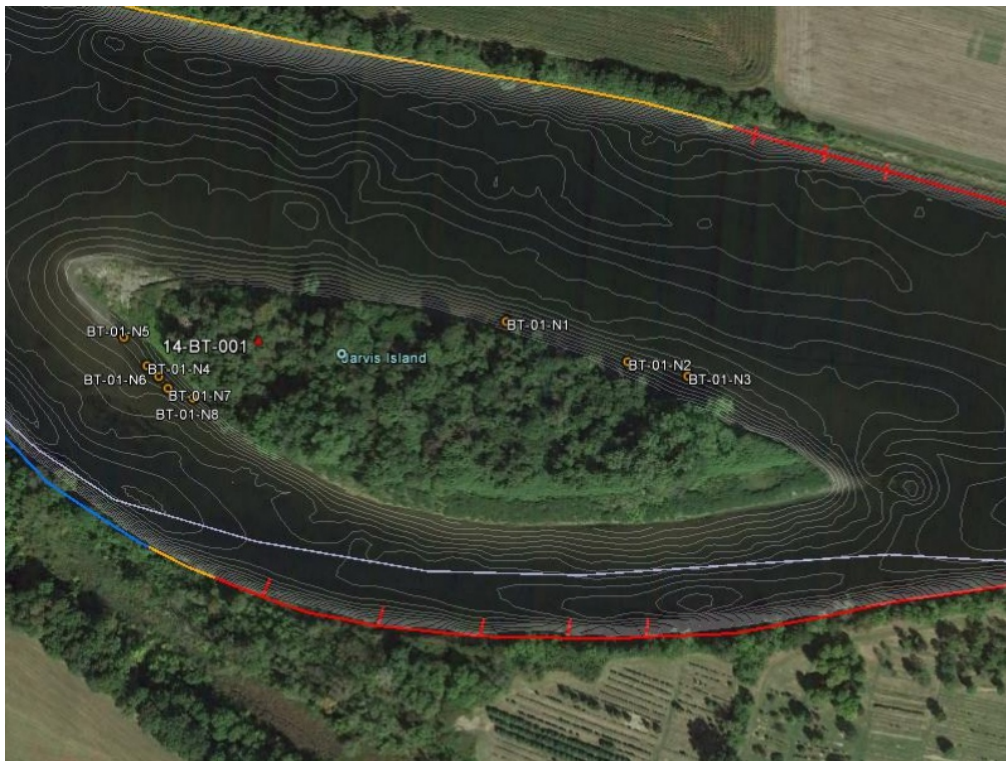
Comparison of nearshore bathymetry at unstable banks in the impoundments with known spawning locations of Smallmouth Bass clearly shows that bass utilize low-slope habitats for spawning. The slopes to nests were measured from the bank to each nest and the mean distance of the nests from the banks was used to generate equivalent distances from unstable banks to calculate those bank slopes. For example, eight Smallmouth Bass nests constructed along the margin of Jarvis Island in the Bellows Falls impoundment showed an average slope of 13 percent, whereas a comparable number of slope measurements estimated from the same mean distance from the mainstem banks mapped as unstable showed a mean slope of 27 percent (Figure 6.4.4-2, Figure 6.4.4-3). When comparative slope measurements from three tributary delta study sites were added, similar results were produced (11 percent slope for bass nests, 33 percent for eroding banks (Figure 6.4-10).

Figure 6.4.4-2. Map of Jarvis Island study site (site 14-BT-001) showing location of 8 Smallmouth Bass nests and 8 comparative slope transects at eroding banks (red perpendicular lines). Note the length of erosion slope transects is equal to the average distance of bass nests from the bank.
