**TRANSCANADA HYDRO NORTHEAST INC.**

**ILP Study 2 and Study 3  
Riverbank Transect and Riverbank Erosion Studies**

***Final Study Report***

Wilder Hydroelectric Project (FERC Project No. 1892-026)  
Bellows Falls Hydroelectric Project (FERC Project No. 1855-045)  
Vernon Hydroelectric Project (FERC Project No. 1904-073)

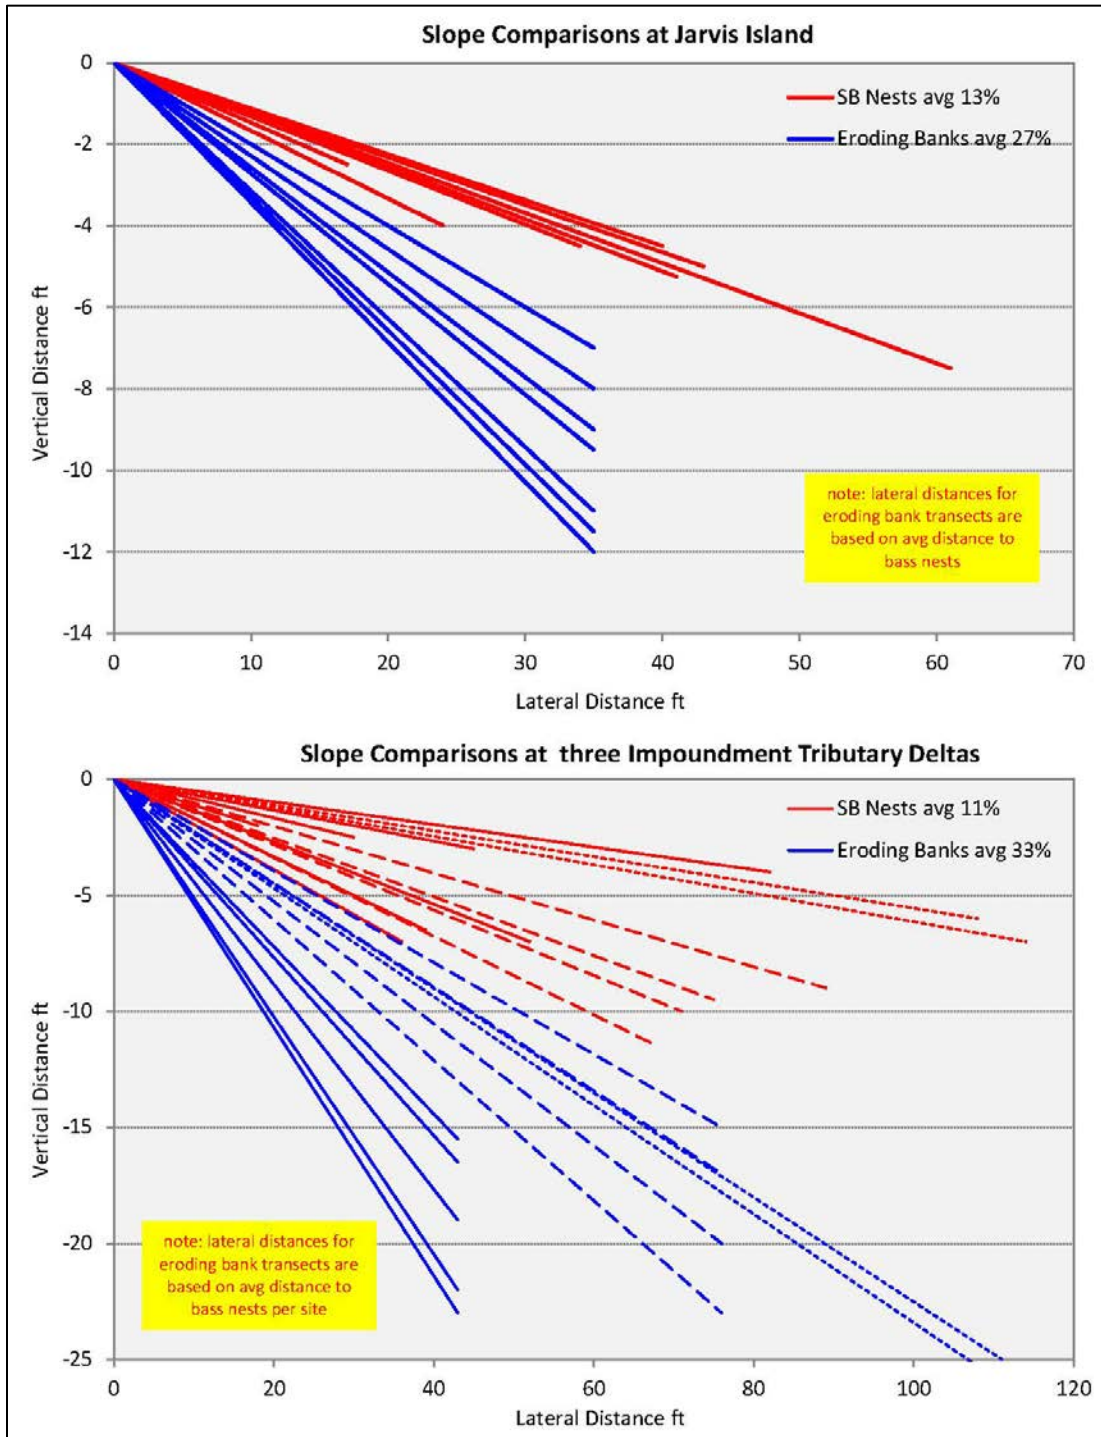
Figure 6.4.4-3. Channel slopes at Smallmouth Bass (SB) nests and at nearby eroding banks at Jarvis Island (top graph) and at three tributary deltas (bottom graph). Note that the lateral distance of eroding bank slopes were equal to the mean distance of bass nests per study site. Line types represent different study sites.

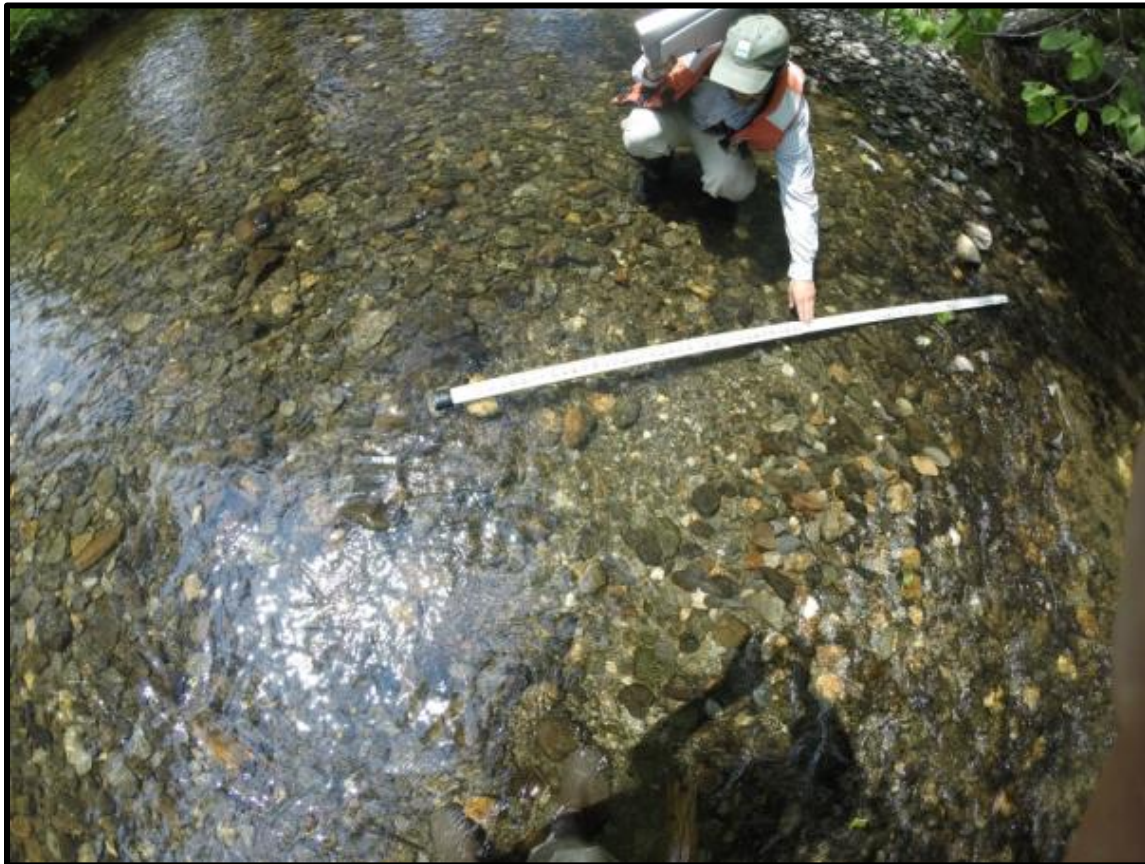
Figure 6.4.4-4. Sea Lamprey nest site in the project-affected reach of Partridge Brook.

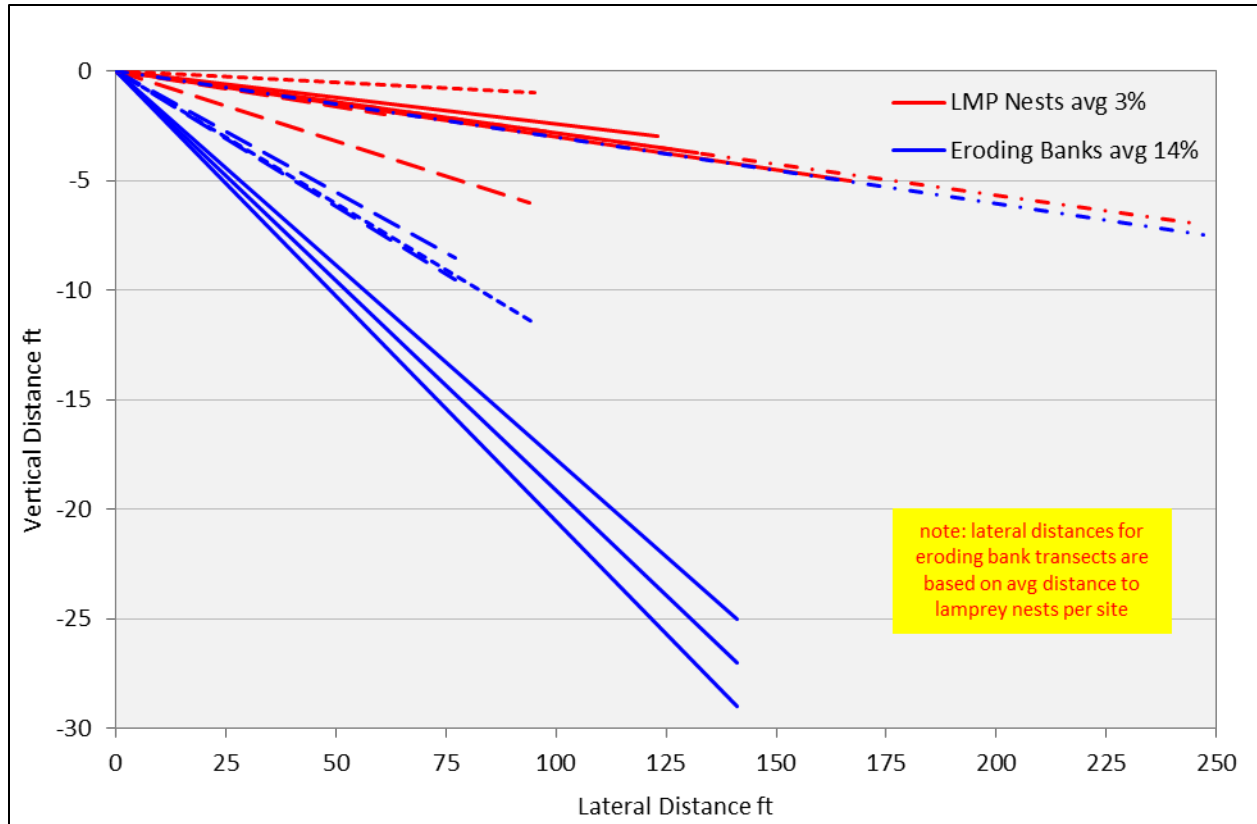
Comparison of slopes at seven lamprey nests with slopes at nearby eroding banks (also extending far from shore) at four impoundment study sites again showed that lampreys typically did not spawn at sites proximal to eroding banks, which possessed steeper slopes with deeper water (Figure 6.4.4-5).

Figure 6.4.4-5. Comparison of slopes at Sea Lamprey (LMP) nest sites and at nearby eroding banks at four impoundment study sites. Note that the lateral distance of eroding bank slopes were equal to the mean distance of lamprey nests per study site. Line types represent different study sites.

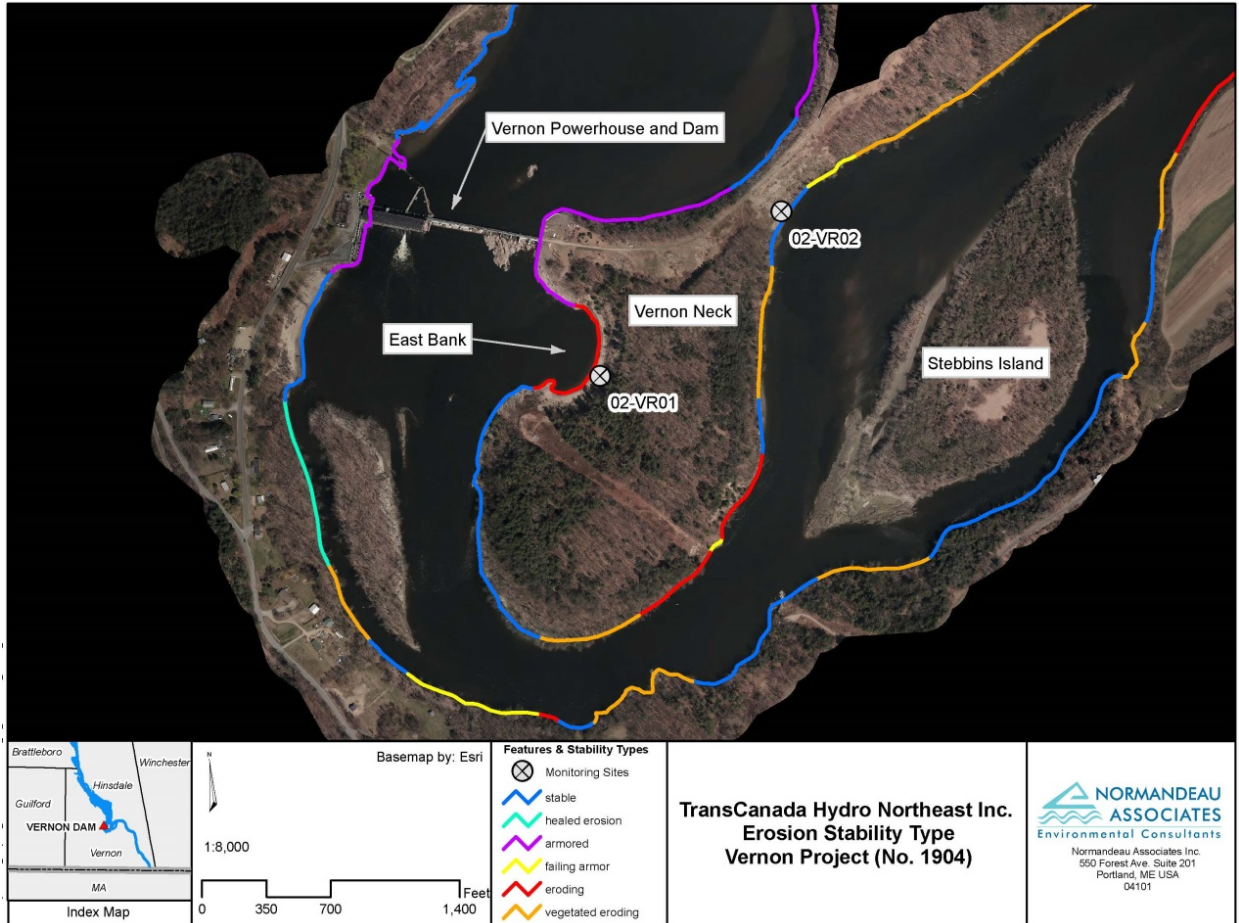
55% of banks mapped as unstable in that reach (see Figure 5.6.5-3c, Section 5.6.5a).

Figure 6.4.5-1. Bank stability in the Vernon riverine reach.
