**ILP Study 2 and Study 3
Riverbank Transect and Riverbank Erosion Studies**

Study Report

Wilder Hydroelectric Project (FERC Project No. 1892-026)
Bellows Falls Hydroelectric Project (FERC Project No. 1855-045)
Vernon Hydroelectric Project (FERC Project No. 1904-073)

August 1, 2016

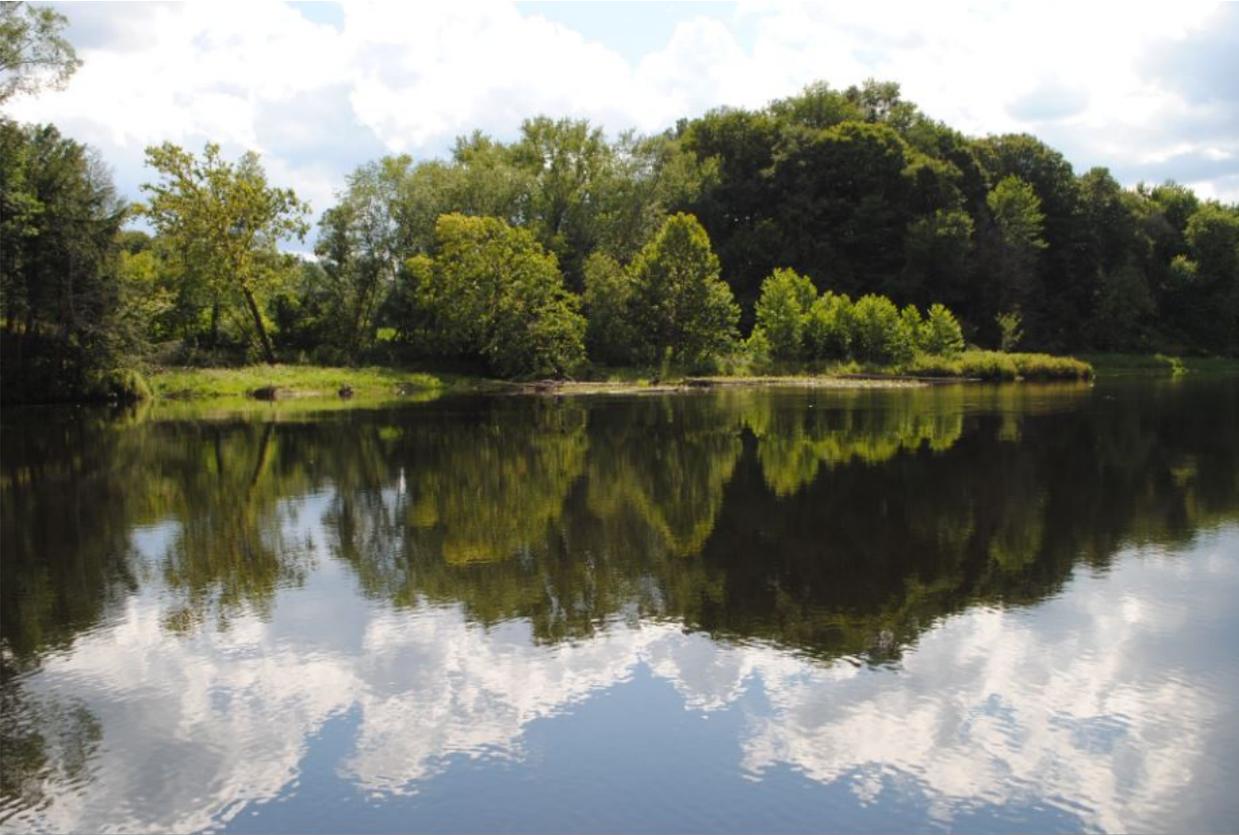
Figure 5.2.1-1. Delta building out from a small tributary into Vernon impoundment.

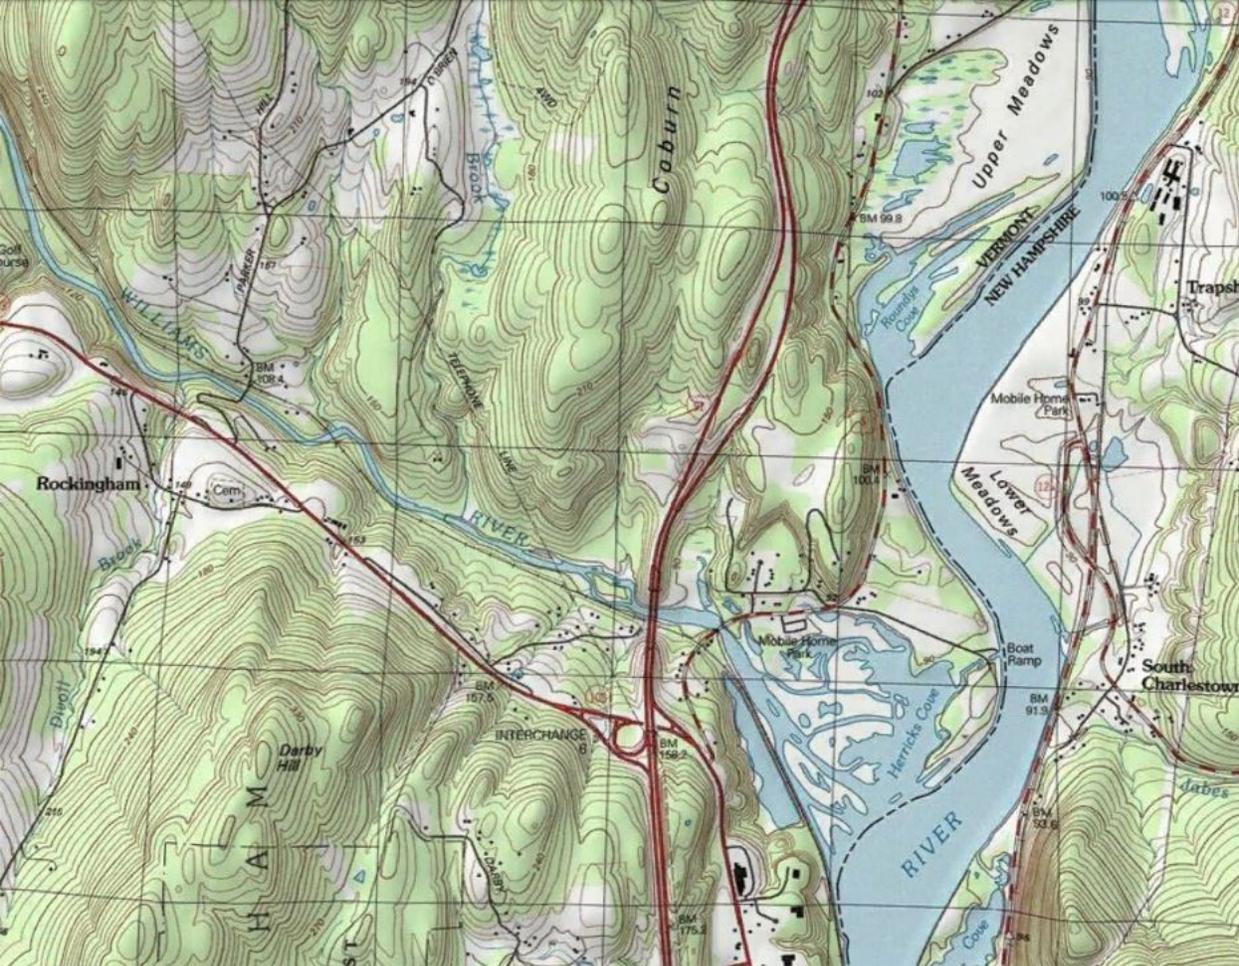
Figure 5.2.1-2. Williams River delta in Rockingham, Vermont forces river to opposite valley wall and backwaters upstream to form low meadows.

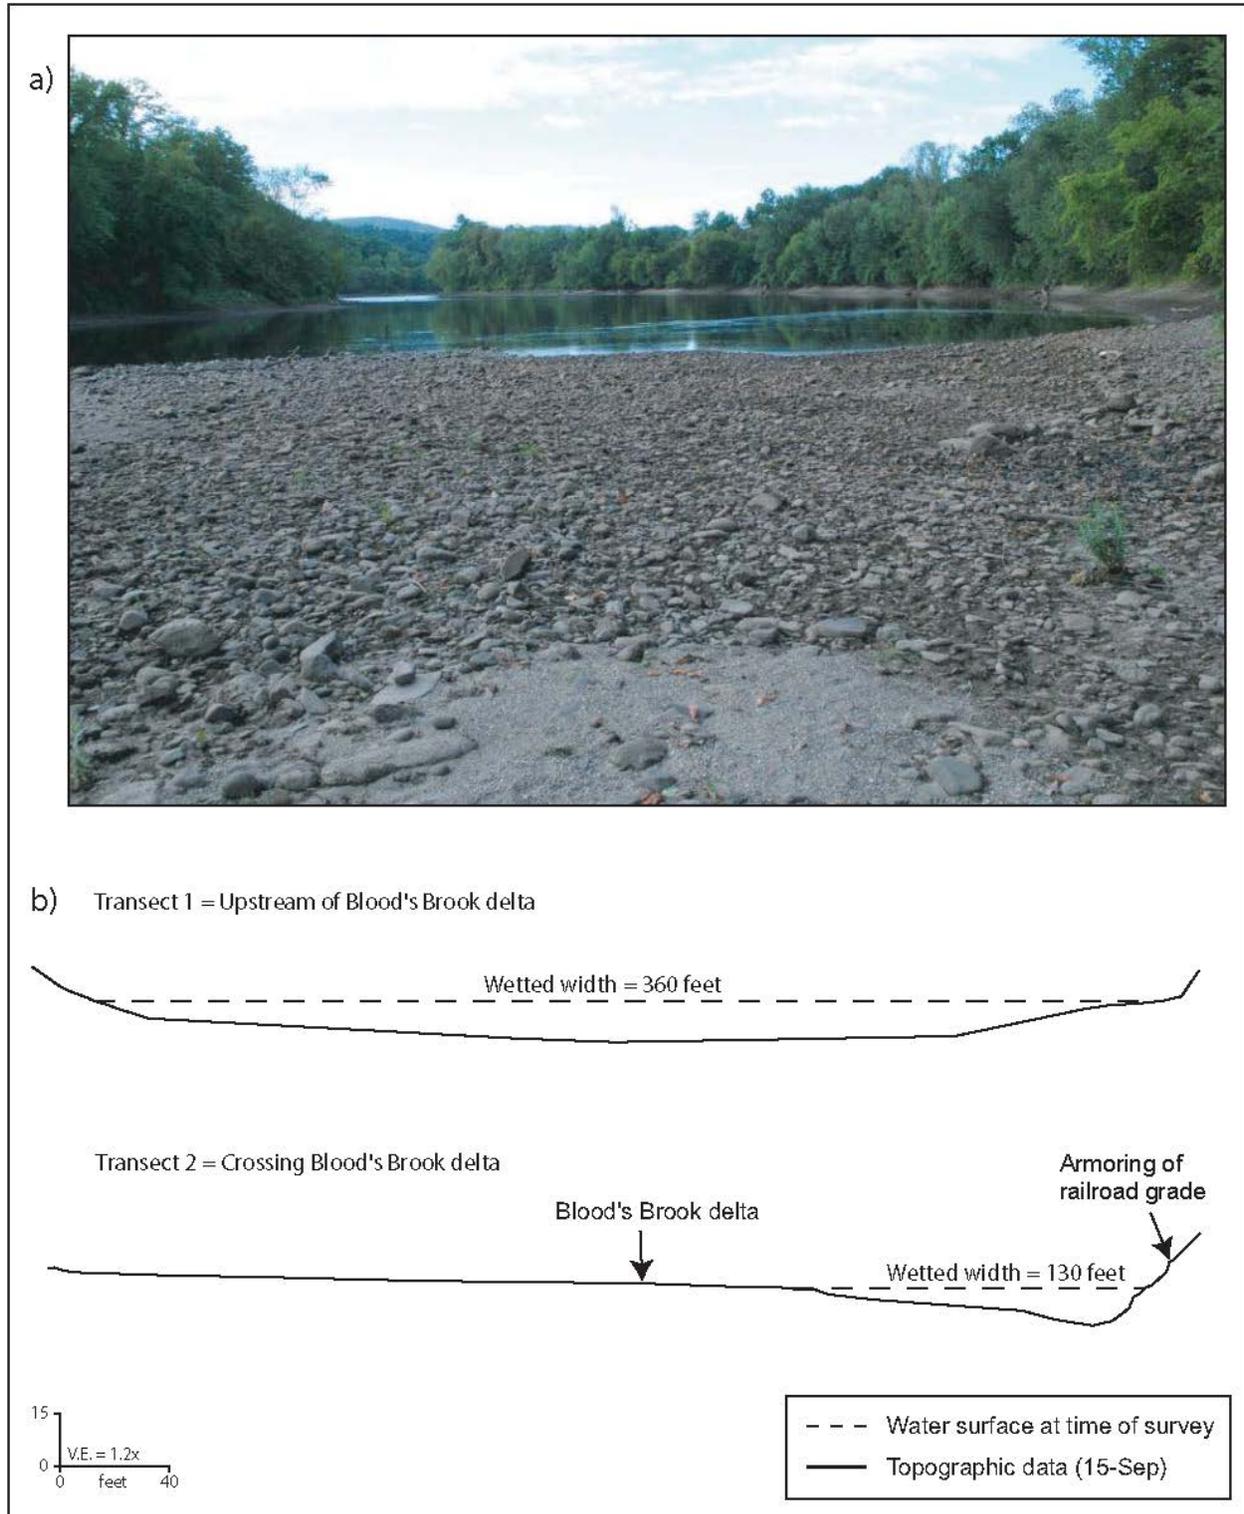
the channel and often leads to erosion along the opposite bank. Where erosion is not present, the bank as at Blood’s Brook, has been armored to prevent erosion.

Figure 5.2.1-3. Blood's Brook has a) formed a large boulder delta that has b) narrowed the channel compared to upstream (and downstream, not shown).

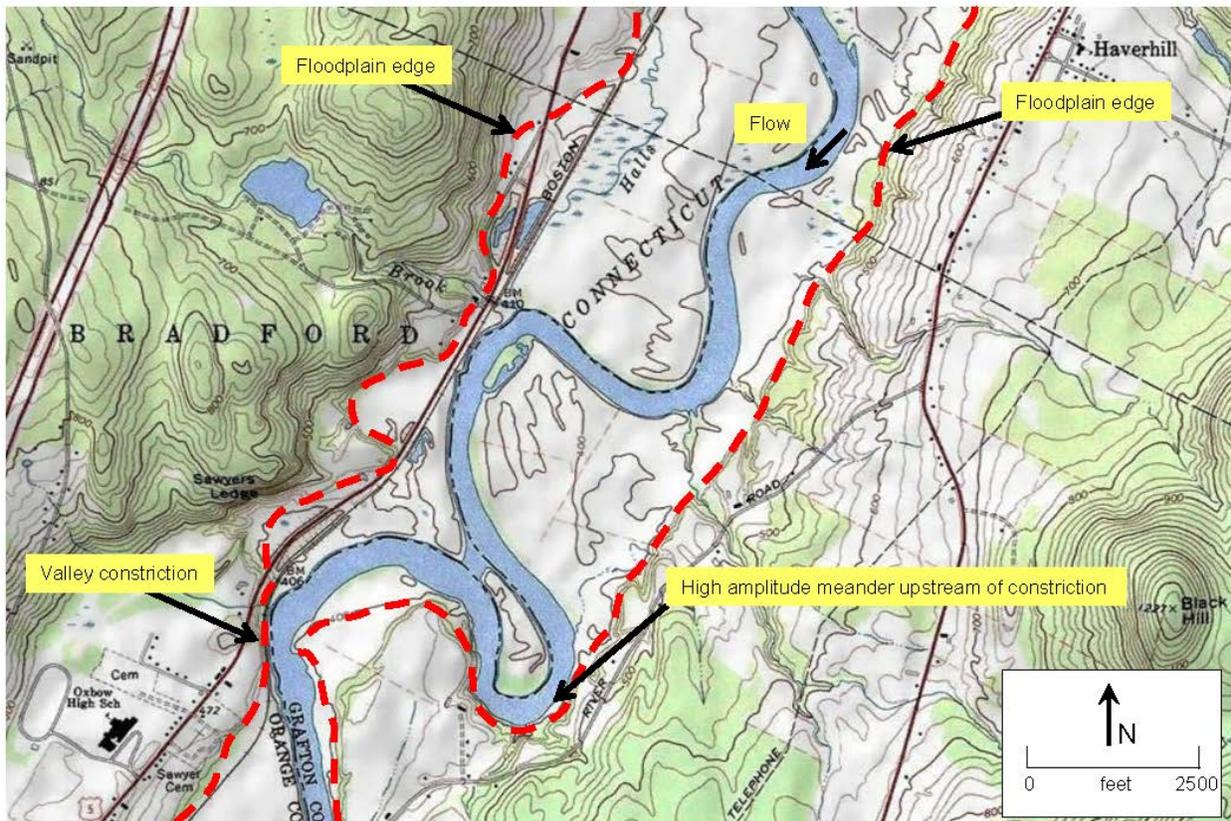
At several locations in the study area, the river is constrained by mountainous valley side slopes or by the high banks of stream or glacial terraces, thereby creating natural constrictions along the river relative to areas immediately upstream where a wide floodplain is present (Figure 5.2.2-1). At least 36 significant constrictions were identified in the study area by carefully inspecting topographic maps and a GIS point shapefile (Appendix C, filed separately in ArcGIS [zipfile] format) created to show their locations. Flood flows encountering a constriction like these will back up on the wider floodplain upstream before passing through the narrower constricted valley. Deposition often results upstream of the constriction in response to the backwatering and associated reductions in flow velocities. The deposition, in turn, results in flow deflection into the riverbanks and consequent bank erosion. These processes ultimately lead to the growth of the high amplitude meanders that are evident at many valley constrictions in the study area (Figure 5.2.2-1). Although developed over long periods of time (i.e., decades or centuries), the presence of these meanders is evidence that the constrictions are capable of altering the passage of flood flows down the valley, so are likely to govern the distribution of depositional features and bank erosion near the constrictions.

Figure 5.2.2-1. Valley constrictions are often associated with upstream deposition, meander formation, and bank erosion.

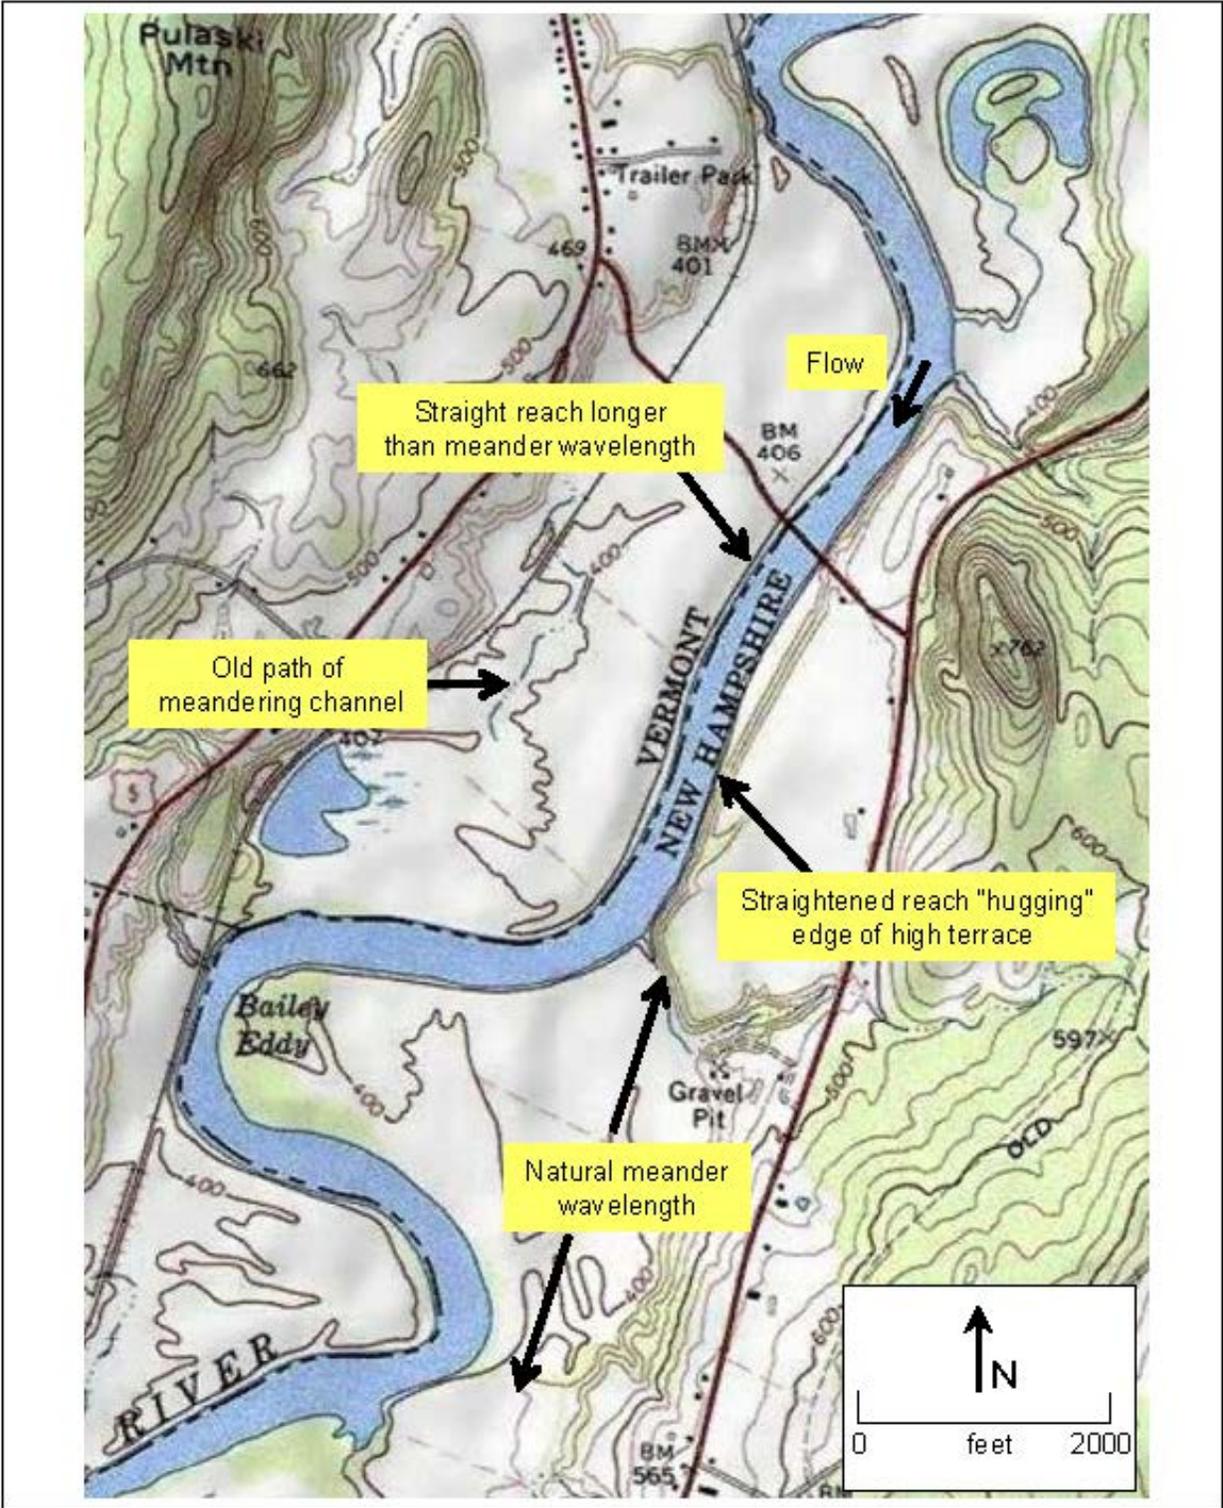
Human activities in the watershed and in the channel have also impacted channel conditions and the distribution of bank erosion. On the upper Connecticut River upstream of the study area, evidence drawn from maps and field studies suggests more than 30% of the river channel was artificially straightened and is considered a primary cause for erosion today (Field, 2005) even though much of that straightening was due in large part to large log drives that occurred throughout the late 19th and early 20th centuries (Gove, 2003); and railroad construction in the latter half of the 19th century. The evidence for straightening is ubiquitous on rivers and streams throughout New England (Field, 2007a). Straightening is more difficult to confirm within the study area due to the river's large size, the presence of impoundments which may obscure evidence of straightening, and extensive valley confinement (where the channel could be naturally straight). In the upper Wilder impoundment where the floodplain is at its widest, some straightening can be observed on topographic maps (Figure 5.2.3-1). At least one of three features should be present to verify channel straightening: 1) a straight reach longer than the wavelength of nearby meanders; 2) a channel position that "hugs" the edge of the valley; and 3) the presence of the original meandering channel in some form on the adjacent floodplain. Figure 5.2.3-1 shows possible evidence for all three features and also shows how railroad construction cut off the apex of a meander, a type of partial straightening (or channel shortening) seen at multiple locations in the study area. The shortening of the channel resulting from straightening increases the channel slope and flow velocity which in turn, often results in bank erosion as the channel adjusts in response to the alteration of its natural form.

Figure 5.2.3-1. Evidence for channel straightening near Newbury, VT.

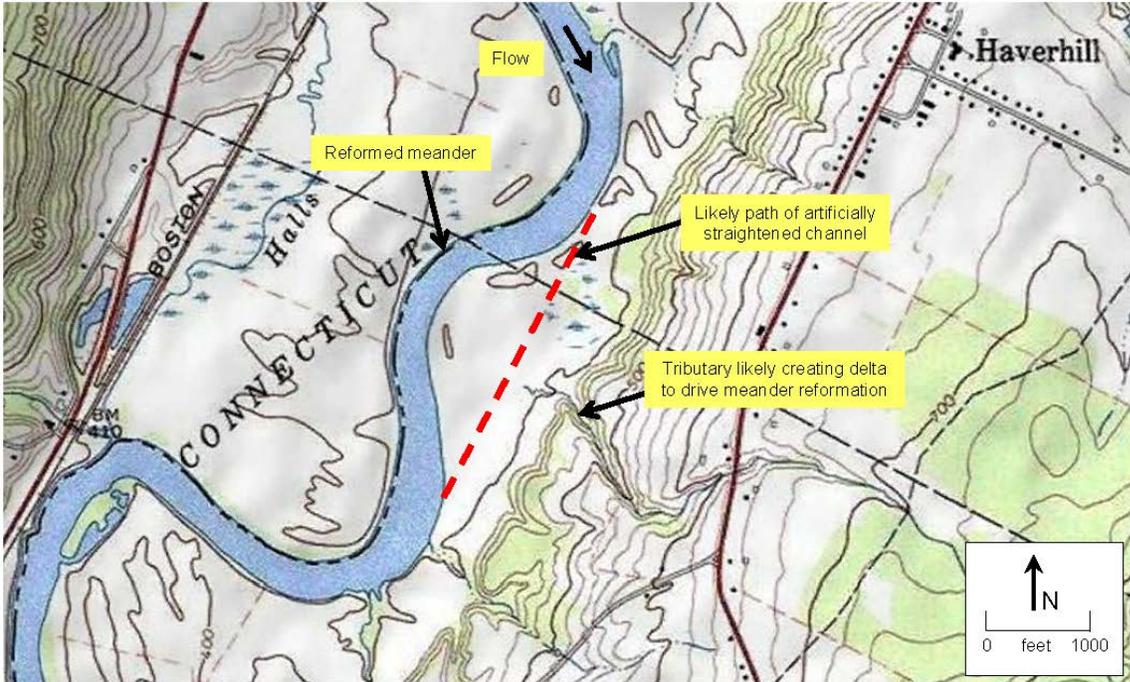
The channel adjustments following straightening ultimately lead to the reformation of meanders along artificially straightened channels (Field, 2007b). Evidence for this is also seen in upper Wilder impoundment on the Haverhill/Piermont, New Hampshire town line where a small unnamed tributary built out sediment into a straightened reach of channel to form a symmetrical meander (Figure 5.2.3-2). Although the meander formed prior to 1935 (as seen on an historic topographic map), topographic surveying of the area as part of this study confirms a low area along the bank where the delta built out into the channel several decades ago (see data presented in Section 5.7). Very rapid meander formation, and as a result rapid bank erosion, can occur where considerable sediment enters the channel at tributary confluences. This is enhanced where the tributary passes through easily erodible clay deposits, producing high sediment loads. At the mouth of Clark Brook near North Haverhill, New Hampshire, after flowing for over 2.5 miles through clay deposits, well stratified bank sediments on the Connecticut River show evidence for the rapid growth of a point bar that has now developed into a low floodplain surface (5.2.3-3). Slowly deposited bank sediments are often homogenized through disturbance by animals (e.g., burrowing) and plant growth (e.g., roots), so the preservation of point bar features in the bank is an indication of rapid bar growth.

Figure 5.2.3-2. Meander reformed on straightened reach at Piermont/Haverhill, NH townline where tributary enters Connecticut River valley.

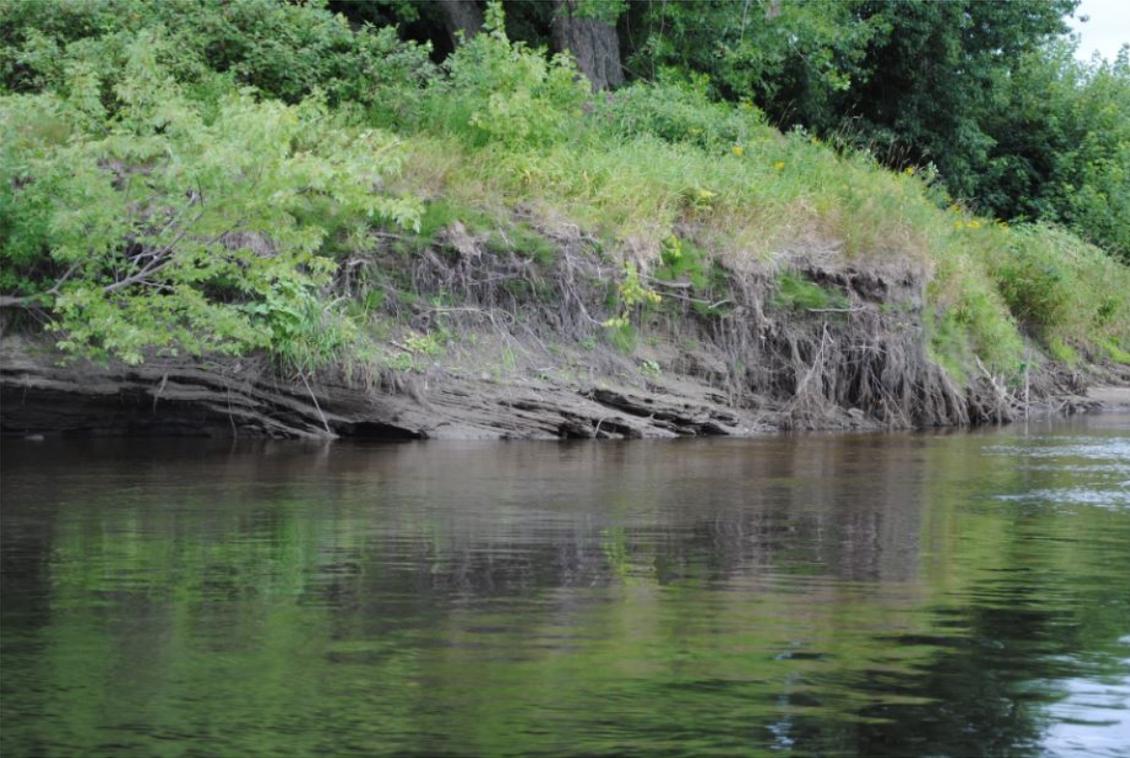
Figure 5.2.3-3. Bank sediments preserving rapidly deposited point bar near North Haverhill, NH.

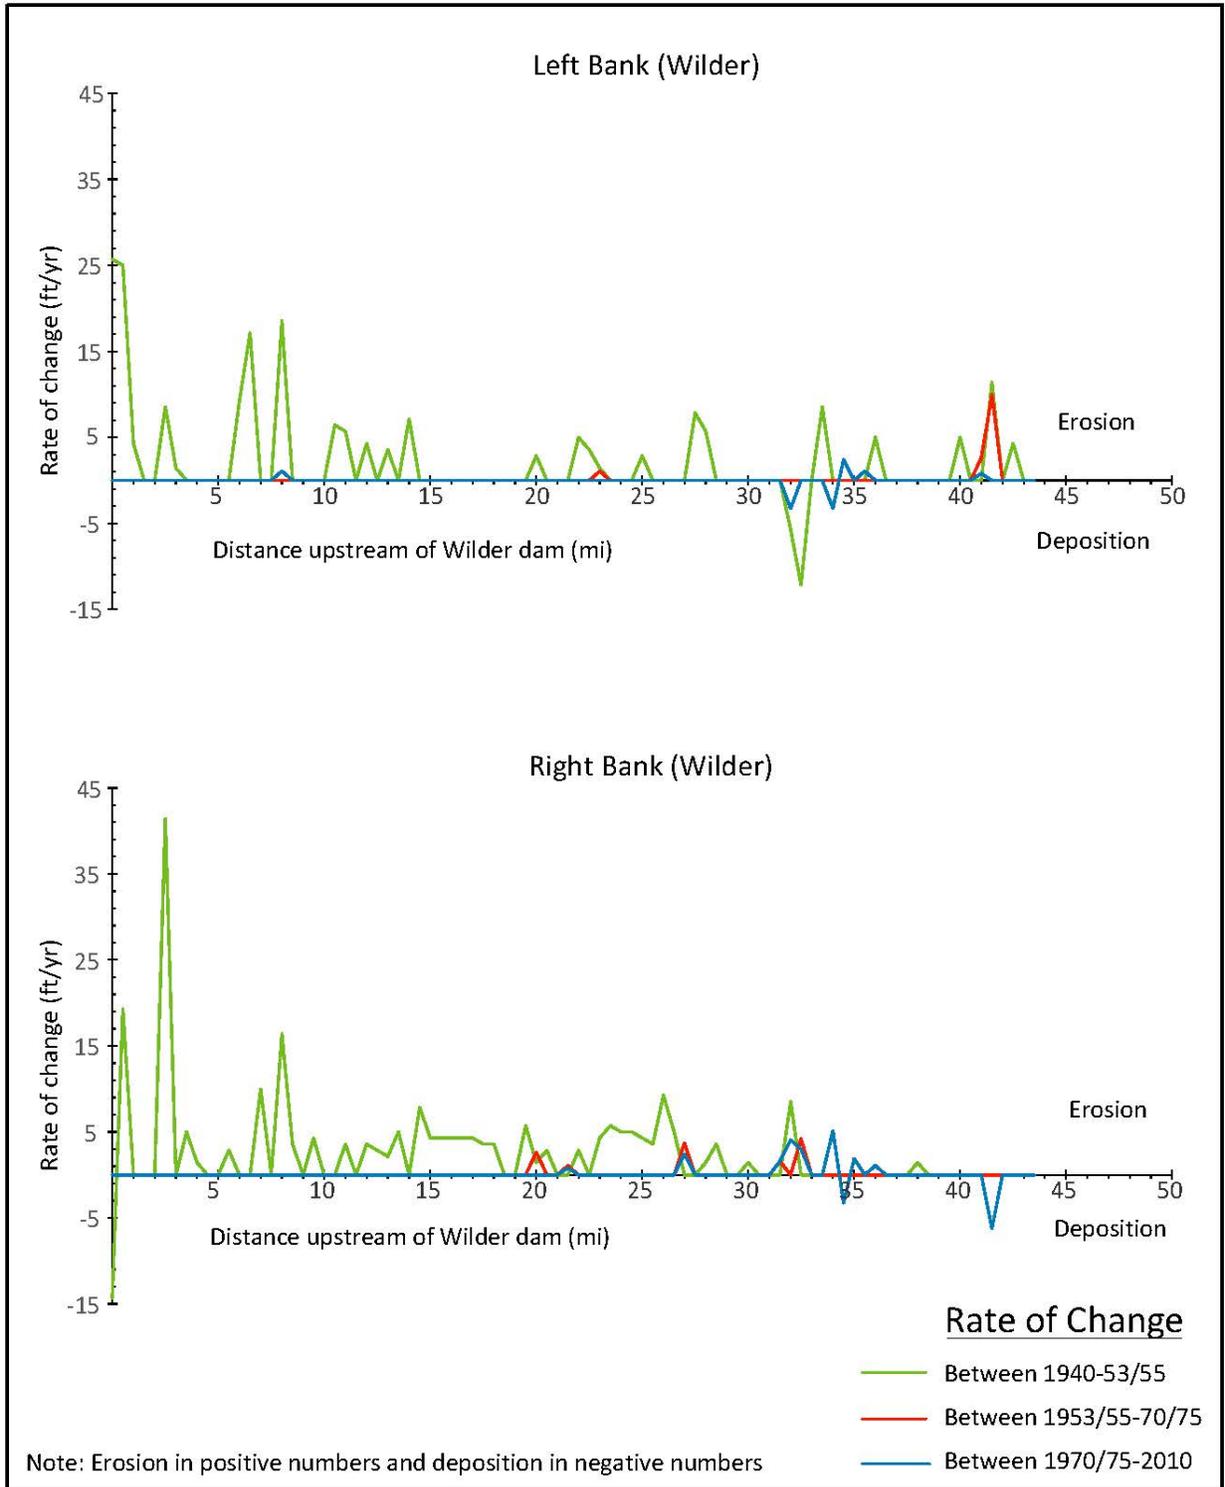
Upstream of Wilder dam, considerable change occurred between the 1939/40 and 1953/55 sets of aerial photographs. Changes observed on the historical aerial photographs are most dramatic in the lower Wilder impoundment between the 1939/40 and 1953/55 photographs. Although displayed as a rate of change in Figure 5.3-1a, these changes are the result of inundation caused by the raising of Wilder Dam in 1950, likely happened in less than a year, and are not the result of erosion. Actual erosion seems likely around mile 32 above the dam on the right bank (as shown on Figure 5.3-1a) as matching deposition is present on the left bank, whereas at other locations the changes occur on both banks simultaneously, a trend consistent with the inundation up and perhaps over the banks. The actual change due to the raising of the dam in 1950 likely occurred in less than one year but expressing the change as a rate over the whole time period enables more meaningful comparisons with the rest of the data set. The rapid spatial changes expressed by spikes on the graphs in Figure 5.3-1 with large changes at one 0.5-mile point and no change at an adjacent 0.5-mile point may reflect changes in bank height (as a steep vertical bank would reflect little change in position in response to the raising of the dam) and bank composition or armoring (as a resistant bank would be less likely to recede even if the erosive forces are the same over a mile long reach of river). After the 1953/55 series very little change is documented through the historical aerial photograph analysis and what change is observed is almost exclusively restricted to the upper half of the Wilder impoundment. The lack of change in the lower impoundment is likely due to the extensive bank armoring in that area (see Section 5.6).

Figure 5.3-1a. Rates of change in riverbank position through time upstream of Wilder dam.

impoundment (Figure 5.3-1a) is more likely related to upstream inflows than Wilder project operations. The upper Wilder impoundment is closer to the McIndoes project than to Wilder dam. Therefore, McIndoes inflows along with significant natural discharges likely have a greater impact on erosion rates in upper Wilder impoundment than Wilder project operations.

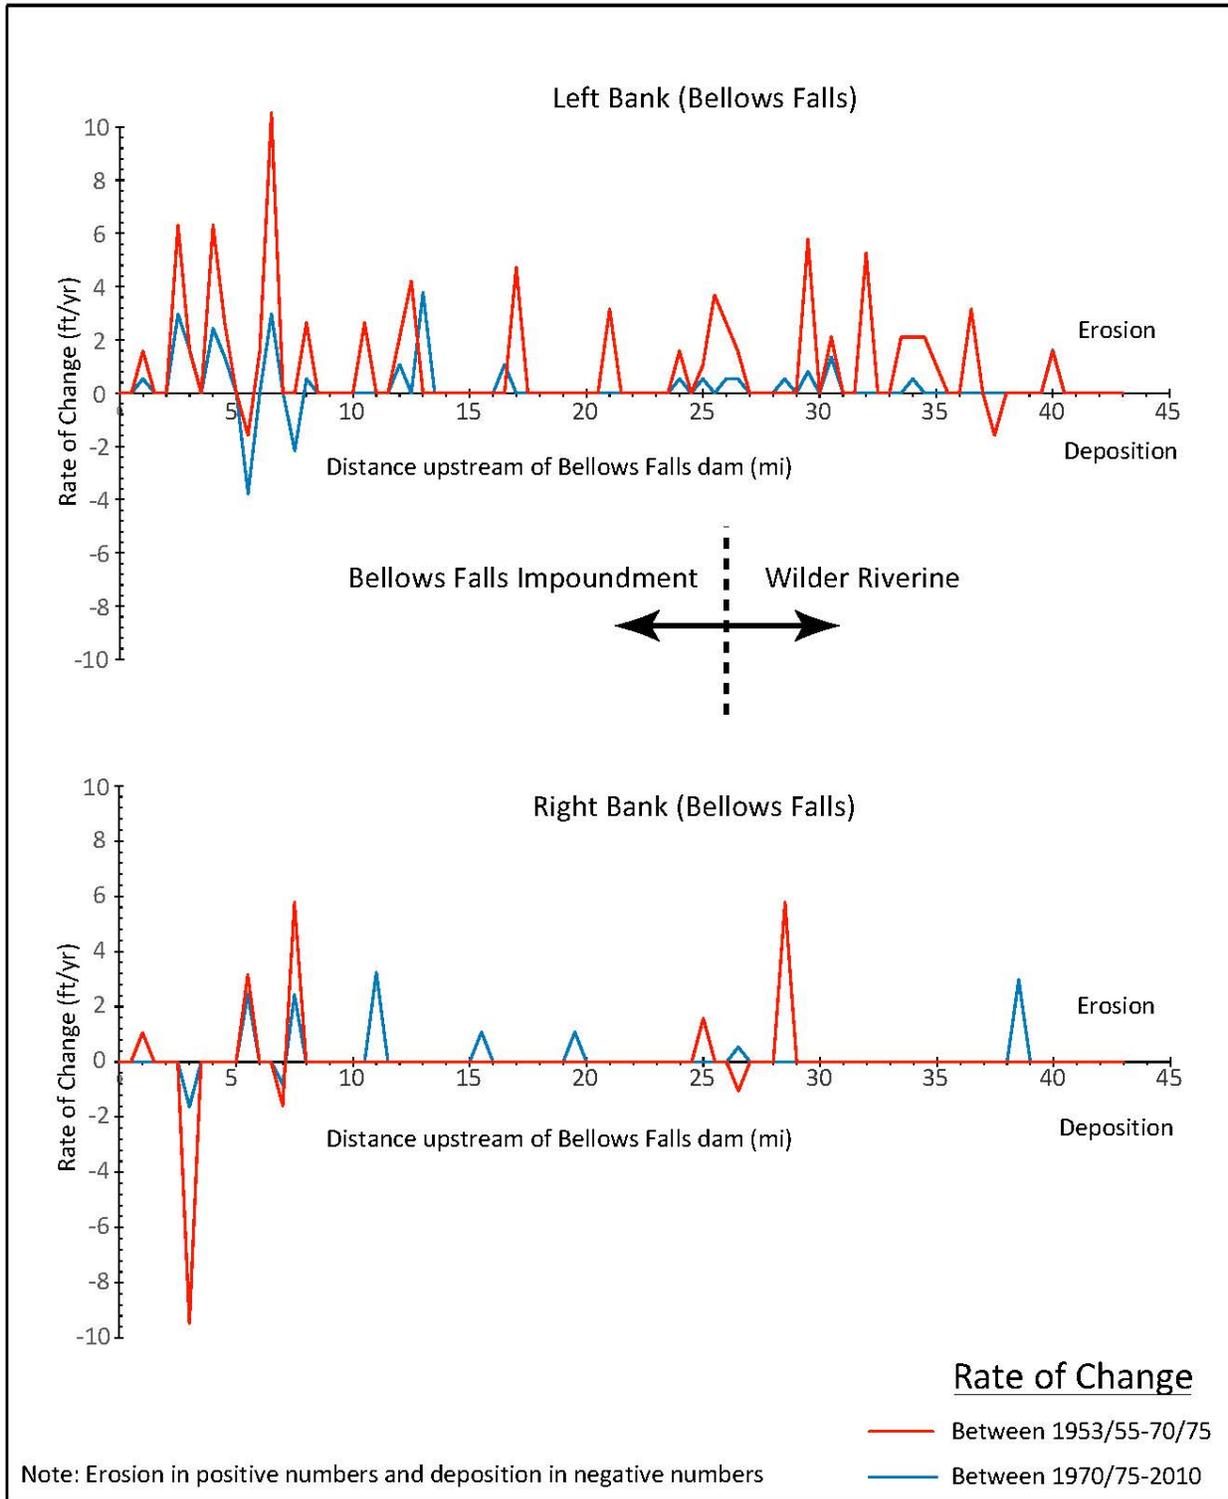
The channel through the Bellows Falls impoundment appears to have experienced far more bank erosion and deposition than Wilder (and Vernon) impoundments through time (Figure 5.3-1b). Ground evidence such as sand bars in the channel, scroll bars on the low floodplain (i.e., subtle ridge and swale topography formed by meander migration), and the most significant bank retreat at any of the 21 monitoring sites throughout the study area (see Section 5.4) all corroborate the finding that significant changes have occurred. Spatially, the rate of erosion in the lower Bellows Falls impoundment in general, has been higher through time than in the upper impoundment or Wilder riverine reach. This may be due to the backwatering effects upstream of the Williams River confluence that could enhance erosion in the lower impoundment (as described in Section 5.2.1). Temporally, the rate of erosion appears to have declined through time as expressed in Figure 5.3-1b by the shorter peaks of the 1970s-2010 time interval nested inside the taller peaks of the 1950s-1970s time interval. Very few aerial photographs from the 1939/40 series were available downstream of Wilder dam so were not included in those analyses below Wilder dam. The rate of erosion has declined by 50% or more since the 1970s at many locations. As described in Section 5.4, one Study 2 erosion monitoring site (Site O2-B07) along the left bank (looking downstream) in the lower Bellows Falls impoundment experienced more than 7 ft of bank recession over a two year period. Based on the approximately 3 ft/yr erosion rate derived from the historical photo analysis at many sites in the lower impoundment for the 1970s-2010 time interval, additional bank recession at that monitoring site seems possible every few years.

Figure 5.3-1b. Rates of change in riverbank position through time upstream of Bellows Falls dam.

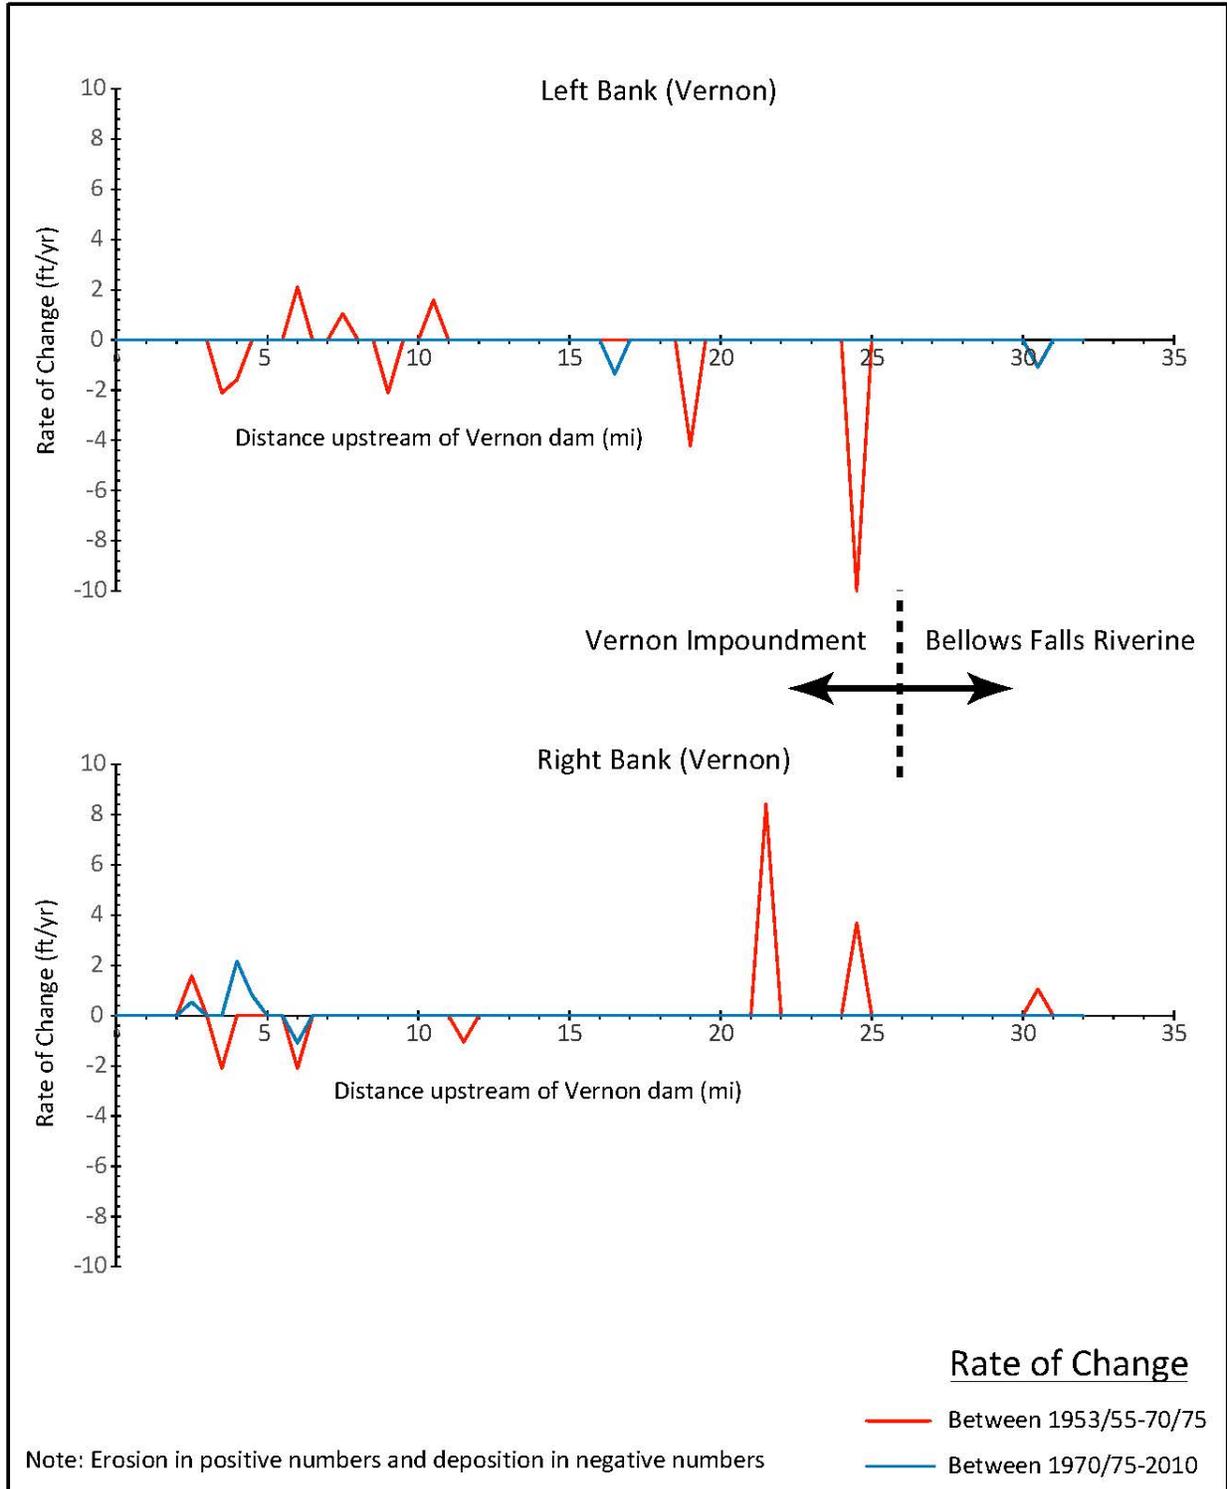
In contrast to the significant changes in the Bellows Falls impoundment and Wilder riverine reach, the Vernon impoundment and Bellows Falls riverine reach show relatively little change in bank positions since the 1950/55 aerial photographs (Figure 5.3-1c). Although more locations in the lower Vernon impoundment show change, the rate of change appears higher in the upper impoundment, perhaps because of the extensive slackwater (i.e., low velocity current) areas in the lower impoundment. Very little change is documented in the Bellows Falls riverine reach. As with the Bellows Falls impoundment, the rate of change in Vernon impoundment appears to have decreased through time. In fact, most of the change observed occurred during the 1950s-1970s interval, with what little erosion did occur in the 1970s-2010 interval occurring mostly in the lower impoundment.

Figure 5.3-1c. Rates of change in riverbank position through time upstream of Vernon dam.

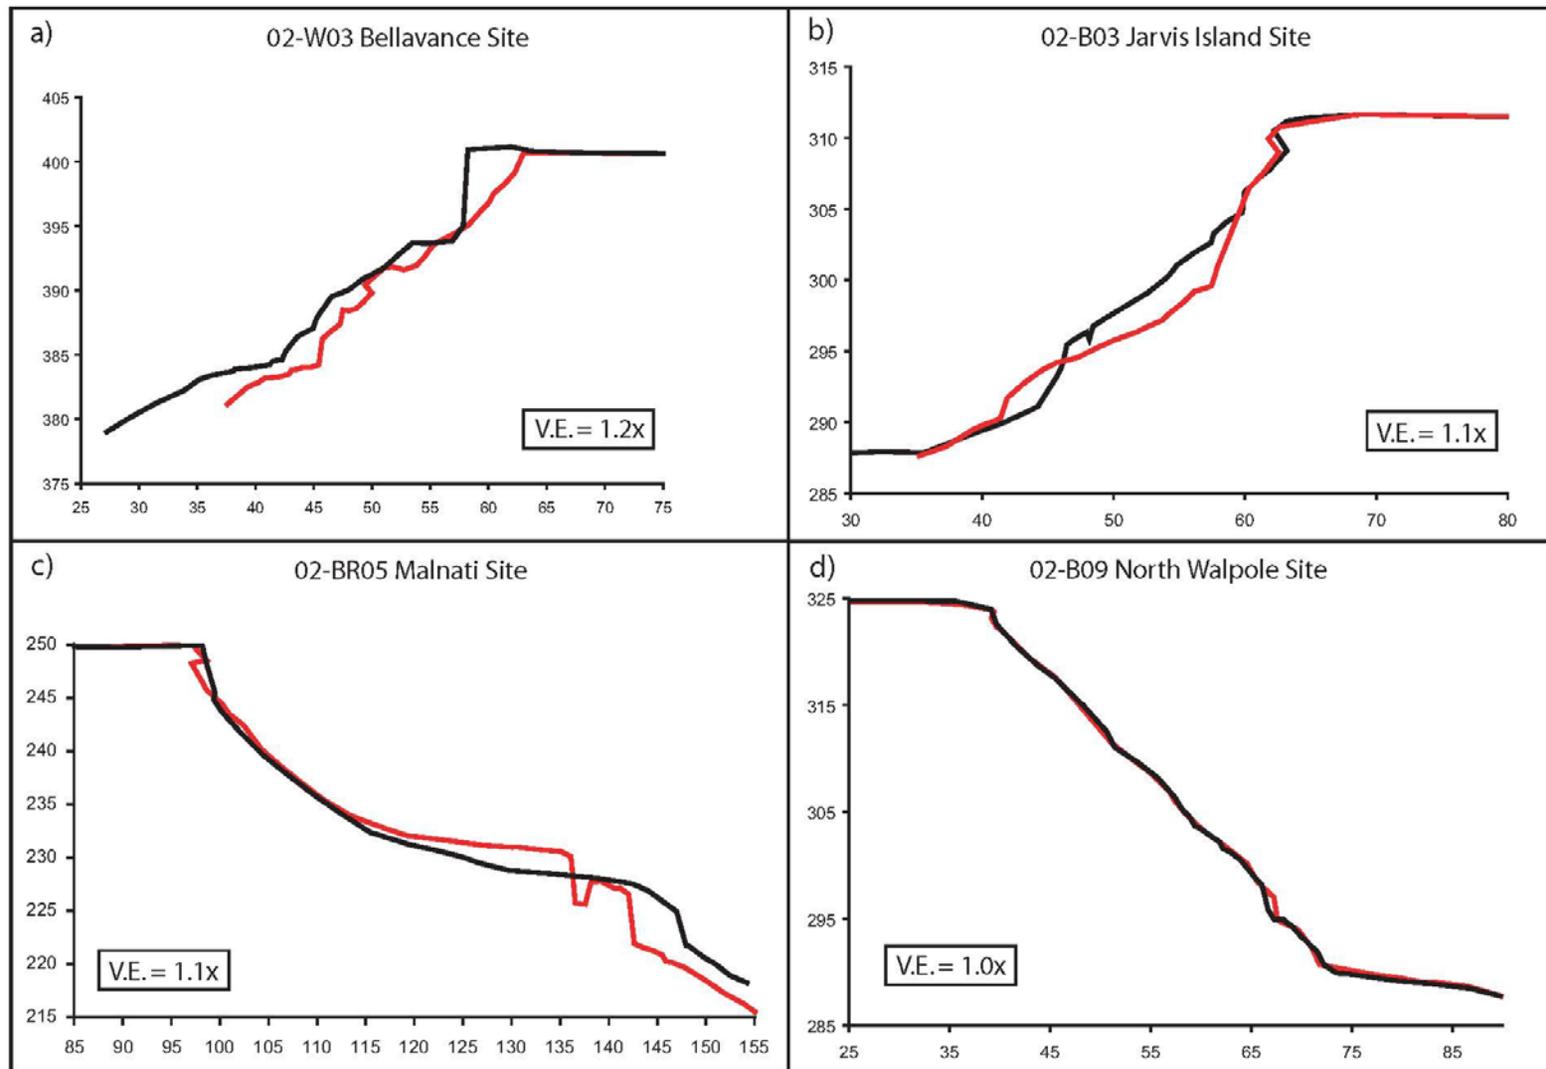
Four general conditions were observed along the transects during the two-year monitoring period: 1) bank recession at the top of the bank, 2) changes on the bank slope, 3) loss or accumulation of bank material at the bank toe, and 4) no change (Figure 5.4.2-1 and Figures 5.4.2-2a and 5.4.2-2b). Note that two or more of the above conditions reflecting bank change could occur along a single transect (even during a single interval between monitoring periods) and that change may have occurred during only one monitoring interval with no other change observed during the rest of the monitoring period (Table 5.4.2-1).

Figure 5.4.2-1. The types of conditions observed on the monitoring transects included a) top of bank recession, b) bank slope changes, c) bank to accumulation or loss, and d) no change.

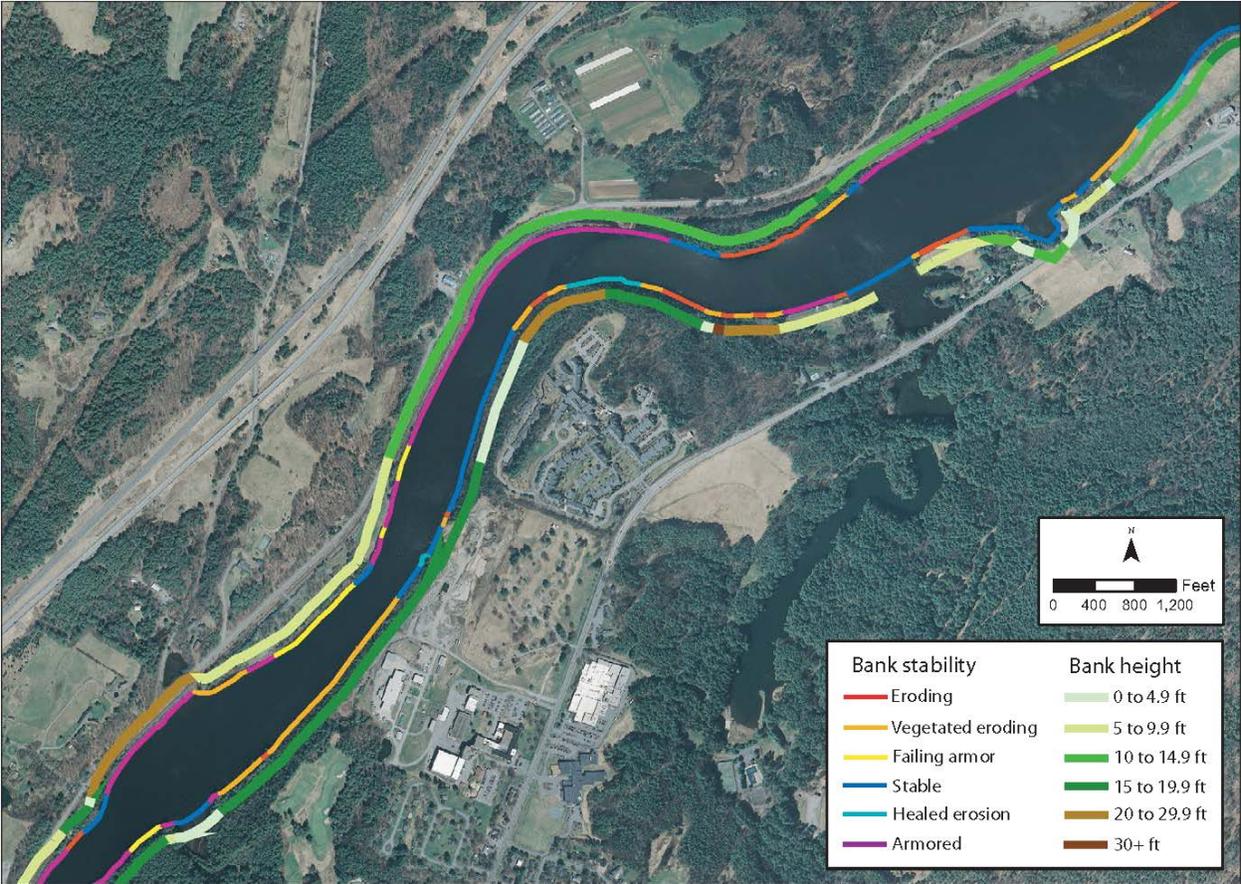
The results of the bank features mapping are presented in Appendix C (filed separately) as GIS shapefiles. Within GIS, the bank conditions at any location can be shown and compared with other bank features such as bank stability and bank height (Figure 5.6.4-1). Considering bank stability for the study area as a whole, 11% of the banks were mapped as eroding, 22% as vegetated eroding, and 6% as failing armor, resulting in a total 39% of bank length that can be considered unstable (Figure 5.6.4-2). In contrast, 61% of the banks are either stable (42%), armored (15%), or no longer eroding (i.e., healed erosion) (4%). For comparison, mapping along 85 miles of the upper Connecticut River outside of the study area found that 49% of the banks were unstable (Field, 2005).

Figure 5.6.4-1. Map of a short portion of the study area (in lower Wilder impoundment) comparing bank stability and bank height.

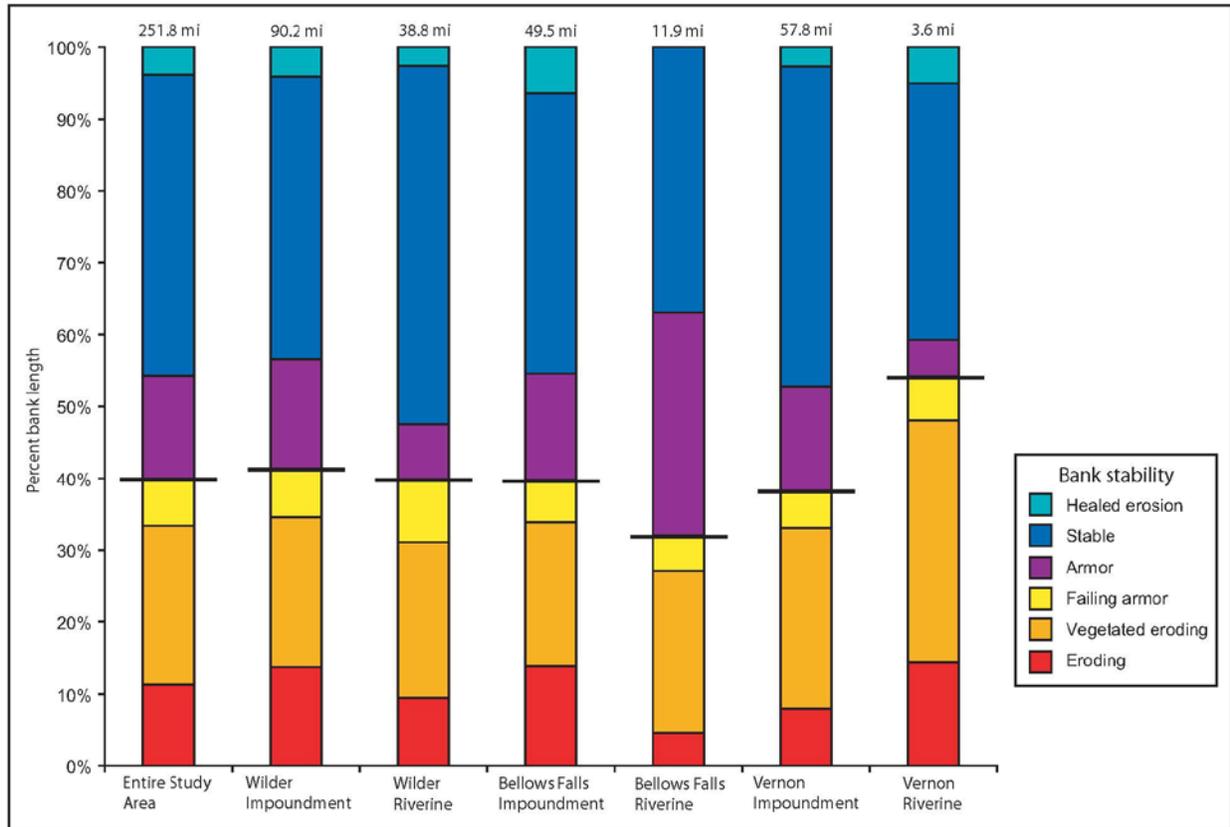
Figure 5.6.4-2. Percentage of mapped bank stability by study reach. The three unstable categories are illustrated below the bold line across each bar in the plot.

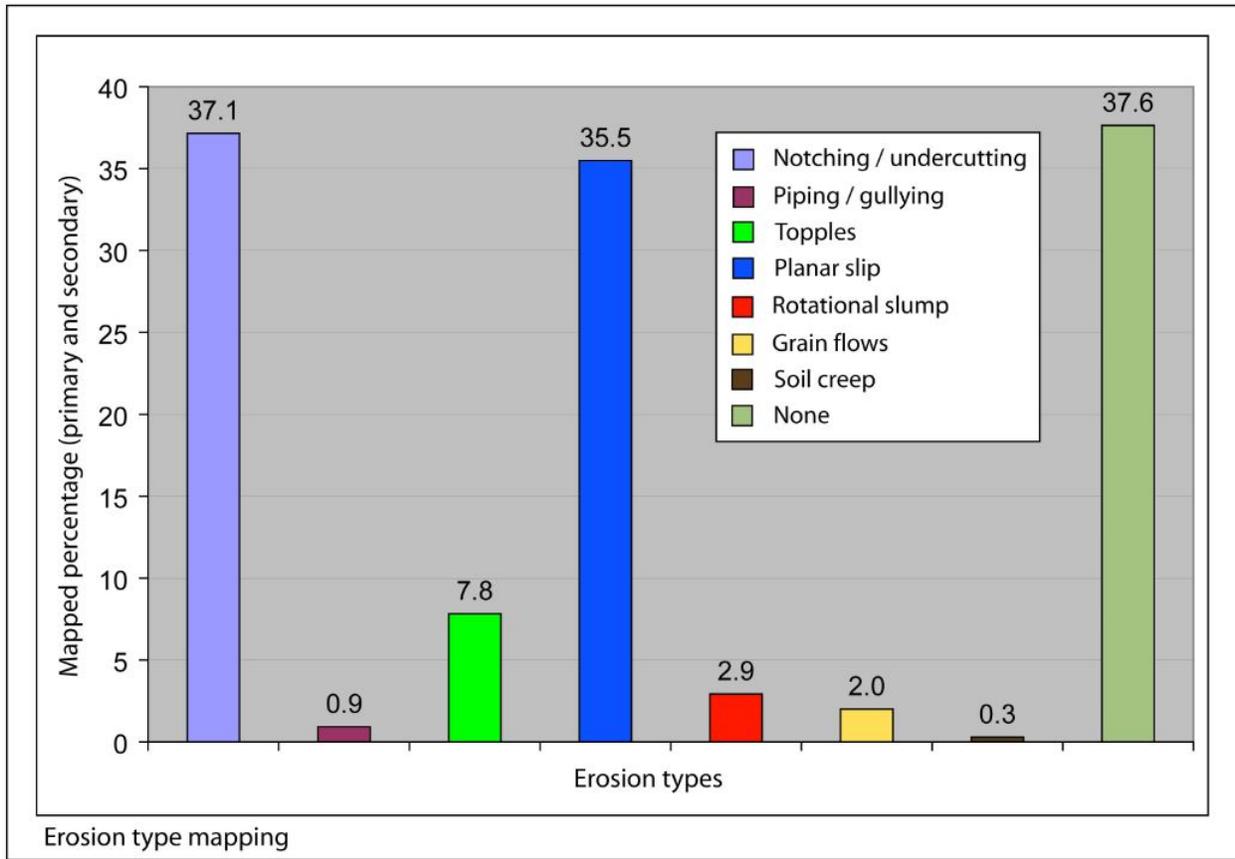
In Study 3 no erosion type was mapped along 38% of riverbank length with notching observed at the base of the remaining 21% of the stable and armored banks (Figure 5.6.4-3). A total of 37% of the banks were observed with notching at the base, so actually slightly more notching was observed along stable and armored banks (21%) than on unstable banks (16%). Notching may have initially triggered instability on the eroding, vegetated eroding, and failing armor banks even where notching was not mapped, but is no longer evident due to the presence of other erosion types that have obscured evidence of notching. Among the erosion types mapped solely along the unstable banks, planar slips were the dominant erosion type observed (36%) compared to topples (8%), rotational slumps (3%), grain flows (2%), and other erosion types. However, other erosion types might be present where planar slips are found but only the dominant erosion type was mapped.

Figure 5.6.4-3. Percentage of different erosion types in the study area as a whole. Two or more erosion types can occur at the same location so totals exceed 100%.
