**ILP Study 2 and Study 3
Riverbank Transect and Riverbank Erosion Studies**

Study Report

Wilder Hydroelectric Project (FERC Project No. 1892-026)
Bellows Falls Hydroelectric Project (FERC Project No. 1855-045)
Vernon Hydroelectric Project (FERC Project No. 1904-073)

August 1, 2016

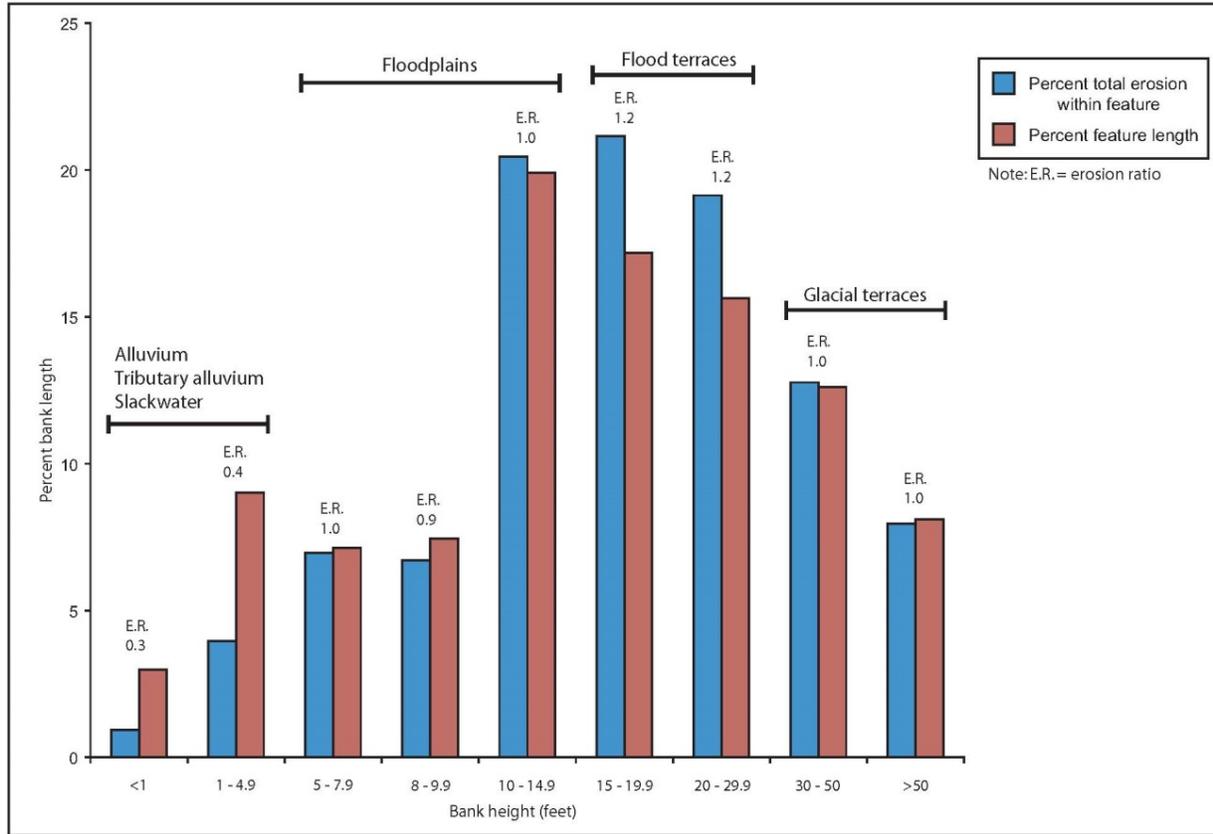
When considering bank height, the erosion ratio (E.R.) is greatest where the riverbanks are 15 to 30 ft high (E.R.=1.2) Unstable banks appear to preferentially occur along these bank heights because they are generally associated with flood terraces (Figure 5.6.5-1) that are composed of sandier, more erodible soils. The height of the banks is also sufficient to create gravitational forces that lead to bank instability with such height-dependent gravitational forces. In contrast, reduced gravitational driving forces might best explain why erosion ratios decline steadily with decreasing bank heights in the three bank height categories less than 8 ft (Figure 5.6.5-1). An erosion ratio of 0.3 where bank heights are less than 1 ft indicates that unstable banks are highly unlikely to occur in these areas, generally associated with slackwater conditions found in the lower Vernon impoundment.

Figure 5.6.5-1. Erosion rates associated with bank heights and geomorphic surfaces.

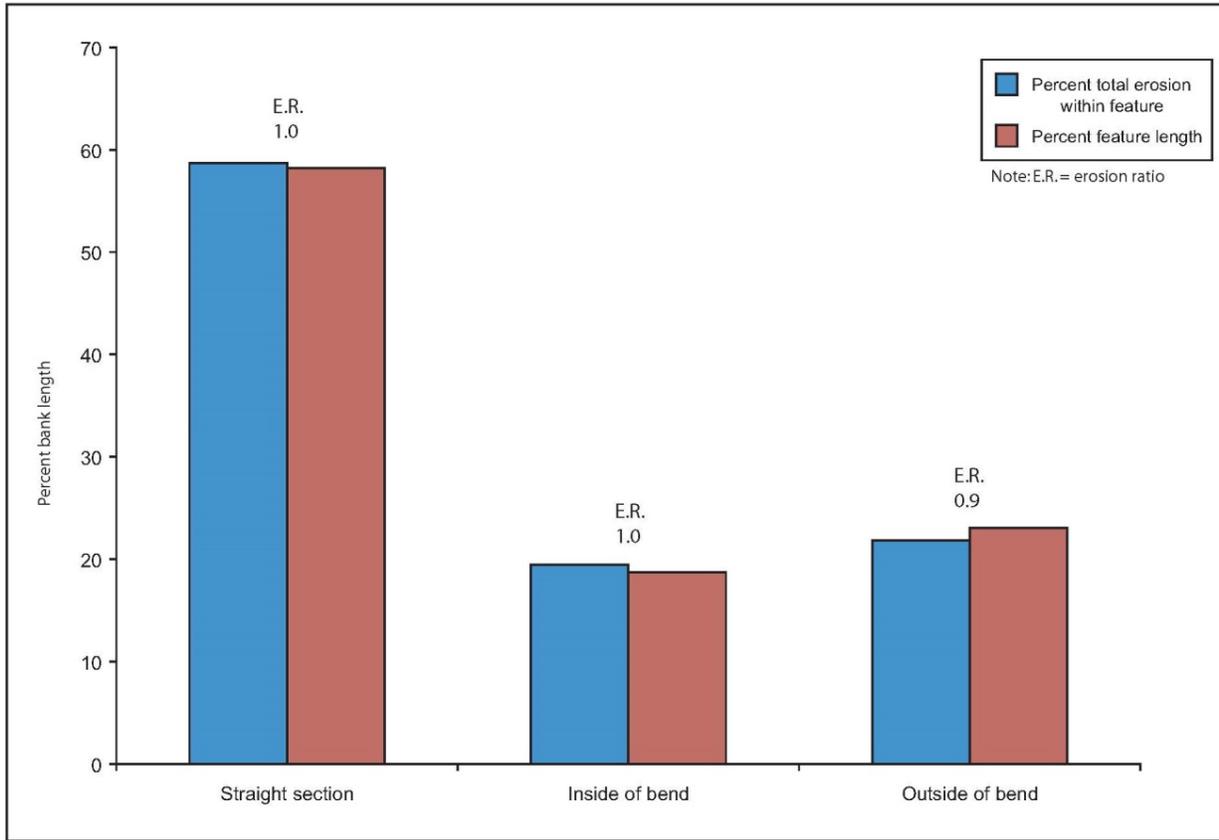
On unaltered meandering alluvial rivers, erosion preferentially occurs on the outside bends of meanders and deposition on the inside portion of the bend (Easterbrook, 1993, p. 121). In addition to meander bends, an analysis of unstable banks relative to bend geometry on the Connecticut River must also consider straight reaches, whether natural or artificially straightened. No pronounced trend between unstable banks and bend geometry is evident on the Connecticut River (Figure 5.6.5-2 and Table 5.6.5-1). An erosion ratio of 1.0 on the inside bends of meanders and 0.9 on the outside bends of meanders is counter to what might be expected on an unaltered alluvial river. The most likely explanation for this counterintuitive finding is the presence of bank armoring placed to prevent erosion. Intact bank armoring in the study area (i.e., armored stability category but not failing armor) is almost twice as likely to be found on the outside bends of meanders and straight segments compared the inside of bends as demonstrated by an armor ratio (defined the same as erosion ratio but instead considering armoring rather than erosion) of 1.1 on outside bends and straight segments and only 0.6 on the inside bends (based on calculations from Appendix C data).

Figure 5.6.5-2. Erosion ratios associated with bend geometry.

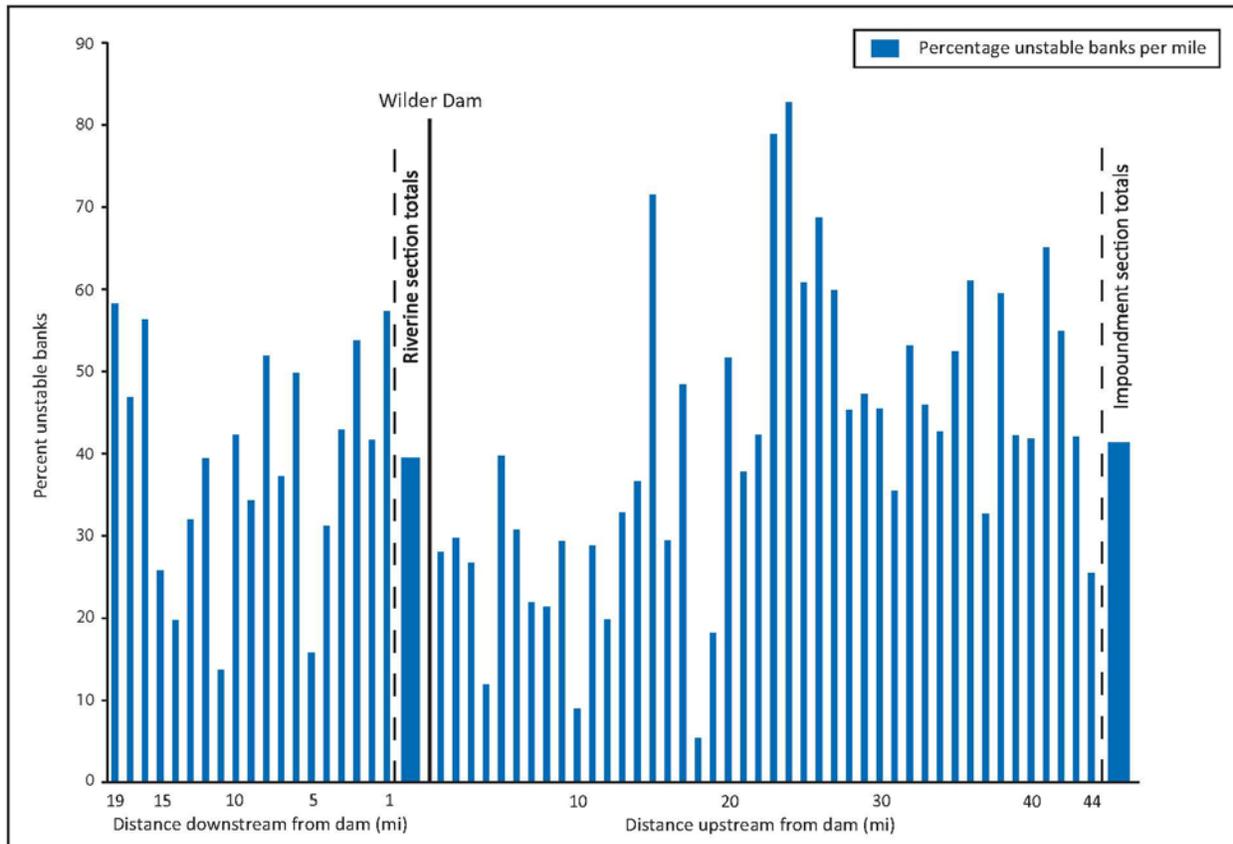
The upper and middle portions of Wilder impoundment show considerably more erosion than the lower impoundment (Figure 5.6.5-3a). The greater erosion could be related to the wider floodplain and more riverine character of the upper impoundment, but the significant armoring along the banks of the lower impoundment are a more likely explanation for this discrepancy (Appendix C). No strong pattern in the amount of erosion relative to distance downstream of Wilder dam is apparent in Figure 5.6.5-3a, although the percentage of erosion does appear highest at the immediate upstream and downstream portion of the Wilder riverine reach. The dramatic drops in erosion rates in certain mile-long segments in the middle portion of the Wilder riverine reach (e.g., mile 5 and 11 below the dam) are most likely associated with sections where significant bedrock is found along the banks.

Figure 5.6.5-3a. Variation in amounts of erosion with distance from Wilder dam.

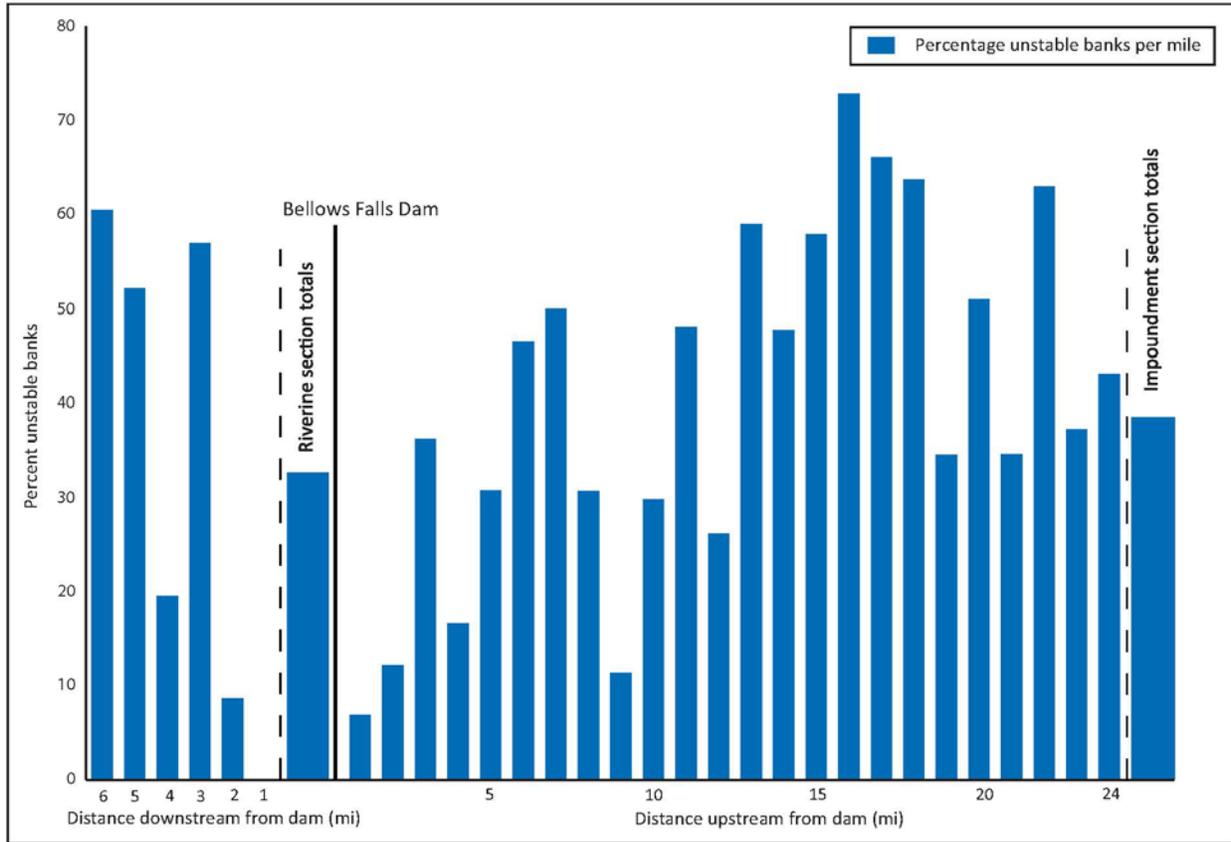
Upstream of Bellows Falls dam erosion rates are greatest in the mid to upper impoundment, perhaps a reflection of the higher percentage of lower banks and slackwater areas in the lower impoundment (Figure 5.6.5-3b). The level of erosion in the Bellows riverine reach tends to increase with increasing distance downstream

of Bellows Falls dam, with the absence of erosion in the first mile downstream of the dam the result of bedrock banks.

Figure 5.6.5-3b. Variation in amounts of erosion with distance from Bellows Falls dam.

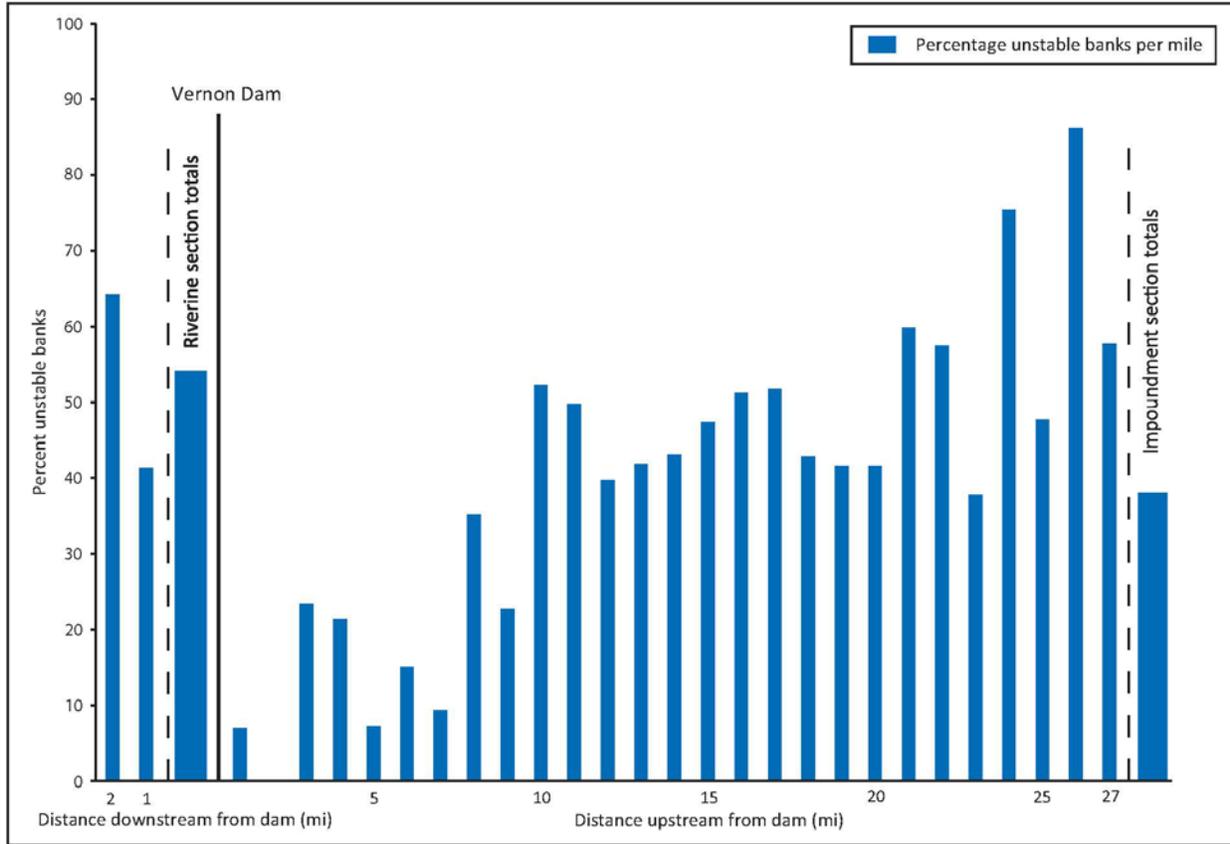
As with the Bellows Falls impoundment, the low levels of erosion in the lower Vernon impoundment compared to the mid and upper impoundment is likely associated with the prevalence of low banks and slackwater areas in this area (Figure 5.6.5-3c). Although only a small portion of the study area is downstream of Vernon dam, the erosion rates are much higher than observed immediately downstream of Bellows Falls dam where bedrock predominates, and more similar to erosion rates below Wilder dam. No true riverine reach is present downstream of Vernon dam as the Turners Falls impoundment extends upstream to the base of Vernon dam.

Figure 5.6.5-3c. Variation in amounts of erosion with distance from Vernon dam.

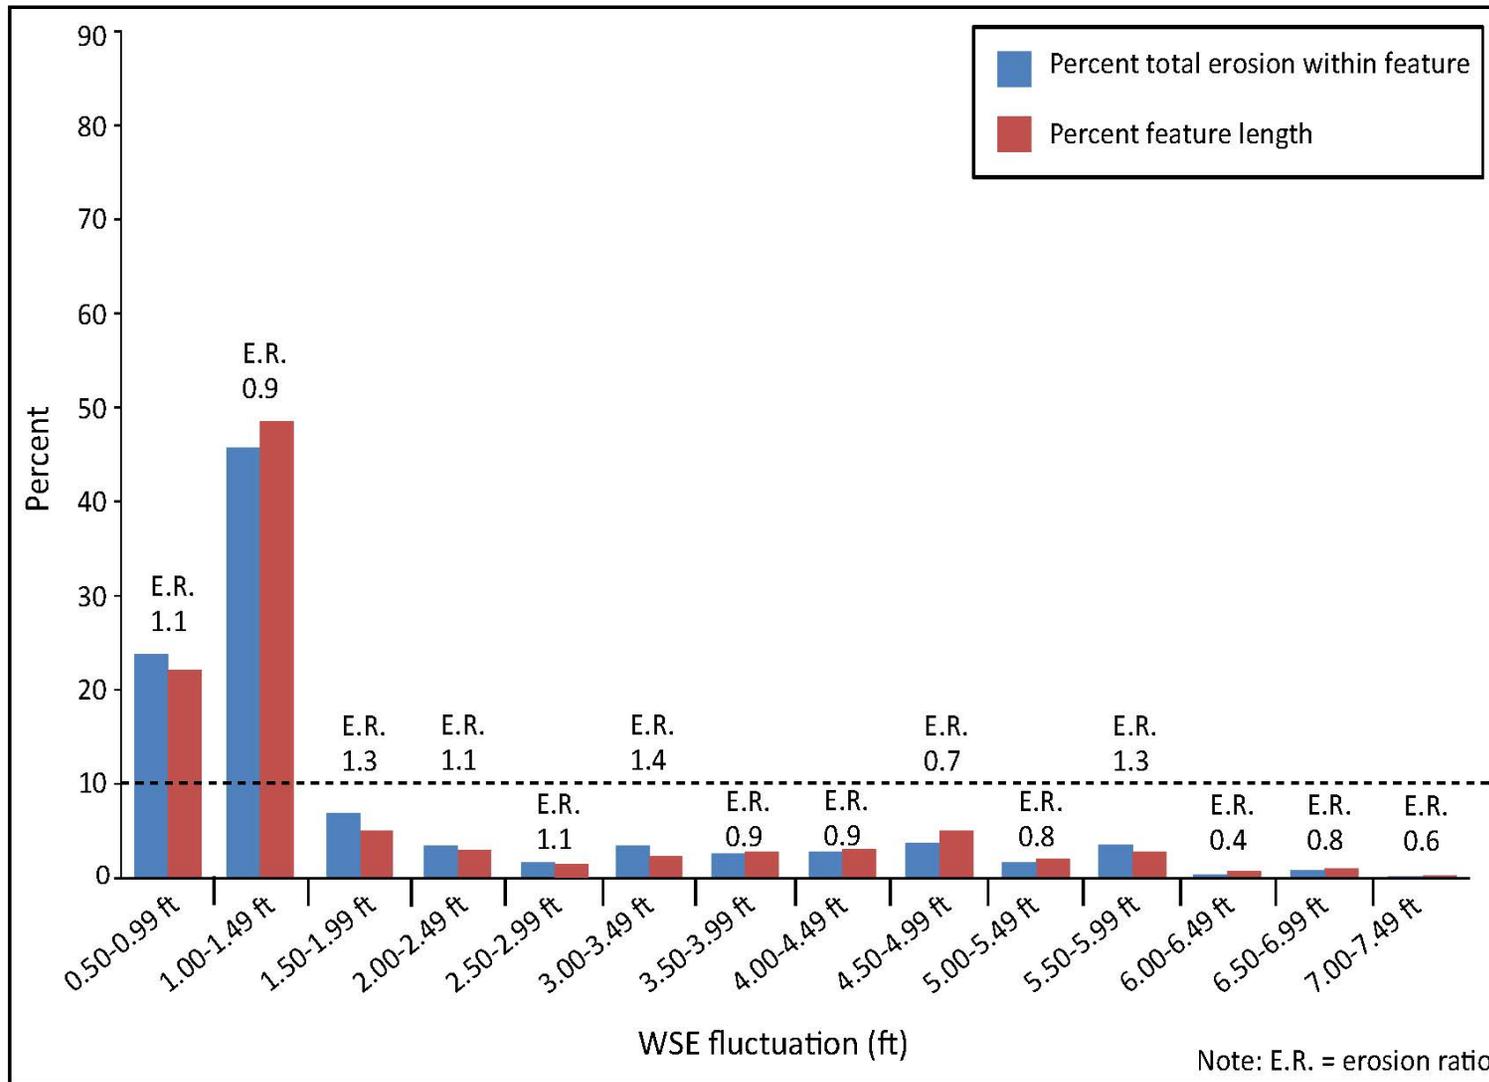
To determine if the magnitude of water level fluctuations due to normal project operations is related to the amount of erosion, Study 4 (GEI, 2016) hydraulic modeling data combined with Study 5 (Hatch, 2016) operations modeling data were used to establish the median water level fluctuation (i.e., 50% exceedance interval) under no-spill conditions for each of the 1,087 hydraulic model cross sections in the study area (see Section 5.7). The median values were assigned to points along the bank stability shapefile that enabled the creation of a matching shapefile showing the magnitude of WSE fluctuations anywhere in the study area, that were then grouped in 0.5-foot increments for analysis (Appendix C). The median WSE fluctuation was used as these values most closely matched WSE changes recorded by water level loggers at the Study 2 erosion monitoring sites. Furthermore, the median value represents the WSE fluctuation range that occurs most frequently and, therefore, would be most likely to affect erosion if WSE fluctuations have a destabilizing influence on the banks. Comparing erosion to the median WSE fluctuations enabled calculation of erosion ratios to determine if erosion preferentially occurs where WSE fluctuations due to normal project operations are greatest (Figures 5.6.5-4a - f and Table 5.6.5-1).

Figure 5.6.5-4a. Erosion ratios associated with WSE fluctuations under normal project operations for the whole study area.

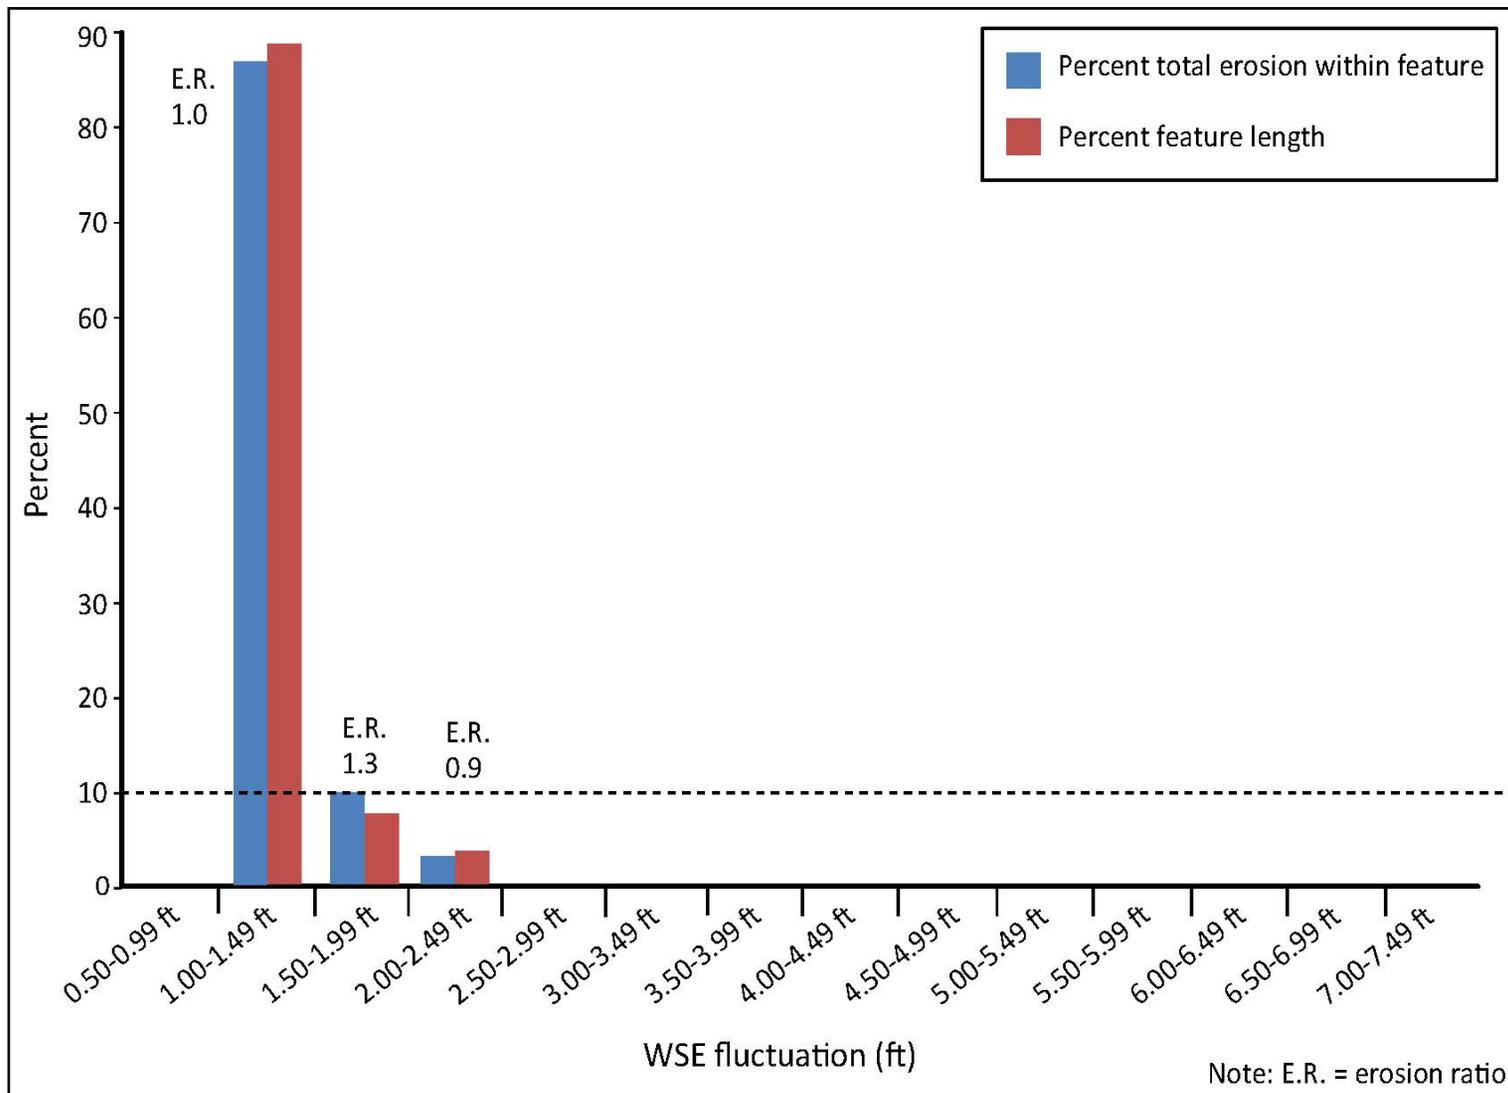
Figure 5.6.5-4b. Erosion ratios associated with WSE fluctuations under normal project operations in the Wilder impoundment.

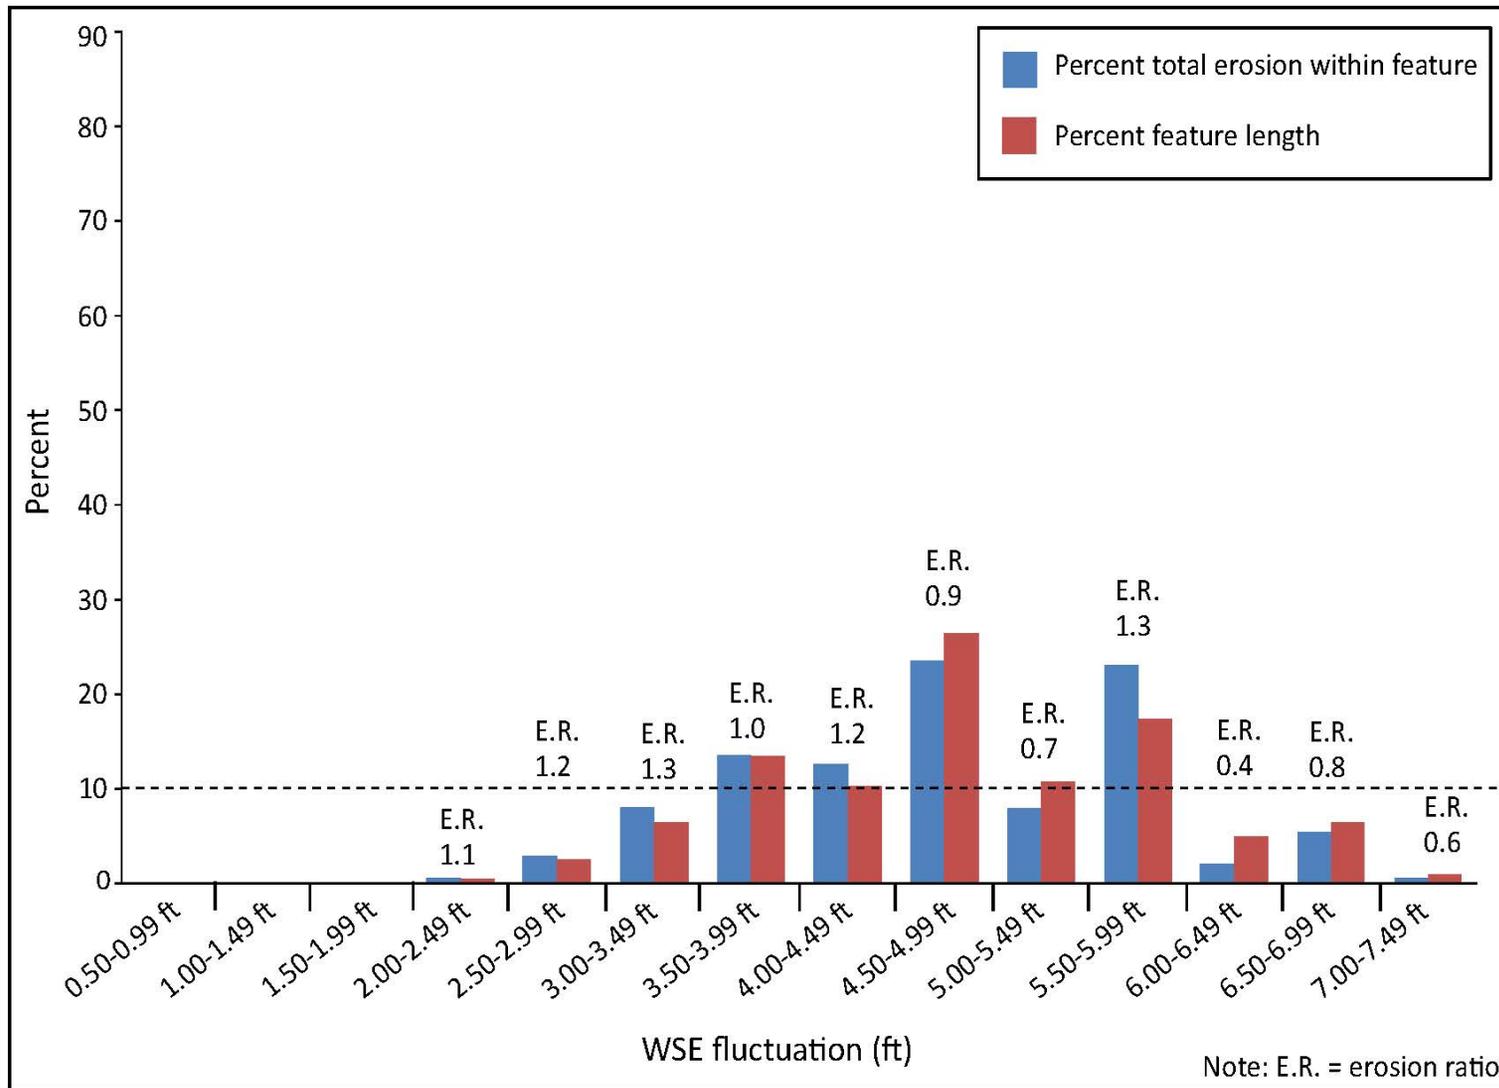
Figure 5.6.5-4c. Erosion ratios associated with WSE fluctuations under normal project operations in the Wilder riverine reach.

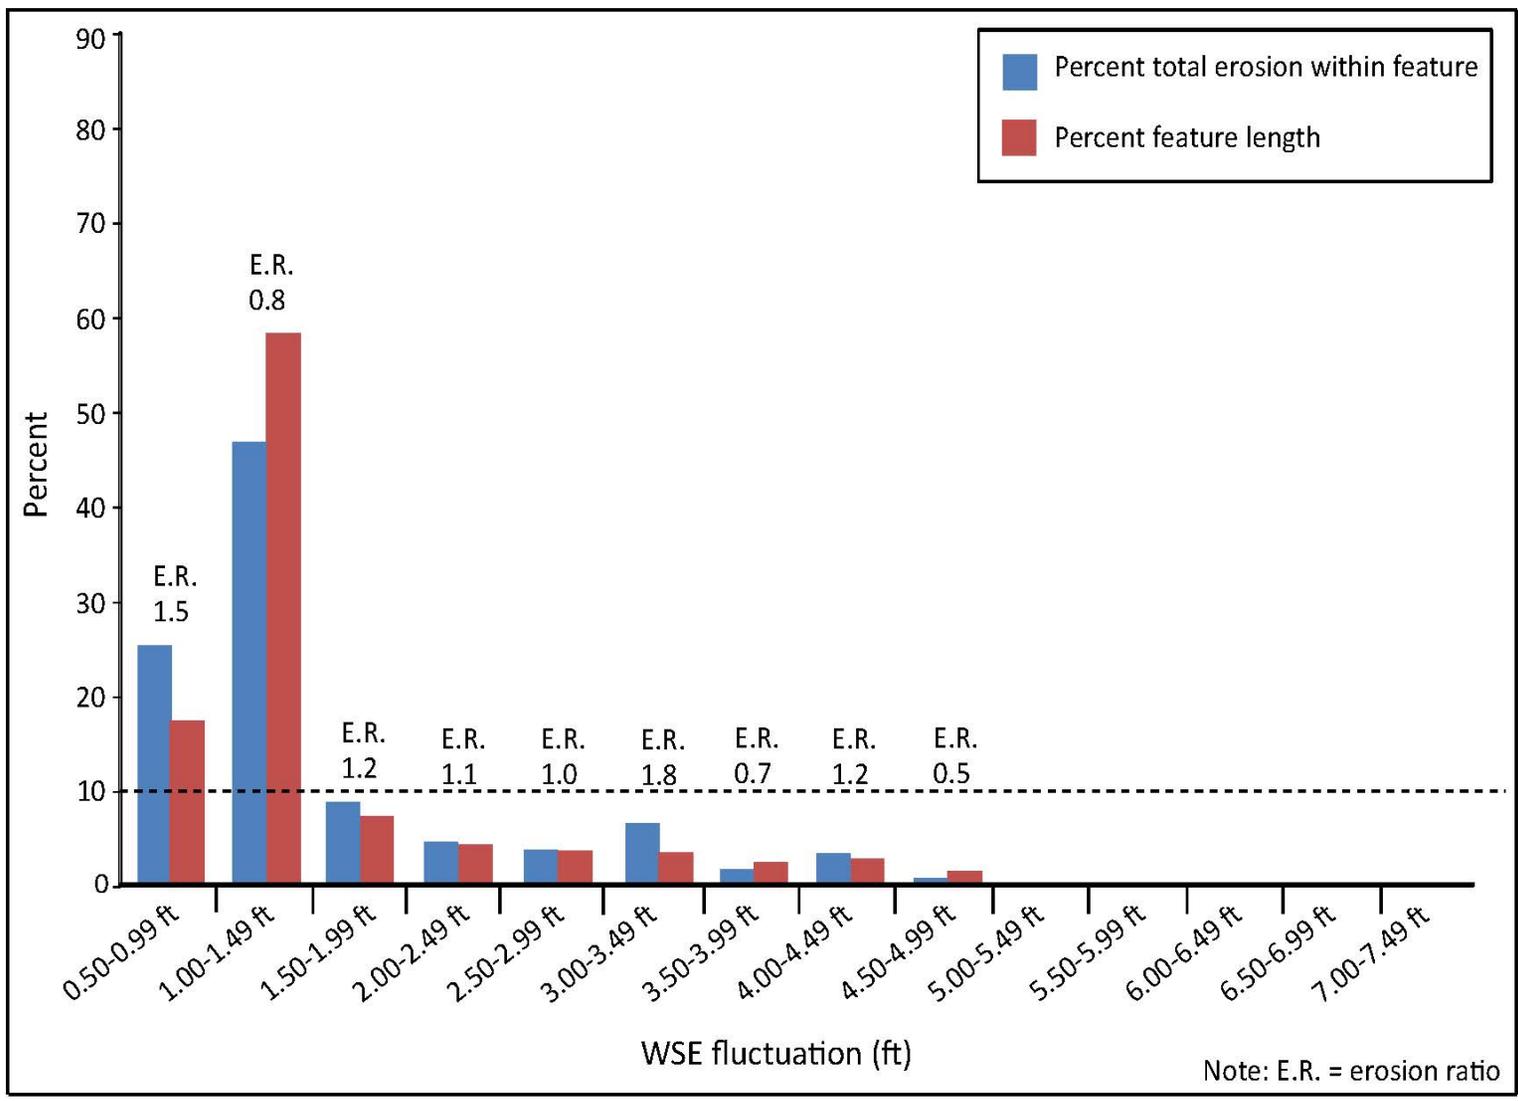
Figure 5.6.5-4d. Erosion ratios associated with WSE fluctuations under normal project operations in the Bellows Falls impoundment.

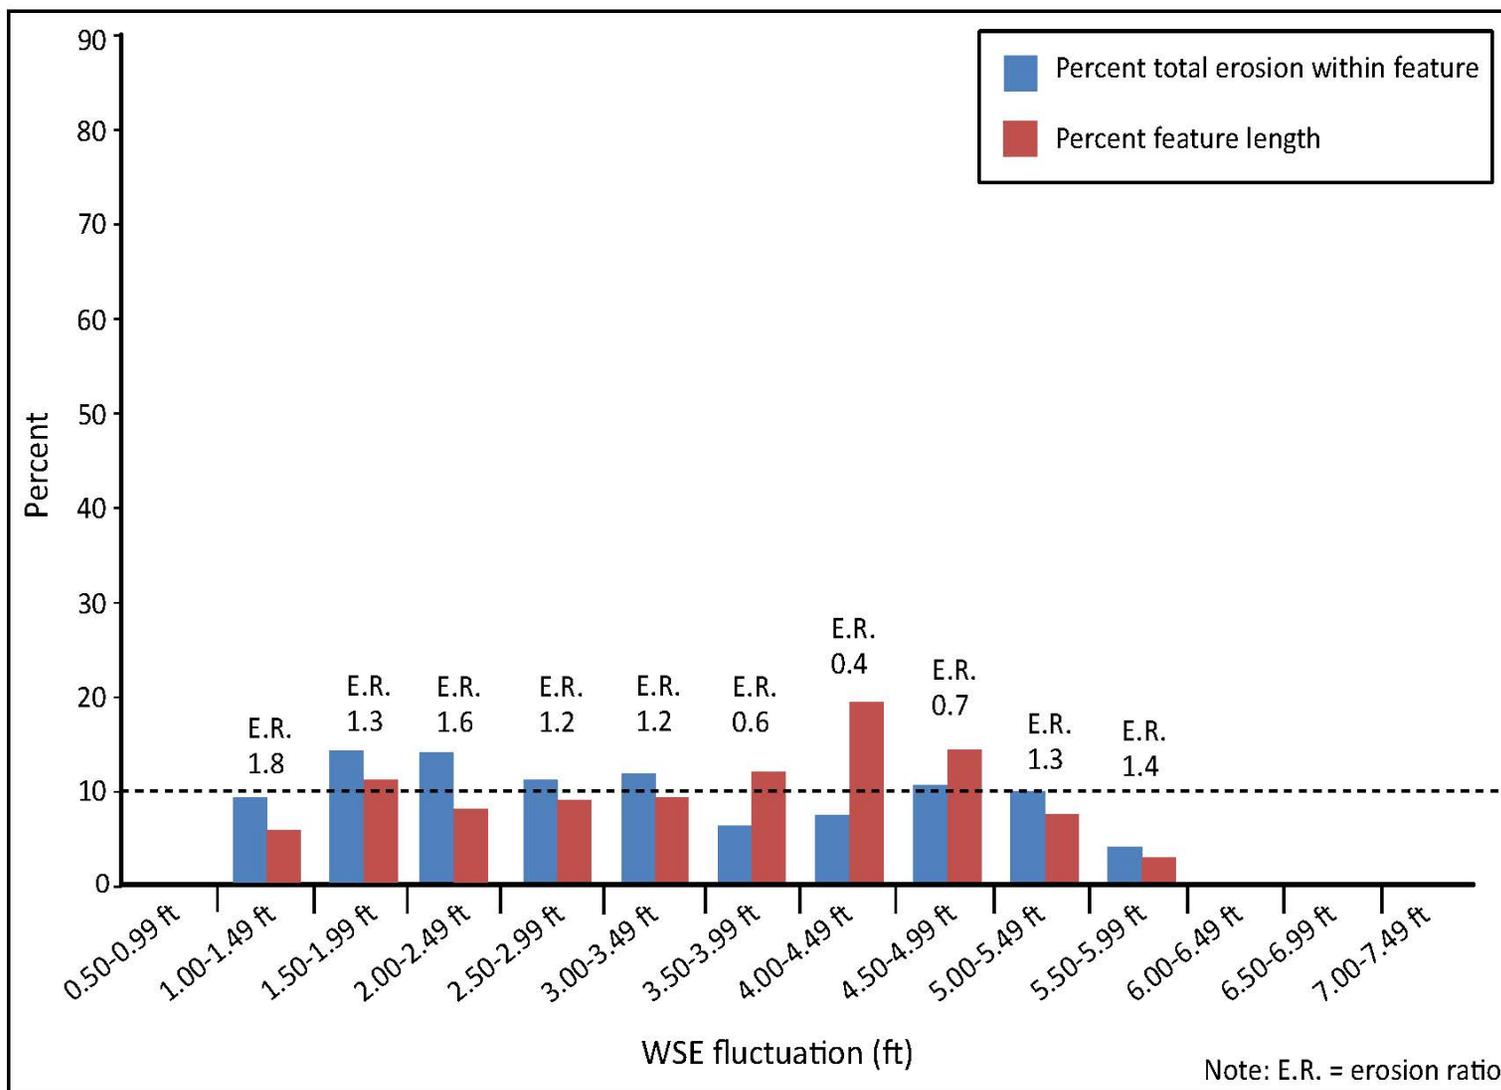
Figure 5.6.5-4e. Erosion ratios associated with WSE fluctuations under normal project operations in the Bellows Falls riverine reach.

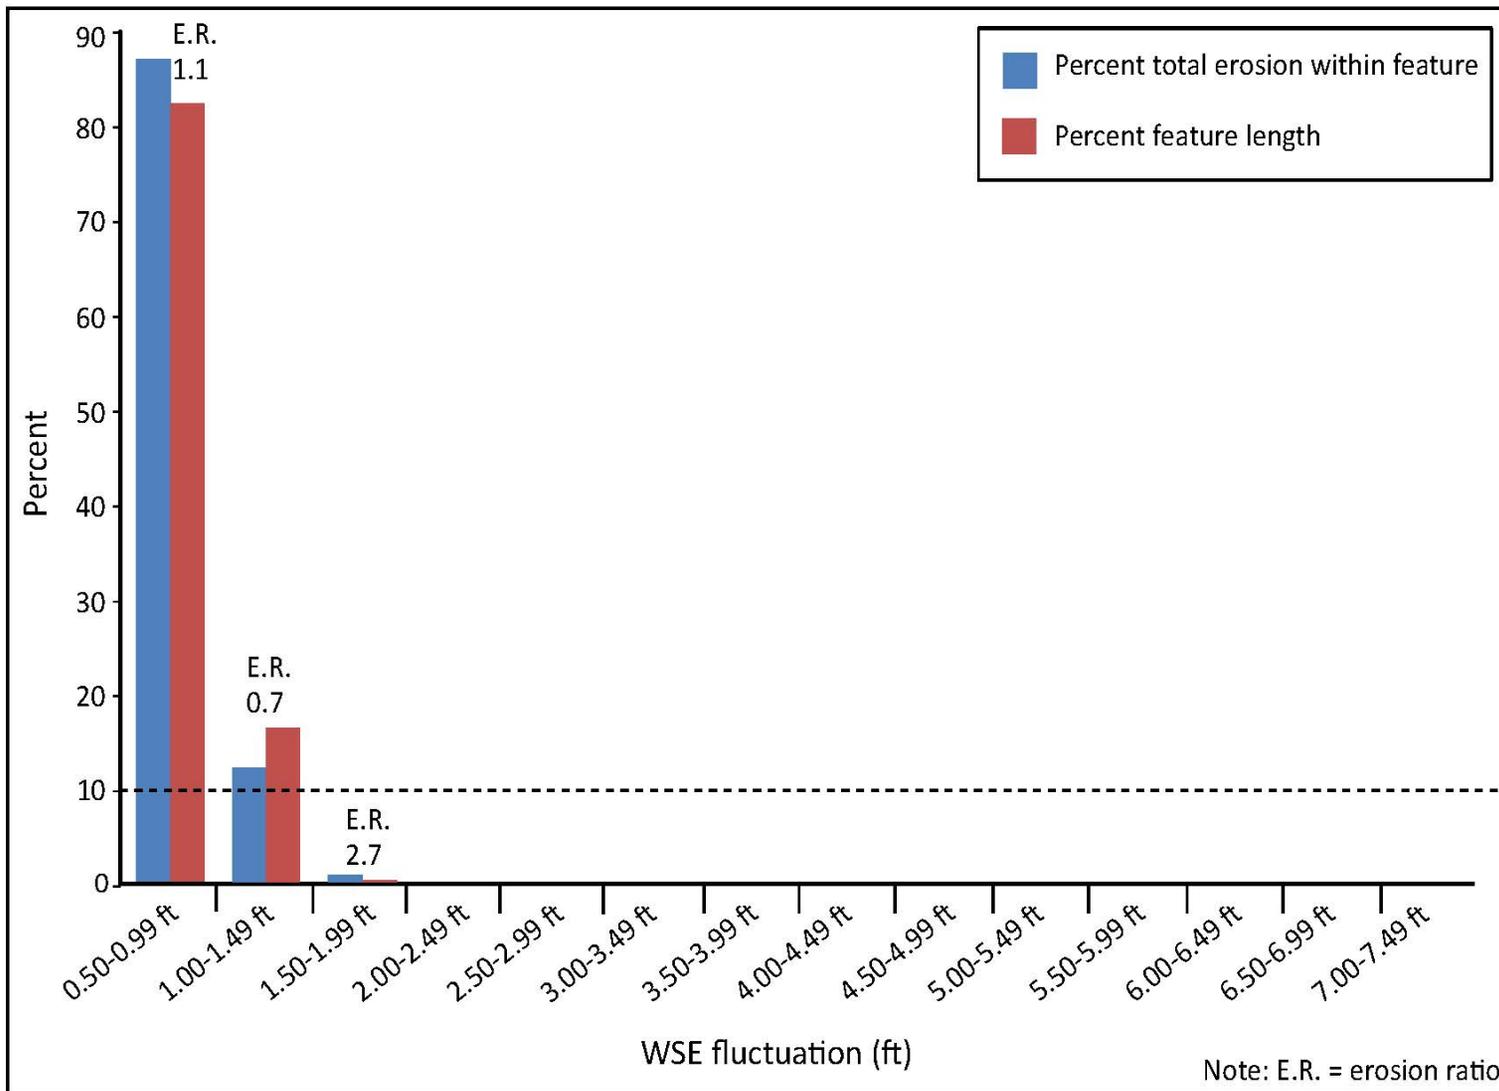
Figure 5.6.5-4f. Erosion ratios associated with WSE fluctuations under normal project operations in the Vernon impoundment.

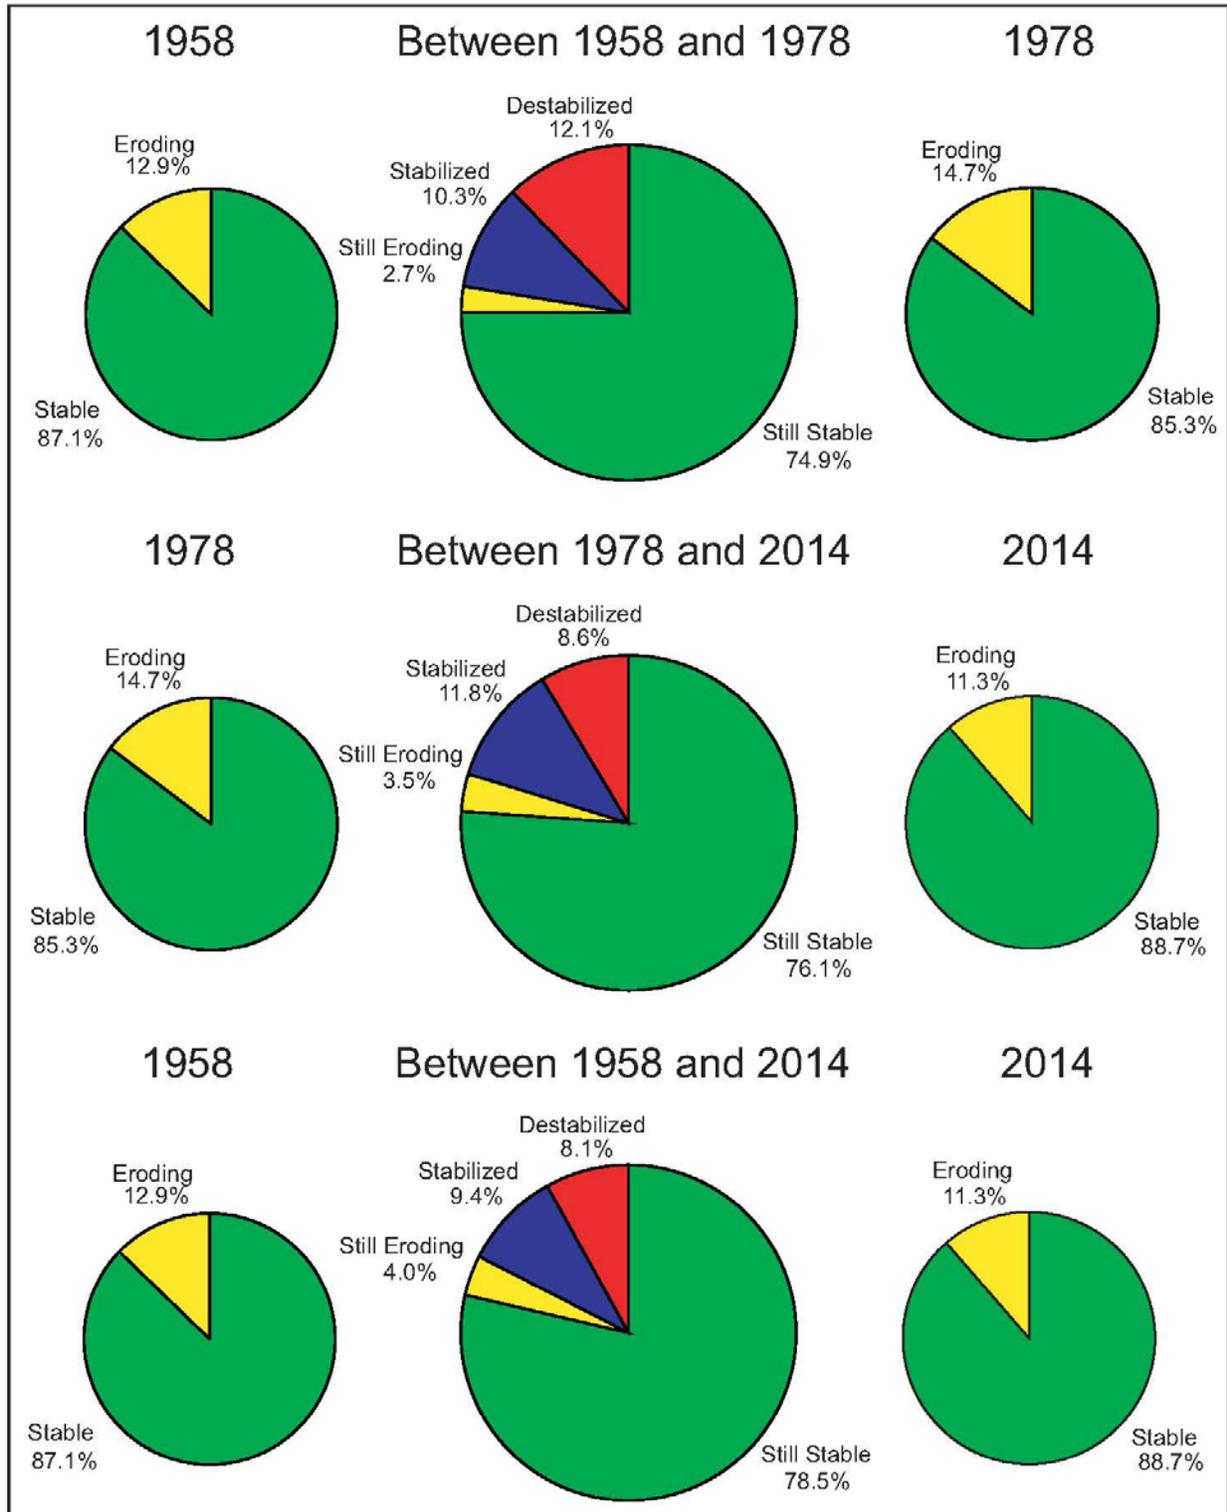
Figure 5.6.5-5. Percentage of bank erosion in 1958, 1978, and 2014 for the whole study area.

Given a low confidence level in comparing mapping efforts over different years, the conservative conclusion to draw from the data is that the level of erosion has stayed essentially constant through time. However, levels of erosion do show variation through time when analyzing each impoundment and riverine reach on its own. In the Wilder impoundment, erosion apparently increased between 1958 and 1978 over 10% before decreasing again slightly between 1978 and 2014 (Figure 5.6.5-5 and Table 5.6.5-2). Bellows Falls impoundment, in contrast, appears to have had an over 20% decrease in the amount of erosion between 1958 and 1978 before increasing back to approximately half of the 1958 levels. Erosion levels in the Vernon impoundment first increased slightly between 1958 and 1978 before declining to below 1958 levels between 1978 and 2014. Trends over time in the Wilder and Bellows Falls riverine reaches are also variable with trends in the first time interval reversed in the second time interval (Figure 5.6.5-5 and Table 5.6.5-2).

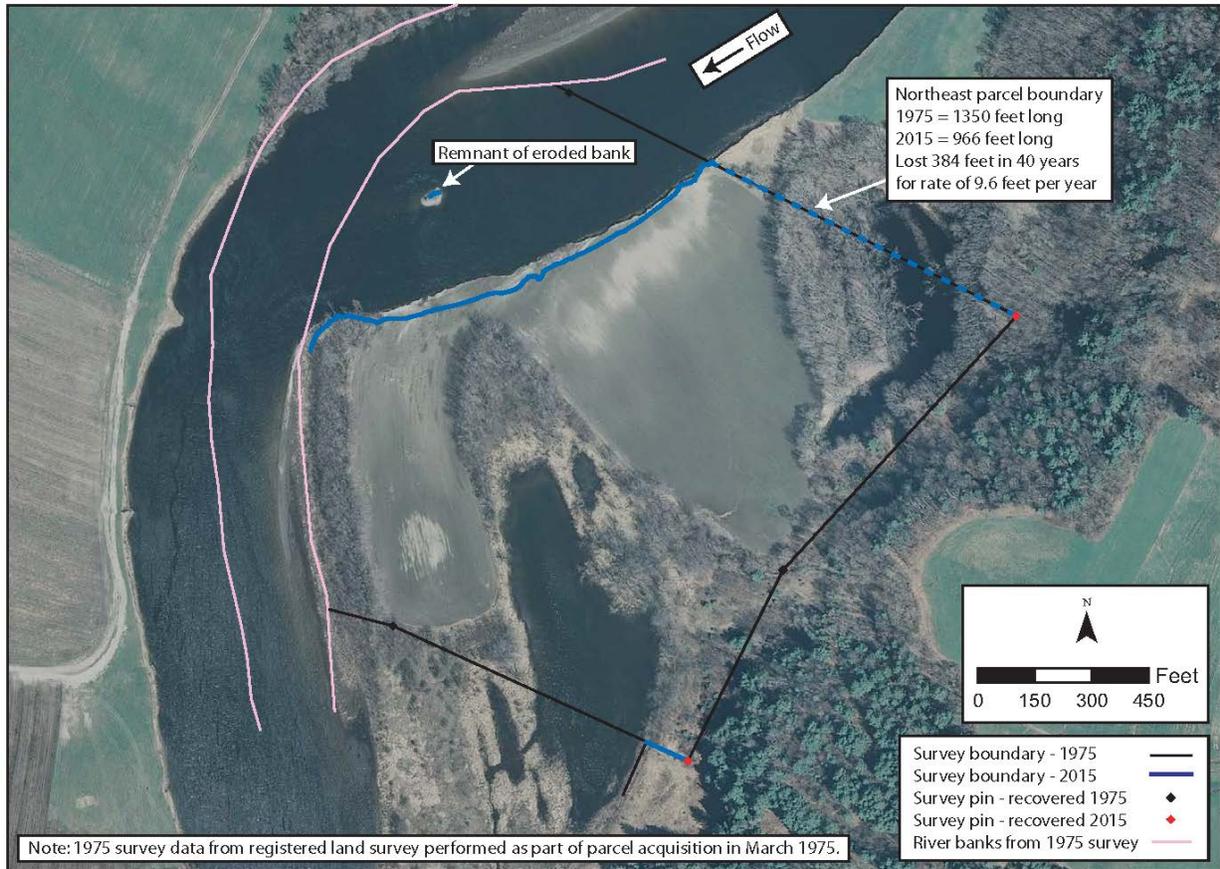
Through landowner contacts, two previous surveys of the riverbank in the Wilder impoundment were identified and these banks were resurveyed in 2015 to identify changes since the earlier surveys. In addition, the monitoring site 02-VR01, a high eroding bank immediately downstream of Vernon dam on the left bank, was also surveyed along the entire bank multiple times as part of long term monitoring conducted by TransCanada before this study was conducted. This bank below Vernon dam has receded at an average rate of 2.7 ft/yr over the 9 years of earlier monitoring where the most recession occurred, although no bank recession was observed during this study's two years of monitoring along a single transect, which is in large part what the more recent long term survey intervals also indicate. For the Wilder impoundment sites, the upstream most location is near the Haverhill-Piermont, New Hampshire town line (and just upstream of the reformed meander discussed in Section 5.2.3) with the original survey from 1975 showing the east bank of the Connecticut River extending 384 ft further west than in the 2015 survey, suggesting bank recession has occurred at a rate of 9.6 ft/yr in the past 40 years (Figure 5.6.5-6).

Figure 5.6.5-6. Comparison of 1975 and 2015 surveys of the Lewis property on the Haverhill/Piermont town line.

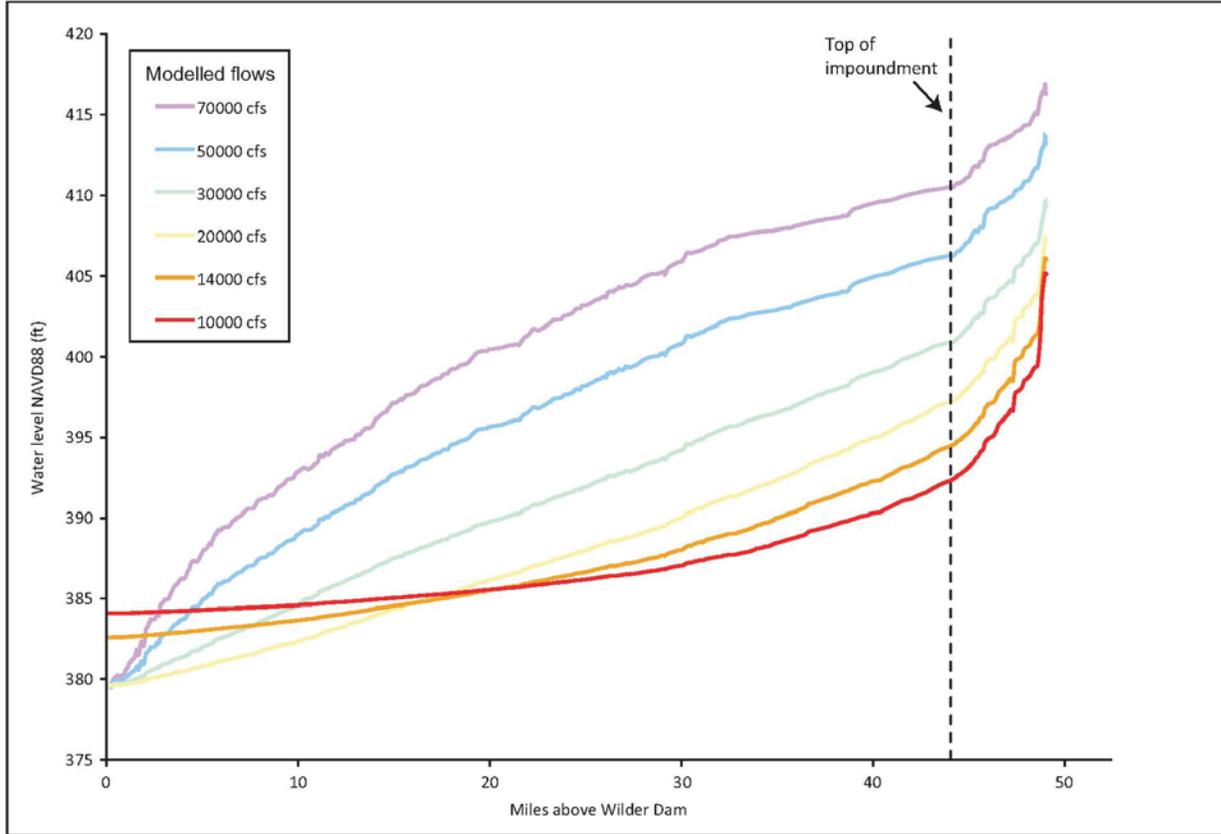
As a result of lowering WSE at the dams, a convexity in the longitudinal profile develops at the lower end of the impoundments (Figure 5.6.7-1) that could potentially engender a channel response as a stable river profile typically has a concave-up profile in contrast to the observed convexity. Similar convexity and rapid gradient changes result where flow releases from an upstream project entering a downstream impoundment encounter lowering water in the receiving impoundment.

Figure 5.6.7-1. Convexity develops in longitudinal profile at lower end of the Wilder impoundment when the dam WSE is lowered for high inflows.
