GREAT RIVER HYDRO, LLC

**ILP Study 18
American Eel Upstream Passage Assessment**

Supplement #3 to Study Report

Wilder Hydroelectric Project (FERC Project No. 1892-026)
Bellows Falls Hydroelectric Project (FERC Project No. 1855-045)
Vernon Hydroelectric Project (FERC Project No. 1904-073)

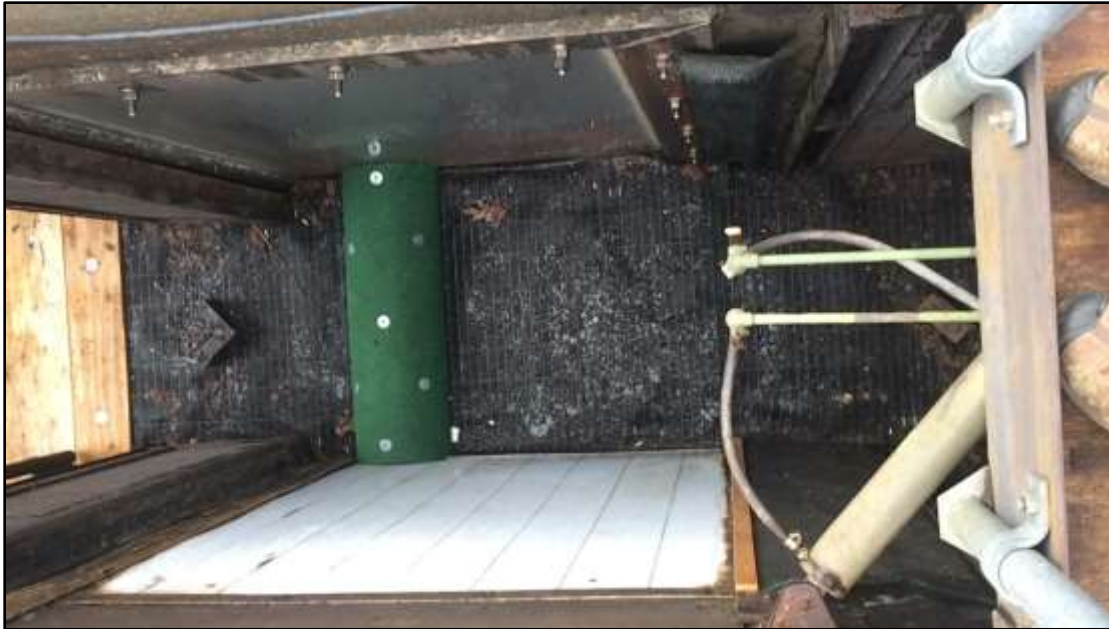
Floor grates of counting window: (Figure 1.0-2)

- Covered with plastic mesh (4mm opening) to keep eels from swimming under grating where not observed by motion activated camera.
- Installed outdoor carpet-like material on wall directly upstream and downstream of window to prevent lampreys from attaching to wall and affecting video counting software.
- Approximately $\frac{1}{4}$ of distance from the downstream end of the counting window floor, installed an approximately 12" wide x 8" high speed bump, perpendicular to window surface and extending across entire floor to act as a physical directional guidance feature to encourage eels traveling along the floor to more reliably enter the video camera/counting software field of view. Speed bump covered with outdoor carpet-like material.

Figure 1.0-2. Counting window floor covered in plastic mesh and speed bump installed.

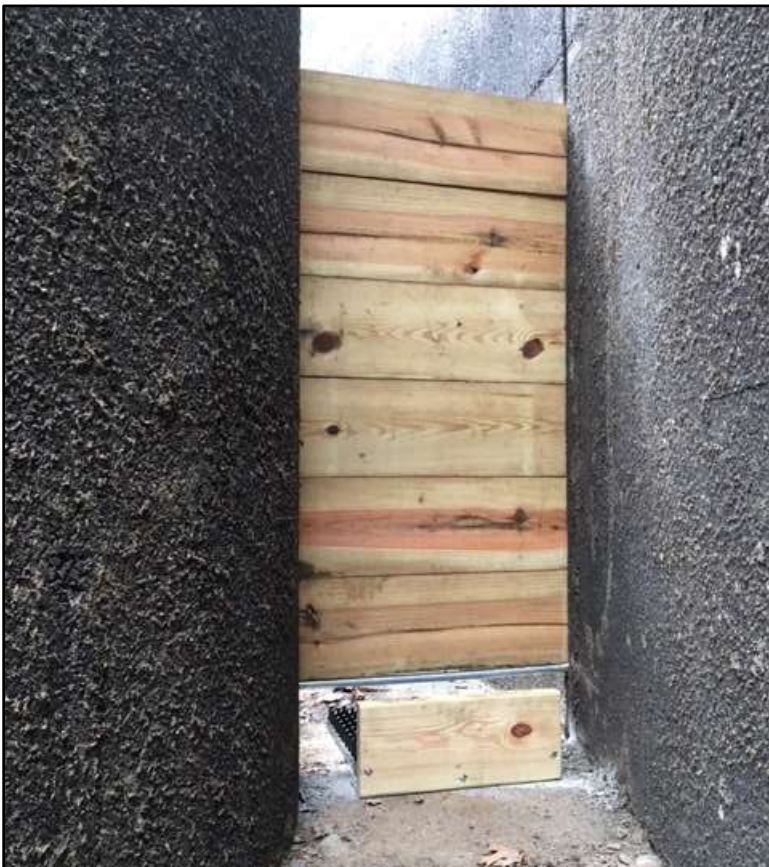
Exit Weir: (Figures 1.0-3 and 1.0-4)

Figure 1.0-3. Exit Weir looking downstream with eel tile and upstream baffle.

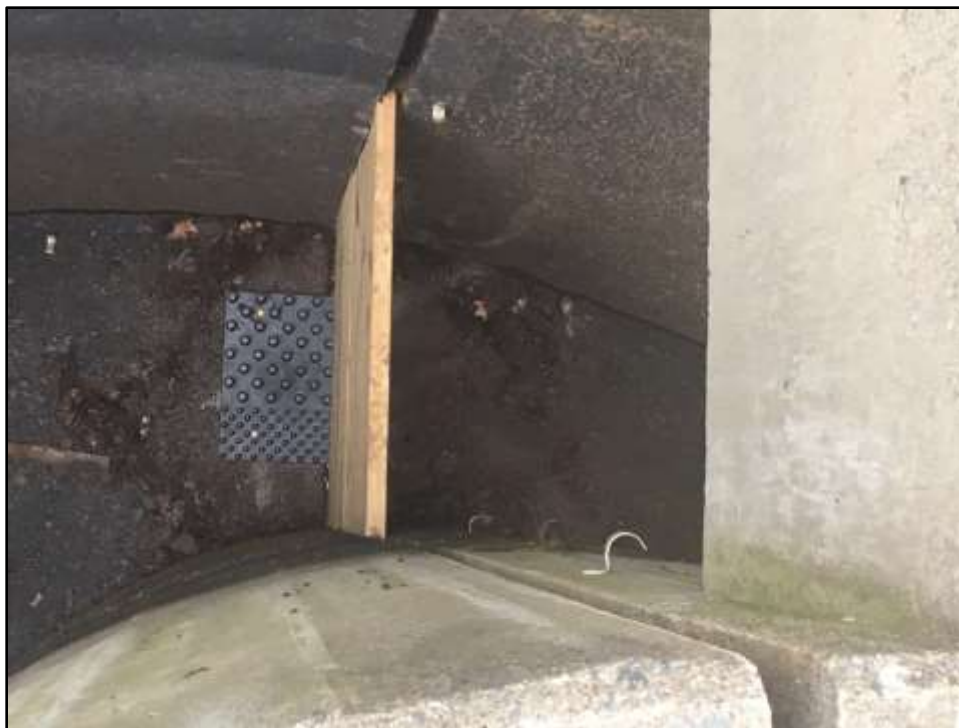
Figure 1.0-4. Exit Weir from above with eel tile and before upstream baffle installed.

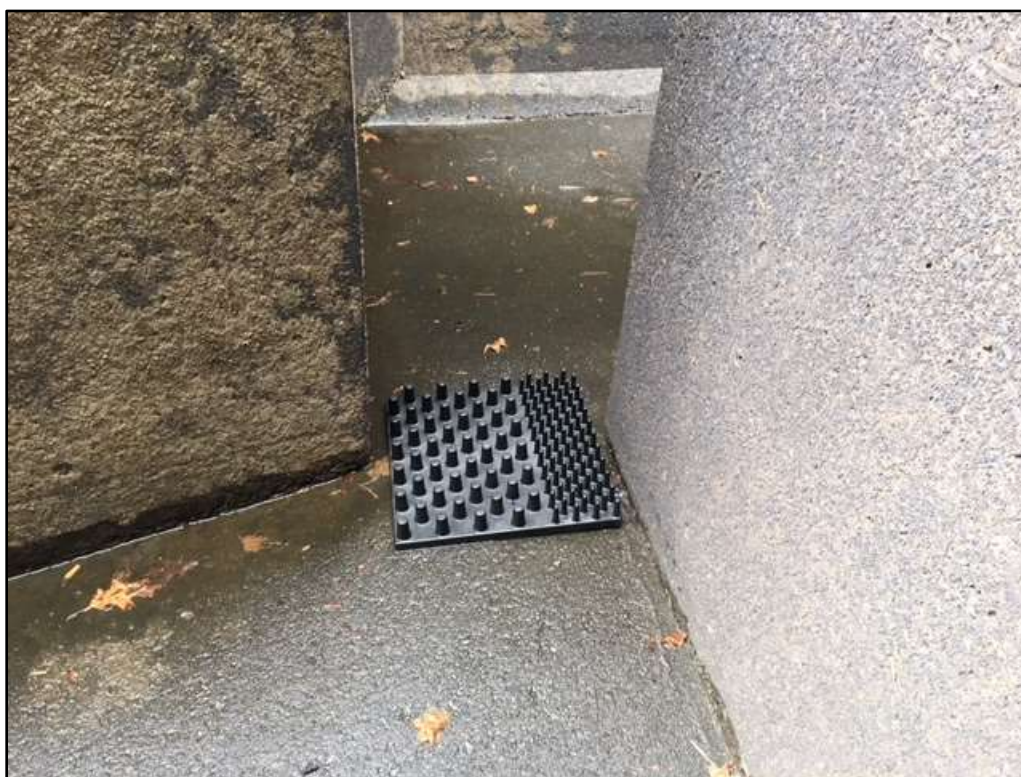
Attach eel tiles for trial: (Figure 1.0-5)

Figure 1.0-5. Eel tile placement in serpentine section upstream of the counting window.

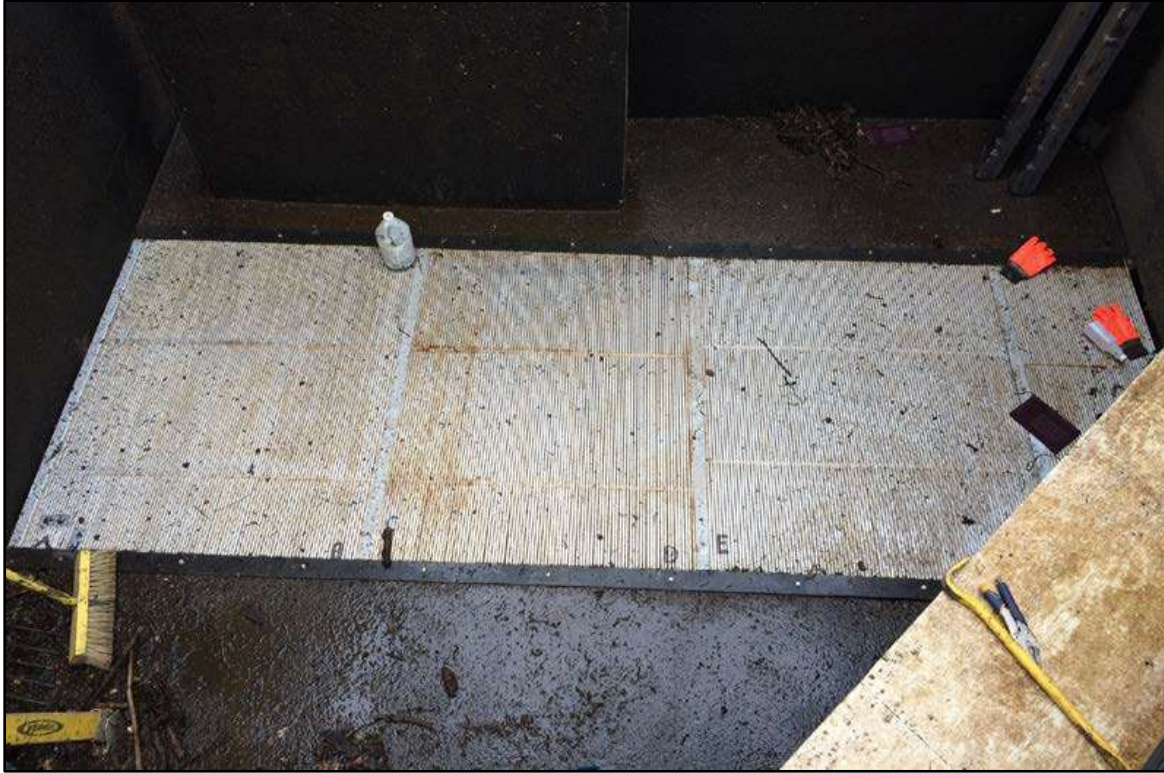
- Counting room floor grates covered with plywood,
- All visible cracks sealed with underwater sealant (e.g., floor of counting room, regulating pool walls, etc.),
- Diffuser mesh covering replaced with aluminum dewatering screen (Figure 1.0-6).

Figure 1.0-6. Aluminum dewatering screen on diffuser room floor.

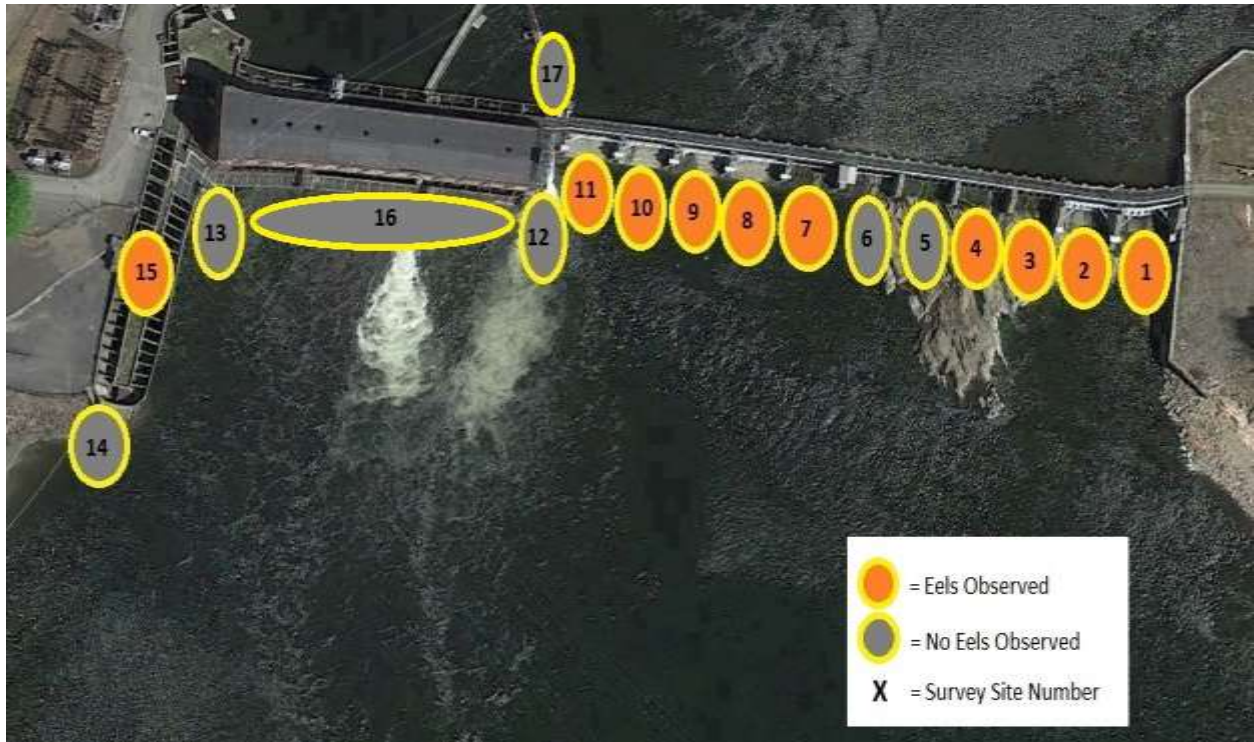
Figure 4.1-1. Vernon nighttime visual survey sites, 2018.

Over the 22 weeks of visual surveys conducted from June 7, 2018 through November 1, 2018, 221 eels were observed at Vernon dam (Table 4.1-1, Figure 4.1-1). The greatest number of eels observed in a single survey was 42 on June 13. Eels were observed at 11 of the 17 survey sites. The greatest number of eel observations (summed for all surveys) were recorded in the fishway (site 15, N = 135, 61.1% of total), the apron of Taintor gate 2 and the bedrock below it (site 02, N = 16, 7.2%); the apron of Stanchion Bay 1 and the bedrock below it (site 03, N = 16, 7.2%); and the apron of Taintor Gate 3 and the submerged flood gate below it (where most of the count was observed, site 08, N = 15, 6.8%, Table 4.1-1). Observations of eels within the fishway were limited to two locations; (1) the visitor’s viewing window, located at a large turn-pool in the fish ladder, or (2) the counting room window. At the visitor’s window, eels were observed to be actively swimming, but frequently appeared to be circling in the large turn pool. In the counting room window, eels usually appeared traveling upstream at the bottom of the water column and “falling back” or traveling downstream mid water column. Although both windows were visited during each survey, observations were more readily made at the counting room window where eels are guided towards the glass. Recorded numbers of eel observed in the fishway represent a “snap shot” and count numbers presented in this report should be considered as an approximate number of individuals visible at the viewing windows at the time of survey.

- a. Survey site numbers can be referenced to site numbers in Figure 4.1-1.
- b. Sites not visited during a given date due to safety concerns are marked by shaded cells.
- c. Site 15 (fish ladder) not surveyed July 24 or after October 15 when the fish ladder was dewatered.
- d. Site 17 (upper end ice/waste sluice) not surveyed due to lack of aggregations at Site 12.

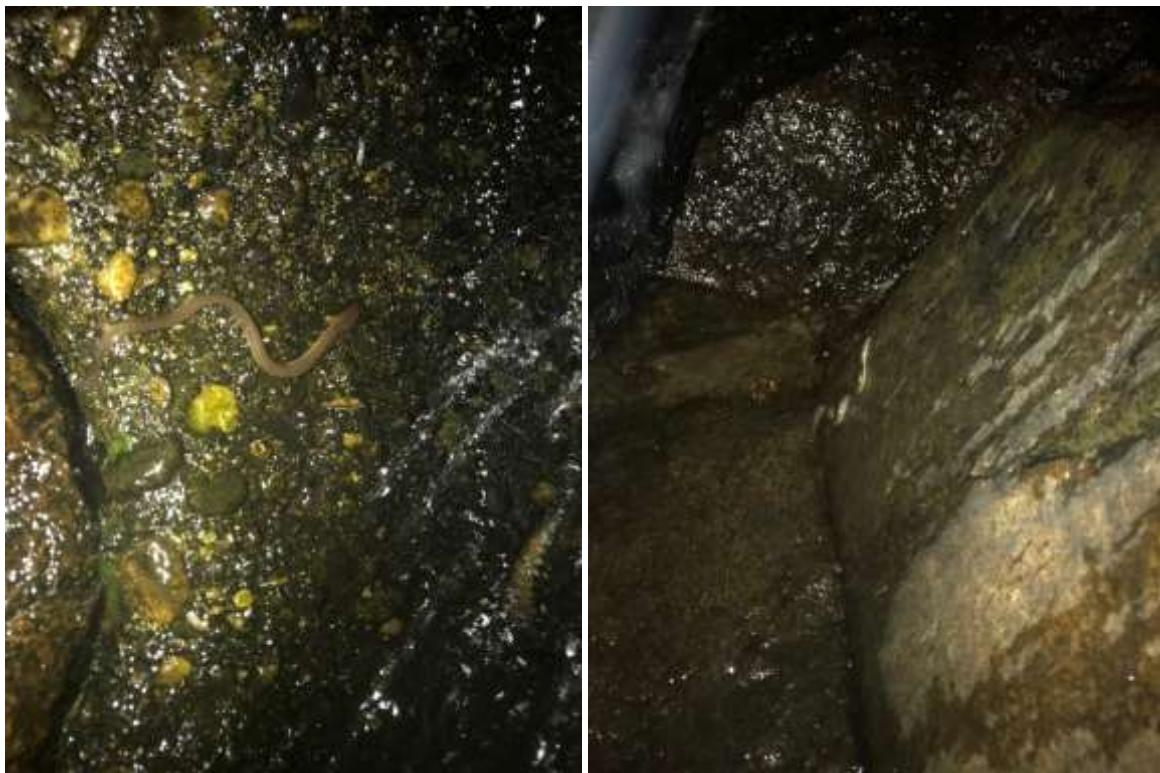
Figure 4.1-2. American Eels attempting to ascend wetted substrates at bedrock outcrop sites 1 (left panel) and 3 (right panel) on August 2, 2018.

observed in that location did not appear to be seeking flow or otherwise actively migrating at the time of observation, but instead appeared to be seeking refuge in the submerged structures. Overall, 40 eels (18% of the total) were observed in the bedrock outcrop (i.e., sites 01-04) and because the area was characterized by rivulets of running water and an increase in elevation, those eels appeared to be actively migrating (Figure 4.1-2).

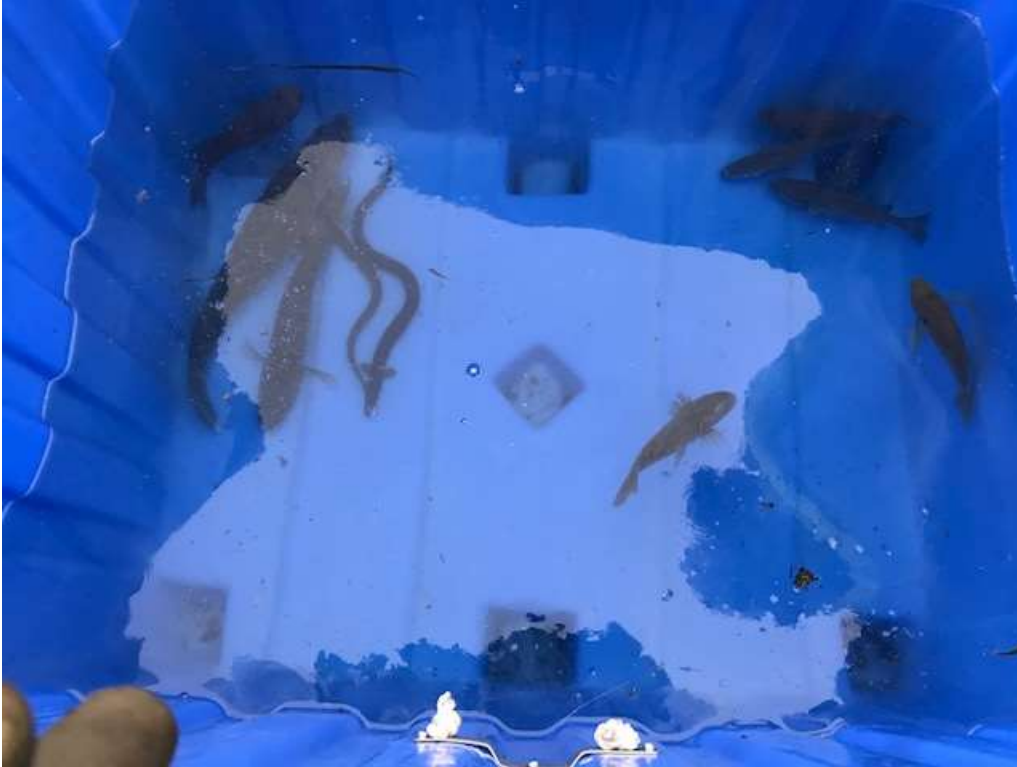
Figure 4.1-2. American Eels and other resident fish species removed from the Vernon fishway during the October 15, 2018 end of season dewatering.

During the 2018 upstream passage season which was initiated on May 14 and concluded on October 15 when the fishway was dewatered, a negative net count of 6,251 eels was estimated using the Vernon fishway as part of VANR's Vernon fish passage monitoring². Observations made during the October 15, 2018 dewatering (by J. Griffin, Great River Hydro) demonstrated a relatively low number of eels using or residing in the facility. American Eels as well as other resident fish species were removed from the fishway during the dewatering process and were later relocated (Figure 4.1-3).

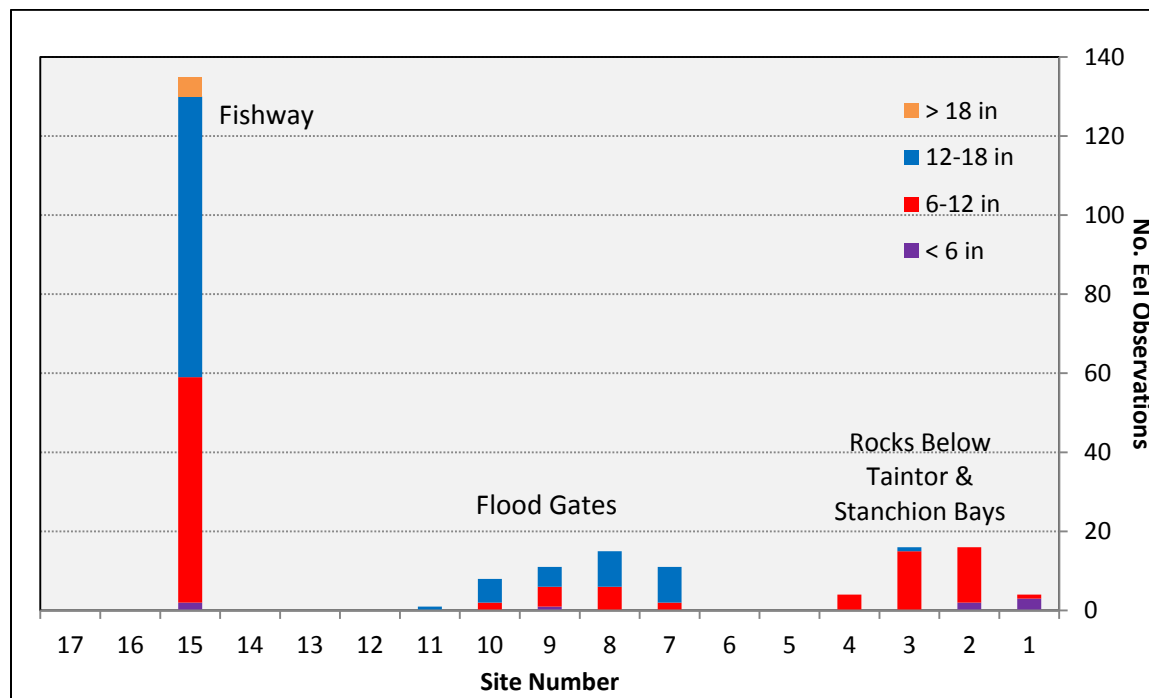
Figure 4.2-1. Length classified counts of eels observed by survey site during nighttime visual surveys, June 7 – November 1, 2018.

Eels classified in the 6-12 inch and 12-18 inch size group were the most abundant during the 2018 visual nighttime surveys, representing 48% and 46% of the total number observed, respectively (Table 4.2-1, Figure 4.2-1). Eight eels (3.6%) were classified in the smallest group (i.e., <6 inches) and five eels (2.3%) were classified in the largest group (i.e., >18 inches). The length classification of eels <6 inches was verified by both biologists conducting the survey. At the fishway (15) and flood gate (sites 07-11) survey sites, the majority of eels observed fell within the 12-18 inch size class. At the bedrock outcrop downstream of the tainter and stanchion bays (sites 01-04), the majority of eels were within the 6-12 inch size class. All five of the eels greater than 18 inches were observed in the fishway. Eels in the <6 inch and 6-12 inch length groups were viewed actively moving up the bedrock immediately below Tainter Gate 1 (site 01) and Stanchion Bay 1 (site 03) on the New Hampshire side of the dam.

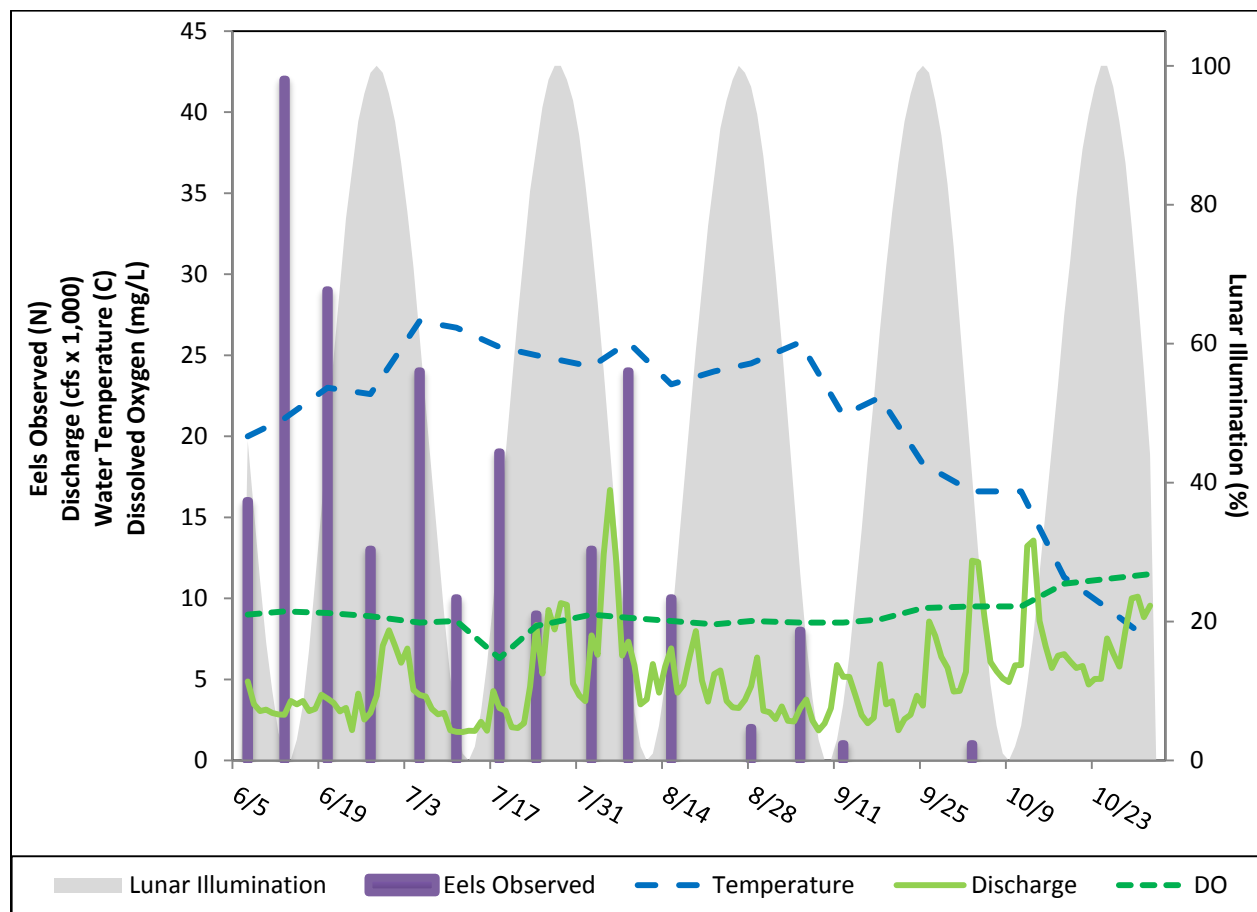
Figure 4.3-1. Number of eels observed in visual surveys (June 7 – November 1, 2018) with water temperature, dissolved oxygen, lunar illumination, and total discharge.

The majority (95%) of eels observed during the weekly visual surveys conducted in 2018 occurred between early-June and mid-August (Table 4.1-1). Approximately 50% of all eel observations occurred over the first five weeks of the study (i.e., June 7-July 5). With the exception of a single individual, all eels were observed when water temperatures were greater than 20°C, with 43% (94 of 221) occurring on survey dates where water temperature was above 25°C (Figure 4.3-1). Dissolved oxygen quality (as measured on each survey date) remained good throughout the study period (Figure 4.3-1).
