**RE:** **Wilder Project, FERC No. 1892-026**  
**Bellows Falls Project, FERC No. 1855-045**  
**Vernon Hydroelectric Project, FERC No. 1904-073**

**ILP Study 2 & Study 3, Riverbank Transect and Riverbank  
Erosion Studies dated February 4, 2017**

**CONTENTS: Landowner's comments re the above referenced document submitted  
by TransCanada / Great River Hydro on February 4, 2017.**

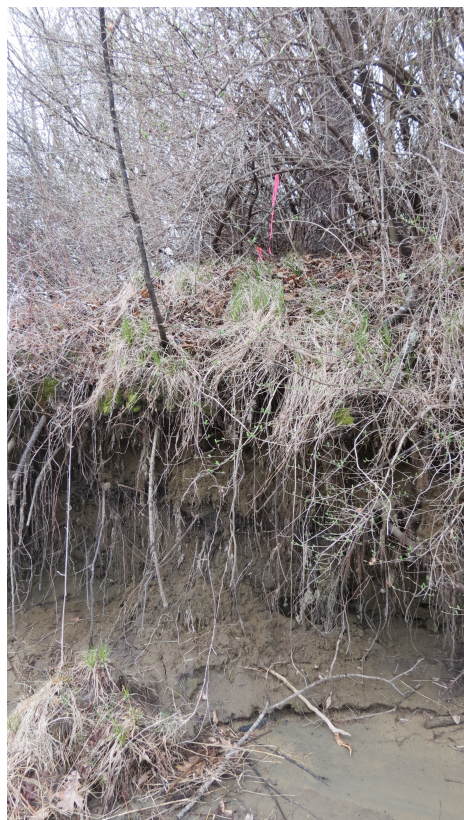
The below picture was taken on April 20, 2017. This is the western (river end) of the boundary line being discussed.

The iron pin put in by Field in 2015 is indicated with the pink flagging near the top of the picture. The erosion, exposed roots, and sculpted riverbank are obvious. In the foreground, at the bottom of the picture, is grass / sod that has fallen *from the top* of the riverbank down to the mud, the toe of the bank. This grass is obviously no longer at the top of the bank. The river is low in the picture, but remember that they say that they do not lower the level of the water. *The fallen grass / sod was at the top of the bank when Field did his measurement and would have been included in his setback. Field's "setback" is eroding and is less than it was in 2015, and in time the pin that he placed there will be gone. This has been more erosion since 2015.* This grass / sod will be washed away when the water level is raised. The dirt will then become suspended silt / sediment in the water and this adversely affects the water quality in the river.

To correct this in the future, dam operations should be modified. Both the maximum elevation of the water should be reduced and the maximum daily change in water elevations should be minimized. You have to get the water away from the permeable riverbank in order to stop the erosion.
