Study Plan Wilder Dam FERC 1892-026
McIntyre 2/26/13

Study Plan, 18CFR Section 5.9b
Submitted for the Wilder Project, FERC 1892-026
By The Town of Lyme, New Hampshire
Office of the Selectboard
Box 126
Lyme, NH 03768
lyme@lymenh.gov

Dated February 26, 2013

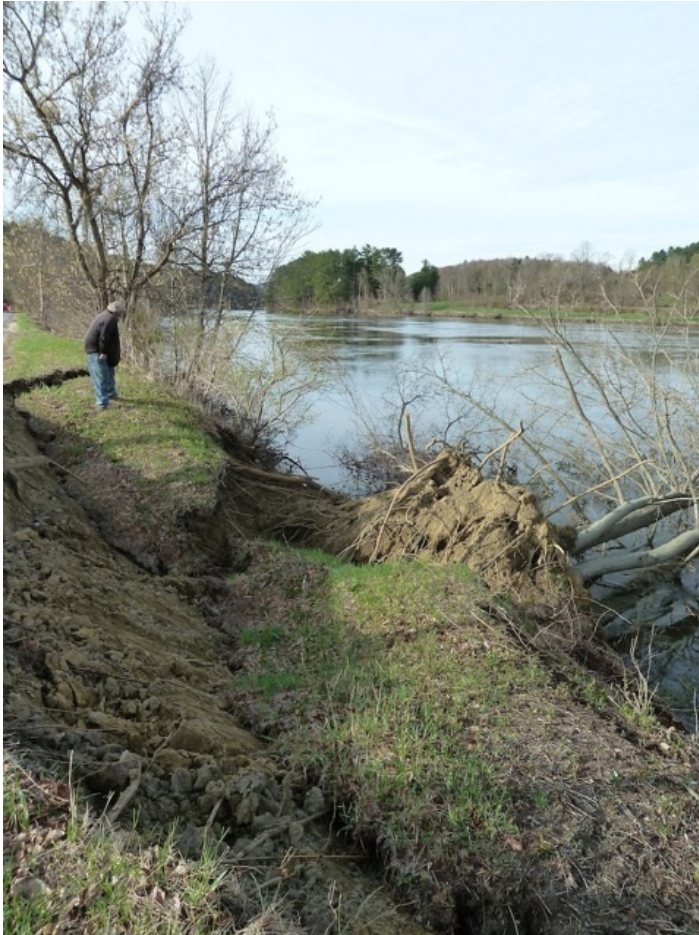
Figure 1. Collapse of a portion of Wilder impoundment bank in spring of 2011 necessitating reconstruction of 1200 feet of River Road south of its intersection with the North Thetford Road in Lyme , New Hampshire.

In 2011 a large section of the bank adjacent to the western side of River Road in Lyme, just south of the North Thetford road, collapsed into the Wilder impoundment. Because of this, 1200 feet of River Road had to be reconstructed. This road passes through Lyme and other New Hampshire river towns and was the route to Canada in colonial times. Very little rerouting has occurred, and for the most part, the road follows the same path as it did more than 250 years ago. The section of road that had to be reconstructed passes between the river and houses built around the time of the signing of the Declaration of

The engineering report prepared by HTE Northeast, Inc. states that the cause of the bank collapse was long-term erosion and undermining due to flow action, and existence of water in the riverbank soils. Piping was not a named cause although the statements concerning water in the riverbank soils is consistent with that mechanism. The report also states, **“The frequent raising and lowering of the water level by downstream dam management (Wilder Dam), over time, is a contributing factor.”**

Additional observations on River Road: Immediately north of the section shown in Figure 1 and 2, another several hundred feet of River road is threatened by erosion and is subject to collapse. **A survey of the rest of the road by the Lyme Roads Committee documents additional segments constituting about a mile in total that are in danger.**

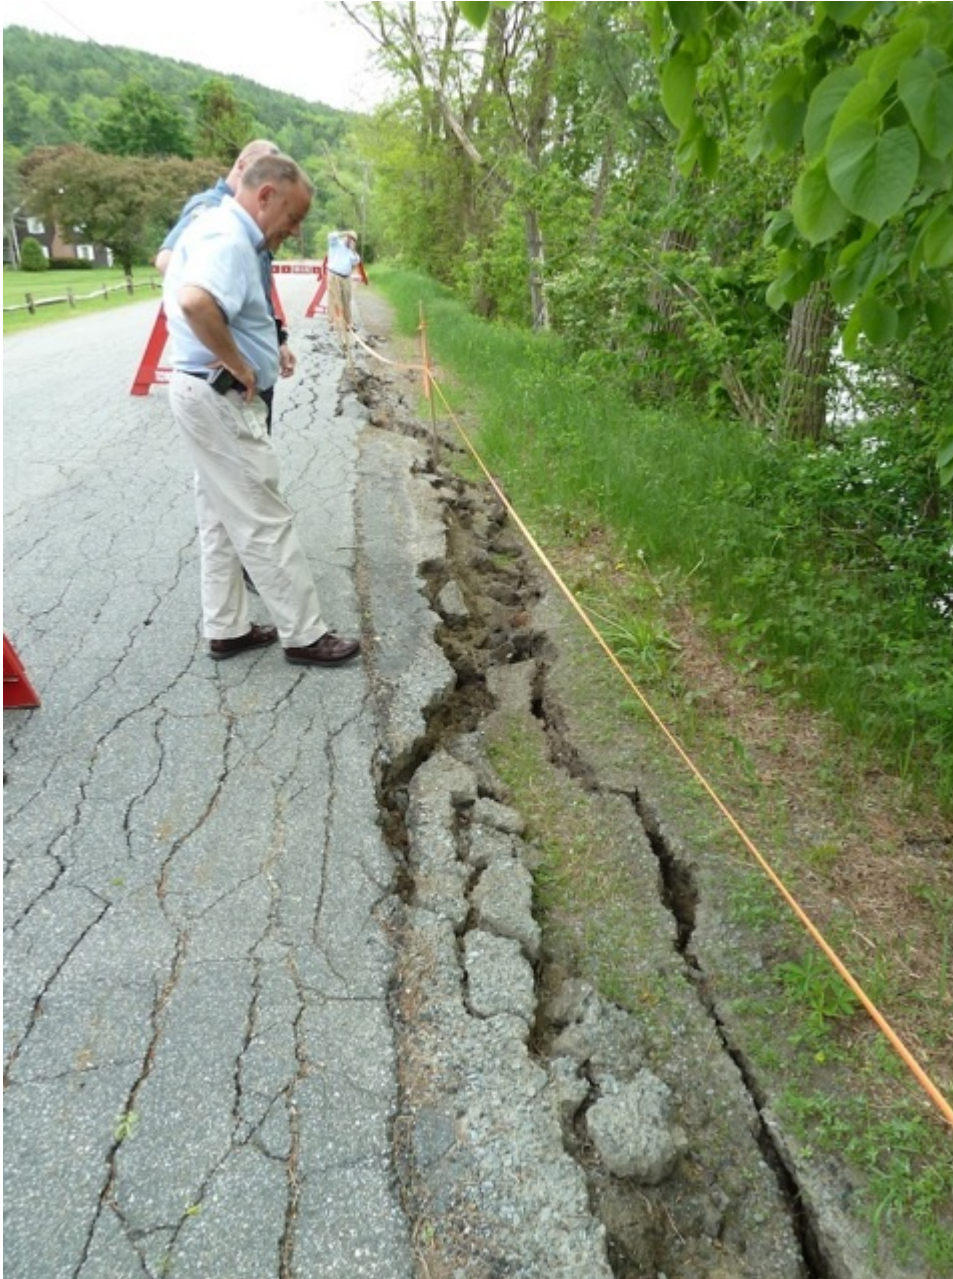
Figure 2 River Road north adjacent to bank collapse. Note pattern of cracks in blacktop and compare with those in photo 3, below, in area of slumping River Road South.

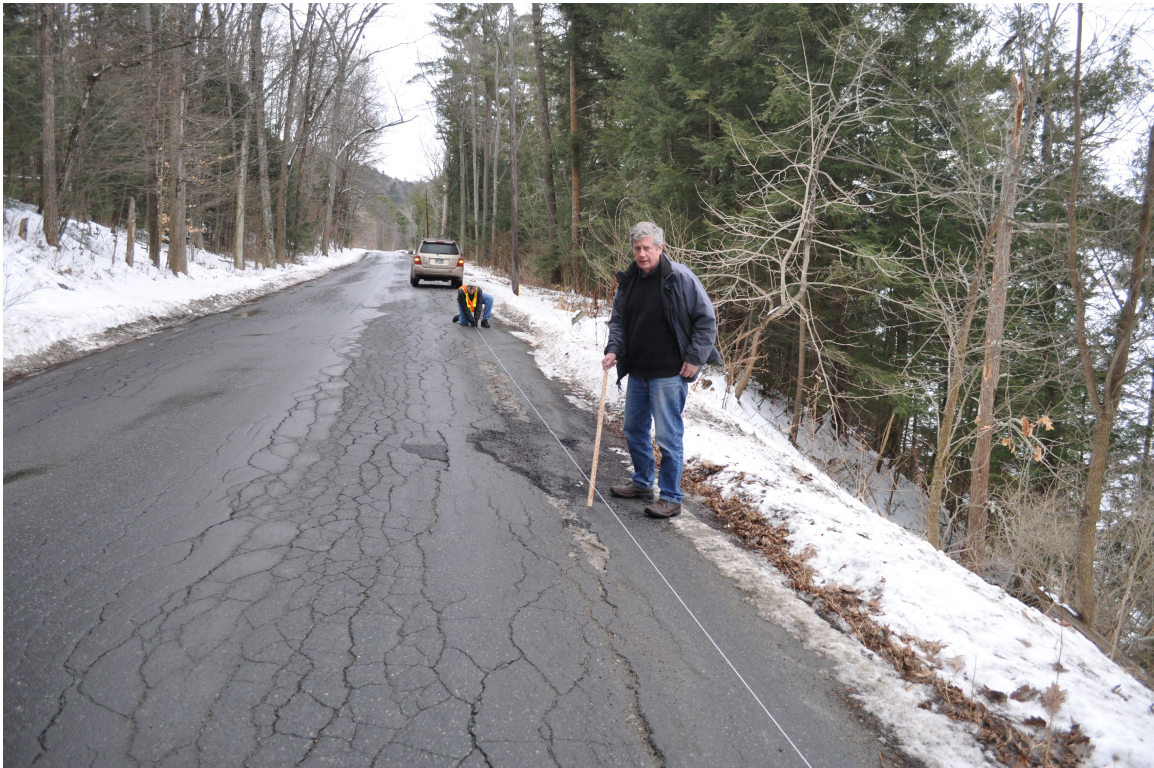
Figure 3. River Road, Lyme, looking south about a quarter mile south of the East Thetford bridge. The string is on the road at each end of the slump which is 7 inches below the string in the center. Note the cracking of the blacktop on the west side of the road due to the slump and compare it with the cracking seen in the photo taken at the site of the collapse near the North Thetford road in figure 2

River Road a quarter mile south of the East Thetford Bridge ascends to a bench that runs along farm and woodland to the east. On the west a steep bank descends to the river below. In this section 120 feet of the western half of this road has settled, with a more pronounced dip of 30 feet as shown in figure 3 below.

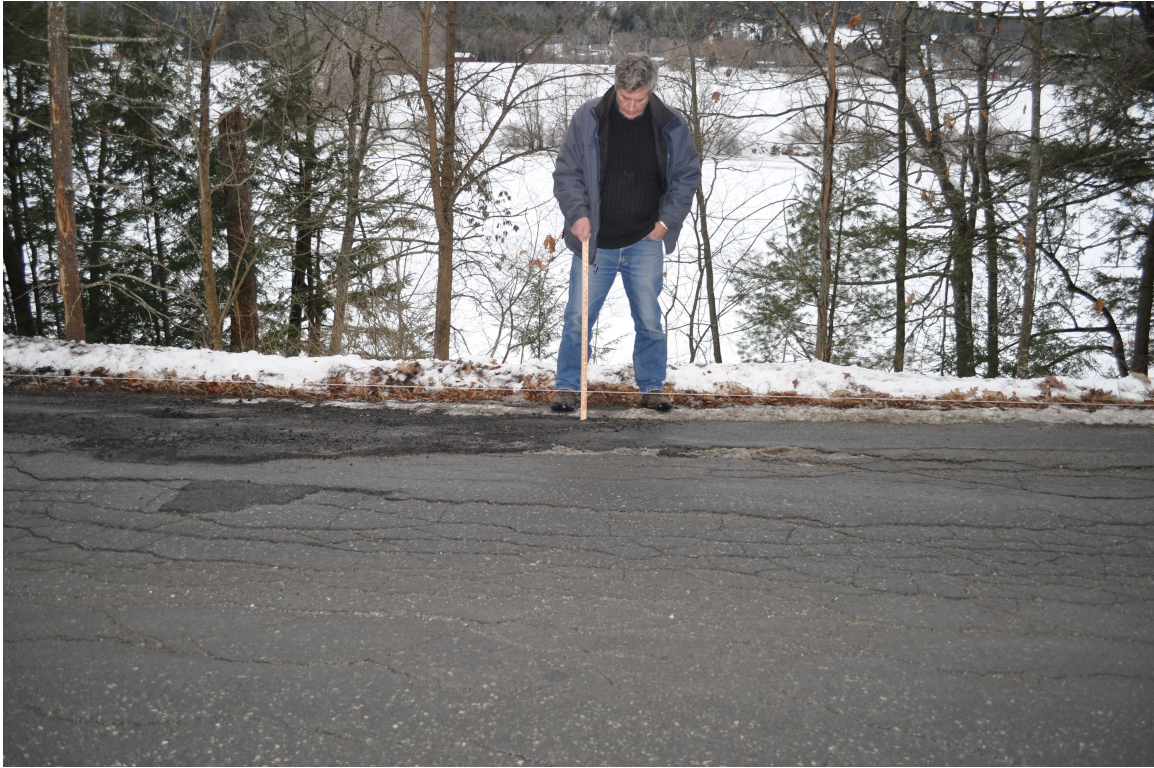
Figure 4. River road south looking west. Wilder impoundment in background. Slump in road is 7 inches.
